Report on the investigation
of a hazardous diving incident
involving

MV Norma

in the Dover Strait

on 21 June 2008

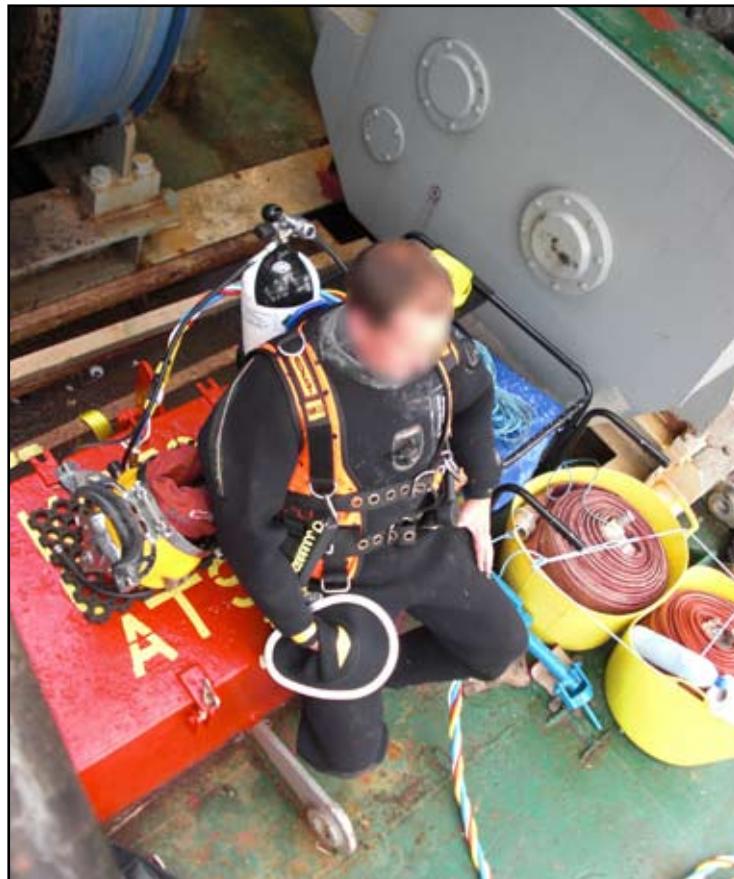
Figure 3

The purpose of the dive was to replace the light shot line with a 32mm polypropylene rope. The diver entered the water at 1125 using a full diving suit (**Figure 3**) and was attached to an umbilical cord which provided him with air, communications and a video link. The diver reported to his diving supervisor that the tide was slightly stronger than expected, but that he was happy to descend. About 3 minutes after leaving the surface he informed the diving supervisor that he was having difficulty because of tension on the umbilical cord. When he reached a depth of 20 metres, he reported that he could hardly move, and asked the diving supervisor if the surface crew were pulling on his umbilical cord. In response, the diving supervisor replied that they were not and, when the diver remarked that he wanted to come up, the supervisor told him to let go of the shot line and surface.

Diving suit

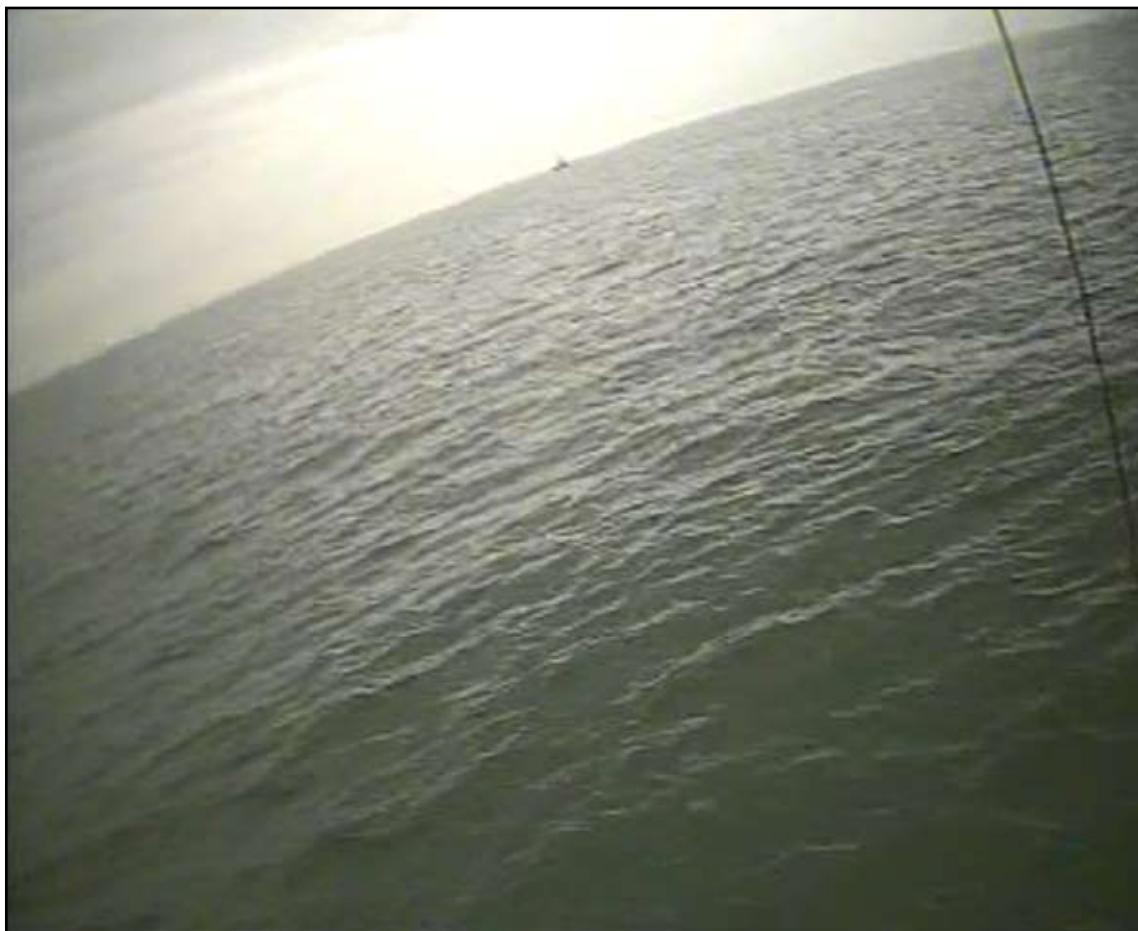
Figure 8

At the time of the incident, the weather was good. The wind was from a west-south-west direction, force 2 and the sea was slight with a low swell (**Figure 8**). High water at Dover was at 1339 and the predicted tidal stream at 1139 was 0.4 knot in a south-westerly direction.

Weather-view of diver before entering the water

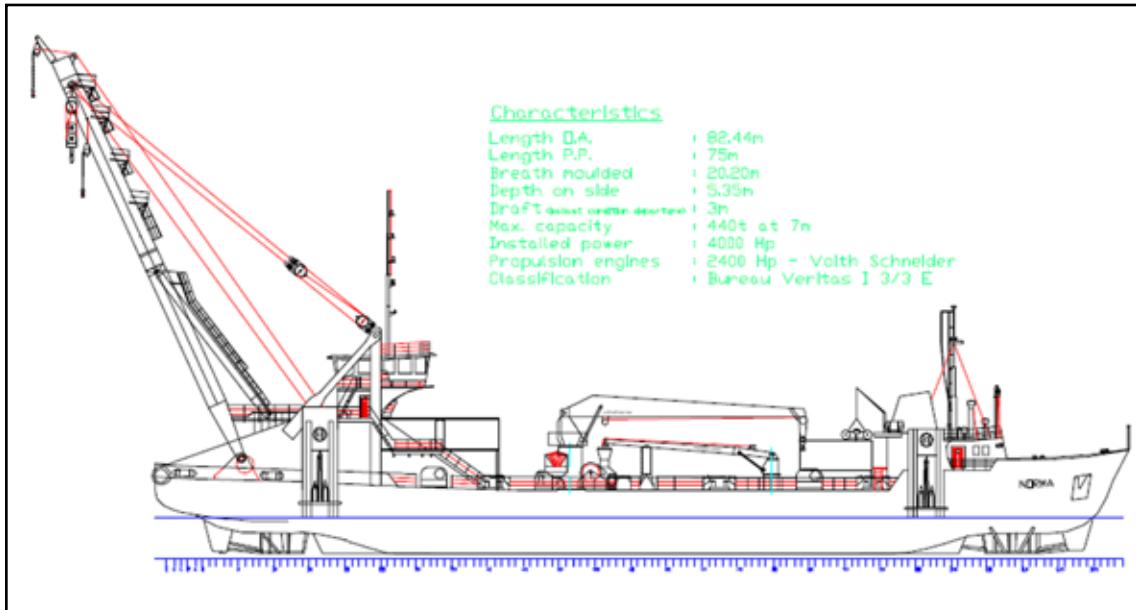
Figure 9

Profile plan of *Norma*
