Report on the investigation of
the console detachment of the
rigid inflatable boat

Partner 1

Studland Bay, Poole

Report No 19/2008
October 2008

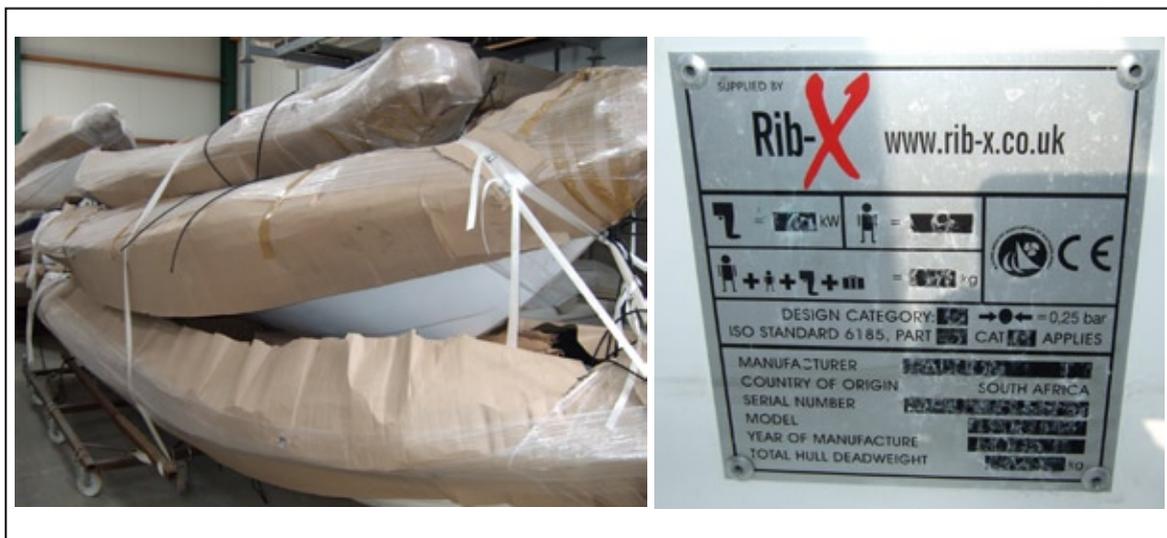
Figure 11

The bare hull of *Partner 1* was manufactured in South Africa in February 2005 and was exported to the United Kingdom (UK) with a CE marked builder's plate attached (Figure 11).

Bare hulls imported into the UK from South Africa

RIB-X sold the Explorer XP510 (*Partner 1*) to Poole Boating Centre, with the original CE marked builder's plate attached (**Figure 11**). RIB-X does not produce its own builder's plates, or generate CINs, for the boats it builds and places on the market. **Figure 13** shows the detail of the information contained on the builder's plates affixed to *Partner 1* and an unnamed RIB-X Expert XT520.
