Report on the investigation of
the grounding of

Astral

on Princessa Shoal,
East of Isle of Wight

Report No 4/2009
January 2009

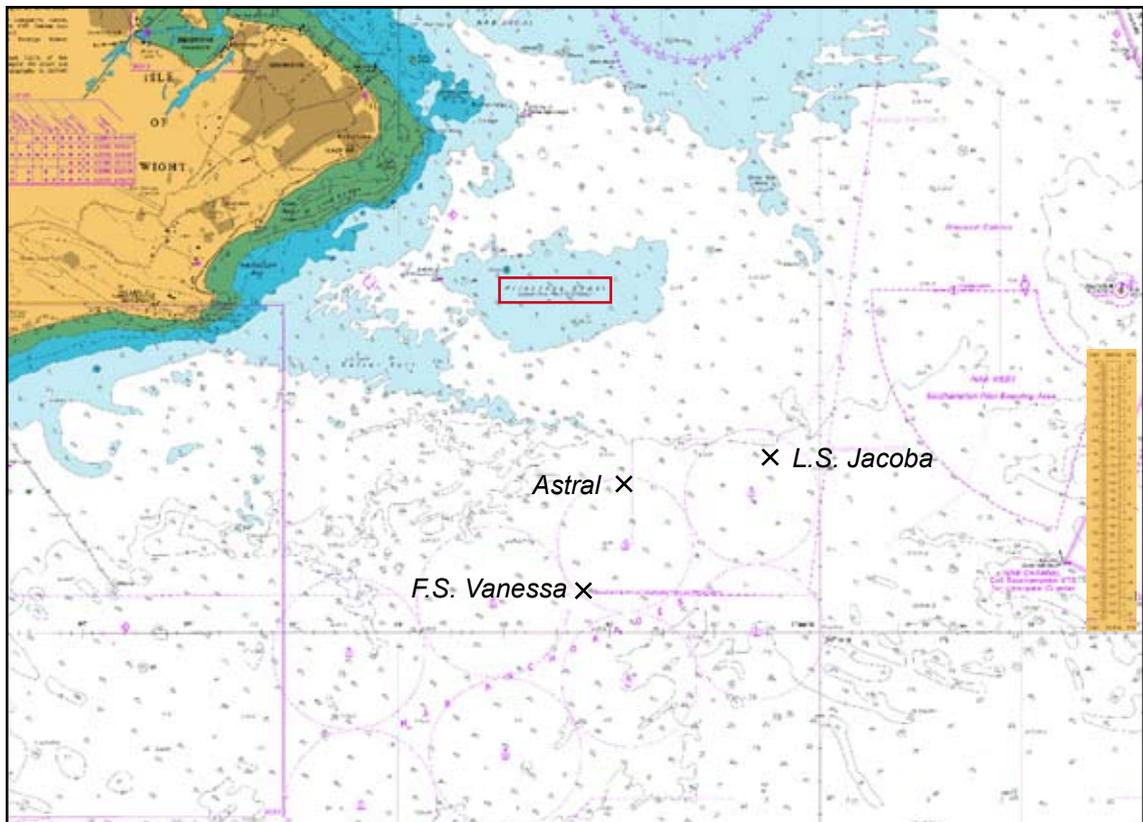
Figure 1

There were two vessels at anchor nearby as *Astral* made her approach to the No.3 anchorage. The 143m long tanker *LS Jacoba*, which was also scheduled to berth at the Esso terminal, was already anchored in the adjacent Nab anchorage No.4. The chemical tanker *FS Vanessa* was at anchor south of the boundary of No.2 and No.3 anchorages (**Figure 1**).

Position of anchored vessels when *Astral* dropped anchor at 1545, 7 March 2008

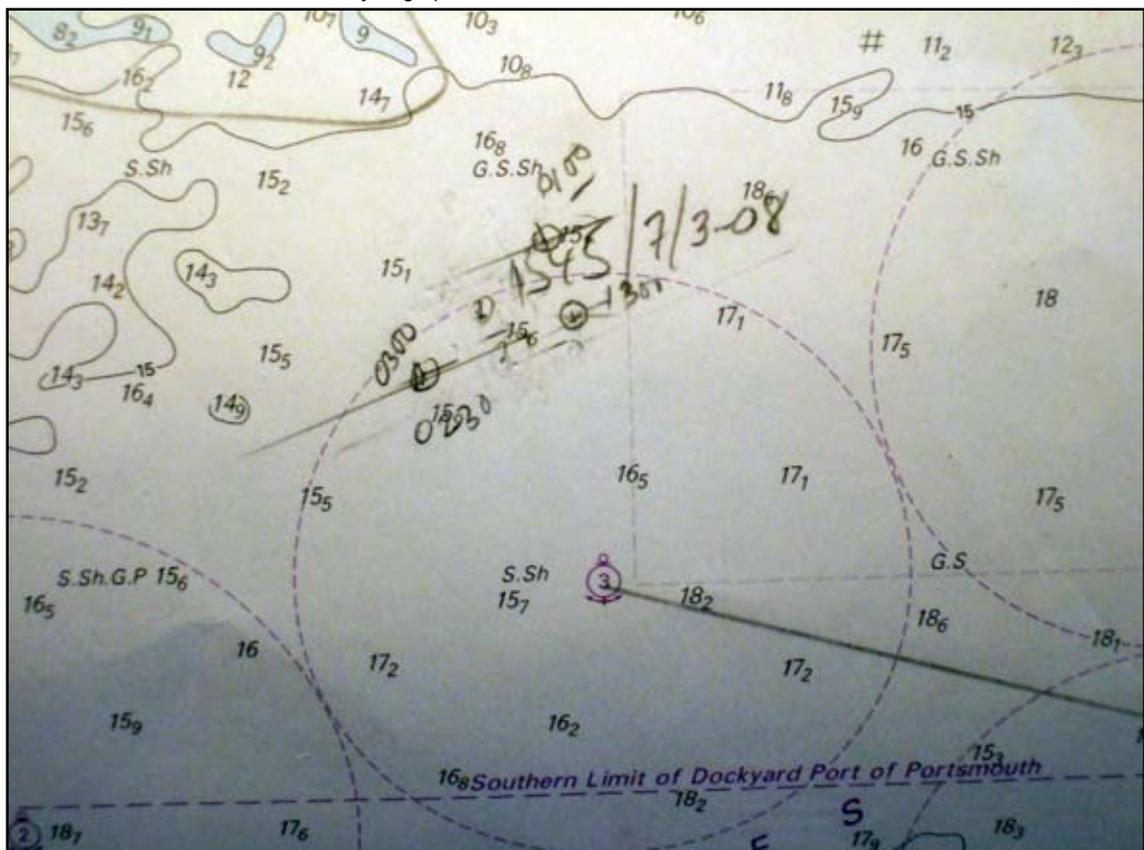
Figure 2

Once the anchor was brought up¹, the 2/OS returned to the bridge and took over the anchor watch from the master. The position of the ship was plotted on the paper chart when the second officer returned to the bridge (**Figure 2**). The position of the anchor had not been established and the bridge swinging circle around the anchor position was not plotted at the time.

Extract of *Astral's* chart showing plotted positions

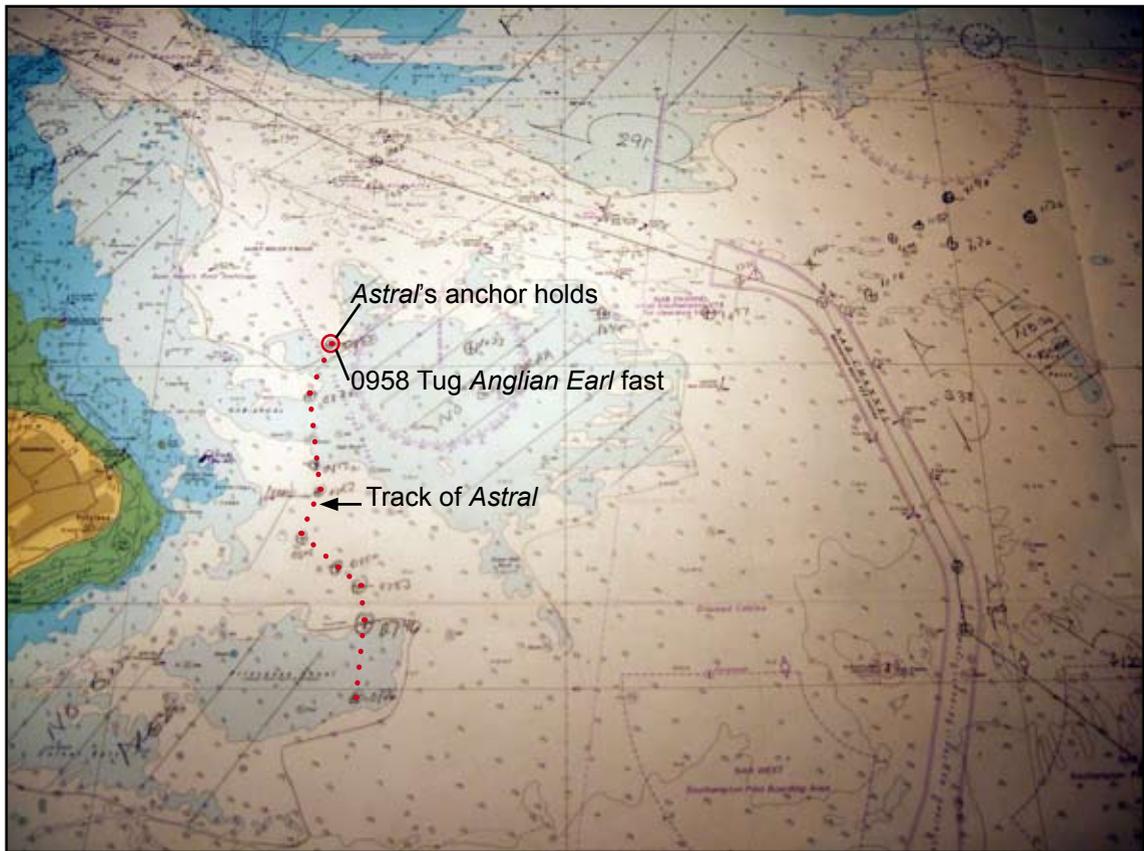
Copy of chart showing *Astral's* positions following grounding

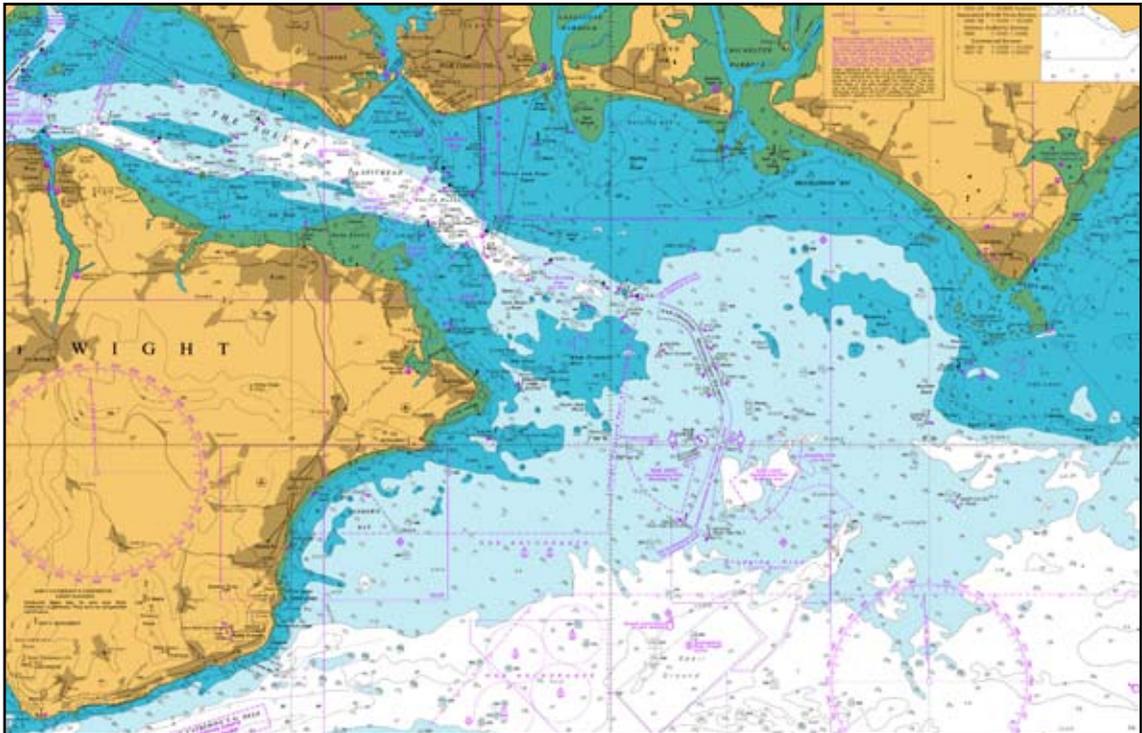
The Nab anchorage was developed by the Port of Southampton and the Dockyard Port of Portsmouth to manage the anchoring of waiting vessels, and to keep them from anchoring directly in the approaches to the pilot boarding position at the Nab Tower. Twelve designated anchoring positions, 8 inner and 4 outer anchorages (**Figure 11**), are situated between 2.5 and 6.5nm south-west of Nab Tower in depths between 15 and 27m. Of the 8 inner anchorages, 1 lies entirely within, and 4 lie partially within the Dockyard Port of Portsmouth Statutory Harbour Area (SHA) (**Figure 5**).

Chart showing overview of NAB anchorages

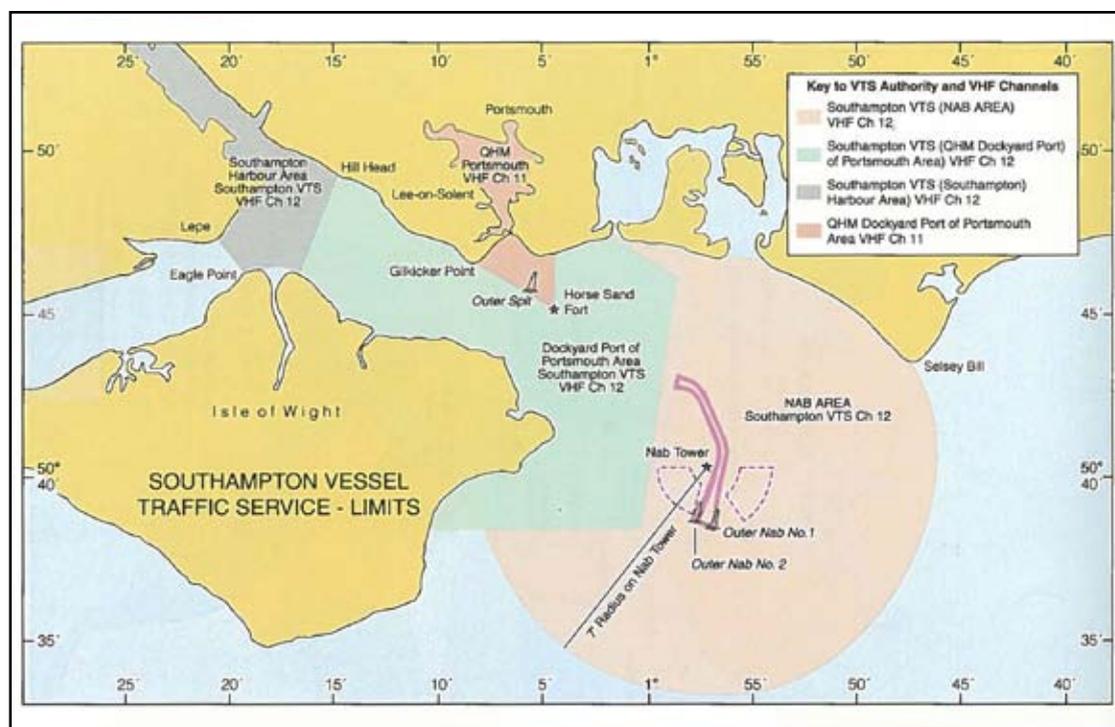
Figure 12

The eastern approaches to the Solent lie in the Dockyard Port of Portsmouth's SHA, but as the channel is primarily the approach to the Port of Southampton, following an agreement between the two ports, ABP Southampton is the VTS Authority and the competent harbour authority (CHA) for the area (**Figure 12**).

CHA areas

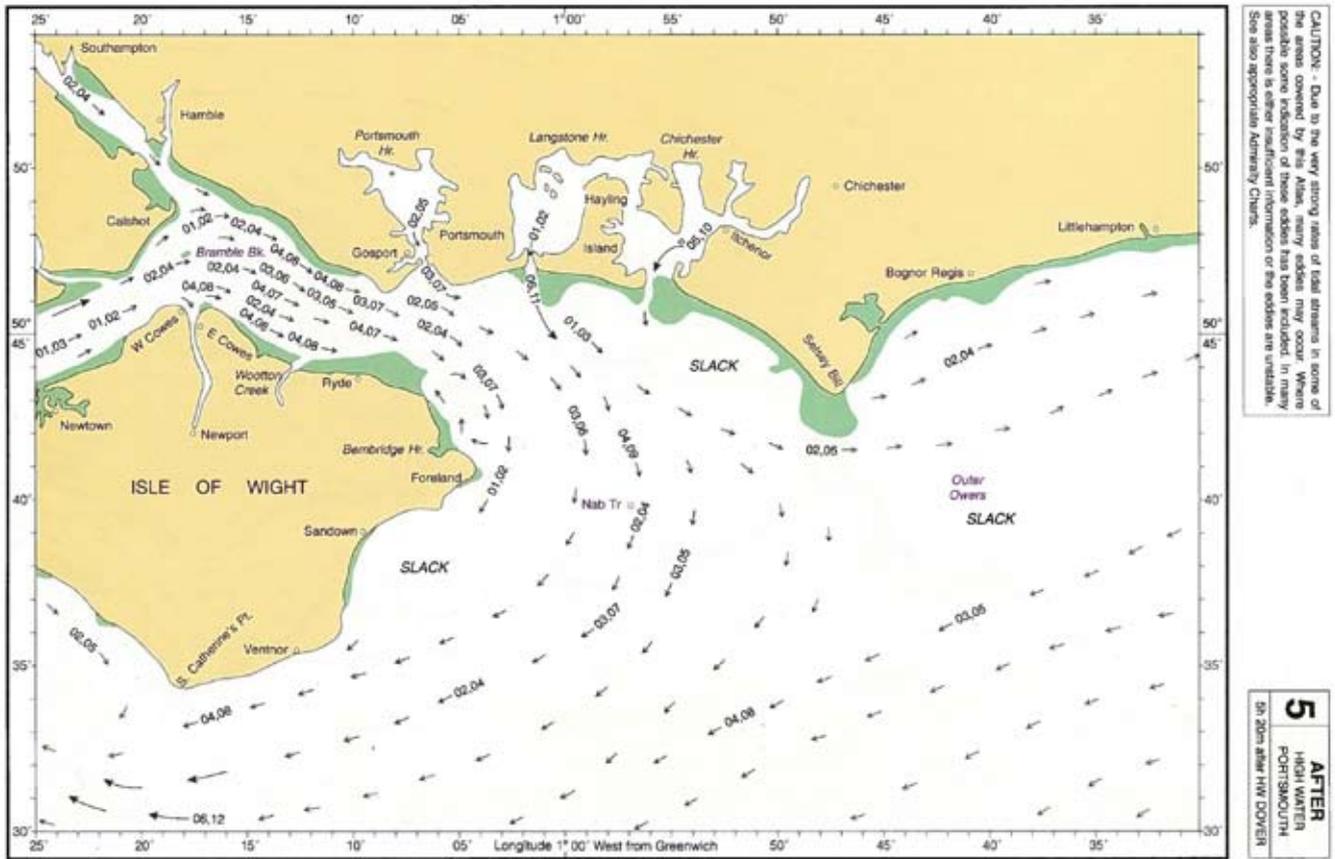
Figure 13a

The Admiralty tidal stream atlas for The Solent and Adjacent Waters is shown for 0644 and 0744 on 10 March (**Figure 13**). The tide can be seen to change from slack water to a NNE'ly flow of around 1kt at the time *Astral* started to drag anchor.

Tidal flow at 0644 (ship's time)

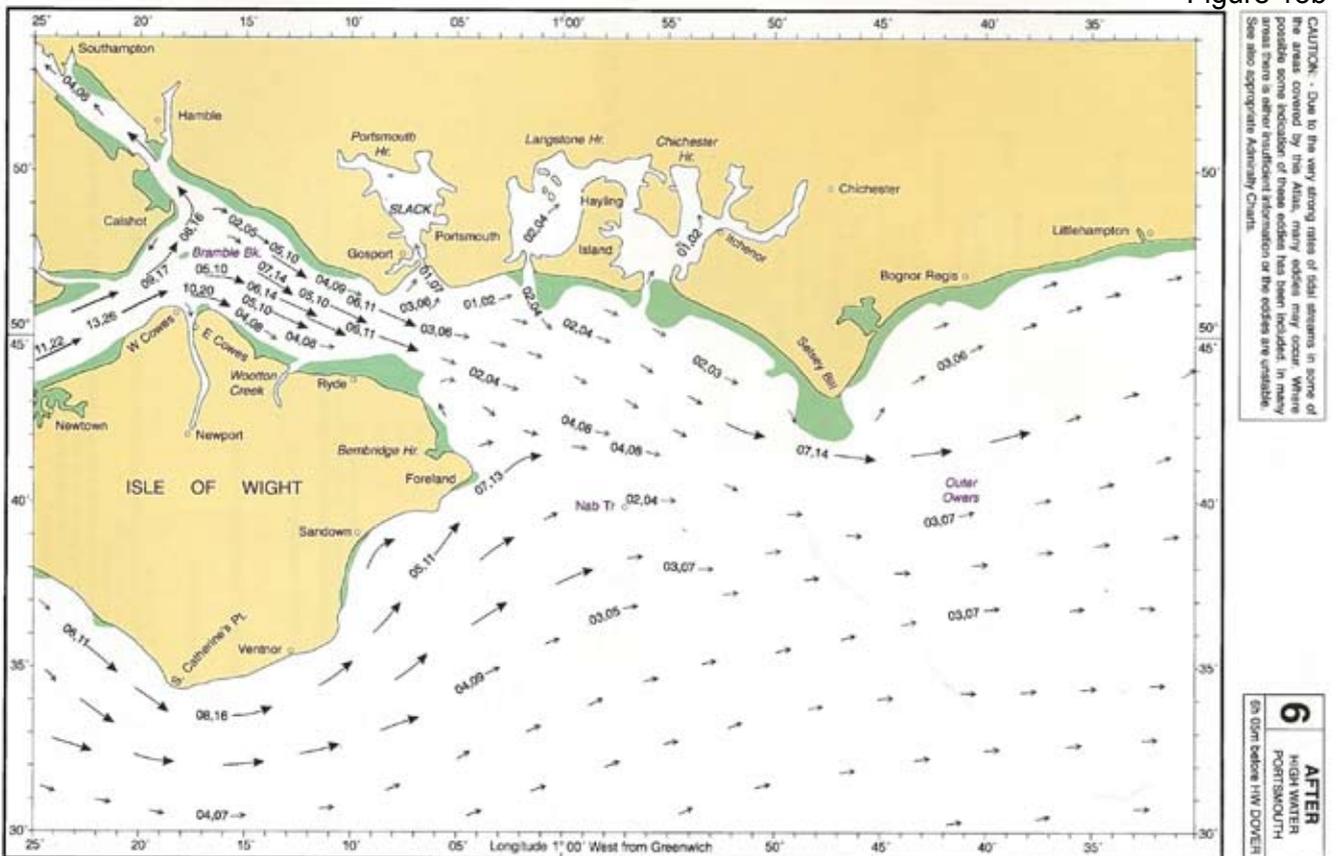
Figure 13b

Tidal flow at 0744 (ship's time)

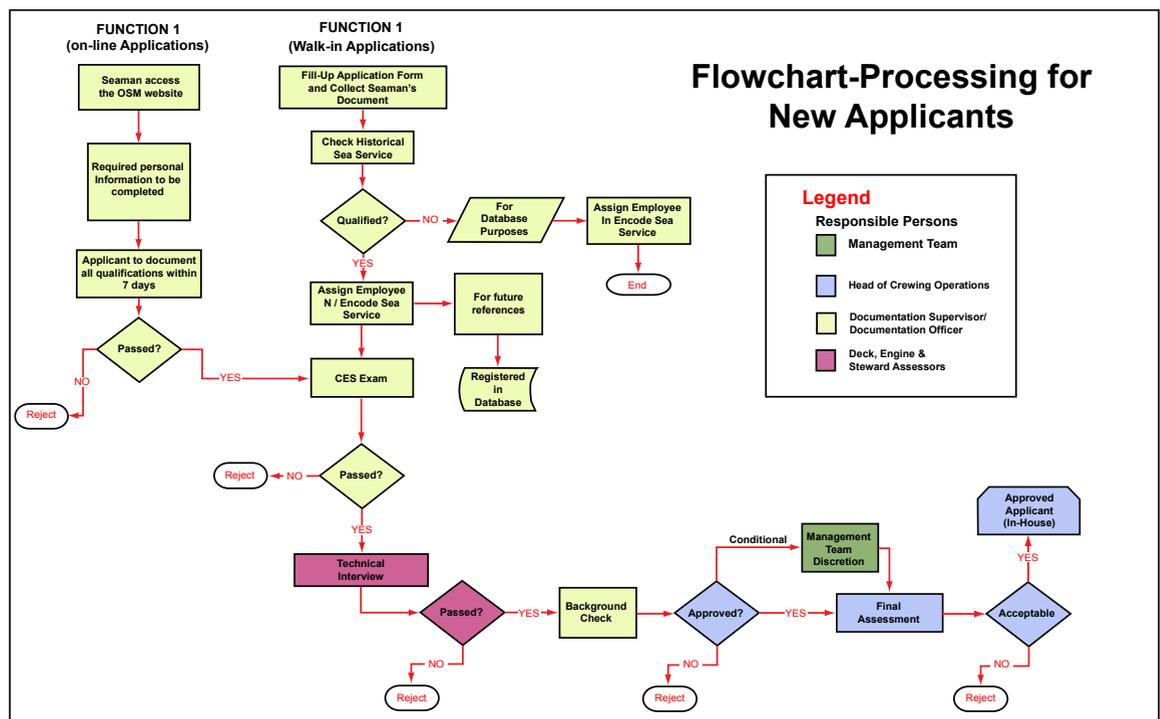
Figure 14

OSM's employment acceptance procedures are illustrated in the flow diagram shown at **Figure 14**.

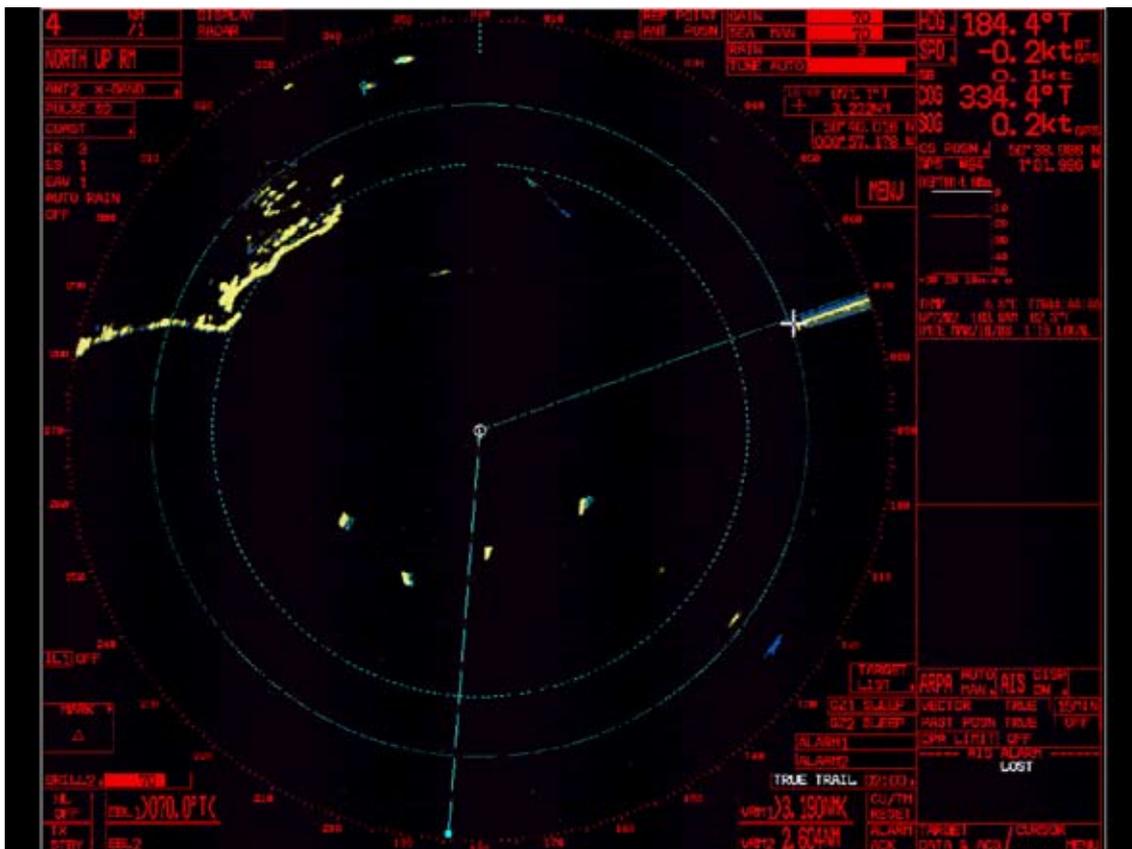
Figure 16a

The 2/ON monitored the vessel's position by noting the range and bearing of Nab Tower by the radar cursor, and visually monitored the GPS position. He did not plot the ship's position on the chart. **Figure 16** shows the radar display used by the 2/ON, showing the position of the cursor and the relative position of the VRM, EBL and the Nab Tower as the vessel drags anchor until the time the 2/ON calls the master and duty engineer.

At anchor

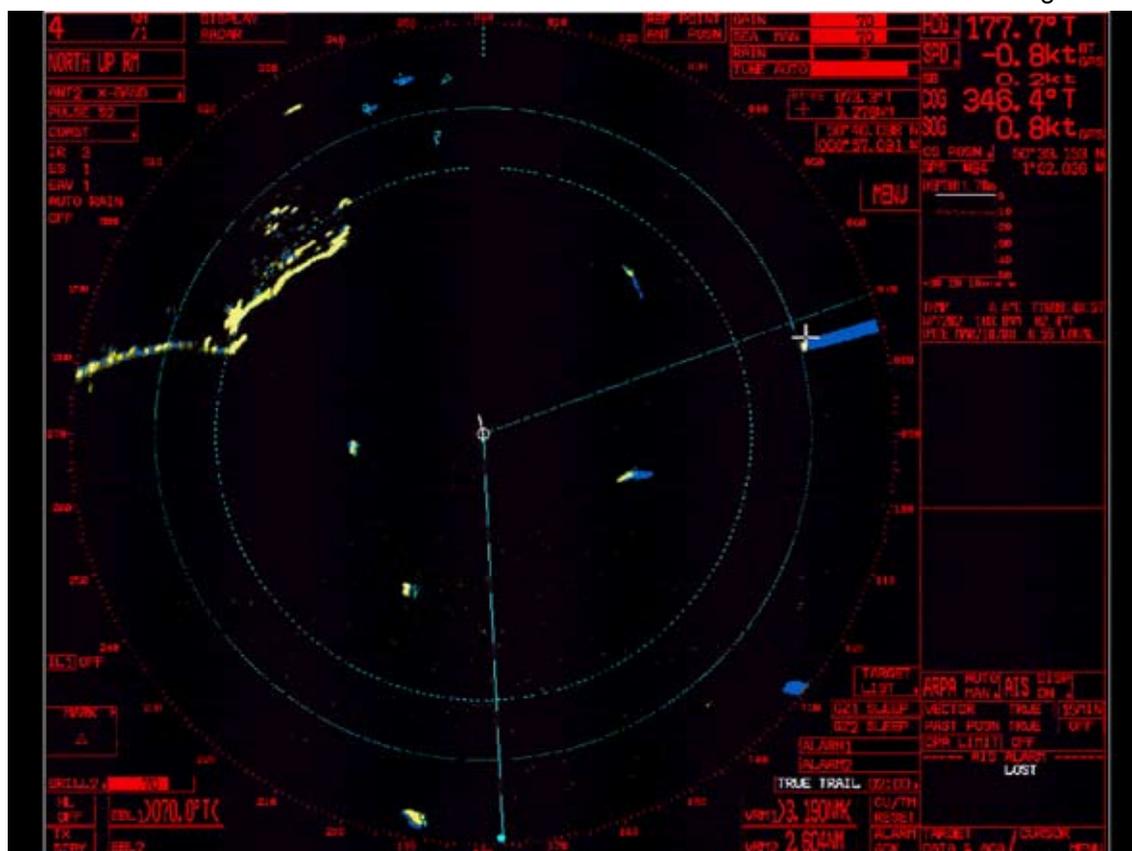
Figure 16b

Astral starts to drag anchor at 0655

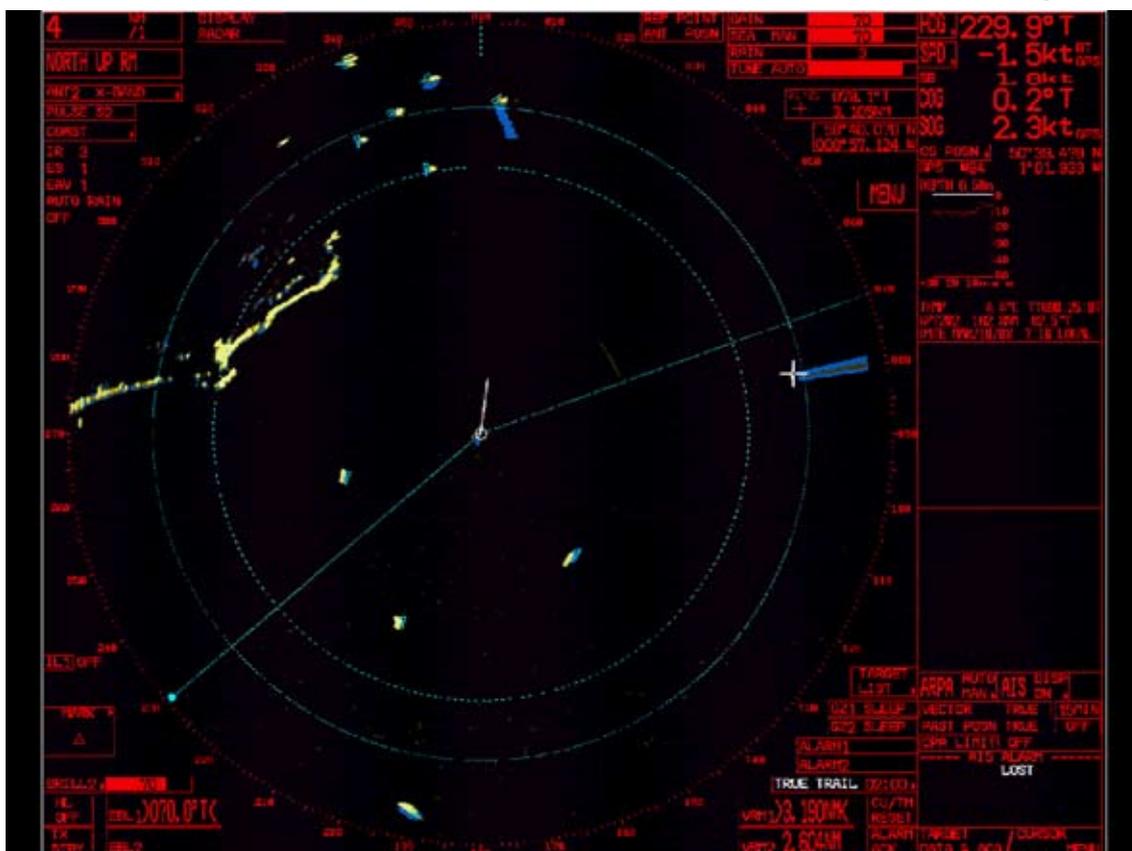
Watch officer calls master at 0710
