Report on the investigation of
Sichem Melbourne
making heavy contact with mooring structures
at Coryton Oil Refinery Terminal
on 25 February 2008

Report No 18/2008
October 2008

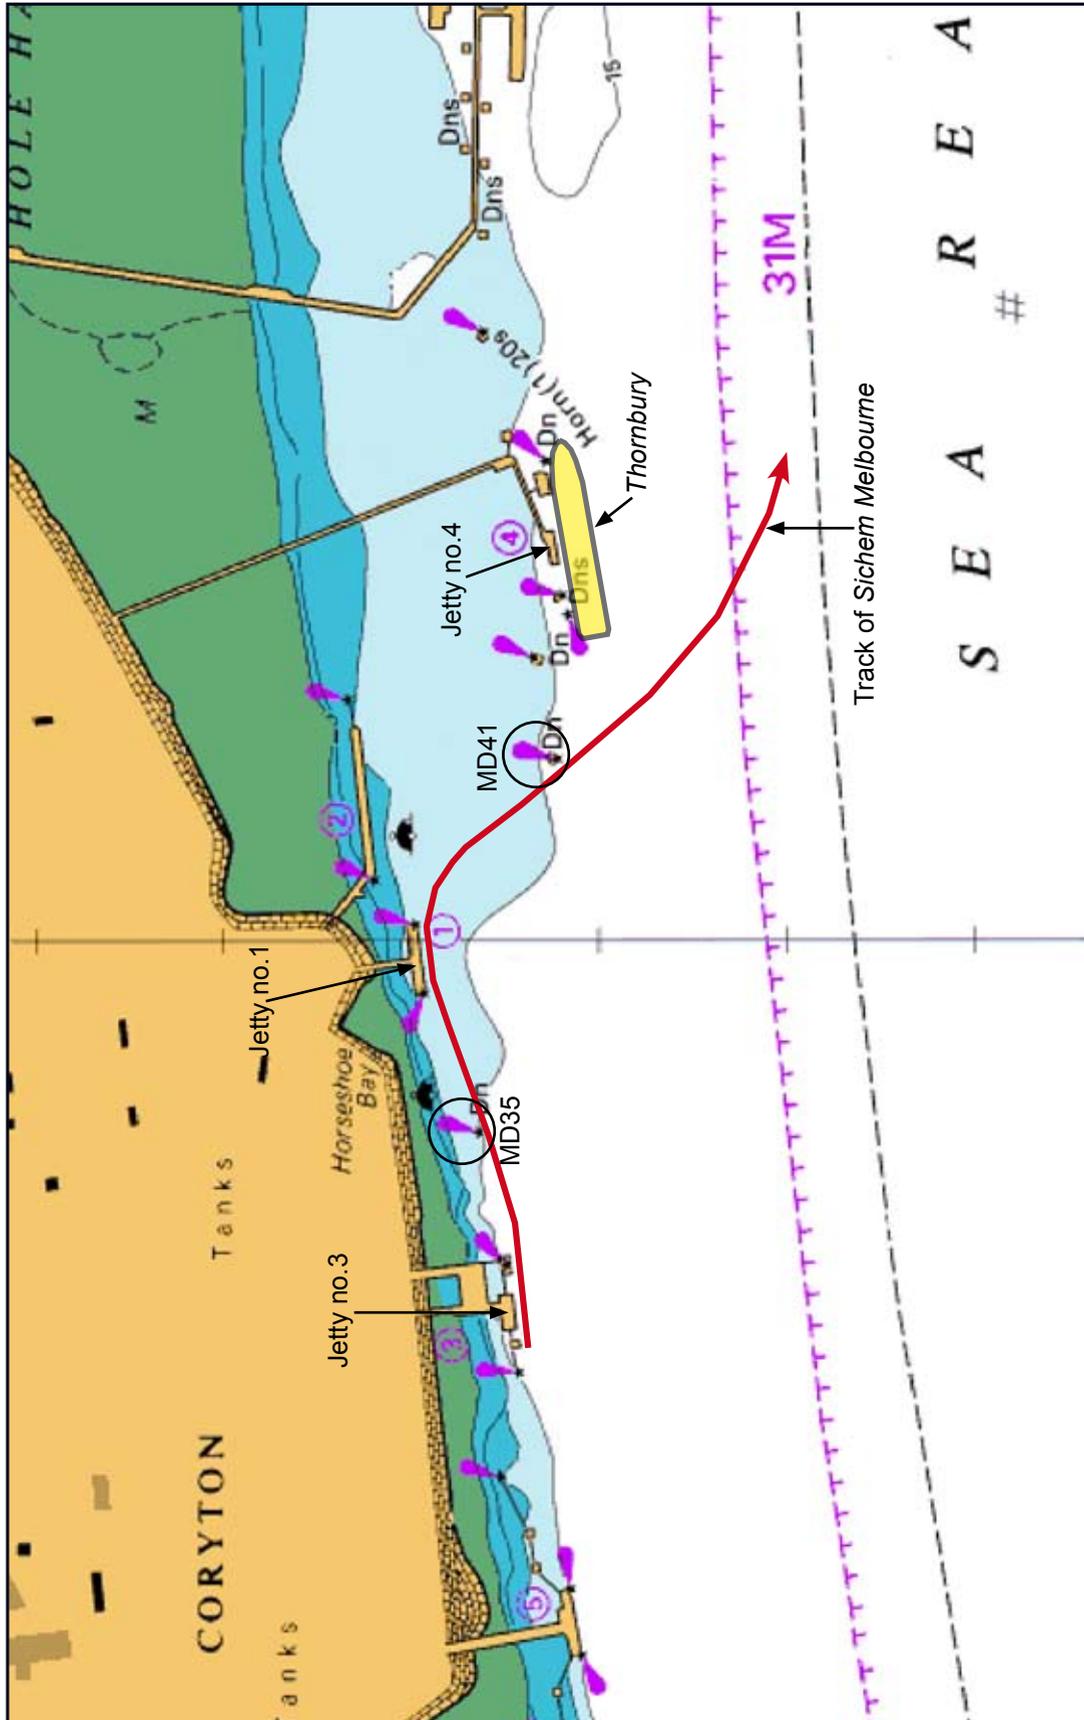
Figure 2

The pilot made an attempt to stop the ship's forward movement by giving instructions to come astern, however this resulted in transverse thrust from the right handed propeller setting the ship towards the shore and mooring dolphin MD35 (**Figure 2**). On seeing this, the pilot requested that the engines were put half ahead, and the helm hard a port in a further attempt to pivot *Sichem Melbourne* clear of the dolphin and move her stern towards the channel; this was thwarted by the master once more applying starboard bow thrust without the pilot's knowledge. Consequently the ship made contact with the dolphin MD35.

Jetty 3's supervisor observed *Sichem Melbourne*'s departure and erratic manoeuvres, and called, using VHF radio, firstly the ship and then the harbourmaster's launch, to advise that *Sichem Melbourne* had hit the dolphin. He also warned that there was a danger that she may experience further problems, and requested tug assistance. Unfortunately this transmission was lost due to both parties speaking on the radio simultaneously. The transmission did, however, alert berthing and workboat staff on jetty 1 (**Figure 2**), who then observed the wayward ship and evacuated the structure as she bore down on them.

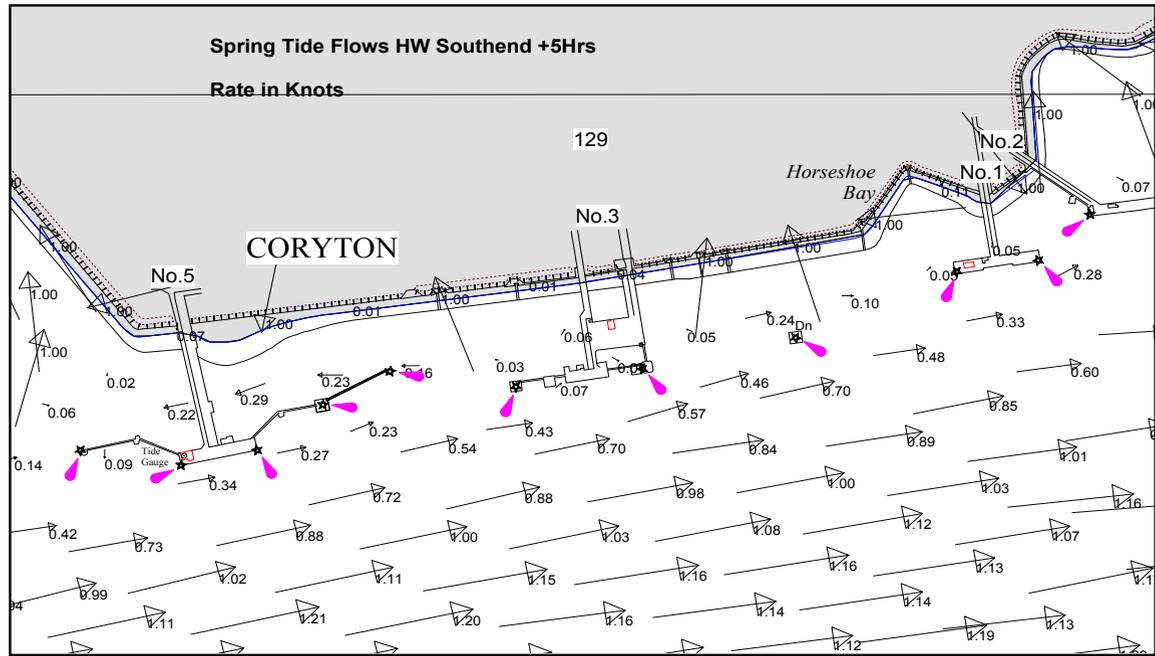
Figure 6

PLA owns, in conjunction with HR Wallingford¹, a sophisticated two dimensional tidal model, which gives detailed tidal predictions at various points on the River Thames; the predictions for Coryton at the time of the accident are shown in **Figure 6**. Observed tidal values and surge differences from the predicted datum are monitored at various points throughout the river; **Figure 7** gives this information for Coryton, 2 hours before and after the incident. This indicates that the heights of tide, and therefore stream velocity at the time of the accident, to be very close to the predicted values.
