QinetiQ report on stability investigation of mv *Riverdance*

# MV RIVERDANCE Stability Investigation for MAIB

August 2009

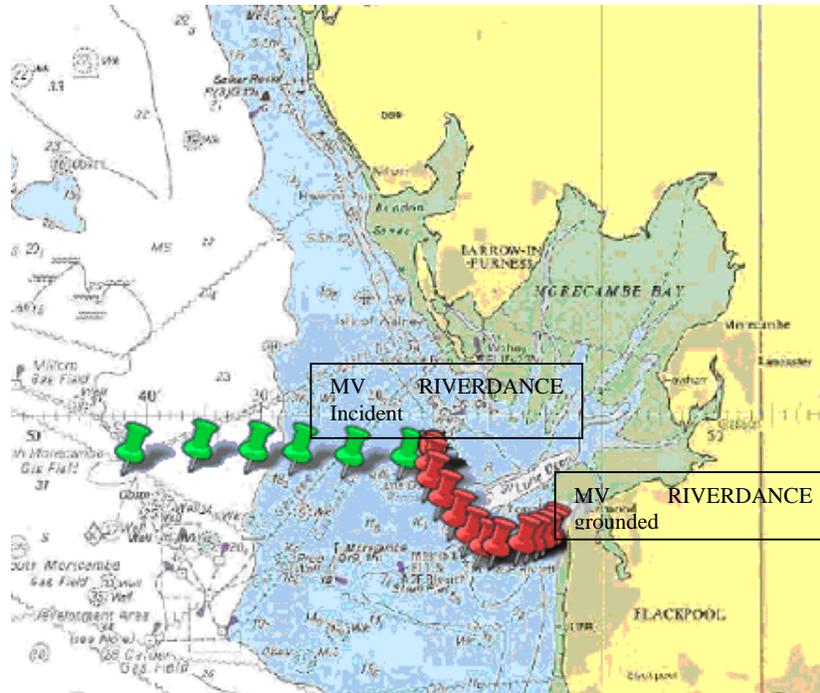
Figure 2-1 - MV RIVERDANCE track

- 2.1.1 Utilising the vessels' GPS track information and recorded data from the vessel heading, it is possible to show the track of the MV RIVERDANCE during the evening of 31st January 2008 on Admiralty Chart 1121, Figure 2-1, showing the location of where the incident occurred. From this data it can be seen that the MV RIVERDANCE was on a steady heading Easterly when at 1930 (approximately) an incident occurred resulting in a sharp and rapid turn to Starboard. From this point on she drifted in close to beam seas until she ran aground on the beach. Prior to the incident the MV RIVERDANCE was travelling at around 13Kts.

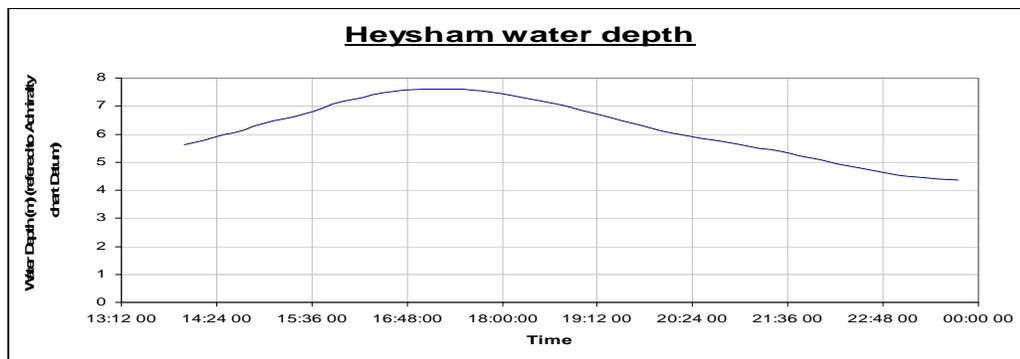
*Figure 2-2 - Water Depth*

2.2.5 Data regarding tidal movements was obtained from a measuring station located at Heysham. The water depth for the time of time of interest is shown in Figure 2-2 below. From this data it can be seen that at the time of the incident the tide was ebbing, with high tide at 1715 (approximately).

2.2.6 From the position data of the MV RIVERDANCE, the position where the rapid turn event occurred was 53° 56' 20.5", -3° 15' 27". At this point the depth (reduced to chart datum) is 10.05m. Water depth (based on Heysham tide data) at the time of the event was 6.5m, therefore the total water depth was 16.55m, Table 2-2 - Water depth Information.

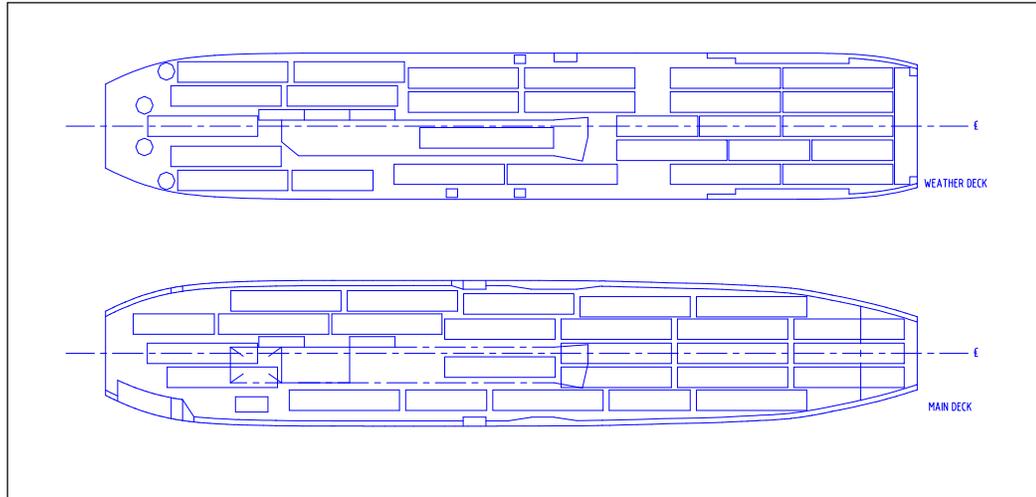
*Figure 2-3 - Most likely cargo positioning*

2.6.18 It is then necessary to consider the positioning of the cargo relative to the ship, i.e. it would be possible to position all the cargo as far forward within the ship as can be physically achieved. The RAF video has been used to establish the most likely positioning of the cargo relative to the ship on leaving Warrenpoint. This is illustrated by Figure 2-3.

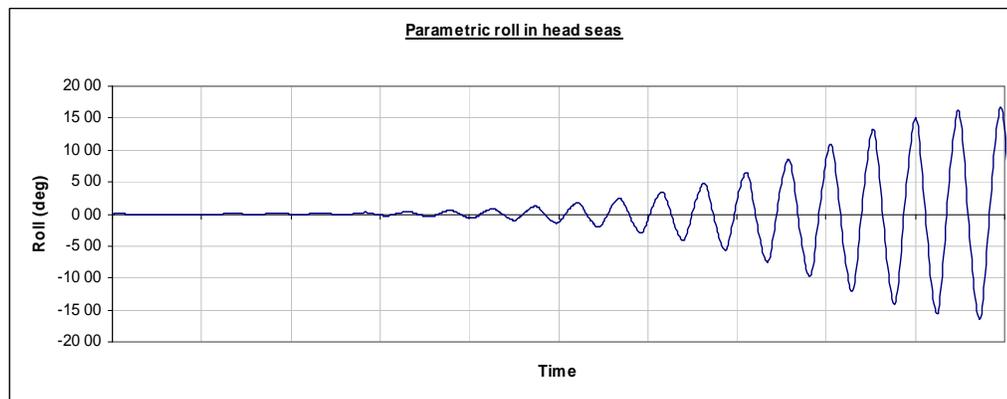
*Figure 3-1- Parametric roll in regular head seas.*

- 3.2.6 The condition required for parametric roll resonance of the MV RIVERDANCE cannot occur in stern waves, which the vessel was at the time of the incident, due to the required encounter period. However, it should be noted that the conditions for parametric rolling could occur in head seas. These ideal conditions were evaluated using regular waves in the FREDYN time domain program and it was found that a small disturbance could lead to parametric roll resonance in head seas with a roll motion building to over 15 degrees, as shown in Figure 3-1. Due to the fact that the MV RIVERDANCE was in stern seas at the time of the incident it is suggested that parametric rolling was not a contributing factor in this incident and can be discounted.

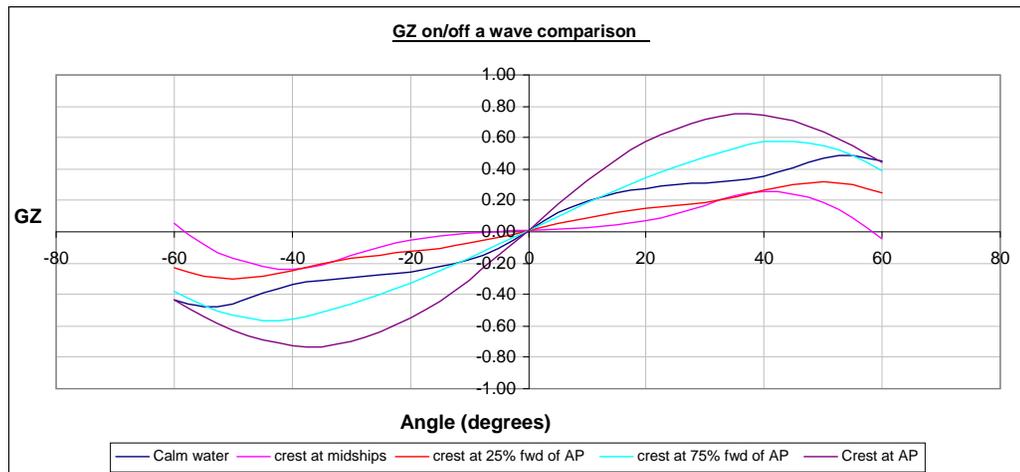
Figure 3-2 - GZ comparison on a wave crest

- 3.2.10 As can be seen in Figure 3-2 there is a very large reduction in the GZ righting arm as the wave slowly passes amidships.

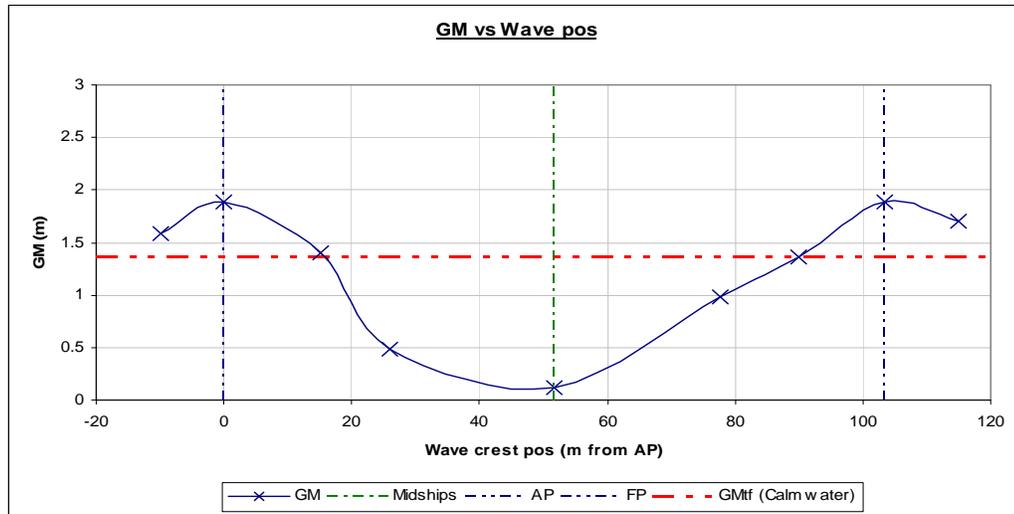
Figure 3-3 - Effective GM variation on a wave crest

- 3.2.11 Plotting the virtual metacentric height (GM) as a regular wave ( $\lambda=103.4\text{m}$ ,  $ht=8.0\text{m}$ ) passes the length of the ship, Figure 3-3, shows the considerable reduction in GM, righting arm and hence stability as the wave crest reaches amidships and then a slight increase when the wave crest is at the forward and aft perpendicular.

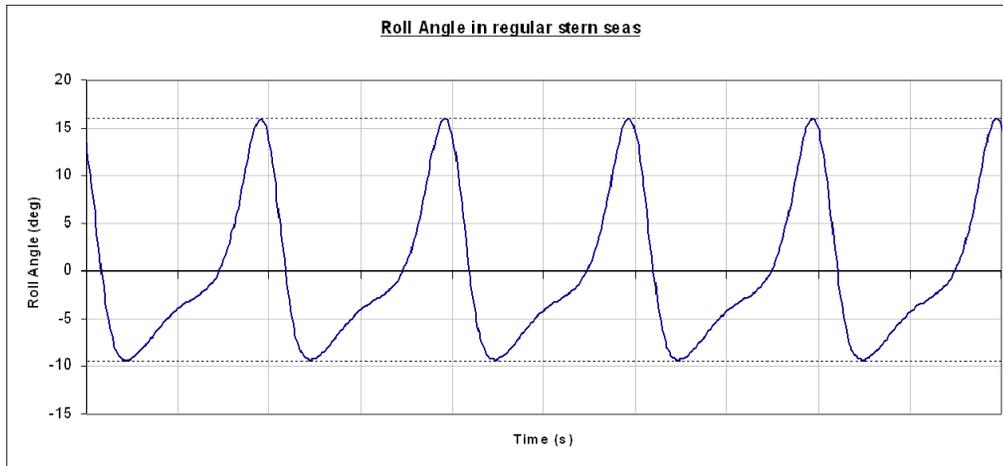
Figure 3-4 - MV RIVERDANCE Roll motion in regular stern seas

- 3.2.13 With the vessel modelled in FREDYN at the best estimated load condition and travelling at 13kts in stern seas, as the vessel MV RIVERDANCE was prior to the incident, the vessel behaviour was first investigated in regular waves. The regular waves were representative of a steep ‘packet’ of waves in the irregular wave train, which could generate the condition for a reduced GZ righting arm with the wave crest slowly passing amidships. This allows the potential for these conditions to be evaluated without long irregular wave simulations. The roll angle trace from the simulation is shown in Figure 3-4.

- 3.2.14 At the peak of the roll trace in Figure 3-4, the vessel is rolling 17 degrees to Port. At this point the wave crest is amidships and has reduced the righting arm. As the wave passes along the vessel and reaches the bow or stern, the righting arm increases, the stability increases and the vessel returns to close to upright – shown by the roll trace passing through the zero roll point..

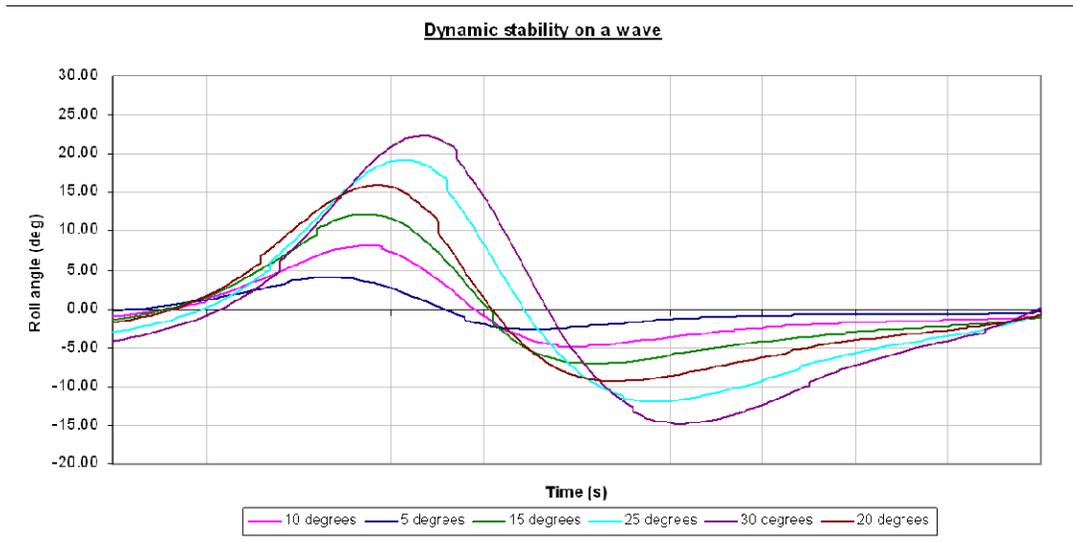
Figure 3-5 - MV RIVERDANCE roll motion in regular stern seas

3.2.15 The roll angle experienced is also influenced by the angle of incidence of the waves. In order to assess the sensitivity of the vessel to changes in angle of incidence, dynamic simulations were carried out in 5 degree heading intervals from stern seas (Simulation = 0 degrees ) to stern quartering seas (Simulation = 30 degrees) and the resultant single roll event traces for a single wave can be seen in Figure 3-5.

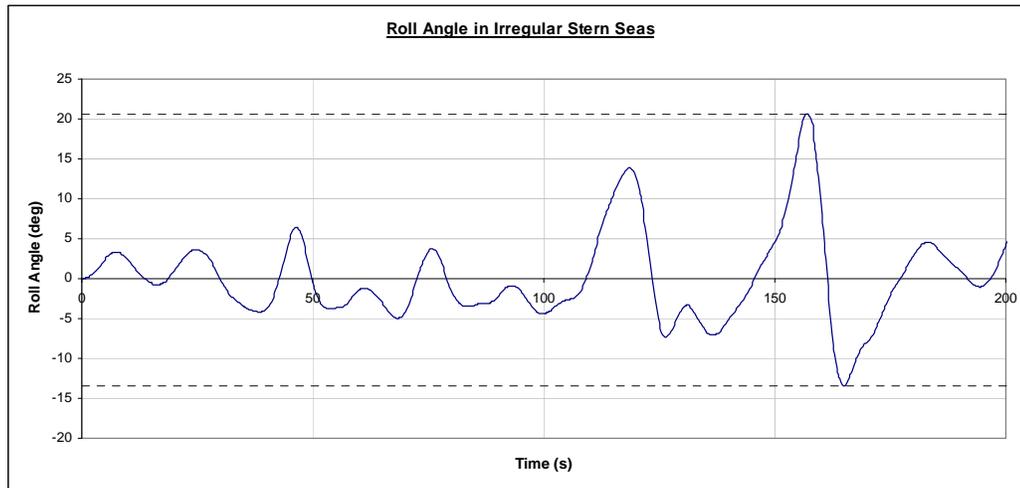
Figure 3-6 - MV RIVERDANCE Roll motion in irregular stern seas

3.2.16 The tests were repeated in irregular waves representing the wave conditions at the time of the incident and run for much longer duration. Several large slow roll motions were again measured in the simulation as a set of larger waves in the wave train slowly passes the ship. An extract of the simulation time history of the roll motion is shown in Figure 3-6 and a large roll event can be clearly seen (20 degrees Port Roll). These roll events are non-linear in nature, but approximately one large roll motion was experienced every 500 seconds in the simulation, this behaviour fits with the reports of occasional long slow roll motions of 15-20 degrees and would be a likely cause of the large slow roll motions which led to the reported initial movement of the cargo on the Main Cargo Deck. Thus it can be concluded that the

most likely cause of the rolling motion prior to the turn to Starboard was partial loss of stability on a wave crest.

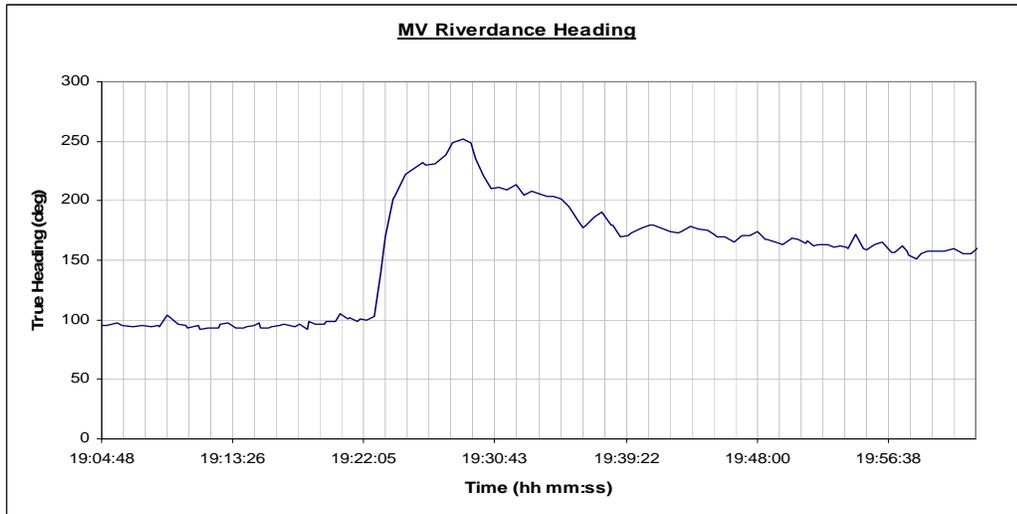
Figure 3-7 - Heading plot at point of incident

- 3.3.3 Reviewing the heading data at the point of the incident, Figure 3-7, it can be seen that the vessel yawed around uncontrollably from stern seas heading into beam seas. The experienced rate of turn, measured from the ship's data was approximately 2 deg/s.

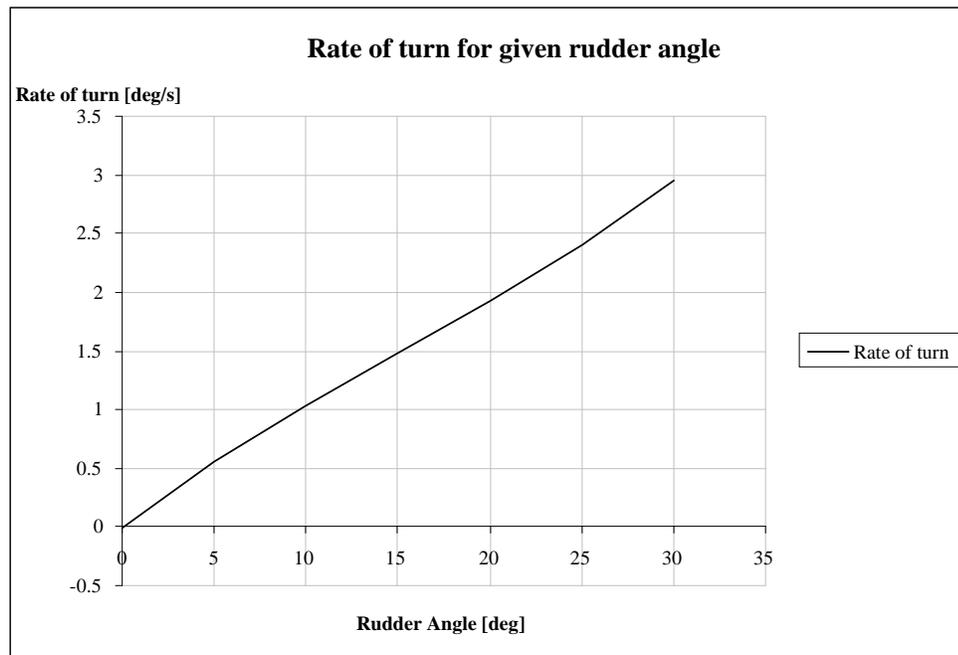
Figure 3-8 - Rate of turn for given rudder angle

3.3.5 The rate of turn for a given rudder angle (in calm water) is shown in Figure 3-8. From the ship's heading data the actual rate of turn is approximately 2 deg/s, this can be seen to be equivalent to a 20deg rudder angle. Under full control, a ship of this type is likely to be able to achieve this rate of turn through the use of the rudders although it would not be recommended. The MV RIVERDANCE was fitted with a high lift type of rudders which would be more efficient at turning the ship than presented in Figure 3-8 and hence the data displayed is conservative.

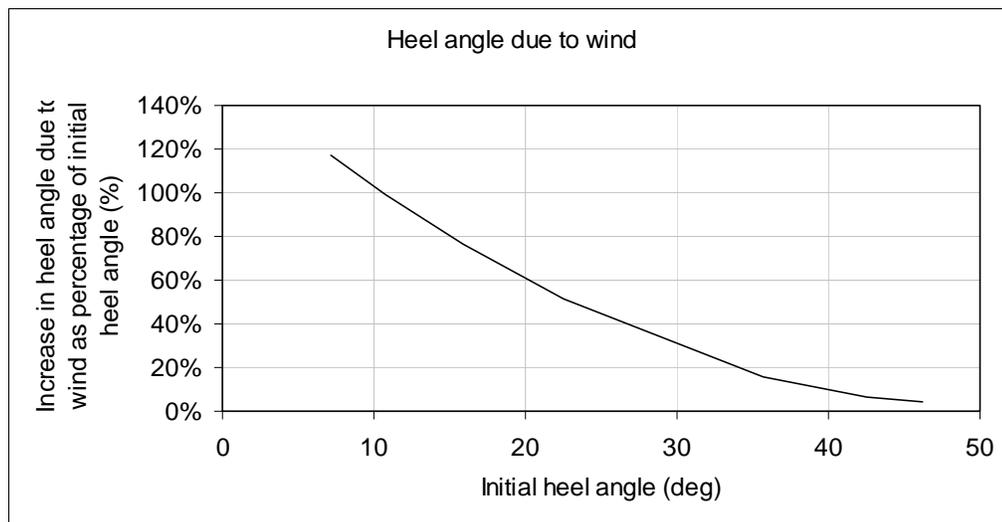
Figure 3-17 - Heel angle due to wind without flooding or ballasting

Figure 3-17 shows the added effect that a beam wind has on the heel of the vessel in the best estimate condition with no changes to loading condition. The magnitude of the wind heeling lever is directly affected by the existing list/heel of the vessel and the righting arm, the more upright the vessel the larger surface area is exposed to the wind and hence the greater the wind heeling lever. The wind effects do however depend heavily on what is happening to the ship condition and the angle of heel of the vessel. With additional water through ballasting or flooding in the vessel, the effect of the wind is different to when the vessel is not flooded.

- 3.5.1.1 This shows that with the realistic cargo shift described above and the inclusion of wind heeling effects, the combined list and heel angle of the vessel would be around 10 degrees (accounting for gusting wind) and so does not explain the mean 35 degree combined list and heel angle seen in the RAF video after the turn to starboard.

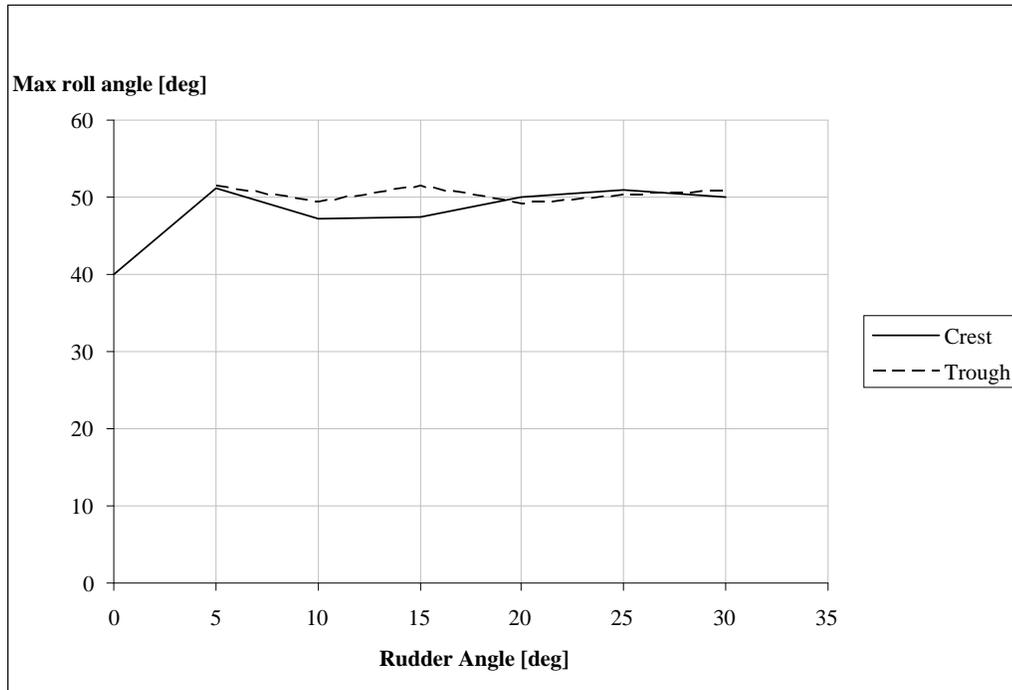
Figure 3-20 - Maximum roll experienced during a turn in regular waves

3.6.8 Figure 3-20 shows the results of these simulations. It can be seen that in waves even a small turn of the rudder can result in angles between 45 and 52 degrees during the turn.

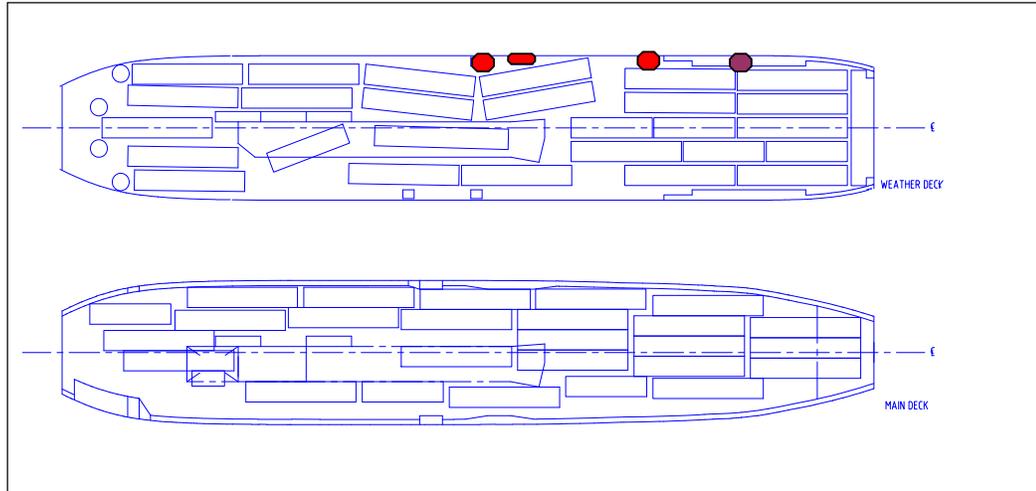
Figure 3-21 - Main potential downflooding points

- One mushroom vent aft of the Port access door to the lower hold;
- One Forward Vent (Port & Stbd) (capable of being closed weathertight) down to Lower Hold (at Frs.106-108 approx);
- Two Open trunk vents (Port & Stbd) (covered by a grille) down to Main Deck (at Frs.116-118 & 120-122 approx. respectively).

These main down flood points are shown pictorially with those most likely to down flood due to their position are marked in red in Figure 3-21 and on photograph Figure 3-22.

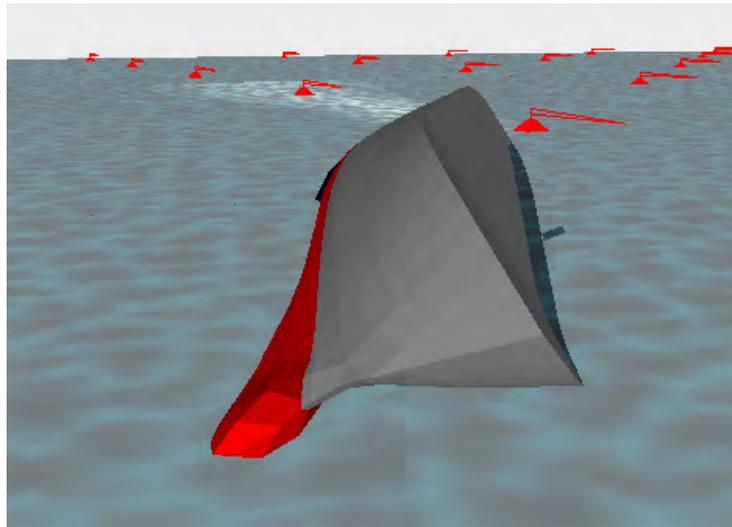
*Figure 3-23 - Extreme roll angle experienced during turn*

- 3.6.13 Both sets of FREDYN simulations have shown that an open door on the Port side and the vents would be likely submerged for between 20 and 80 seconds during the turn, which lasted a total of 120 seconds, based on the log of the ship's heading. A screen shot of the FREDYN simulations of the turn is shown Figure 3-23.

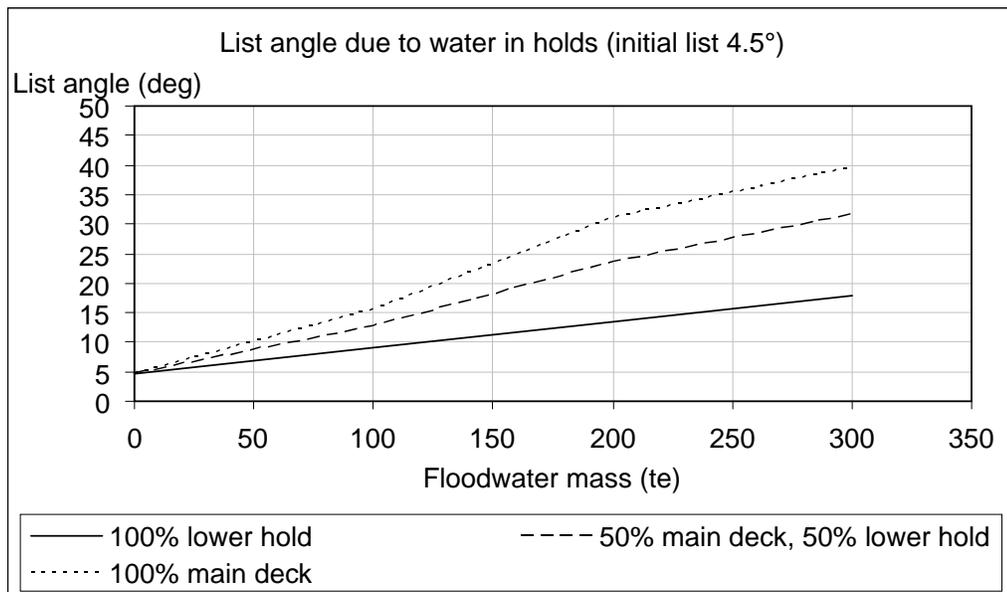
Figure 3-24 - List angle due to water on decks with 4.5 degree cargo shift

and without the inclusion of the wind heeling moment which would have been present due to the vessel drifting in beam seas with mean wind speeds in excess of 45 Knots. Figure 3-24 below shows a plot of mass of flood water distributed between the Main Cargo Deck and Lower Hold versus the mean angle of list. The x-axis represents the mass of water and the y-axis represents the resulting angle of list. The different curves represent differing distributions of water between the Lower Hold and Main Cargo Deck. With zero water there is 4.5 degrees heel due to cargo shift and wind effects.

3.6.14.5 Figure 3-24 shows the effect of water on decks on the vessel heel angle. It can be seen that downflooding through the Lower Hold vent would have contributed between around 3 and 8 degrees of list angle (without wind effects), and potential downflooding from the access door (if open) would have contributed a maximum (assuming no water then downflooded into the Lower Hold) of 10 and 45 degrees of list angle (without wind effects).

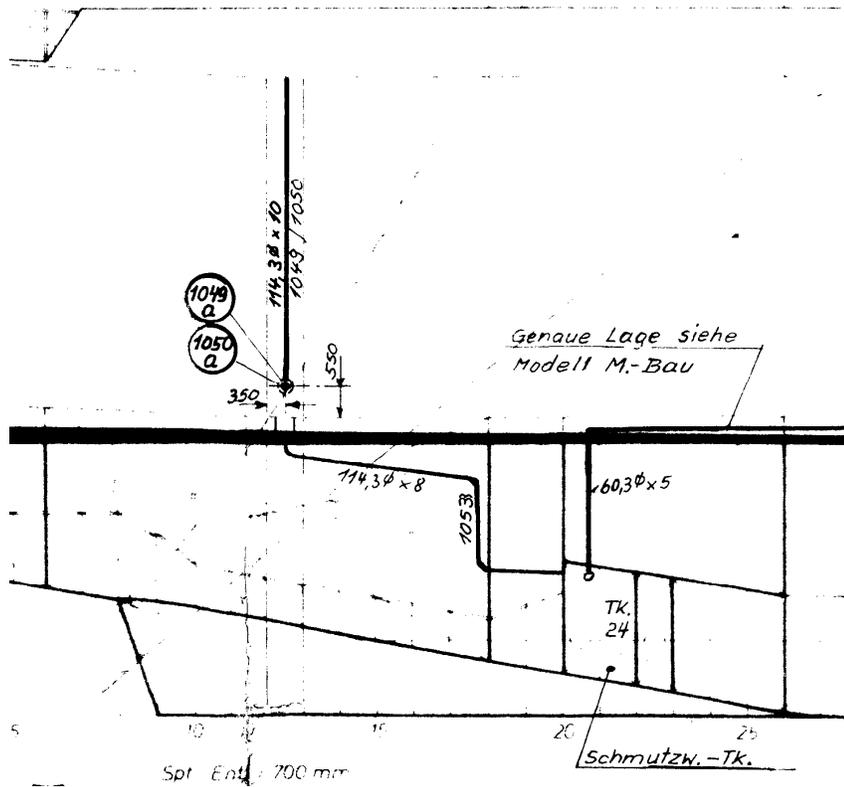
Figure 3-25 – Stern scupper arrangement

- 3.7.4 Towards the stern on the Main Cargo Deck the scuppers are shown to drain into a small aft sludge tank with a capacity of 5.52m<sup>3</sup> (Figure 3-25). Even if the aft sludge tank was empty prior to the flooding, it would have filled within seconds of the water starting to enter onto this deck. Due to the severe list/heel angle, it would have only been the Port stern scuppers that would have been submerged. Even in perfect operating conditions the rate of drainage through the scuppers would have been insignificant in comparison to the inflow through the submerged door opening and would rapidly overwhelm the sludge tank and continue to flood the deck. Due to the angle of the vessel it is likely that the pump to empty this tank when full would not have been able to function. Even if pumping was available, the pump serving this tank is likely to have had difficulties keeping up with the inflow of water on to the deck (pump capacity is 200 m<sup>3</sup>/hr). Even if the vessel had been fitted with scuppers out to the side of the vessel (not shown on the drawings), with the severe list/heel angle, the Port side of the vessel was continually submerged, so no water would have flowed out due to the greater external pressure head of water.

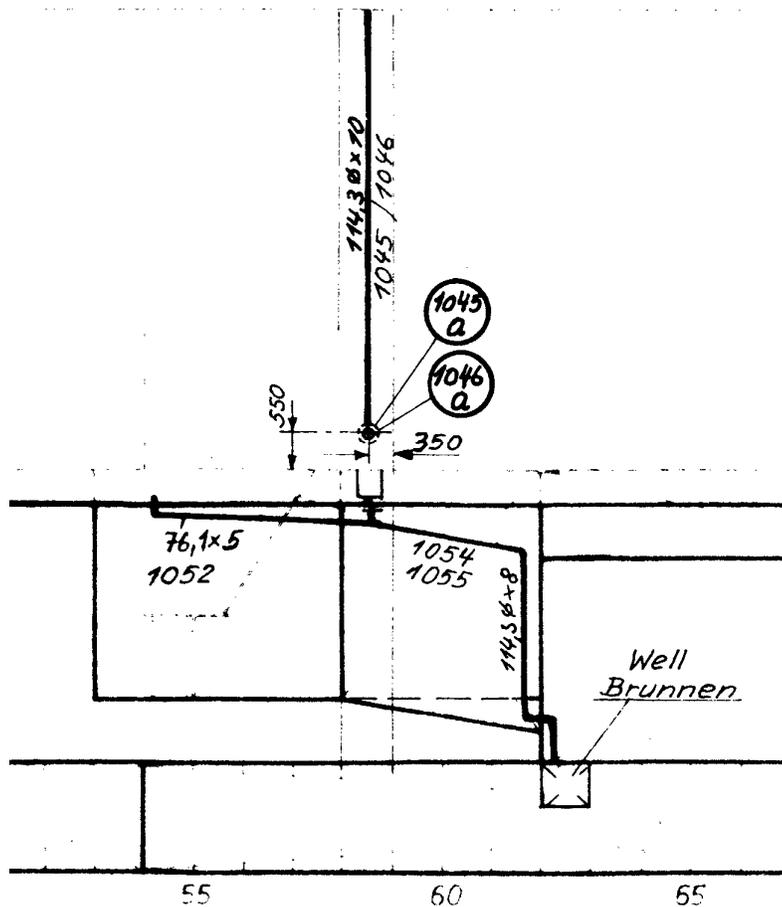
Figure 3-26- Midships scupper arrangement

3.7.5 The forward scuppers and amidships scuppers on the Main Cargo Deck are shown to drain in to the bilge wells in the Lower Hold (Figure 3-26). The bilge wells may have not been emptied and if power was lost, which is likely at the large angles experienced, the bilge alarms and pumps may not have been available. This meant that these bilge wells would rapidly fill, (if not already full) and then would continue to flood the Lower Hold.

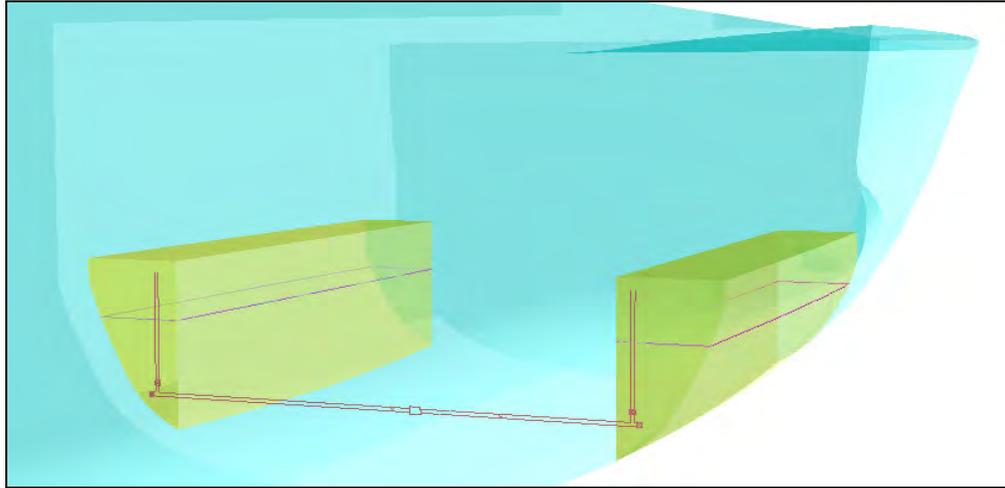
Figure 3-27 - Tanks 13 Port and Starboard with 78te of fluid at departure

The free surface heights of the fluid in these tanks can be seen in Figure 3-29 below, as 2.68m above the inlet at the bottom of the tank.

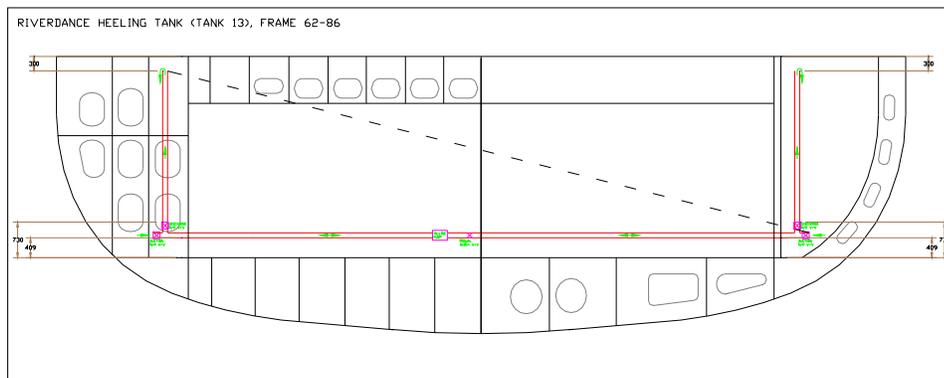
Figure 3-28 - Diagram of cross connection arrangement in Tanks 13 Port and Starboard

- 3.8.2 These tanks have an arrangement of pipes and valves with a central pump that allows the transfer of fluid between the two wing tanks when required. A simple diagram of the arrangement of the pipes, pump and valves is shown in Figure 3-30, with an indication of critical heel/list angle above which the Starboard inlet is above the Port discharge tube.

- 3.8.7 From Figure 3-28 it can be seen that although the discharge valve is low down in the discharge pipe, the pipe exit is 300mm from the tank top. As can be seen in Figure 3-31 & 3-30 below, even at a high list/heel angles, the fluid within the Starboard tank does not reach the top of the discharge vent with 78 tonnes of water in the tank to allow it to cross flood.

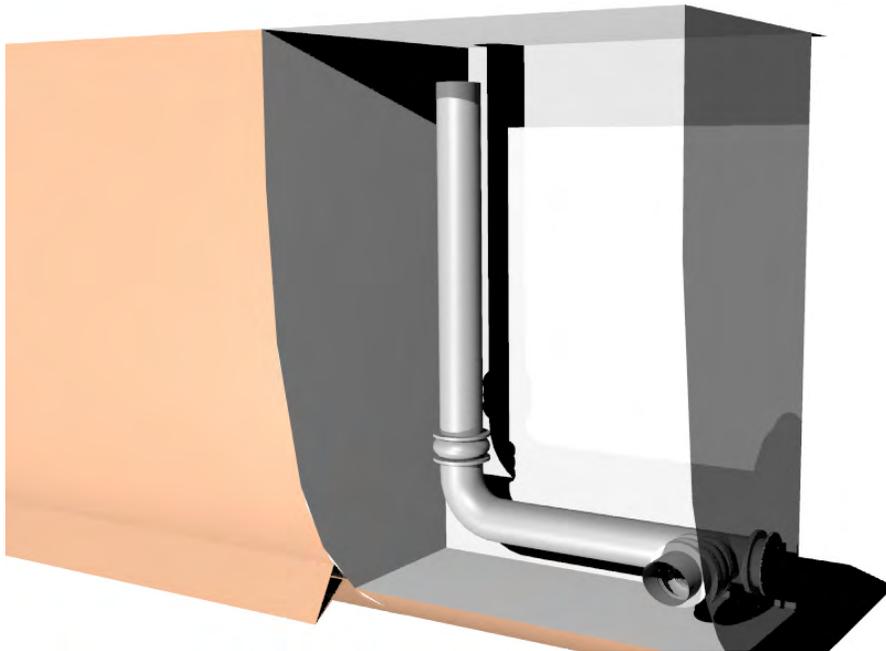
*Figure 3-30; Indicative wing tank piping arrangement*

- 3.8.3 A crew member reported that the valve on the main cross connect between the main heeling tanks 13 Port and Starboard, was opened at some time shortly after 1 hours notice at 1830, approximately 50 minutes prior to the turn to Starboard. If this valve is opened, the pump would not restrict fluid transfer and would spin freely with any movement of fluid in the pipe. The possibility of transfer of fluid between these tanks hydrostatically is investigated. As can be seen in Figure 3-28, once the main cross connection valve between the two tanks is opened there are the sprung non return valves on the pipe inlets and the height of the discharge pipe exits stopping the flow between the tanks. The valve is shown in Figure 3-29 below. The render at Figure 3-30 is shown to further indicate the pipe and valve arrangement in the vessel.

- 3.8.4 Following the examination by MAIB of the valves during demolition, it was found that the discharge valves both sides were stuck in the open position. The suction valves appeared to be closed and operating correctly when visually inspected.

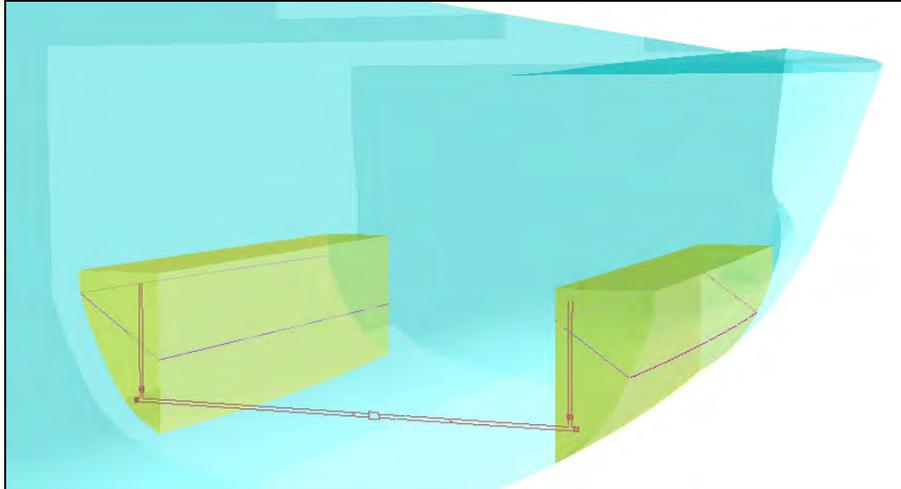
*Figure 3-32 - Diagram of cross connection arrangement in Tanks 13 Port and Starboard with 78 tonnes at 35 degrees Port list*

- 3.8.8 In order for fluid to reach the top of the discharge pipe the Starboard tank contents would need to be in excess of 85 tonnes of fluid, with a list/heel of 35 degrees or greater. Based on the departure condition, which has 78 tonnes in each tank, then it is not likely this could have occurred.

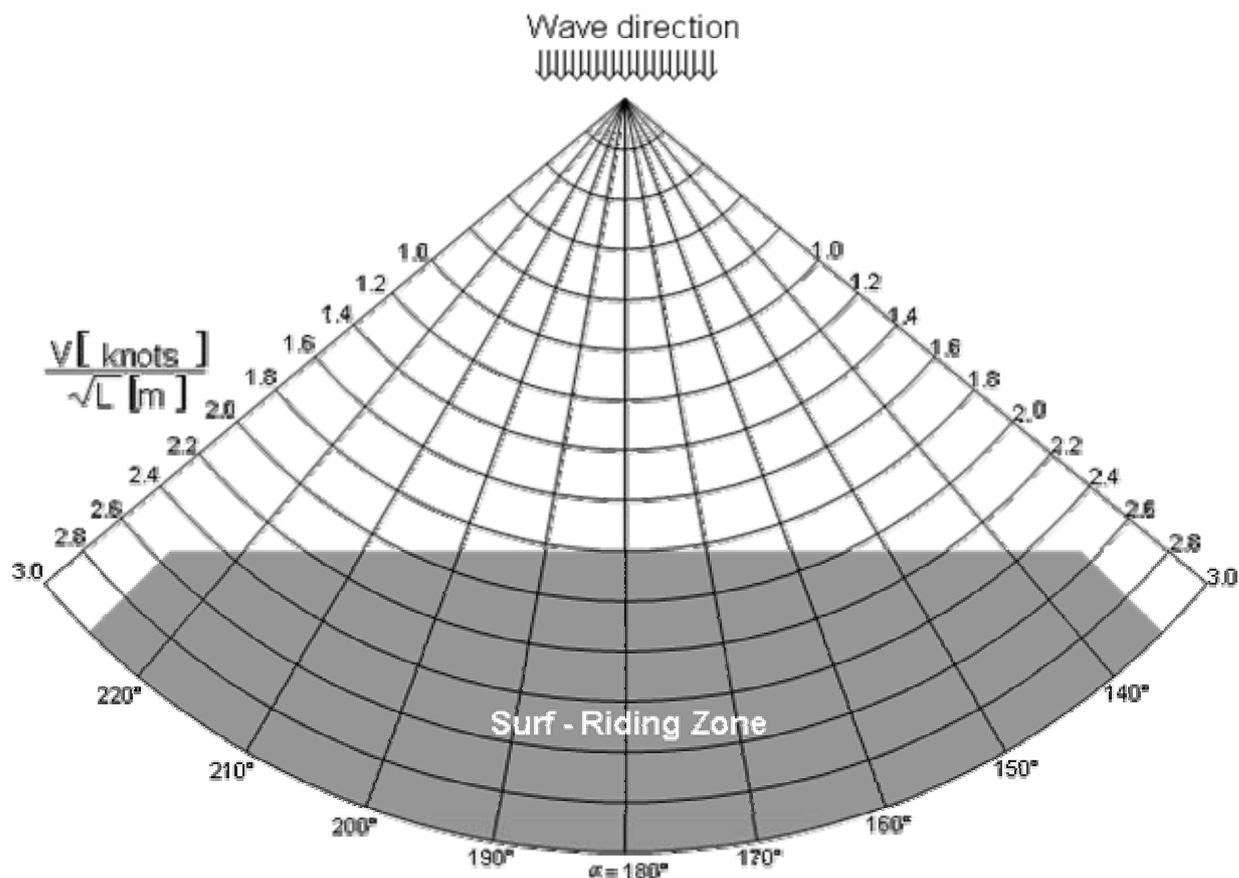
**Figure 2: Risk of surf-riding in following or quartering seas**

Surf-riding and broaching-to may occur when the angle of encounter is in the range  $135^\circ < \alpha < 225^\circ$  and the ship speed is higher than  $(1.8\sqrt{L})/\cos(180 - \alpha)$  (knots). To avoid surf riding, and possible broaching the ship speed, the course or both should be taken outside the dangerous region reported in figure 2.

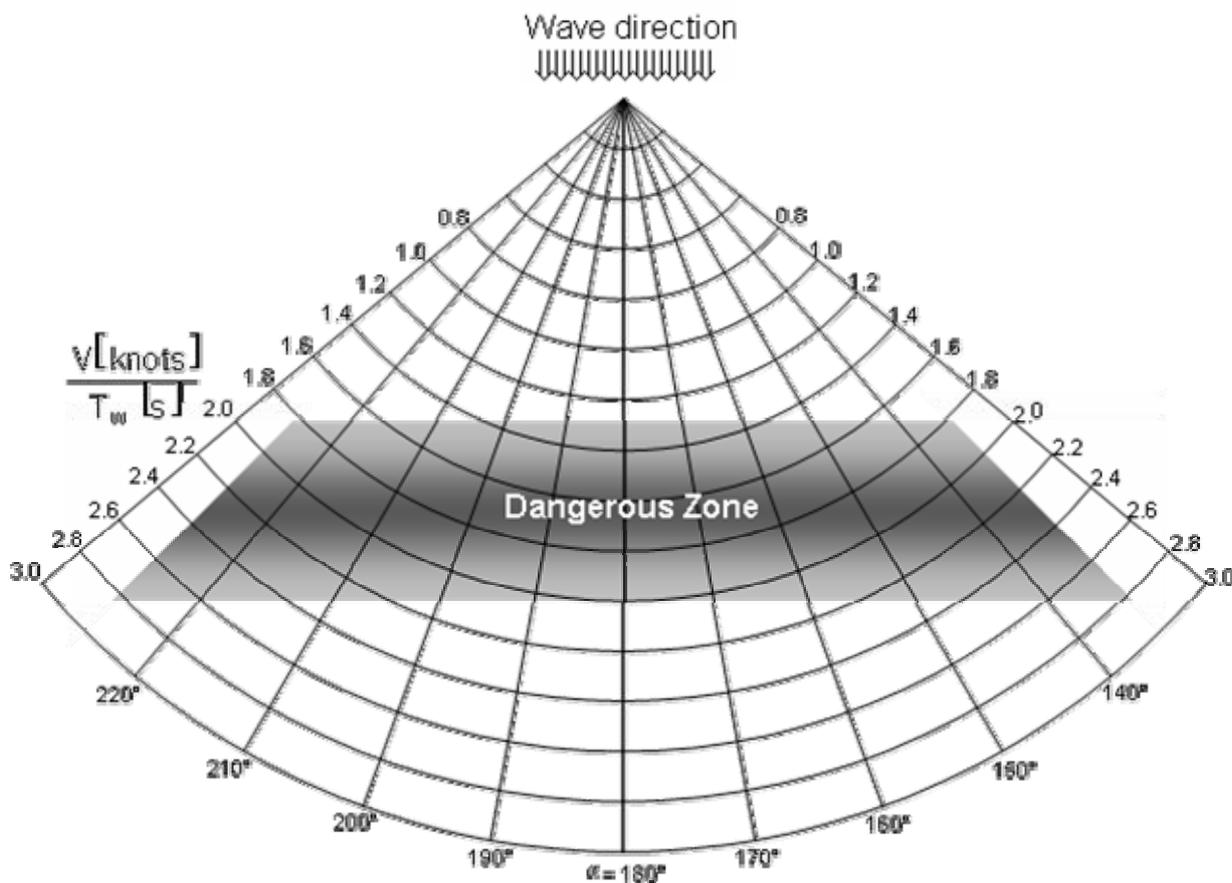
Figure 3: Risk of successive high wave attack in following and quartering seas

4.2.2.1 When the average wave length is larger than  $0.8 L$  and the significant wave height is larger than  $0.04 L$ , and at the same time some indices of dangerous behaviour of the ship can be clearly seen, the master should pay attention not to enter in the dangerous zone as indicated in figure 3. When the ship is situated in this dangerous zone, the ship speed should be reduced or the ship course should be changed to prevent successive attack of high waves, which could induce the danger due to the reduction of intact stability, synchronous rolling motions, parametric rolling motions or combination of various phenomena.

4.2.2.2 The dangerous zone indicated in figure 3 corresponds to such conditions for which the encounter wave period ( $T_E$ ) is nearly equal to double (i.e., about 1.8-3.0 times) of the wave period ( $T_W$ ) (according to figure 1 or paragraph 1.4).
