Report on the investigation of the death by asphyxiation of

two crewmen on board

Sava Lake

**Report No 15/2008
September 2008**

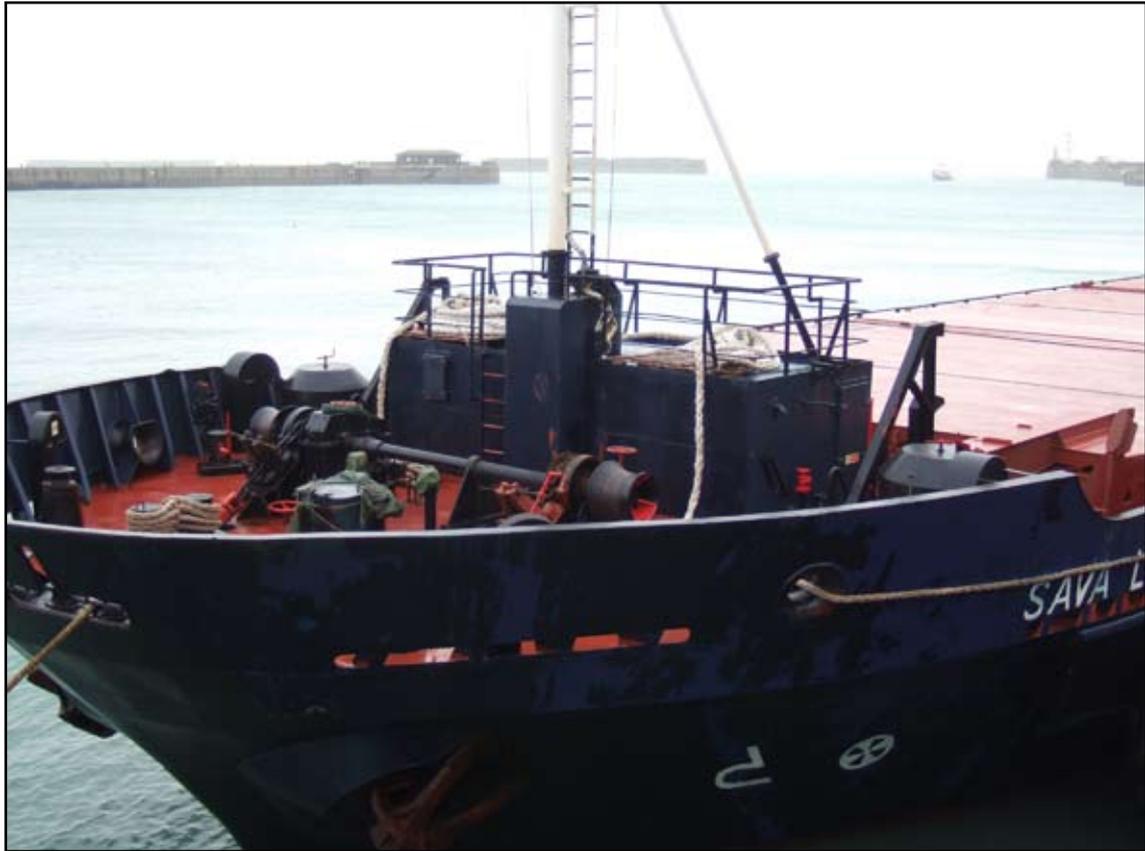
Figure 7

On departure Horsens the forward deck (**Figure 7**) was secured for sea. *Sava Lake* crossed the southern Baltic Sea in moderate weather conditions, initially destined for the Kiel Canal. The master routinely advised the crew not to go forward during the voyage, particularly when heavy weather was forecast, without seeking permission from either the chief officer or himself.

Forward deck of *Sava Lake*

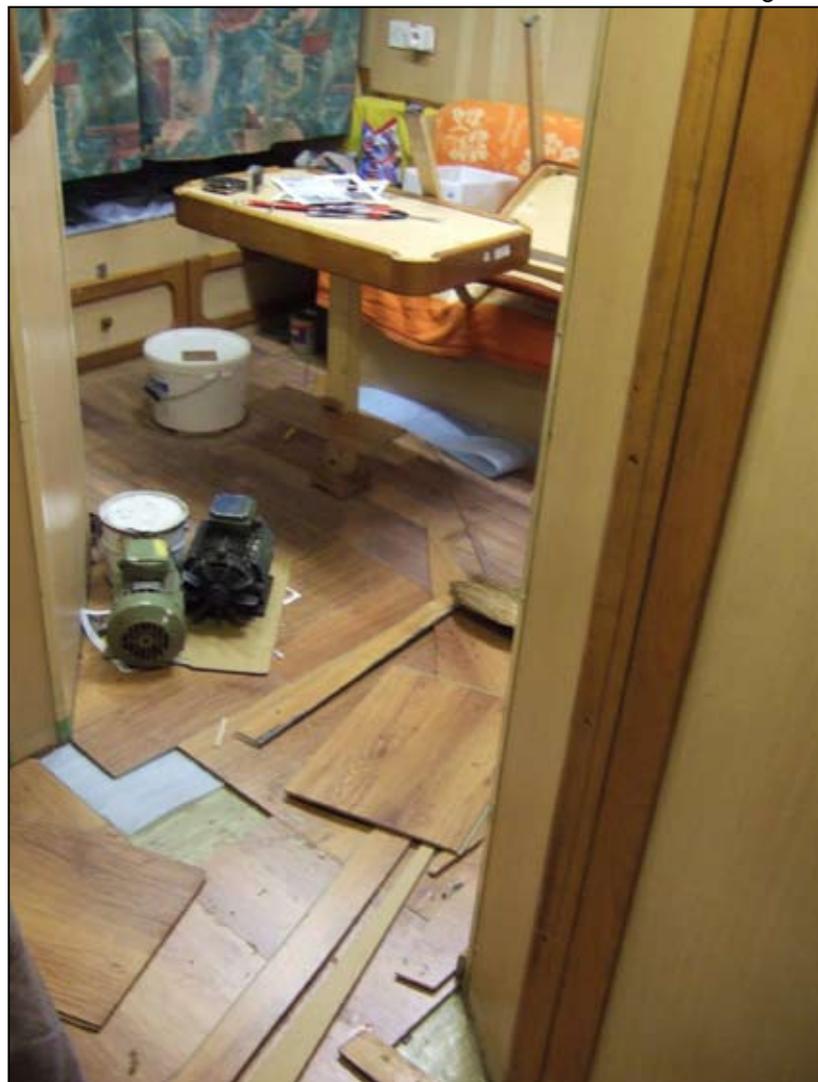
Figure 9

It is not clear when the two ABs went forward, nor is it known why. No evidence has been found to indicate that they were doing anything unusual; the most likely explanation is that they both went to the forward store to collect tools, or materials, to fit replacement laminate flooring in AB Babiienko's cabin (**Figure 9**).

AB Babiienko's cabin

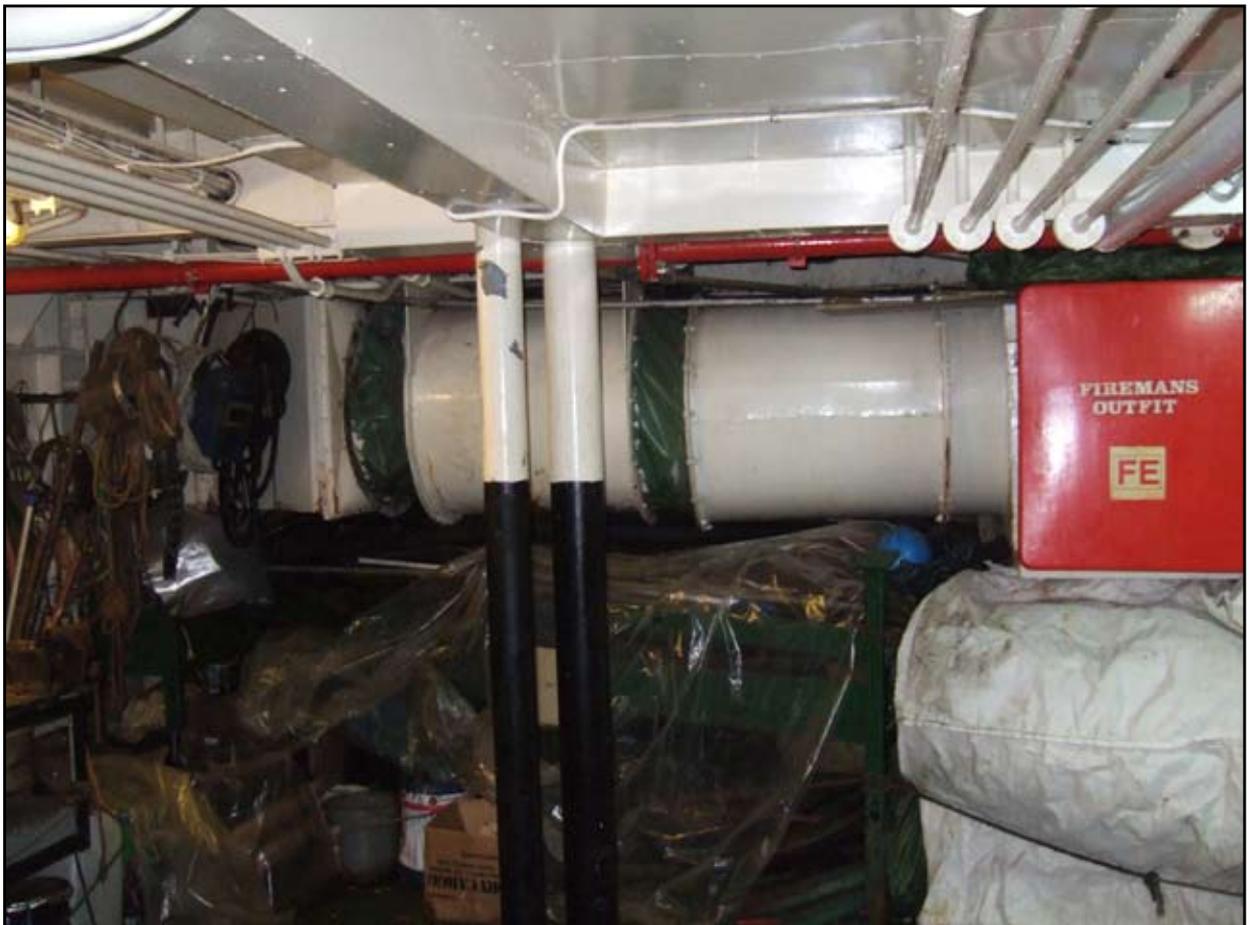
Figure 18

The cargo hold ventilation trunking passed along both outboard sides of the forward store (**Figure 18**).

Forward store - port cargo ventilation trunking

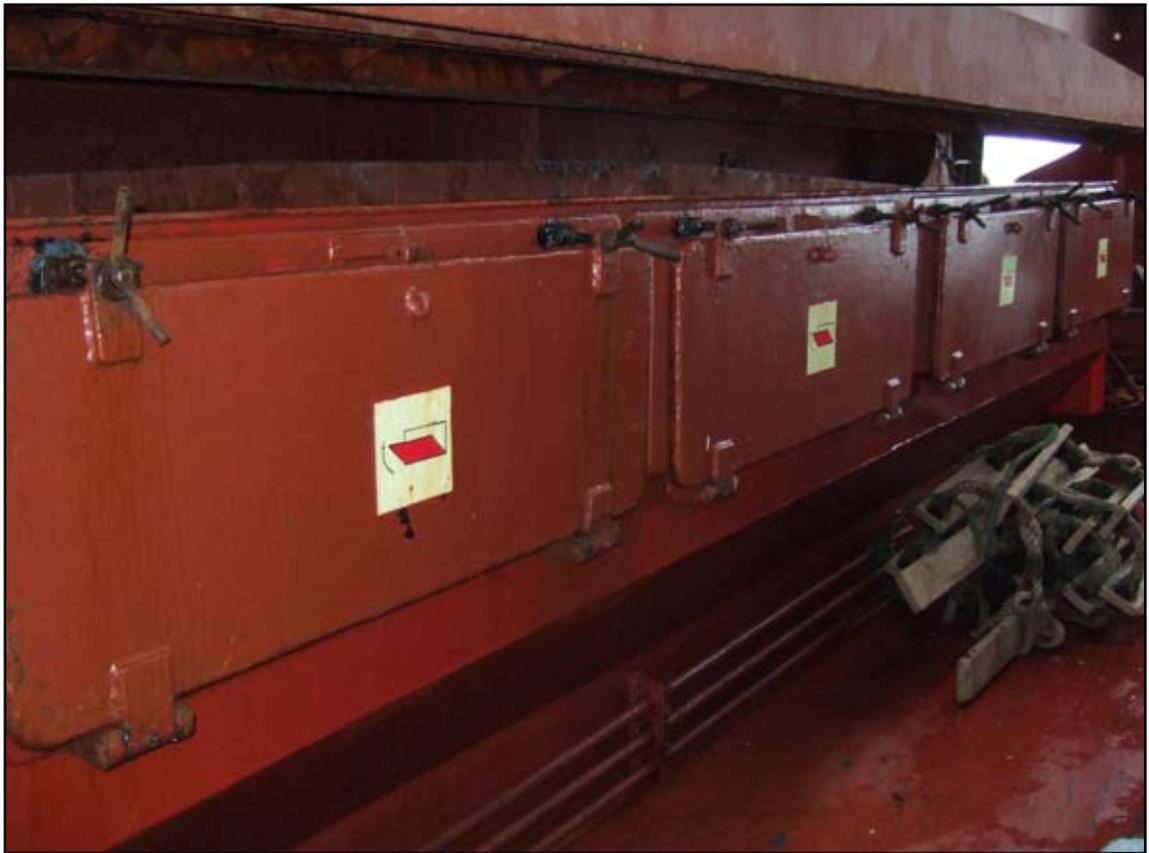
Figure 20

The aft system consisted of natural ventilation only with several securable flaps aft of the cargo hold (**Figure 20**). Within the cargo hold, shutters were fitted over the ducts; the flaps were sealed with various types of expanding foam and sealant (**Figure 21**).

Aft cargo ventilation flaps on deck

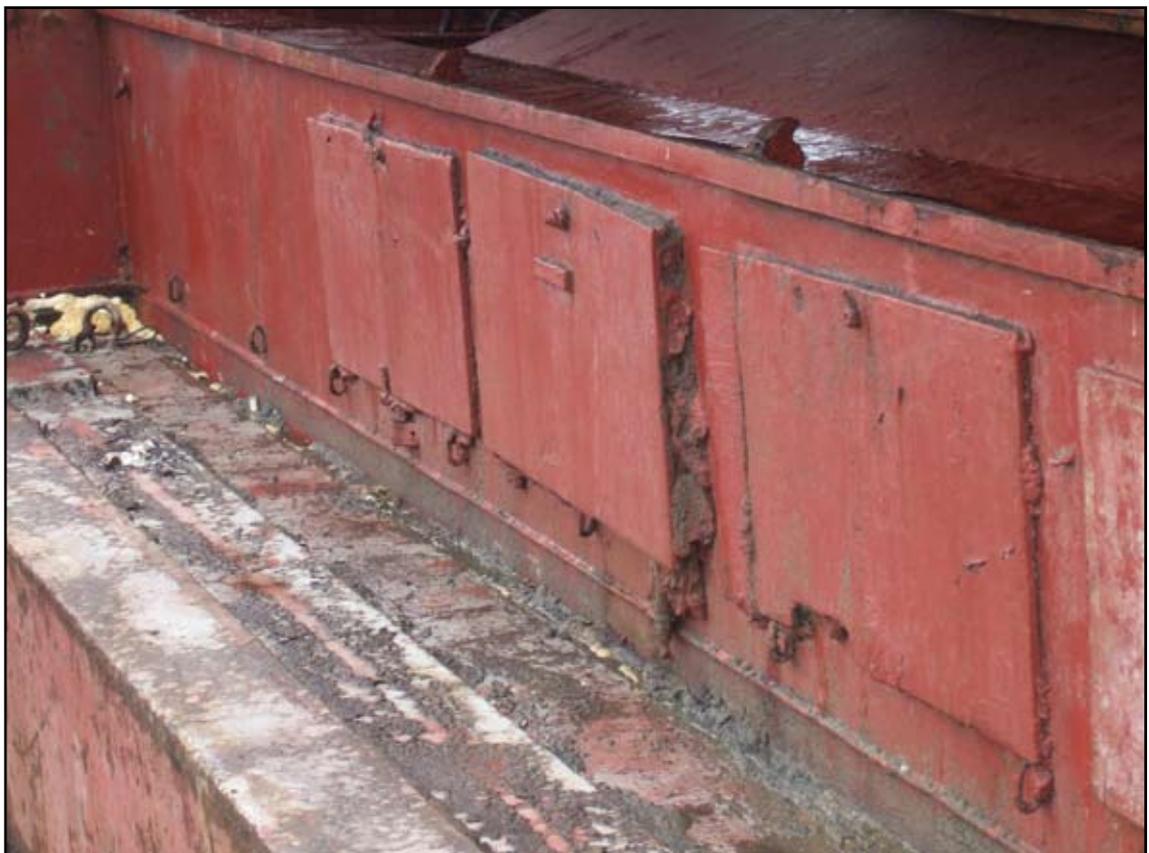
Figure 21

Aft cargo ventilation flaps within hold

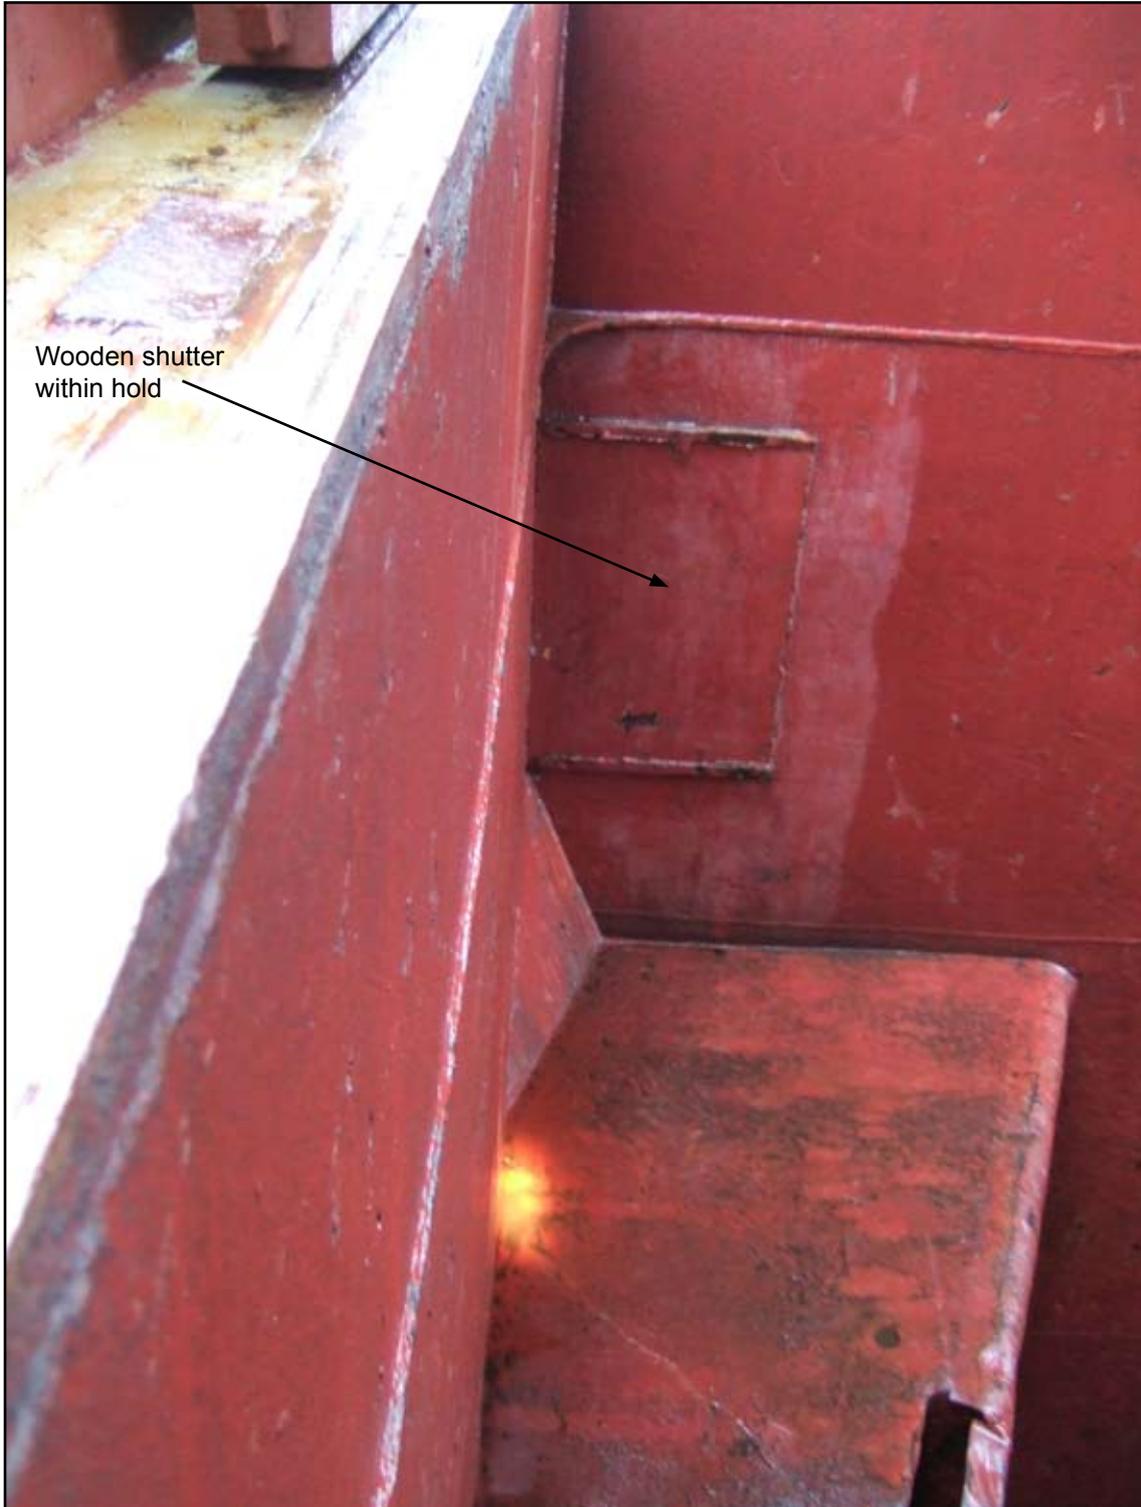
Figure 22

The forward ventilation ducts within the hold were fitted with wooden shutters (**Figure 22**), and attempts had been made to seal these using a sealant of unknown origin.

Wooden shutter to cargo ventilation system - port forward cargo hold

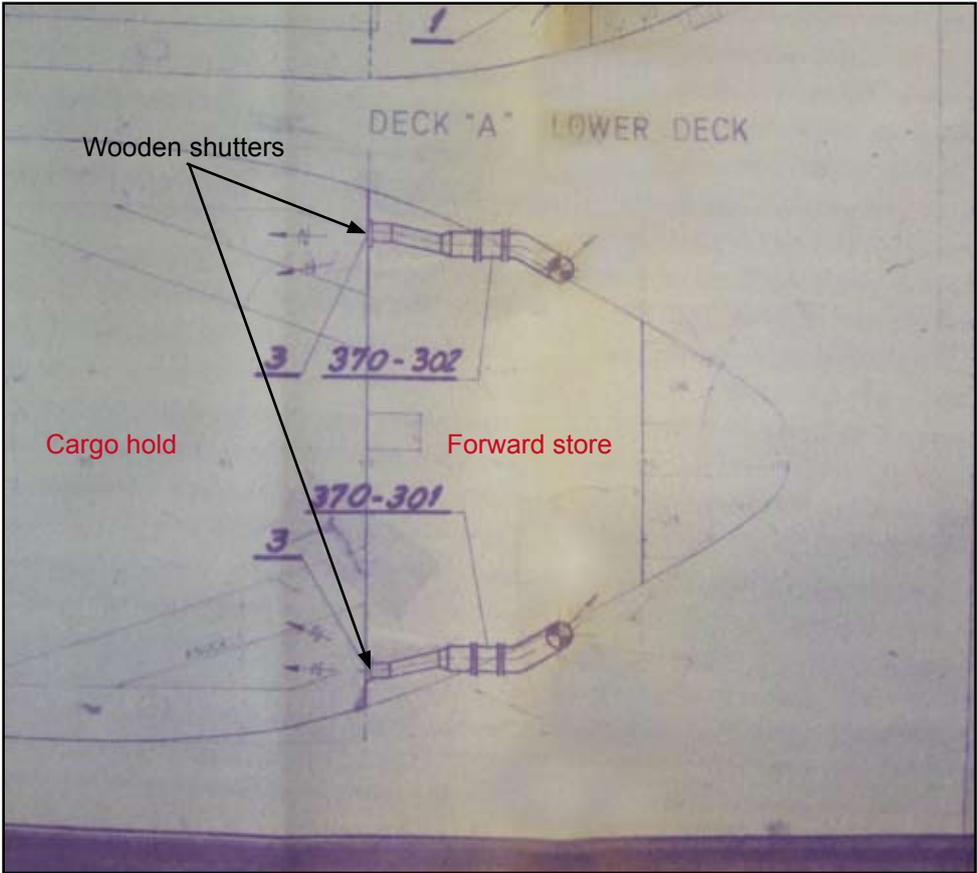
Figure 23a

The system (**Figure 23 a & b**) led immediately into the forward store and consisted of two, symmetrical, independent tubular steel ducts located at the outer extremities of the space.

Plan of forward ventilation system

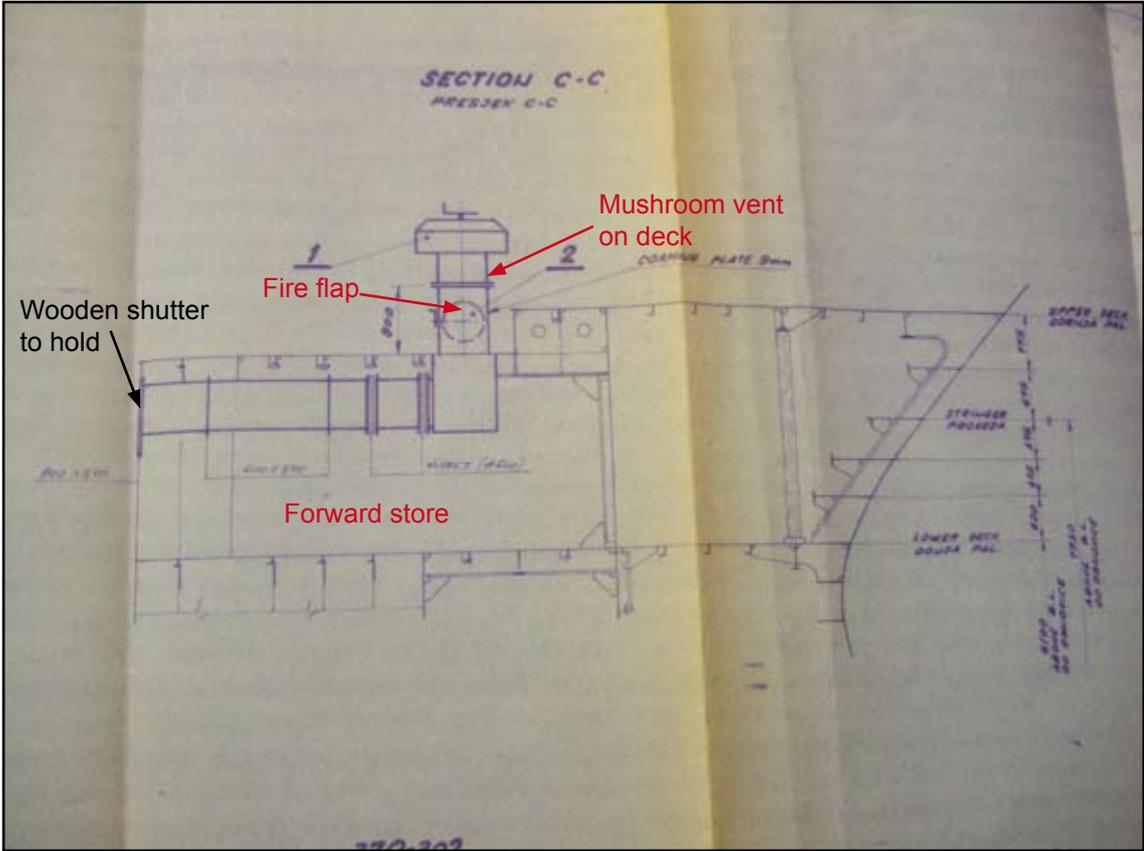
Figure 23b

Plan of forward ventilation system
