Report on the investigation of the
inadvertent release of carbon dioxide and disabling of

Figaro

off Wolf Rock

Report No 14/2008
August 2008

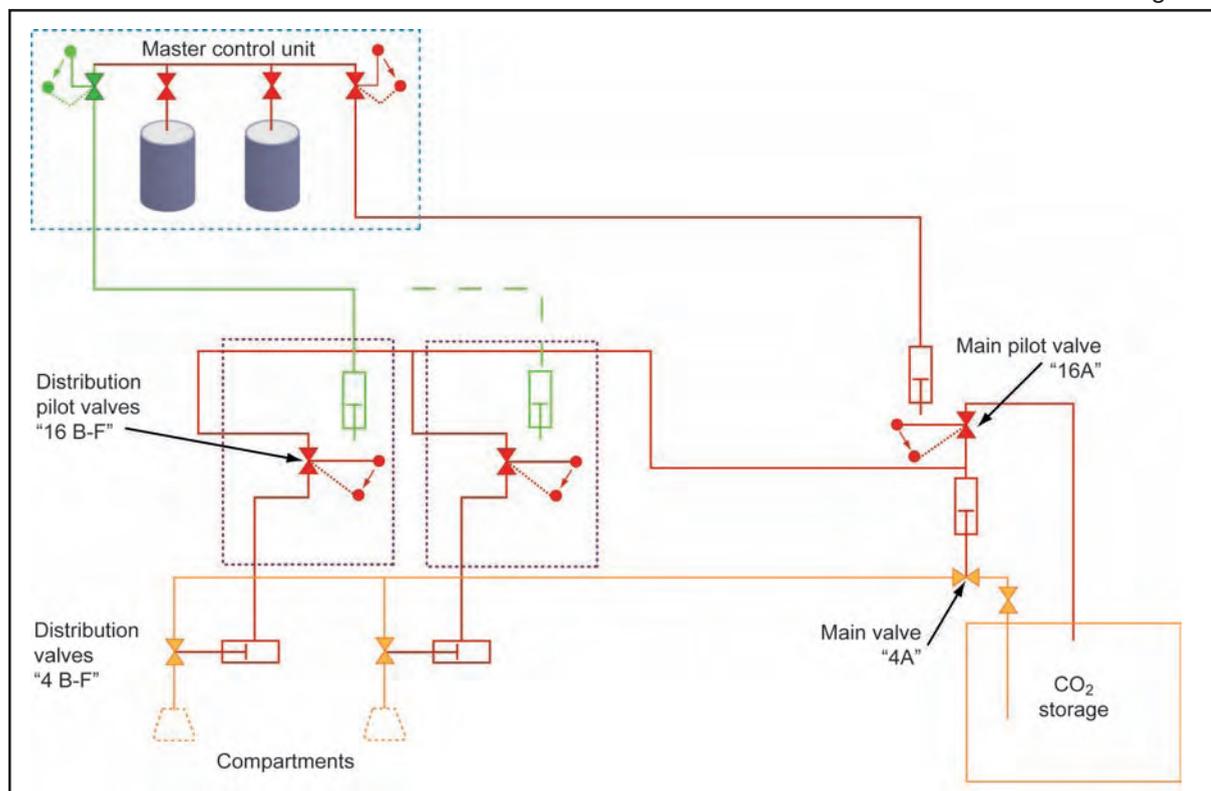
Figure 1

Simplified CO2 System Schematic Diagram

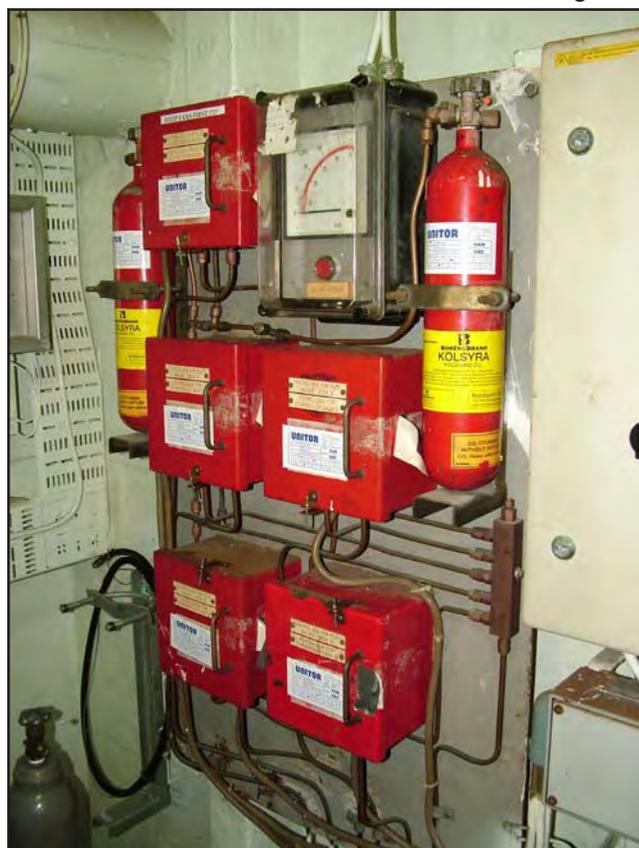
Figure 2

Master Control Unit (MCU) panel on Deck 14

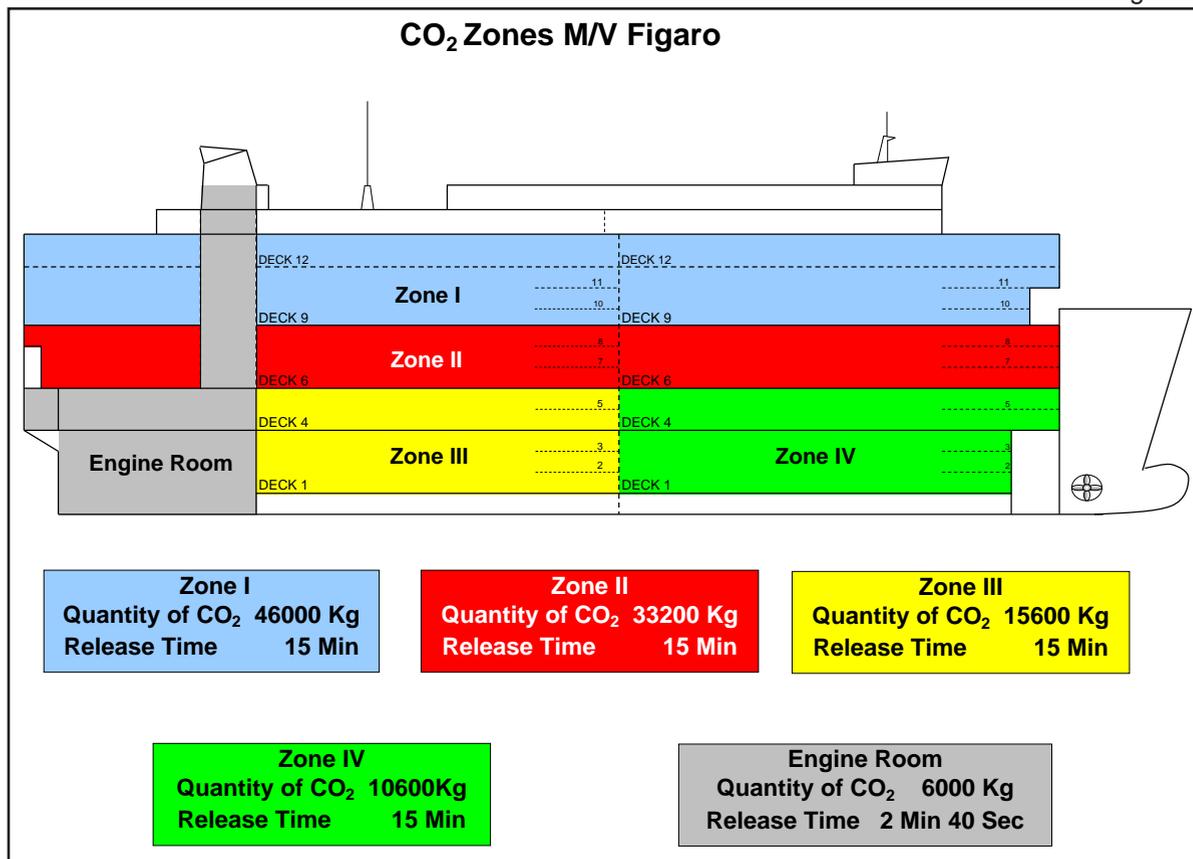
At the muster station, crew reported that fog from the discharging CO₂ gas had also been seen in the engine room and in cargo zone no.1 on deck 9. Sightings of CO₂ being released were confirmed in cargo zones 1, 2 and 3 (**Figure 4**) and in the engine room, the vast majority of the internal volume of the ship. The AB, who had made the initial report, and a cadet escaped from cargo zone 2 on deck 6, the fourth engineer and two engine room ratings had escaped from the engine room and another AB had escaped from cargo zone no.3 on deck 4. No CO₂ was released into cargo zone 4 at the lower, forward end of the vessel.

Schematic diagram of vessel showing CO₂ protected zones

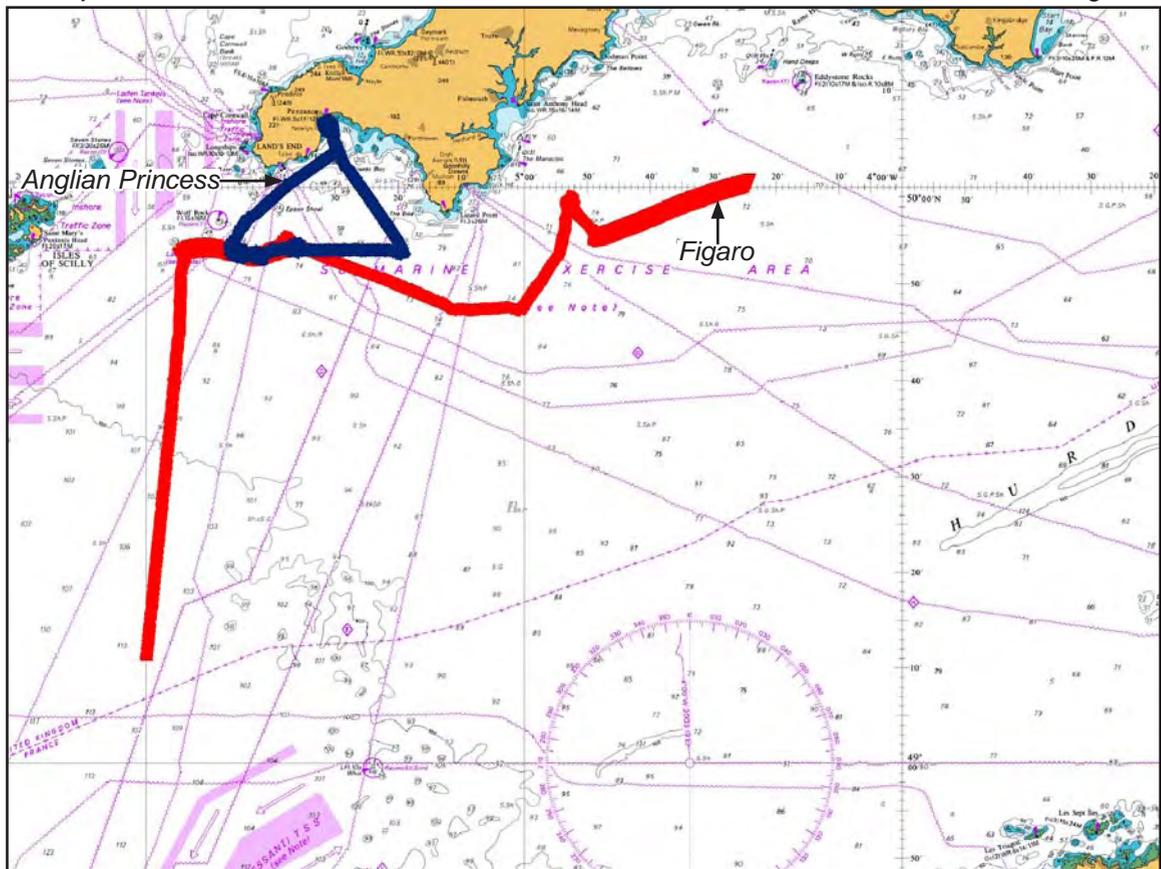
Falmouth Coastguard confirmed the position of the vessel, and by 1652 had determined that *Figaro* had Wolf Rock on a bearing of 050, at a distance of 5nm. They estimated that the Closest Point of Approach (CPA) between *Figaro* and Wolf Rock could be as little as 1nm, and took action to assist the vessel and safeguard those on board. At 1655 the Coastguard tasked the Emergency Towing Vessel (ETV) *Anglian Princess* to proceed from its anchorage in Mounts Bay, to intercept *Figaro* and take it in tow.

By 1707 *Figaro* was within 4.4nm of Wolf Rock, which was on a bearing of 047. The vessel was drifting on a course of 080 at a speed of about 2 kts. The Coastguard had made contingency plans to evacuate the 30 people on board and at 1715, a Royal Navy Search and Rescue helicopter, Rescue 193 from RNAS CULDROSE, was put on immediate standby. Rescue 193 was capable, in normal circumstances, of carrying 10 passengers and the Coastguard also tasked Sennen Cove All Weather Lifeboat (ALB) to intercept *Figaro*. Rescue 169, from RAF Chivenor, was called forward to standby at Penzance Heliport. The Coastguard prepared and began broadcasting "Pan Pan" relay messages.

Chart showing AIS data of *Figaro's* position

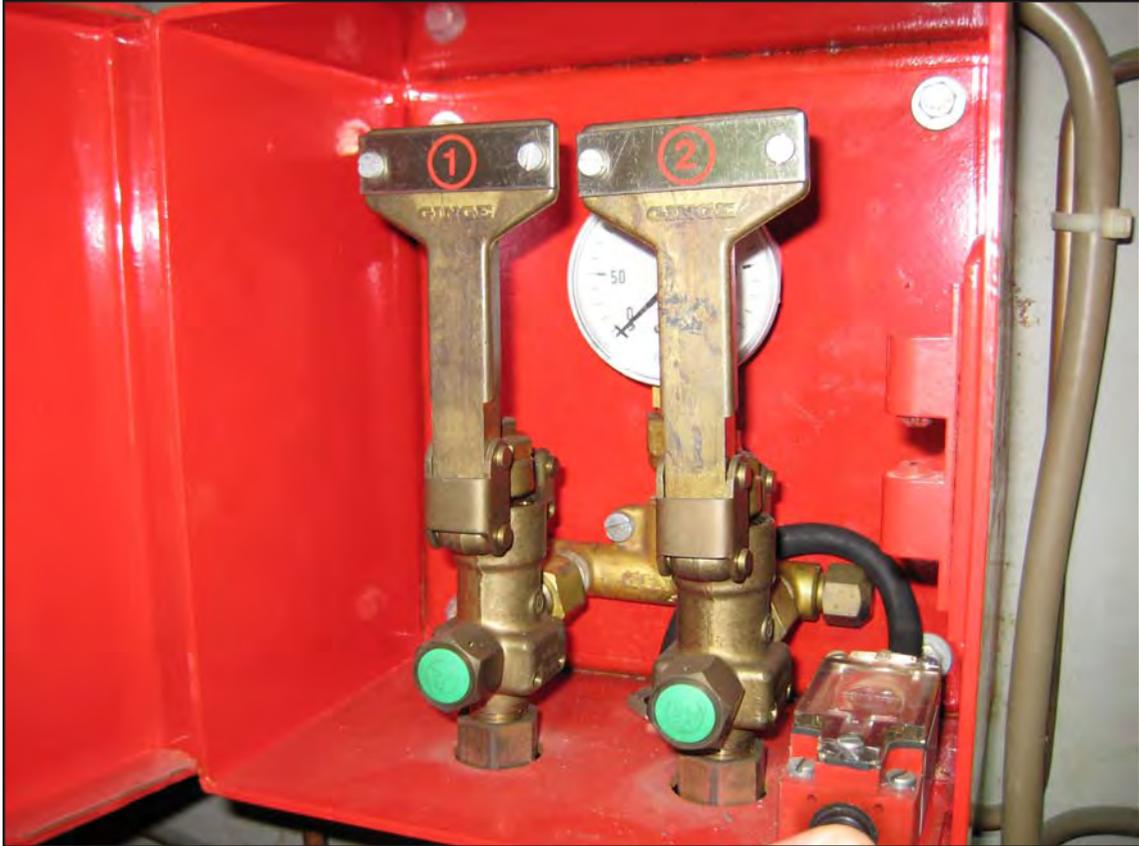
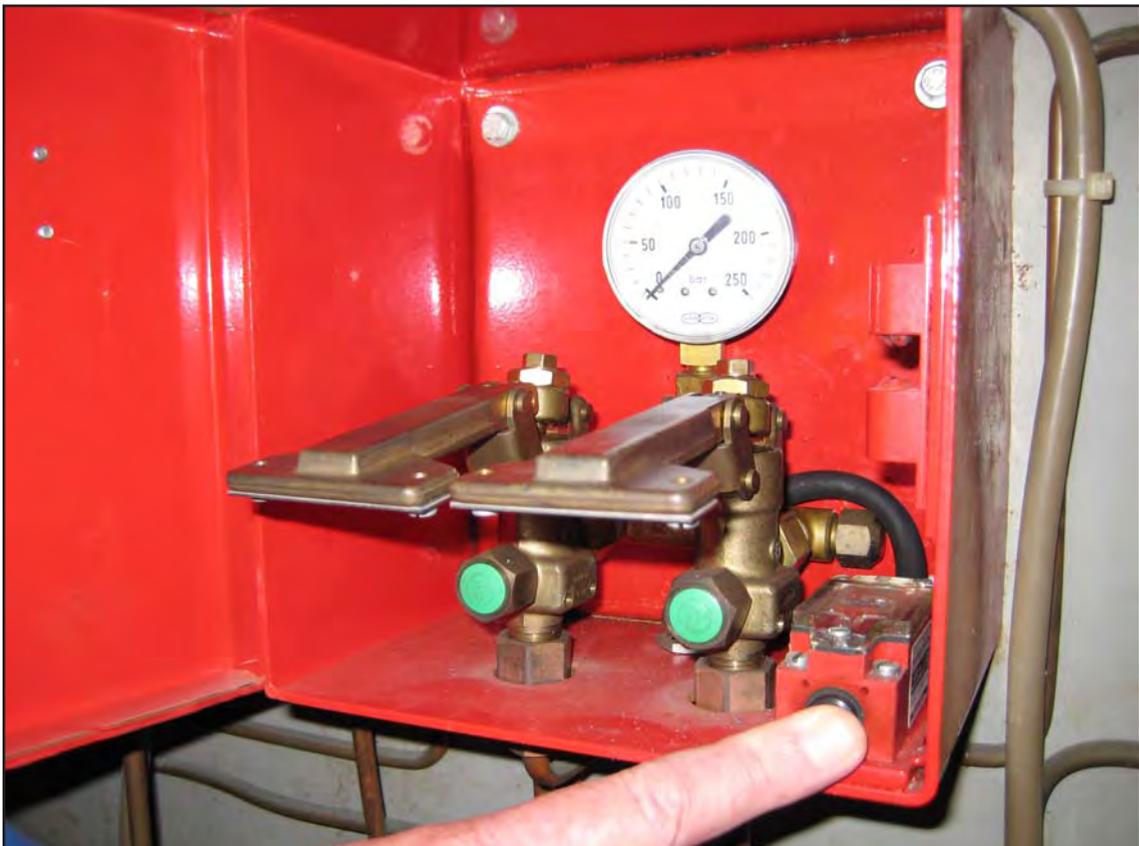
There were no markings on the operating levers to indicate what the different positions signified, and there was little guidance in the manufacturer's manual to assist in diagnosing the problem. The CE concluded that the remote system had malfunctioned, but considered that in the event of a fire he could still release the CO₂ by opening the main and distribution valves manually. He was not sure what position the levers should be in and decided to leave them as they were found. The main stop valves on the CO₂ storage tanks were re-opened so that gas was immediately available in an emergency.

Main Control Unit operating levers

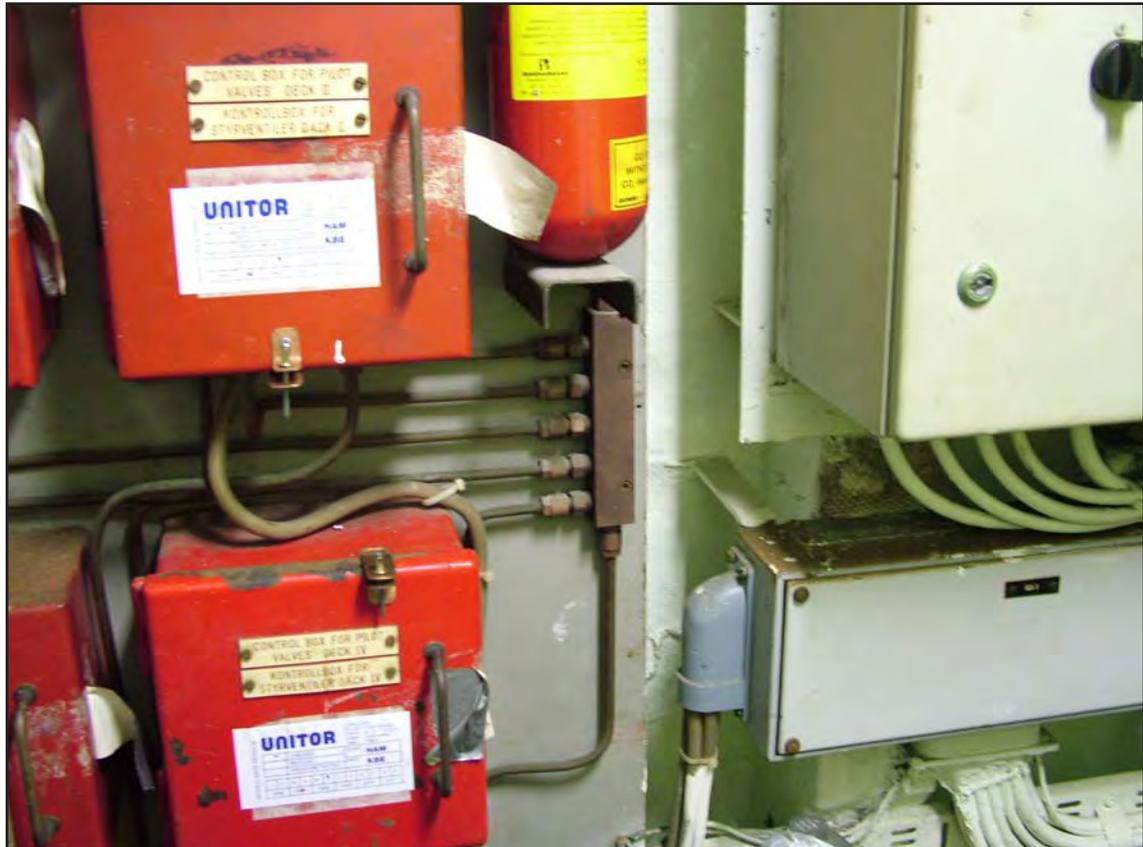
Figure 10

releasing low pressure gas from the small Master cylinders. The distribution controls had separate pipework connecting each of them directly to the respective control in the CO₂ room. However, each of the five different remote controls for the main valve terminated at a non return valve and then joined a common manifold (**Figure 10**). A single pipe from this manifold then lead down from deck 14 to the main valve controls in the CO₂ room. The control lever valves were self purging, with pipework open to the atmosphere when closed and only sealing once operated. The non return valves were required to prevent gas pressure from an opened control valve escaping back through any of the unused control valves.

Manifold for MCU main pilot valve controls
