Report on the investigation into the foundering of the motor cruiser

Last Call

at Whitby

Report No 11/2008
June 2008

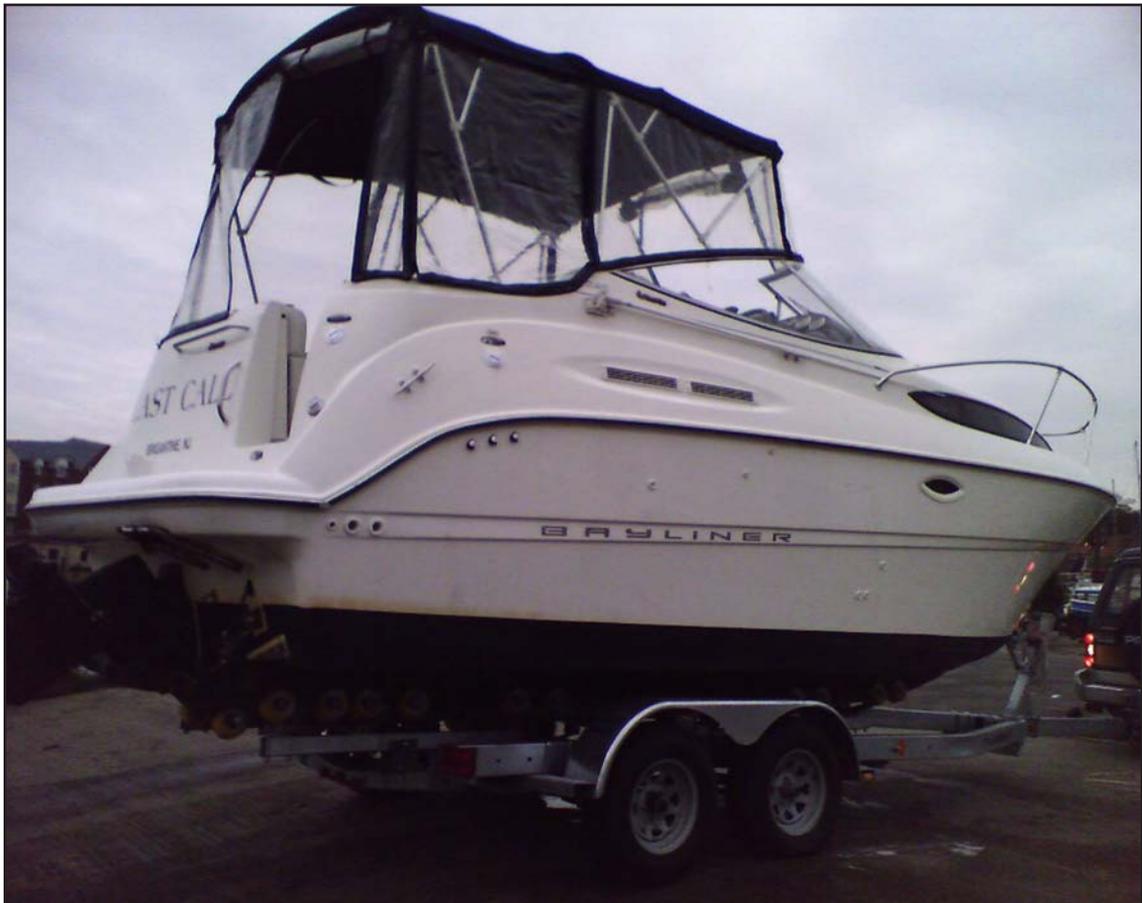
Figure 1

Last Call was imported through the Port of Liverpool. Once import duty and VAT had been paid, the vessel was released by Her Majesty's Revenue and Customs (HMRC) and delivered by road transport to Coates Marine boatyard in Whitby on 12 November 2007. On arrival at Coates Marine, *Last Call* was lifted off the transport and stowed on its own trailer in the boatyard (**Figure 1**).

Last Call after delivery to Coates Marine

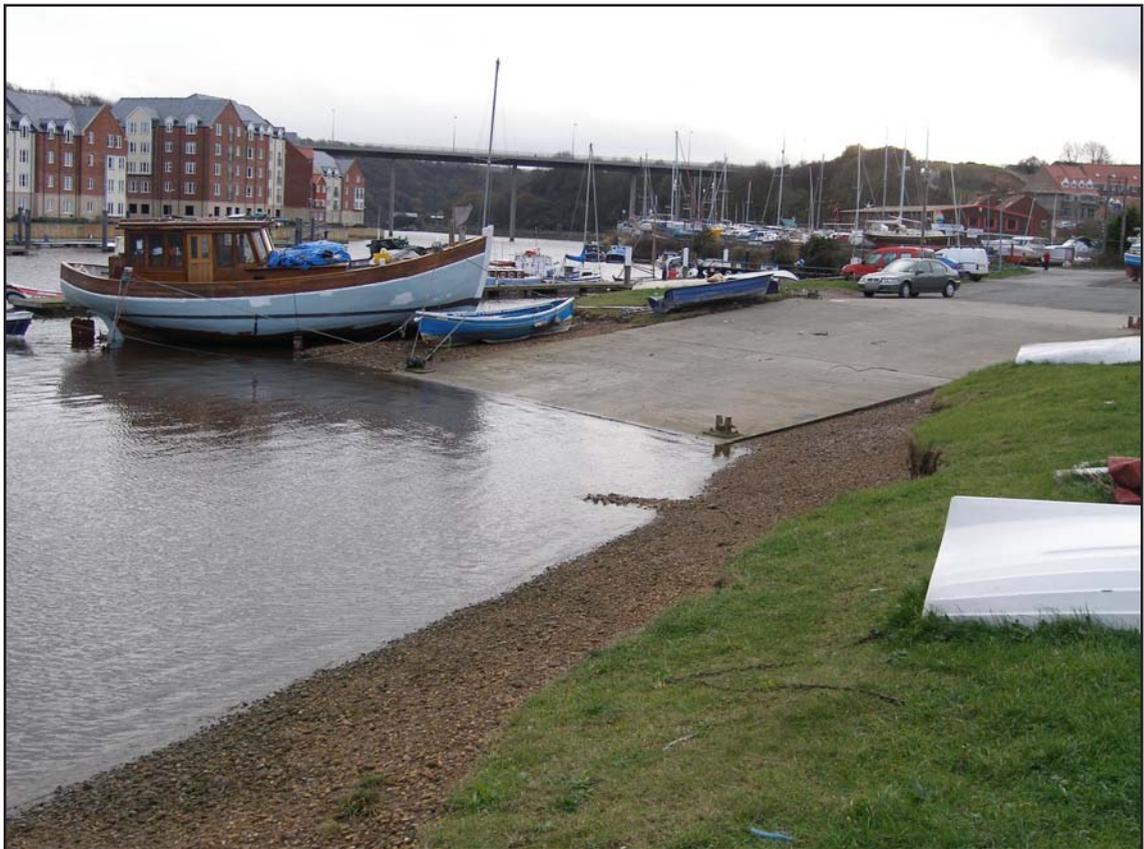
Figure 2

At 0930 on 17 November, after obtaining a launching permit from the Whitby marina supervisor, *Last Call* was launched from the trailer using the slipway operated by Scarborough Borough Council (**Figure 2**). While Jill Russell and John Carrick made arrangements at the marina office for the allocation of a suitable day mooring, *Last Call* was being manoeuvred by Andrew Carrick in the vicinity of the marina, with a friend providing crew assistance.

Launching slipway

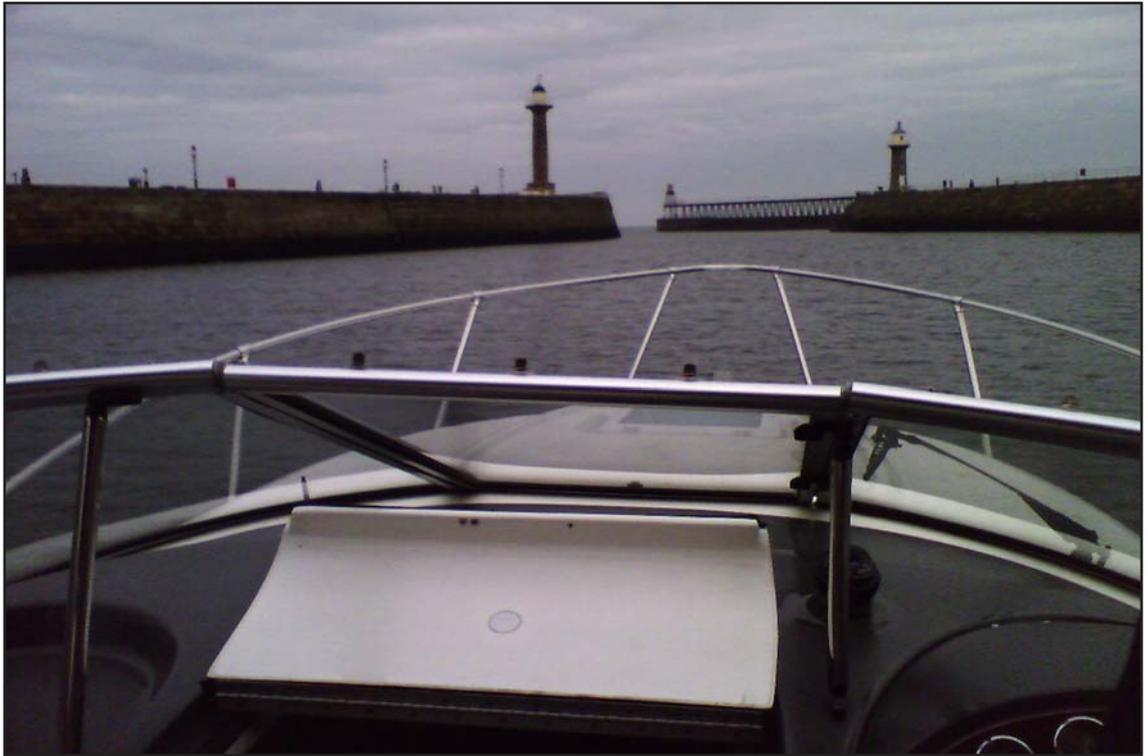
Figure 3

Last Call on passage, 17 November

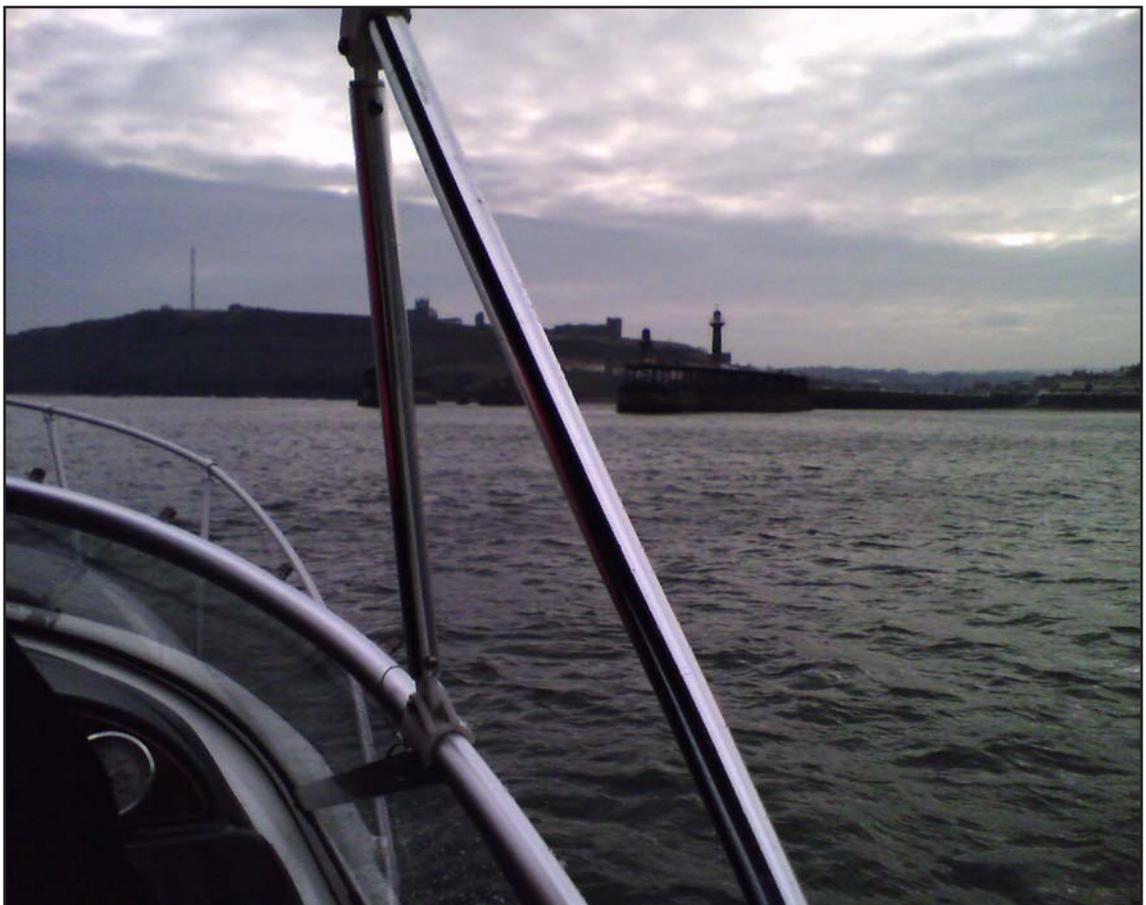
Figure 4

Last Call on passage, 17 November

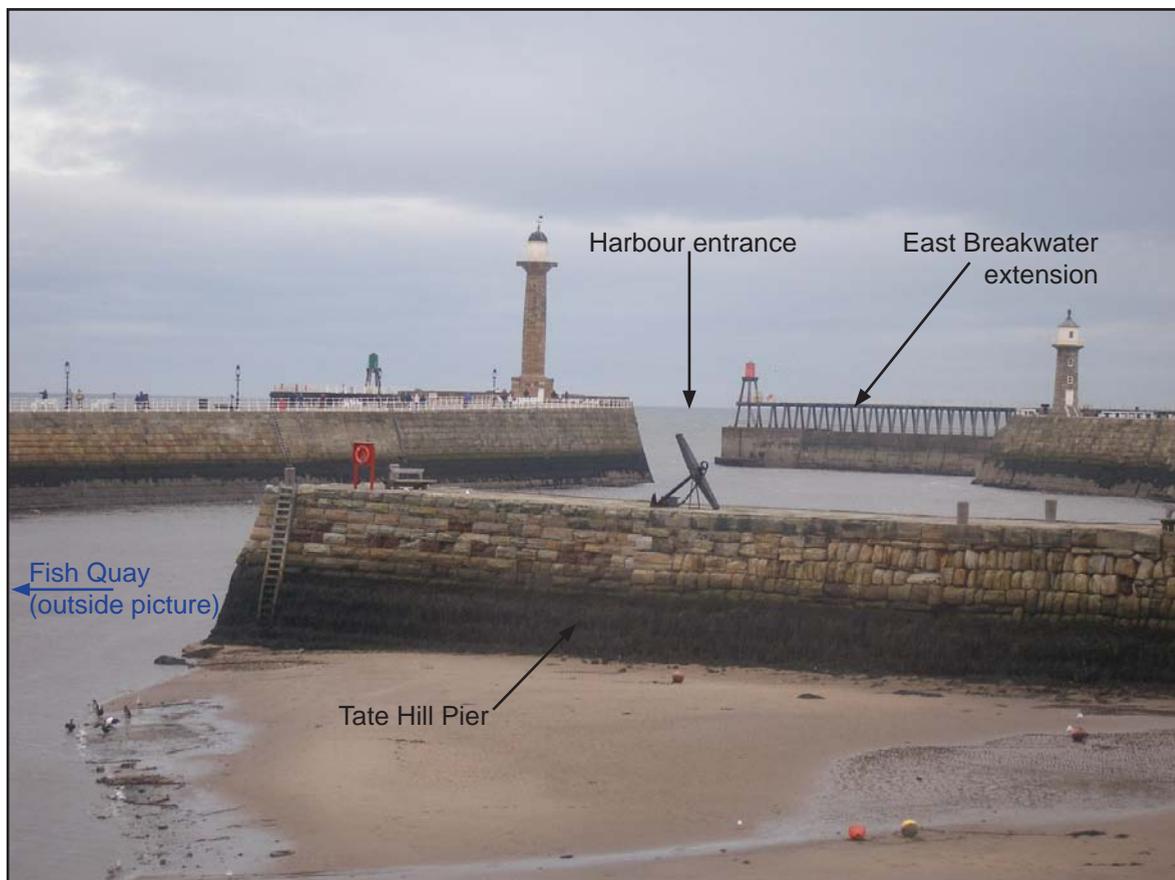
At 1211, the duty harbour watchkeeper, who was working in the vicinity of the Fish Quay, on the west side of the river, saw *Last Call* pass Tate Hill Pier, increase speed, and then head toward the harbour entrance (**Figure 5**). Concerned for the safety of the craft should it attempt to leave the harbour, he called the lifeboat station direct by mobile telephone. At 1212, immediately after the call to the lifeboat station, he informed the Whitby harbourmaster that a pleasure craft was attempting to leave the harbour. On completion of the call he collected his hand-held VHF and made his way toward the end of the west pier.

Whitby outer harbour

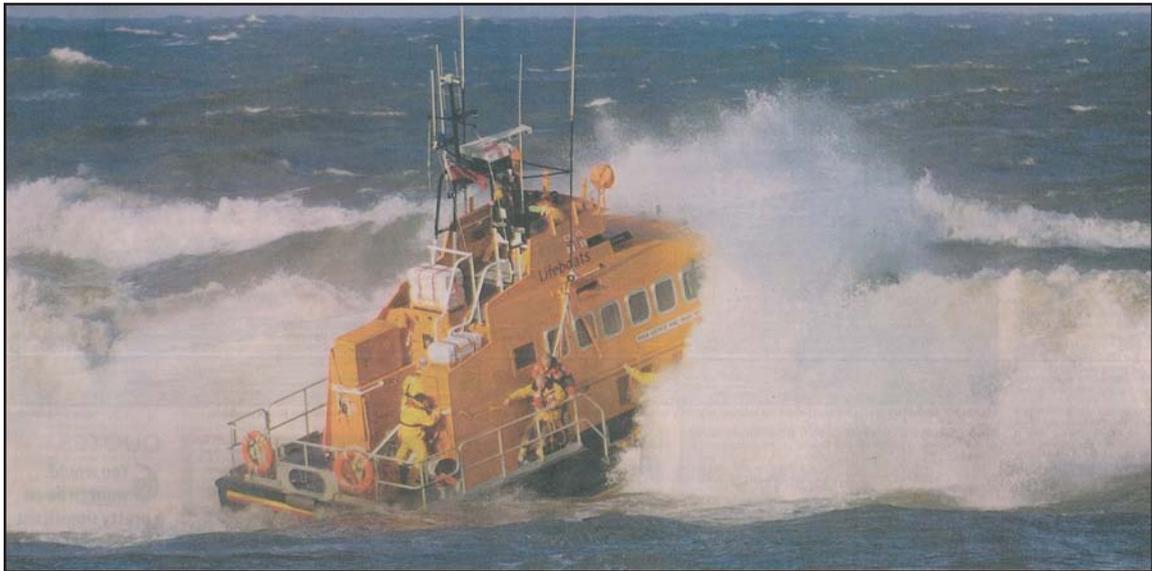
The coxswain manoeuvred the lifeboat to head into the wind and sea, and then drifted astern towards the men (**Figure 8**). During the manoeuvre, a large wave broke over the lifeboat and the two men in the water. When the seawater cleared, the person wearing the lifejacket was sighted face down in the water.

Rescue operation

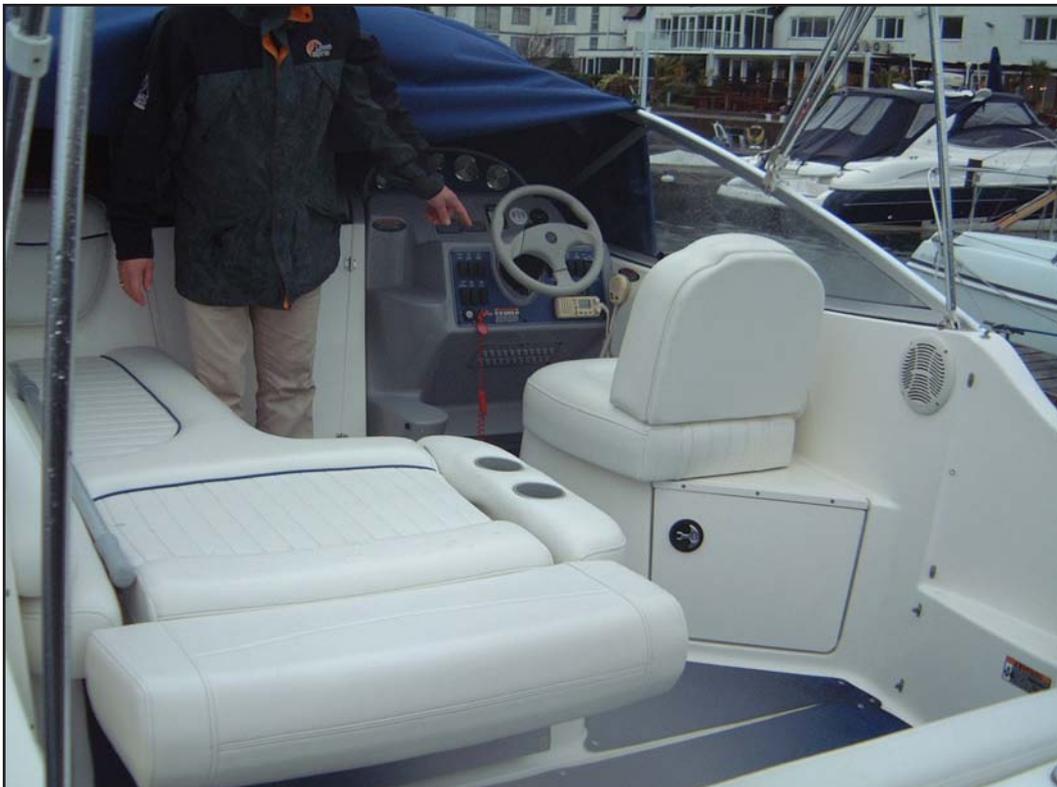
Figure 11

Cockpit layout (similar craft)

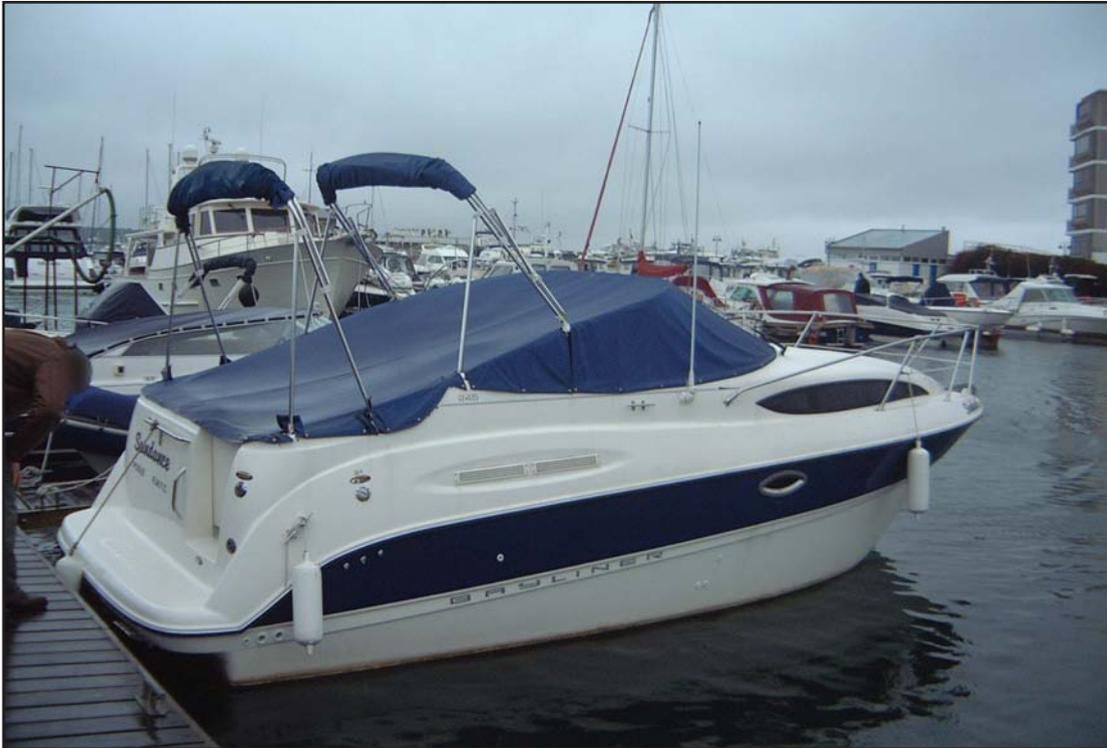
Figure 12

The two-piece canvas and vinyl cockpit canopy could be unzipped, allowing the occupants to remain protected, while the aft section was open to the elements. Access to the boat was via a transom door on the starboard side (**see Figure 12**).

Bayliner 245 SB (similar craft)

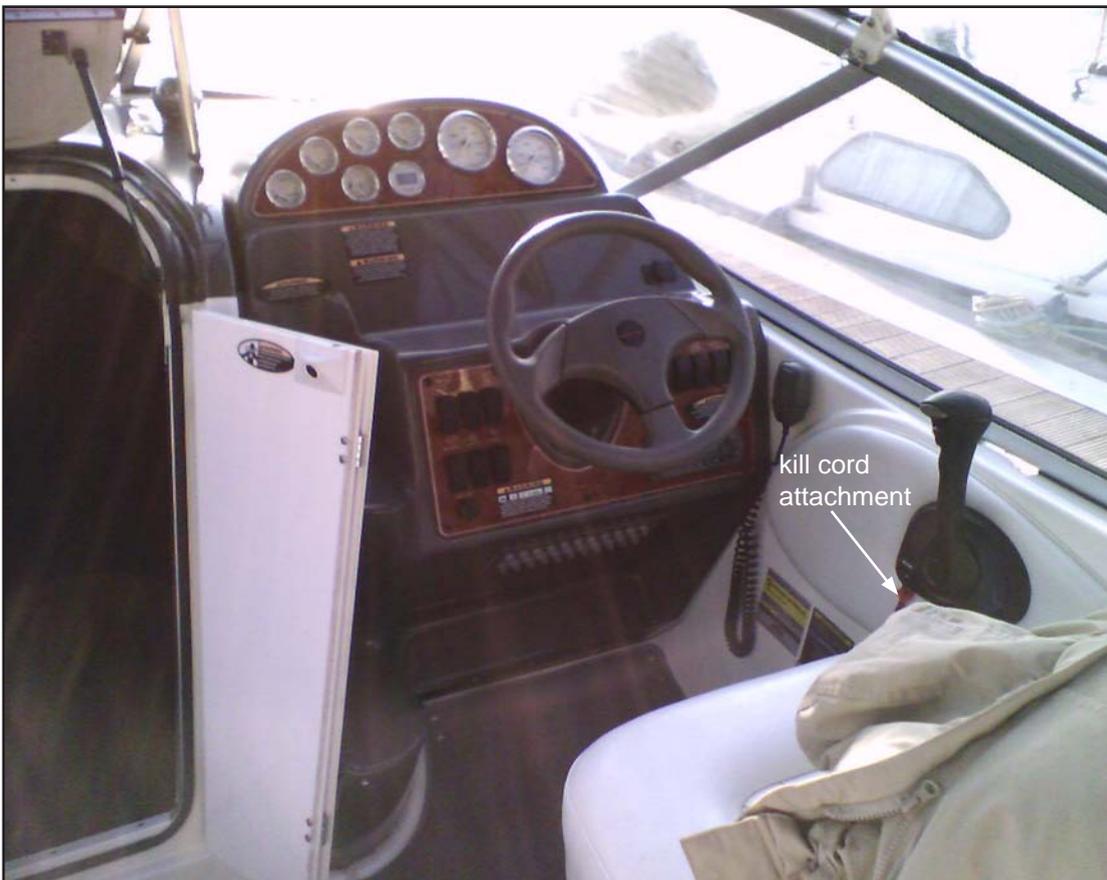
Figure 13

A kill-cord 'toggle' mechanism was fitted adjacent to the throttle lever (**see Figure 13**). Its purpose was to stop the engine if the helmsman moved away from the helm or fell overboard. By doing so, it prevented the boat from injuring third parties, and gave the helmsman an opportunity to re-board the boat if he had fallen overboard.

Last Call - helm position

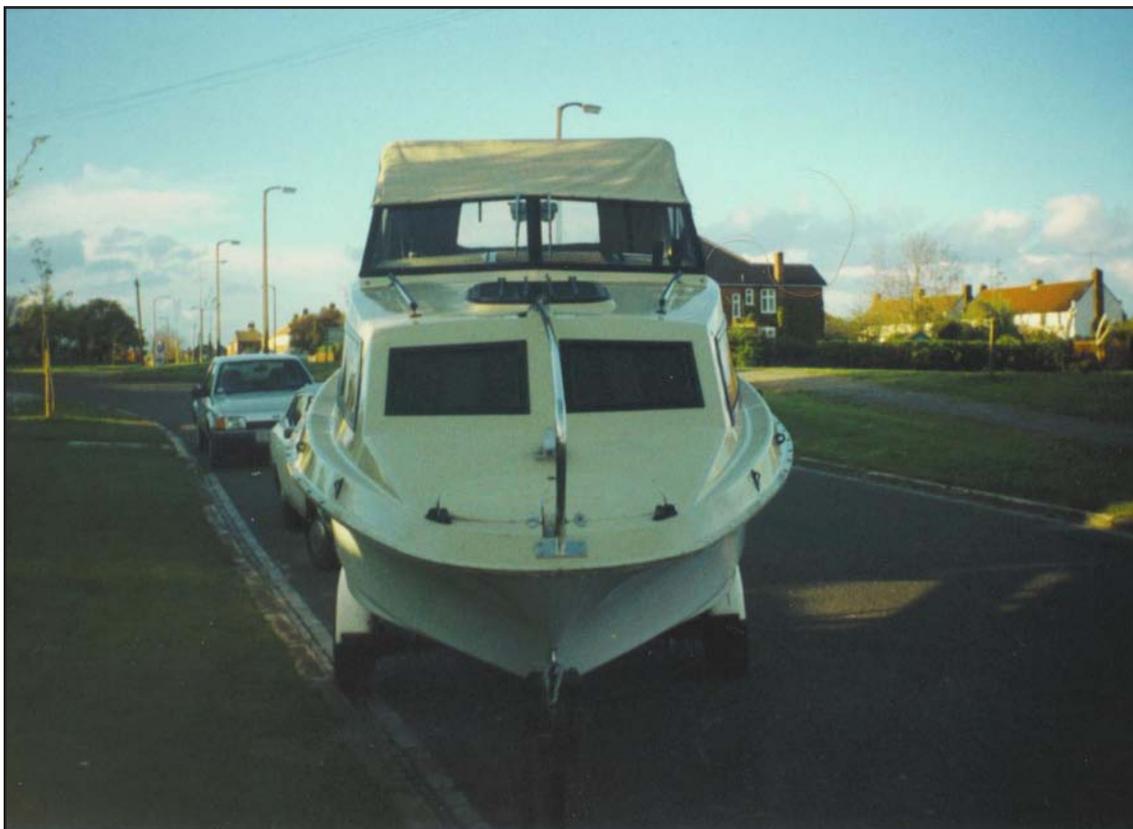
The skipper's previous boat

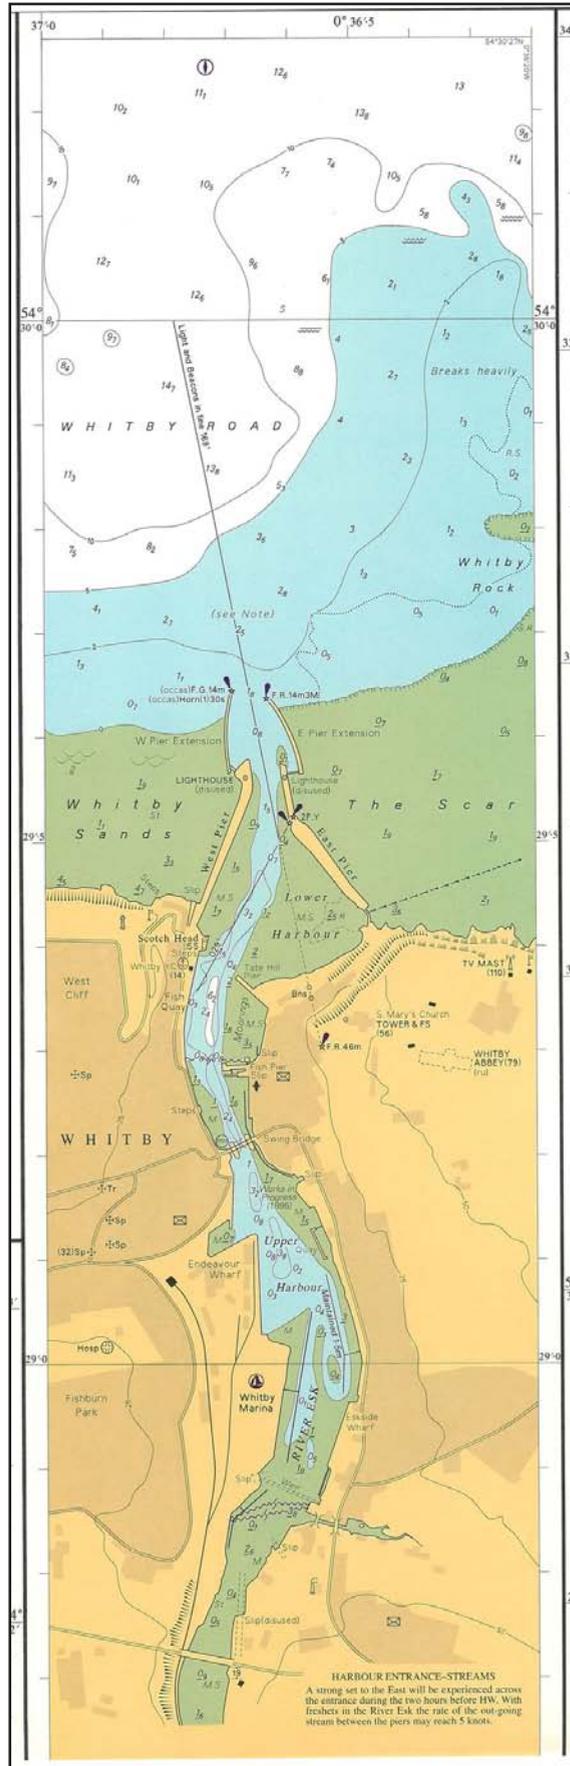
The harbour is divided into the upper and lower harbours, which are separated by a swing bridge. Whitby marina is situated at the south end of the upper harbour. An extract of BA chart 1612 showing the harbour and its approaches can be found at **Figure 15**.

Whitby harbour
