Report on the investigation of

Ursine

Pride of Bruges

Report No 10/2008
May 2008

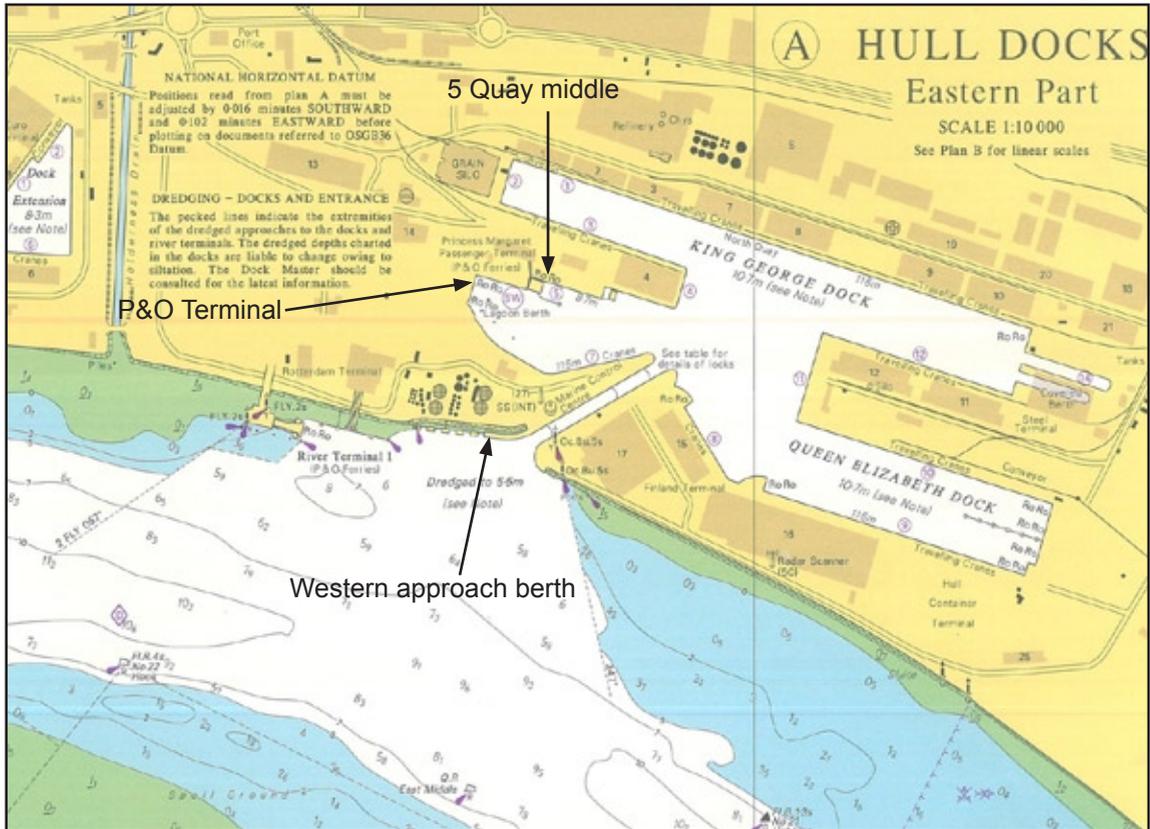
Figure 1

Extract of chart showing western approach berth at entrance to lock and location of P&O terminal

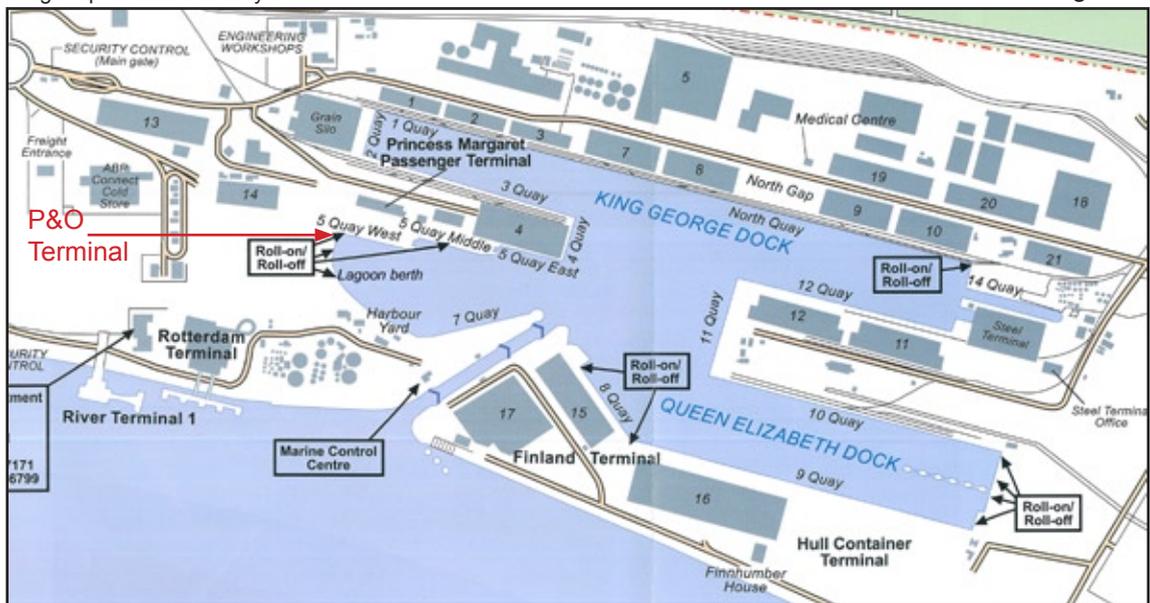
Figure 2

Chartlet showing P&O terminal, King George Dock, Hull

The P&O terminal has three operational berths (**Figure 2**), two of which, 5 Quay Middle and the Lagoon berth, were already occupied when *Ursine* entered the dock.

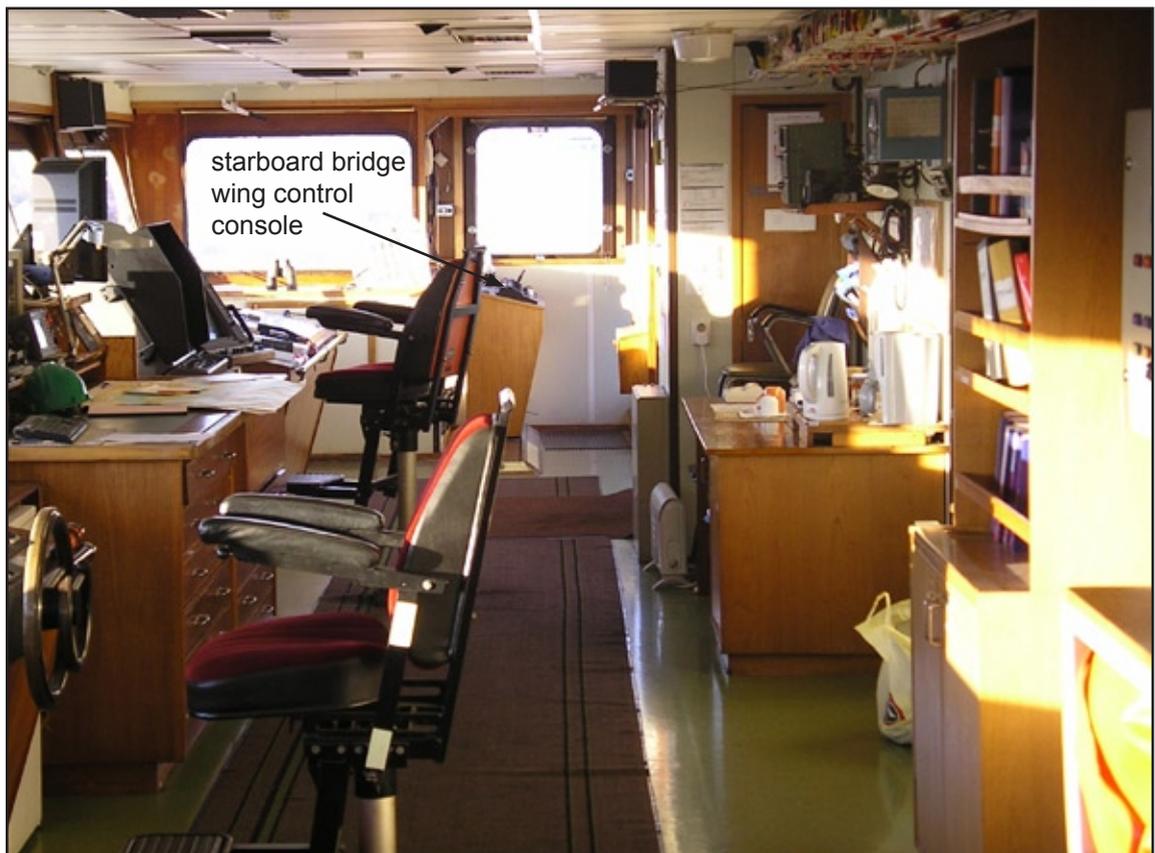
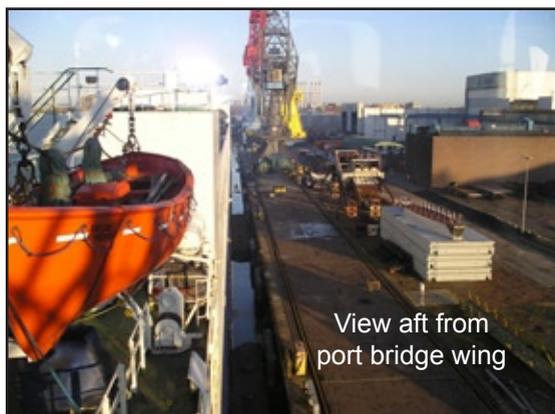
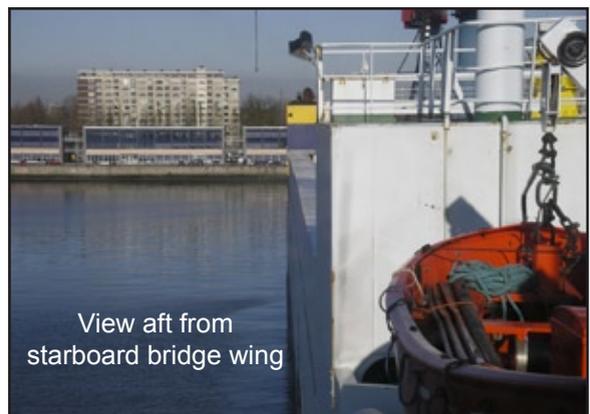
Figure 3

Having entered the dock, the approach to the P&O terminal required *Ursine* to swing 135 degrees to port in order to approach the berth stern first. During this manoeuvre, the master and PEC holder were at the control console on the port bridge wing (**Figure 3**). The chief officer was standing in the area of the control console on the starboard bridge wing, relaying the information received from the 2nd officer about the position of the vessel's stern in relation to berths and other vessels in the dock.

Ursine wheelhouse
