Report on the investigation of

Young Lady

Dragging anchor 5 miles east of Teesport and

Report No 3/2008
February 2008

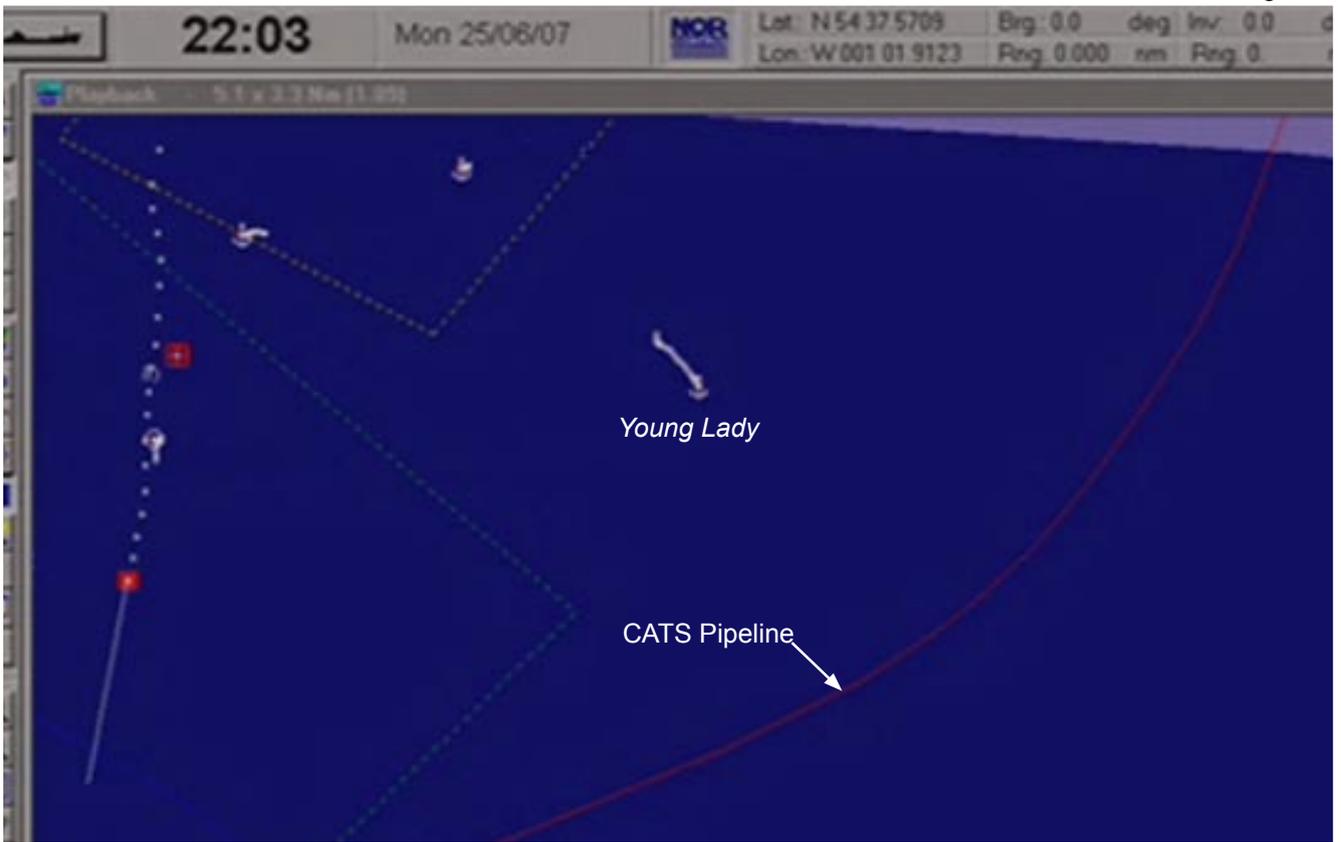
Figure 2

At 2200, the OOW placed a DGPS position on the chart, which showed the vessel lying outside of the swinging circle. He had concerns that the vessel was dragging anchor and called the master at around 2203 (**Figure 2**). The master ordered the third officer to contact the duty engineer to make ready the main engine, and the chief officer to stand by forward. When the master arrived on the bridge he fixed the vessel's position on the chart, and confirmed that *Young Lady* was dragging anchor².

VTS screenshot at 22:03

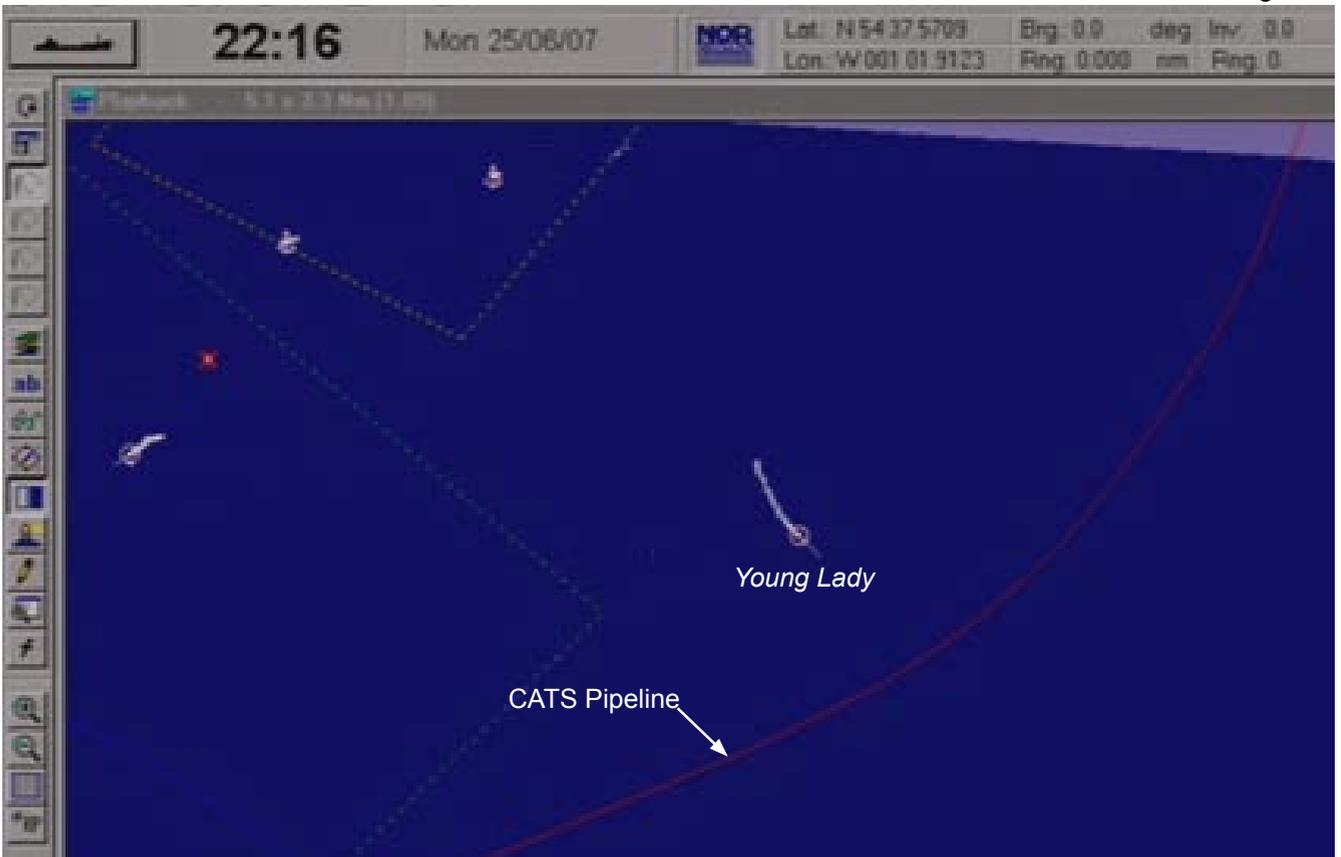
Figure 3

At 2215, the main engine was successfully tested, and at 2216 the engine room was then placed on stand by. Between the times of identifying that the vessel was dragging anchor at 2200, and the main engine being made ready for use at 2216, the vessel had dragged a distance of 0.8 nm at a rate of 3 kts (**Figure 3**).

VTS screenshot at 22:16

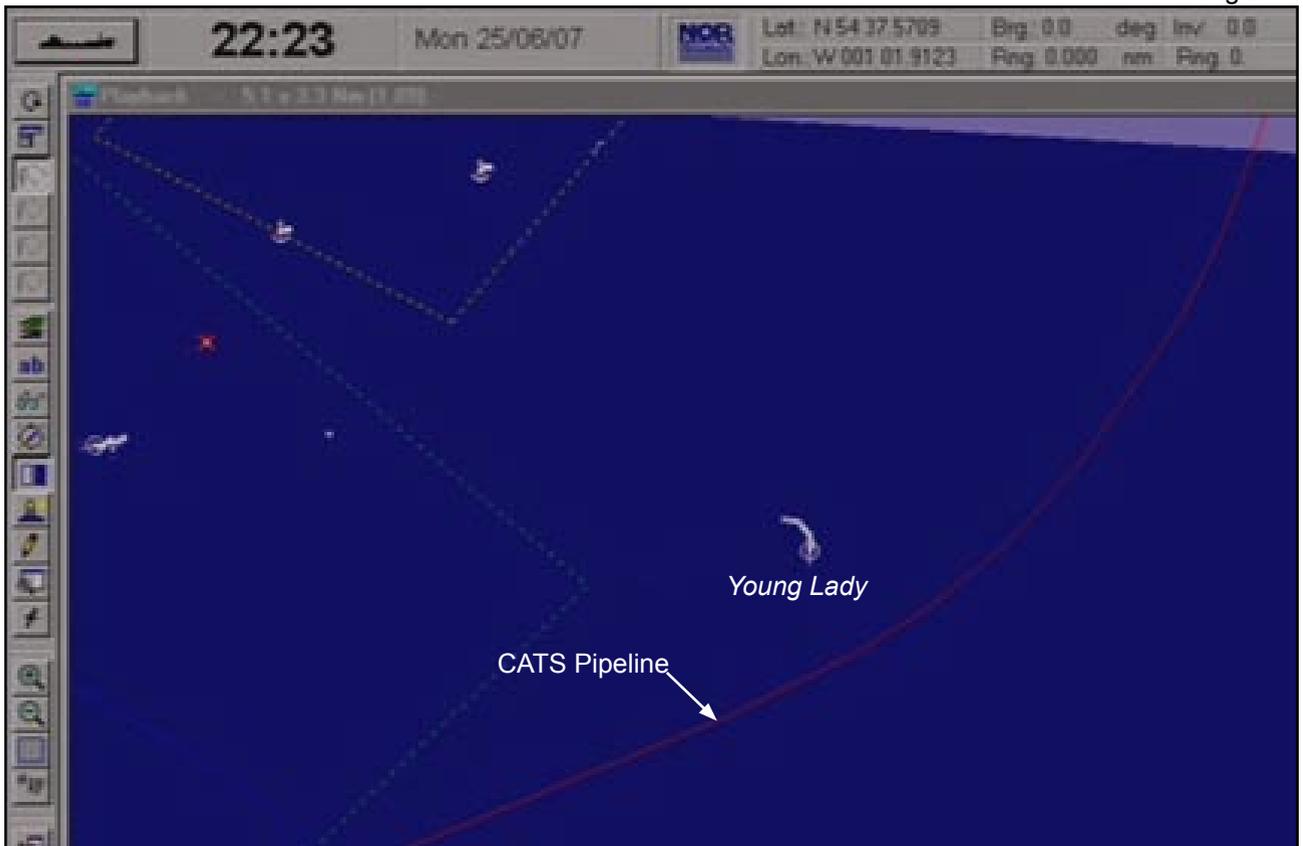
Figure 4

The first engine order was a kick of 'dead slow ahead' recorded at 2223 (**Figure 4**). The chief officer continued to report the direction of the cable which, with the vessel swinging wildly, was leading at very long stay from between starboard 90° to port 180°. The ship's head was recorded as swinging between 068° and 320° over the same period.

VTS screen shot at 22:23

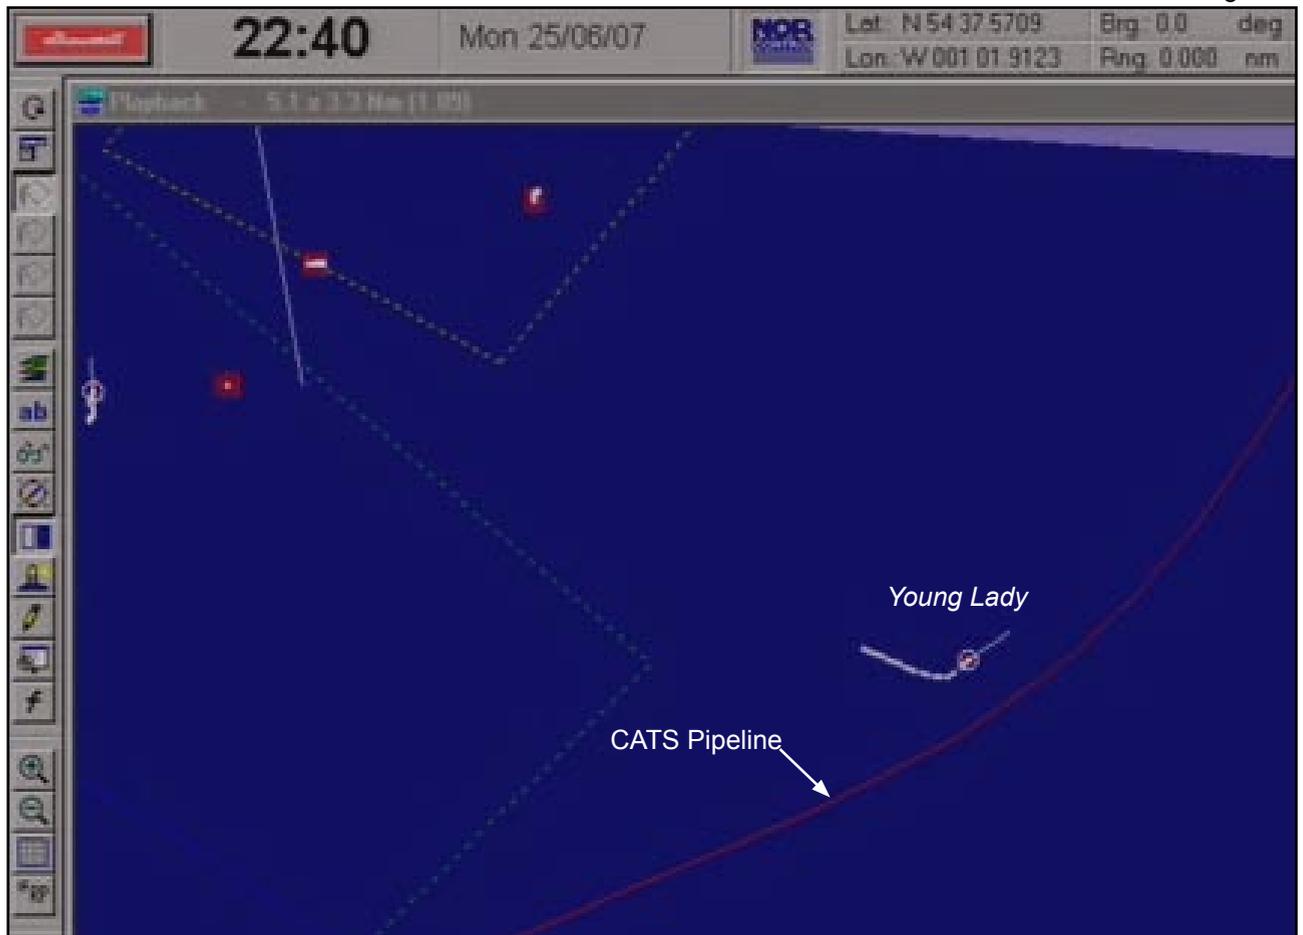
Figure 5

At 2235, the engine was stopped and the rate of drift increased markedly. The next period of engine movements, between 2238 and 2245, succeeded in arresting the drift, and at about 2240 (**Figure 5**) *Young Lady* was stopped over the ground. The vessel had now dragged a total distance of 1.3 nm, and lay only 2 cables north of the charted CATS (Everest) gas pipeline. The wind was steady at about 45 kts from the north-west, and the ship's head was yawing between 310° and 070°. Seas were breaking over the forecastle in the 5m to 6m swell.

VTS screen shot at 22:40

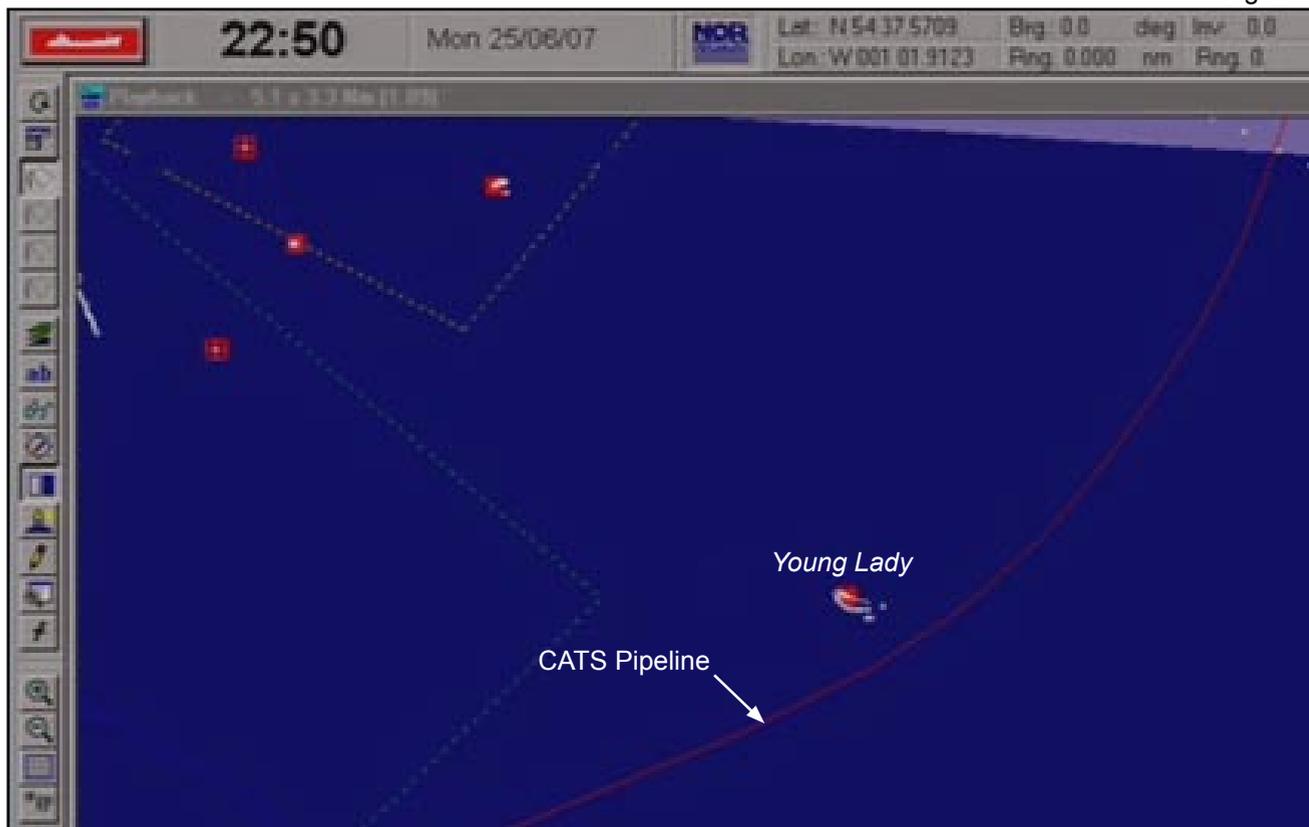
VTS screen shot at 22:50

Following a succession of engine movements up to 'half ahead', the vessel started to make slight headway toward the north-west. At 2250 (**Figure 6**), with the main engine set at 'half ahead' and the third joining shackle visible between the sea and the hawse pipe, the chief officer reported that the cable was leading nearly astern along the port side. The same report advised the bridge that there was too much weight on the cable, and it was the intention to apply the brake and hold on. As the brake was being applied and the crew made the final adjustment, the port windlass, which was still in gear with the control lever in the neutral position, suffered a catastrophic failure of the hydraulic motor unit (**Figure 7**). The cable ran out immediately, the brake lining started to smoke, and sparks from the brake shoe were observed as the lining disintegrated. Hydraulic oil from the windlass motor was spraying over the forecastle at a pressure of 220 bar.

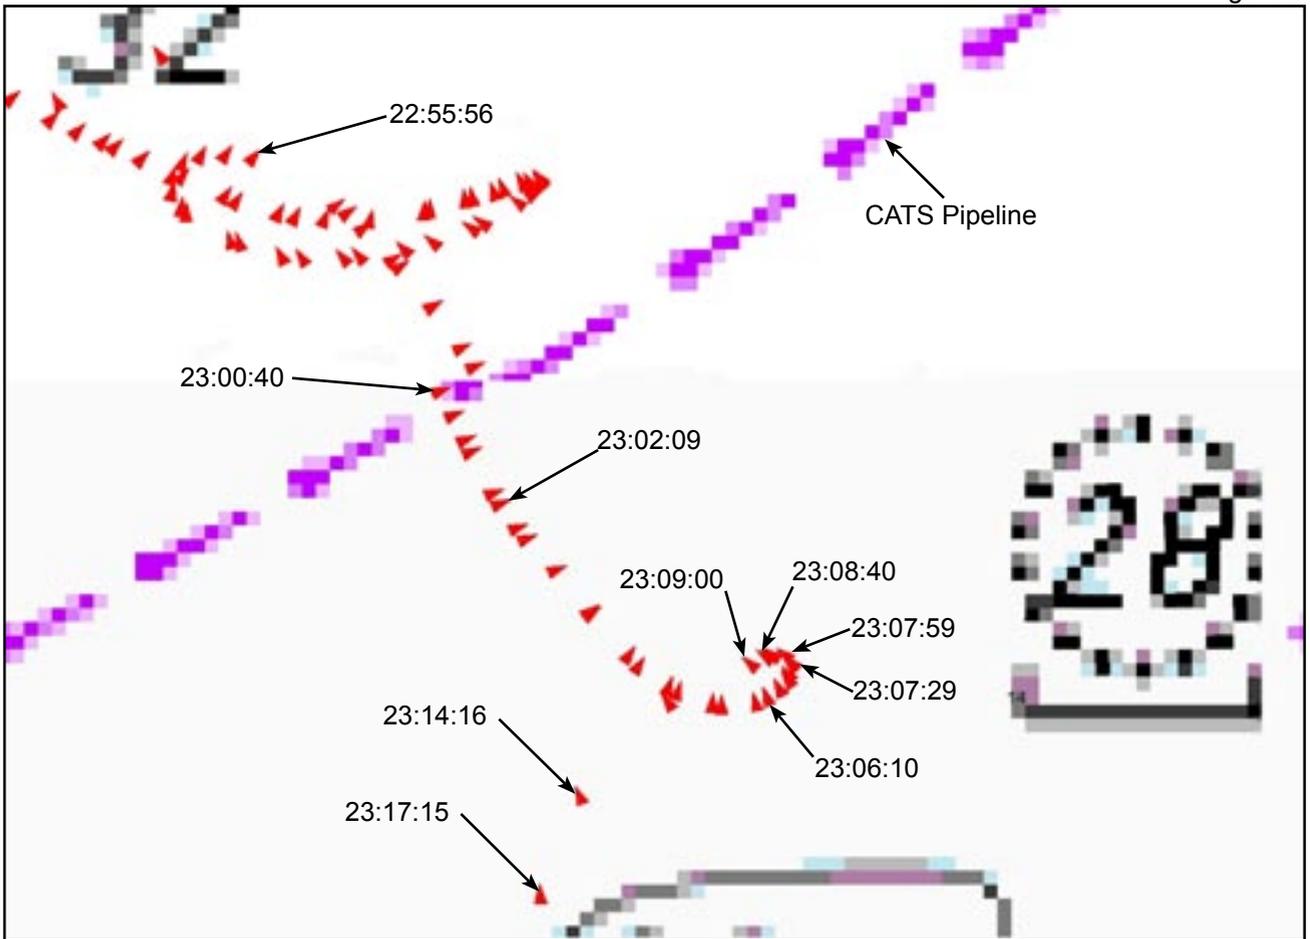
Figure 8

At 2252.5 the main engine was set to 'slow ahead'; at 2253 reduced to 'dead slow', and stopped at 2255. As the port cable payed out to the bitter end, a total of 12 shackles, the vessel drifted quickly to the south, passing over the CATS gas pipeline at 2301. The drift was arrested at 2306 when *Young Lady* was lying 460 m south of the pipeline, a position which corresponded with the port anchor being in the vicinity of the pipeline, some 1.75 nm south-south-east of the original anchor position (**Figures 8 and 9**).

Timings of *Young Lady's* movement over the CATS Pipeline

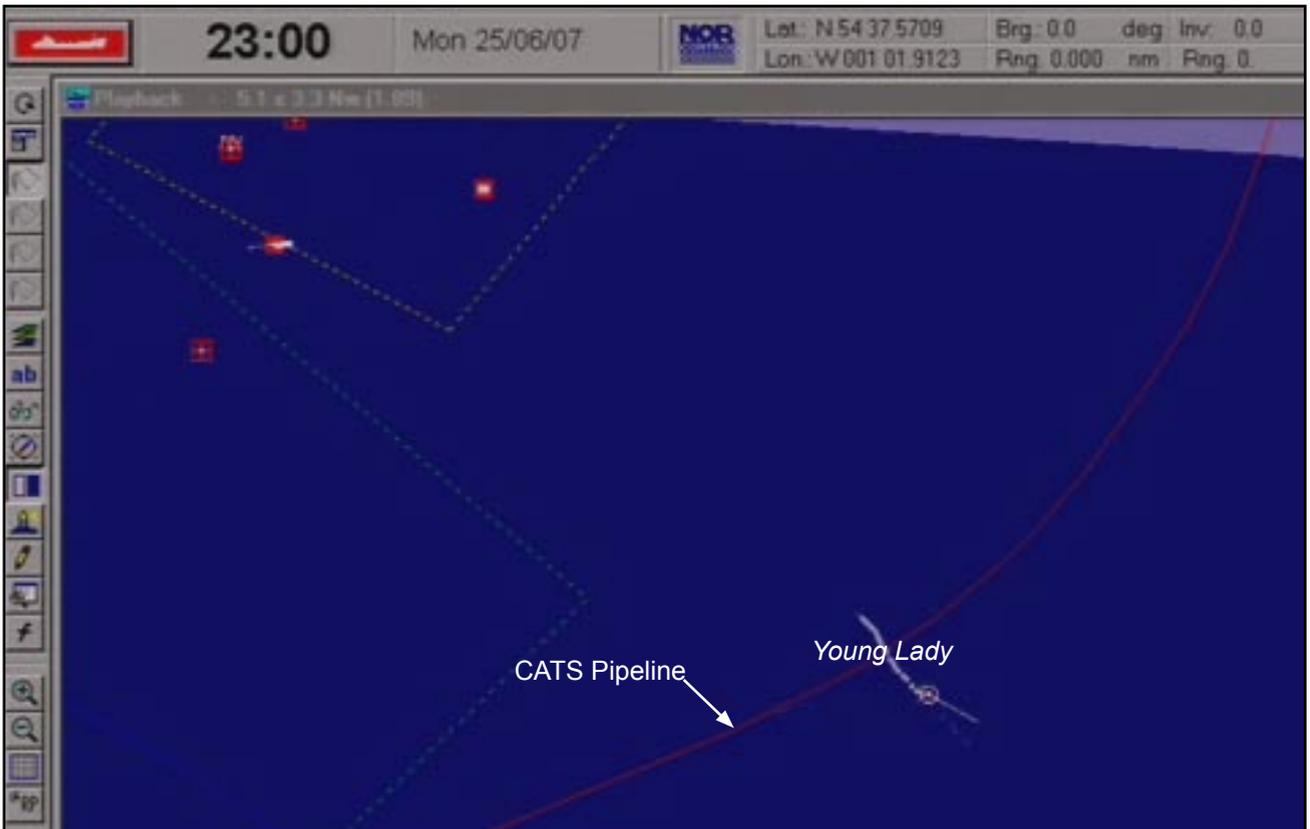
Figure 9

VTS screen shot at 23:00

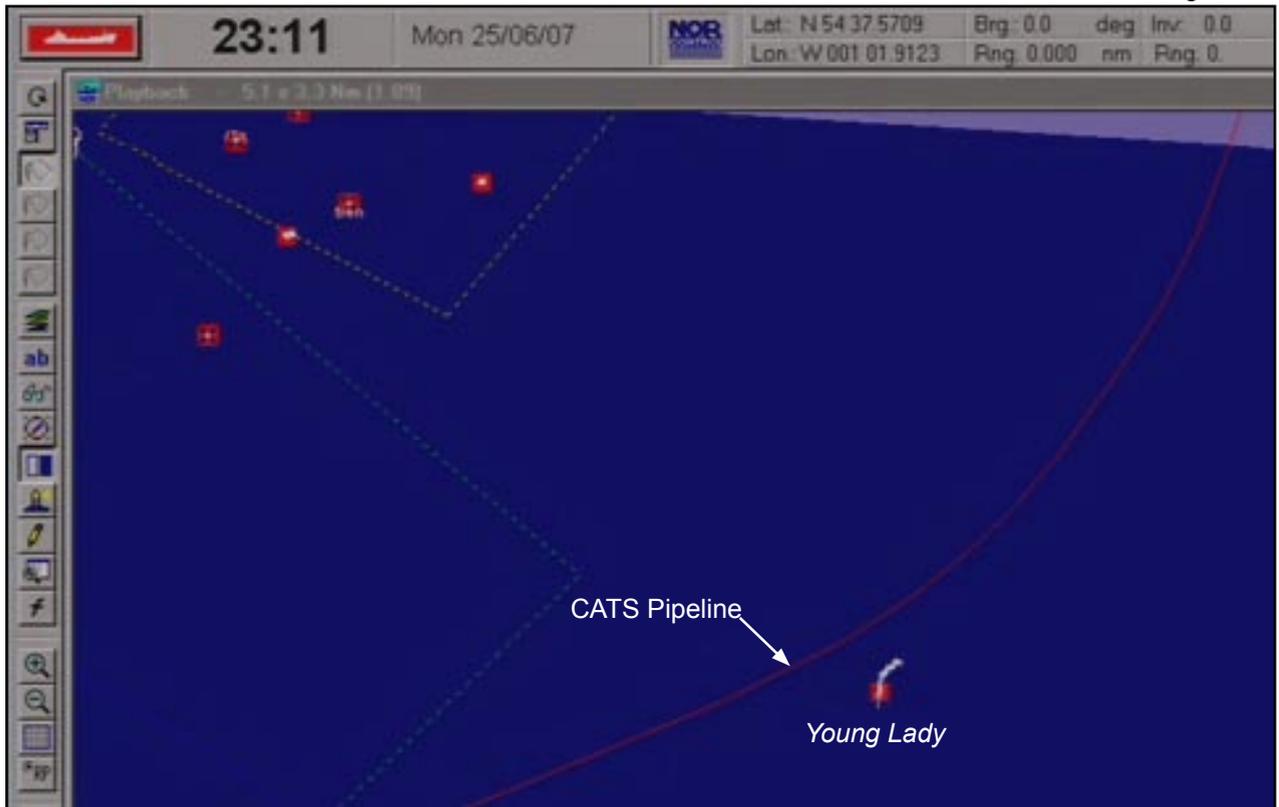
Figure 10

The master, suffering from the effects of shock, was concerned about the dangers faced by the crew working on the forecastle. He was now aware that the vessel had passed over the gas pipeline. The master made a telephone call to the DPA to apprise him of the situation. Between 2301 and 2306.5 engine movements of 'dead slow', and 'slow ahead' were made in an attempt to reduce the weight on the cable, and to control the yawing which was in excess of 100 degrees. At about 2311, when the vessel was at the extremity of a yaw to the north-west, the anchor freed itself from the pipeline and *Young Lady* re-commenced dragging anchor toward the south (**Figure 10**).

VTS screen shot at 23:11

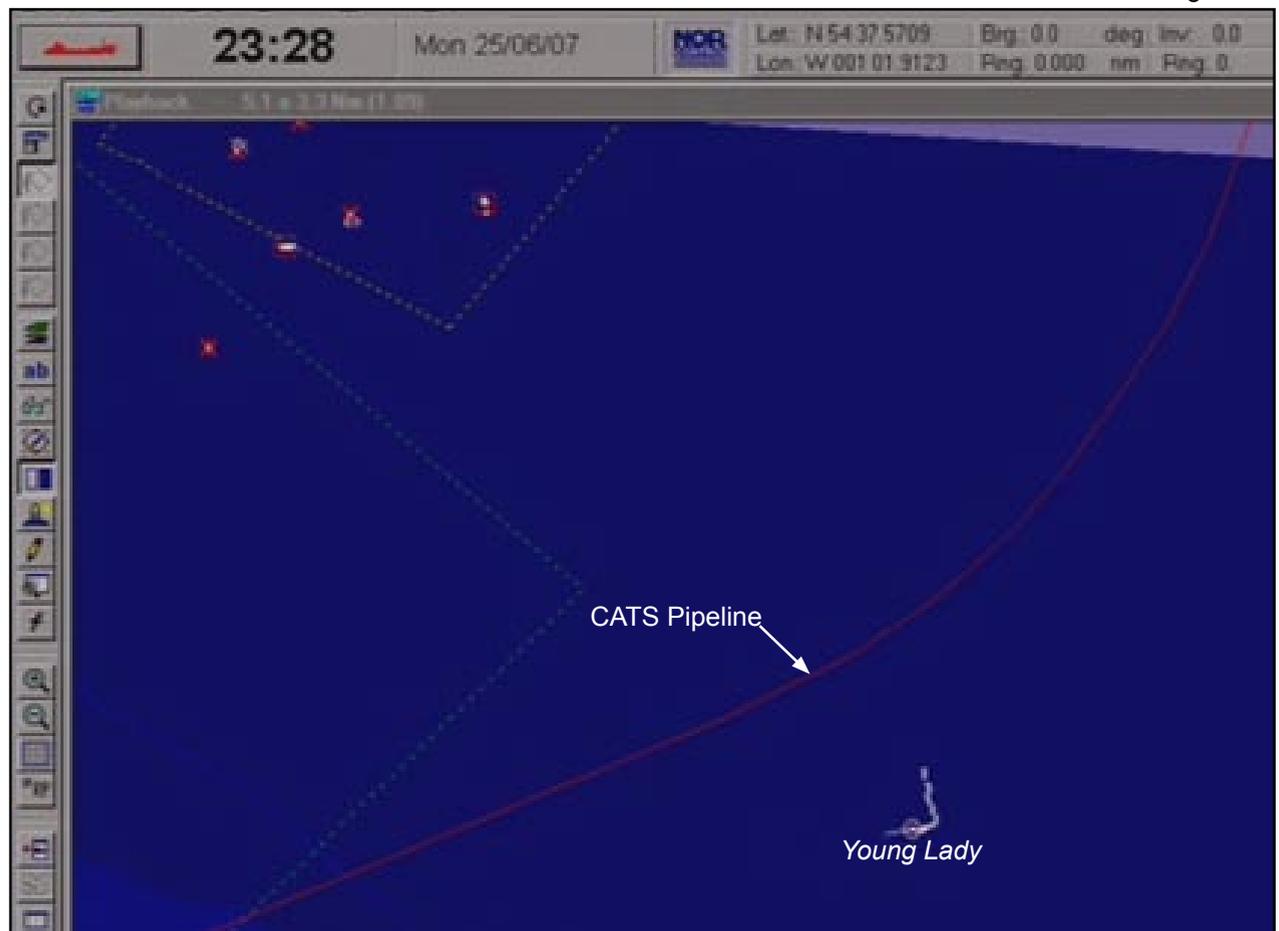
Figure 11

At 2324, the master contacted Tees Ports Control and informed them that the windlass was inoperative and that the cable was now only holding on by the bitter end. Although the master believed that the vessel was no longer dragging, he was conscious of the close proximity of the Salt Scar cardinal buoy. Aware that the vessel was still in the vicinity of the pipeline, it was the master's intention to steam to the north and slip the cable. The main engine was not used throughout this period but, coincidentally as the vessel dragged over a shoaling sea bed, the anchor held and the vessel settled in position 54° 38.55' N 000° 58.9'W at about 2328 (**Figure 11 and 12**).

VTS screen shot at 23:28

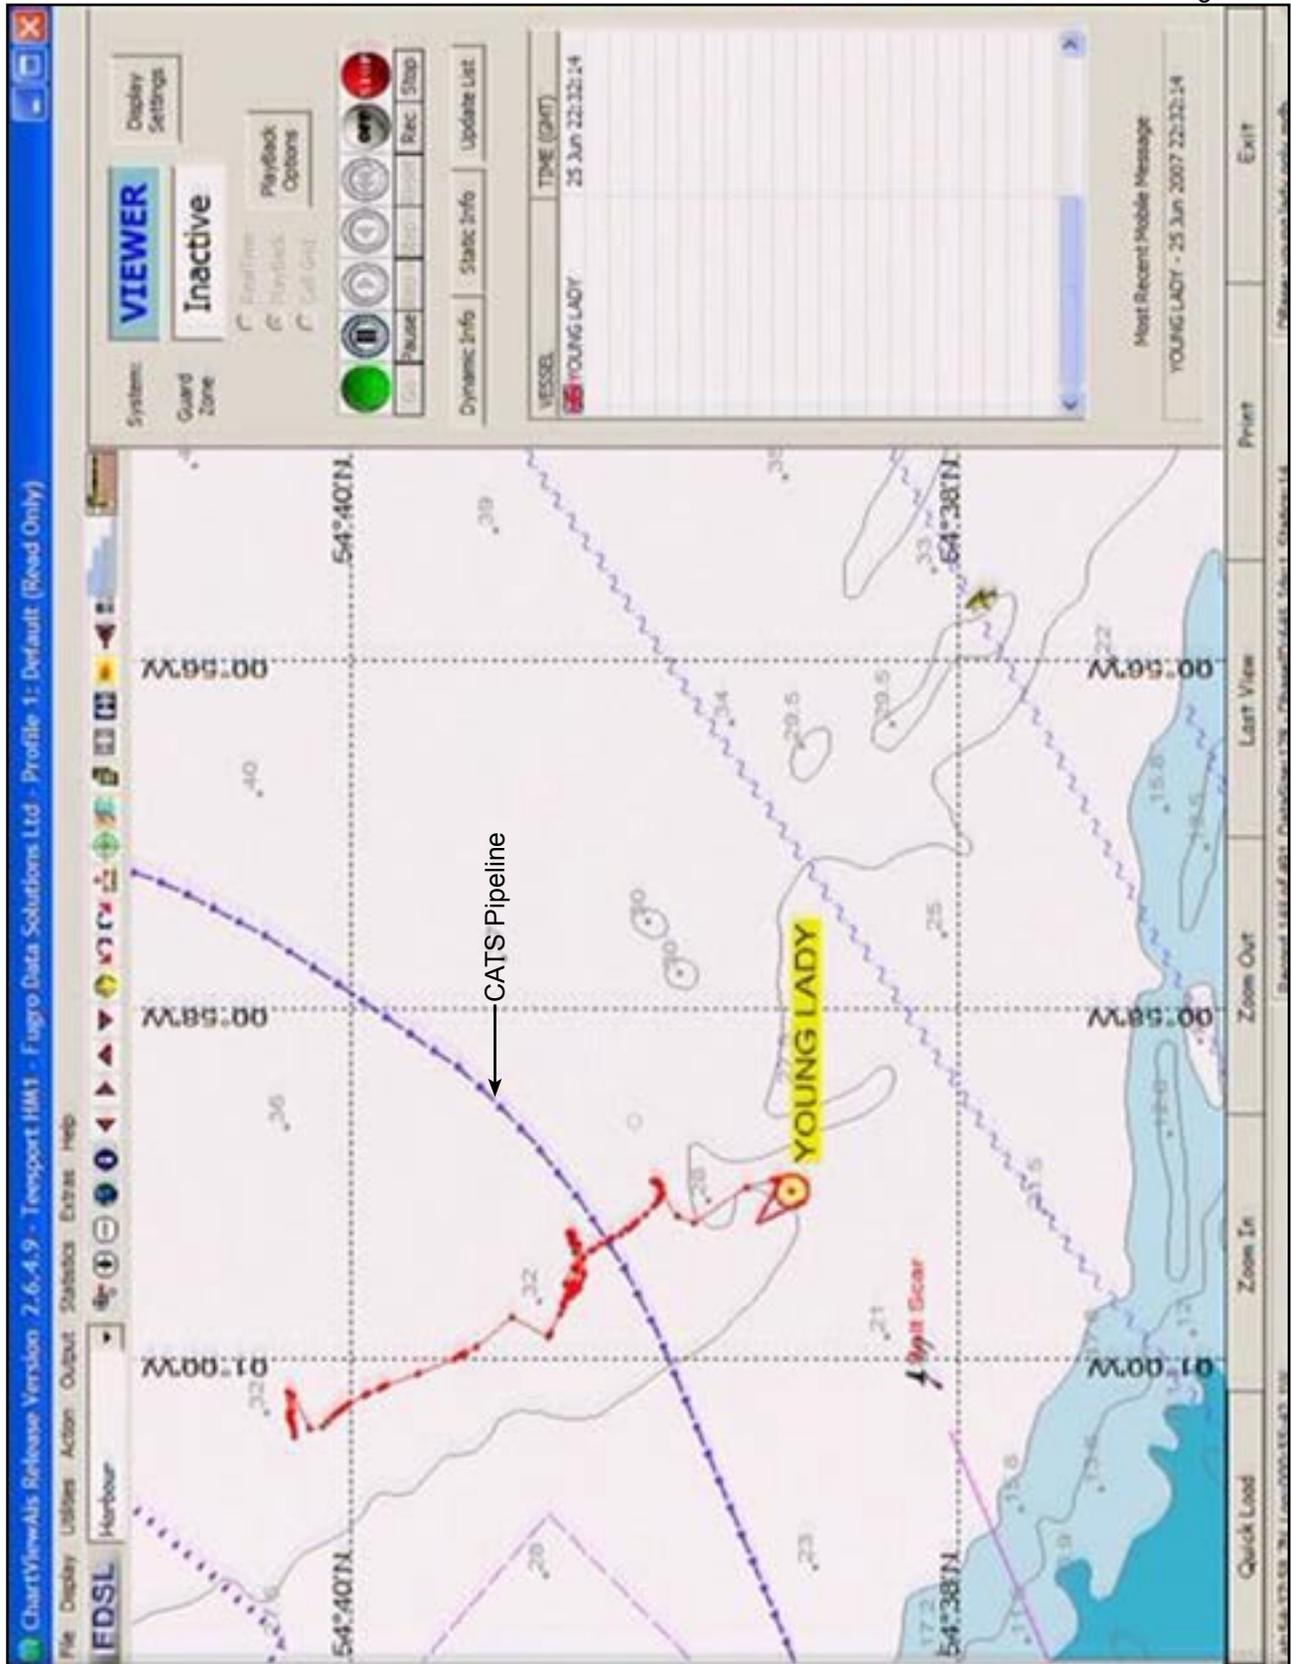
Figure 12

AIS Screen shot, showing Young Lady's movement from 22:00 to 23:32 BST
