Report on the investigation of

the collision between

Sea Express 1

Alaska Rainbow

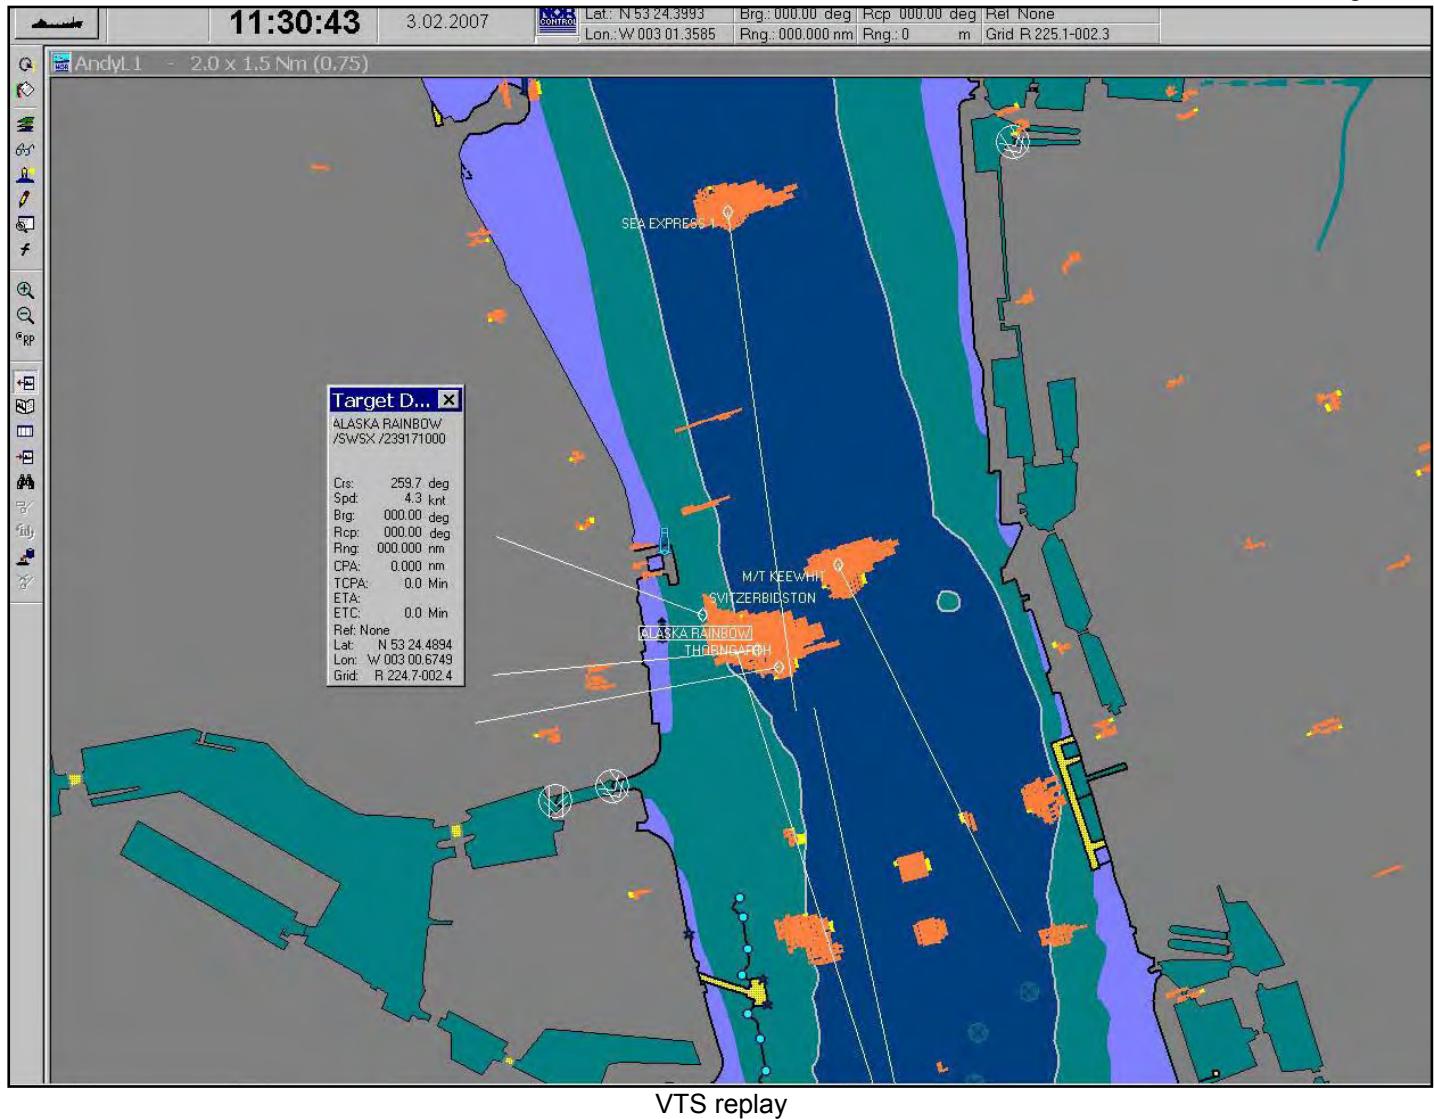
Figure 14

The Port of Liverpool inaugurated the world's first harbour surveillance radar in 1948. The system in operation at the time of the collision combined radar and CCTV surveillance of the port and approaches, with radio and telephone communication. The service was based around a Norcontrol VTS5060 system, which had been updated in 2006. This recorded the radar, AIS and VHF radio transmissions, which were replayed as part of the MAIB investigation (**Figure 14**).

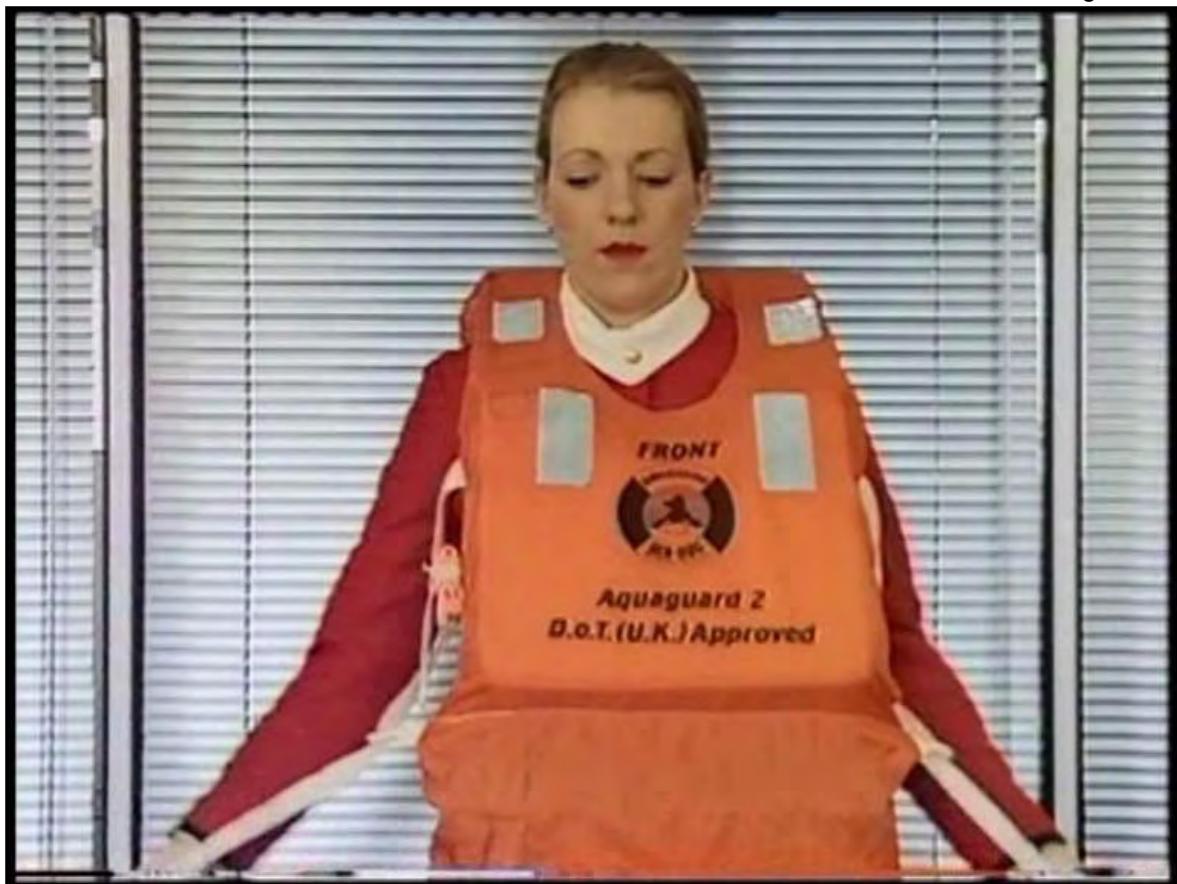
Figure 15a

Available at each passenger seat on board *Sea Express 1* was a card containing safety instructions (**Annex 3**). This detailed the emergency alarm signal and actions to take following the alarm, instructions for donning a lifejacket, and a children's lifejacket and, on the reverse, a plan of the cabin area showing the evacuation route. The instructions were in English and French and supported by a safety video shown shortly after departure from port. This safety video included demonstrations of how to don both types of lifejacket carried (**Figures 15a and 15b**), and a demonstration of the evacuation routes and action to be taken following the emergency alarm. The safety instruction card, however, illustrated only one type of lifejacket.

Lifejacket demonstration - type 1

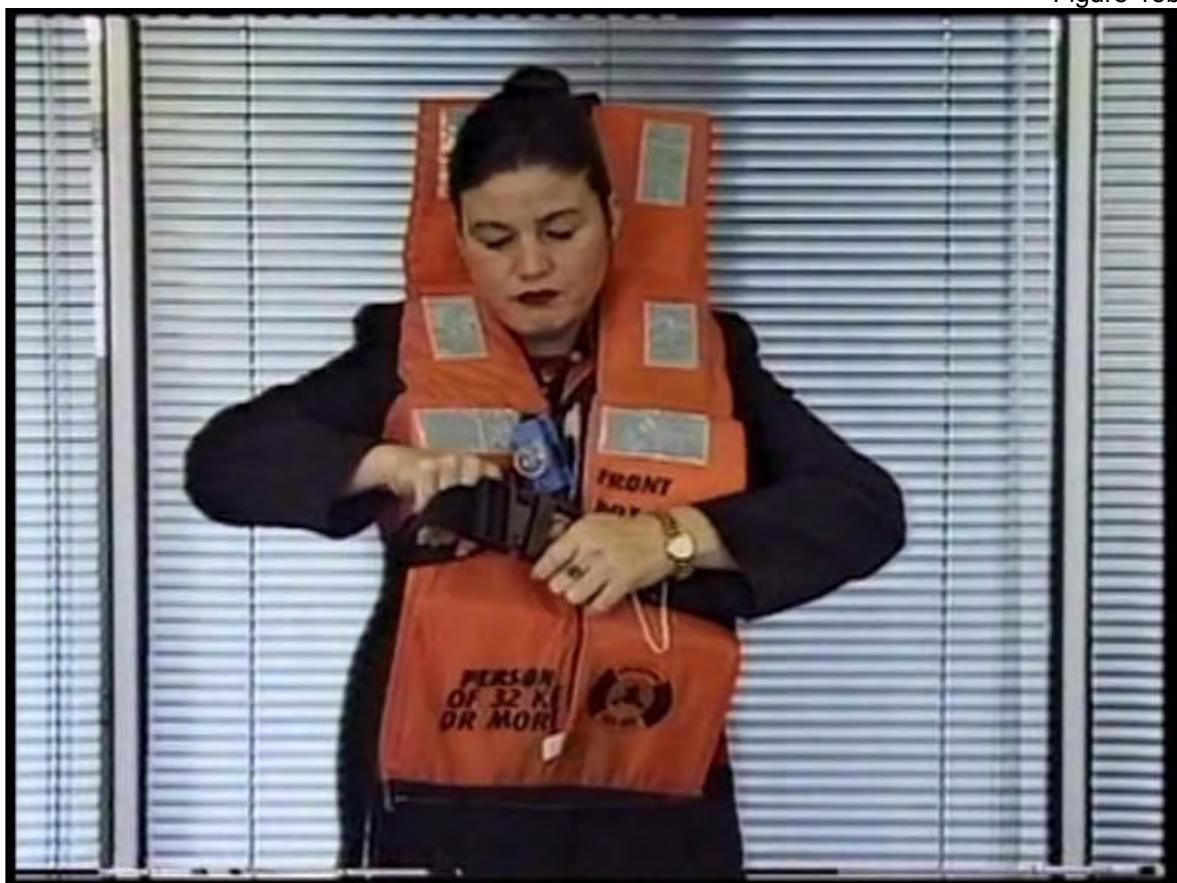
Figure 15b

Lifejacket demonstration - type 2
