Report on the investigation of
the fire on board the canal boat

Lindy Lou

at Lyme View Marina, Adlington

Report No 23/2007
October 2007

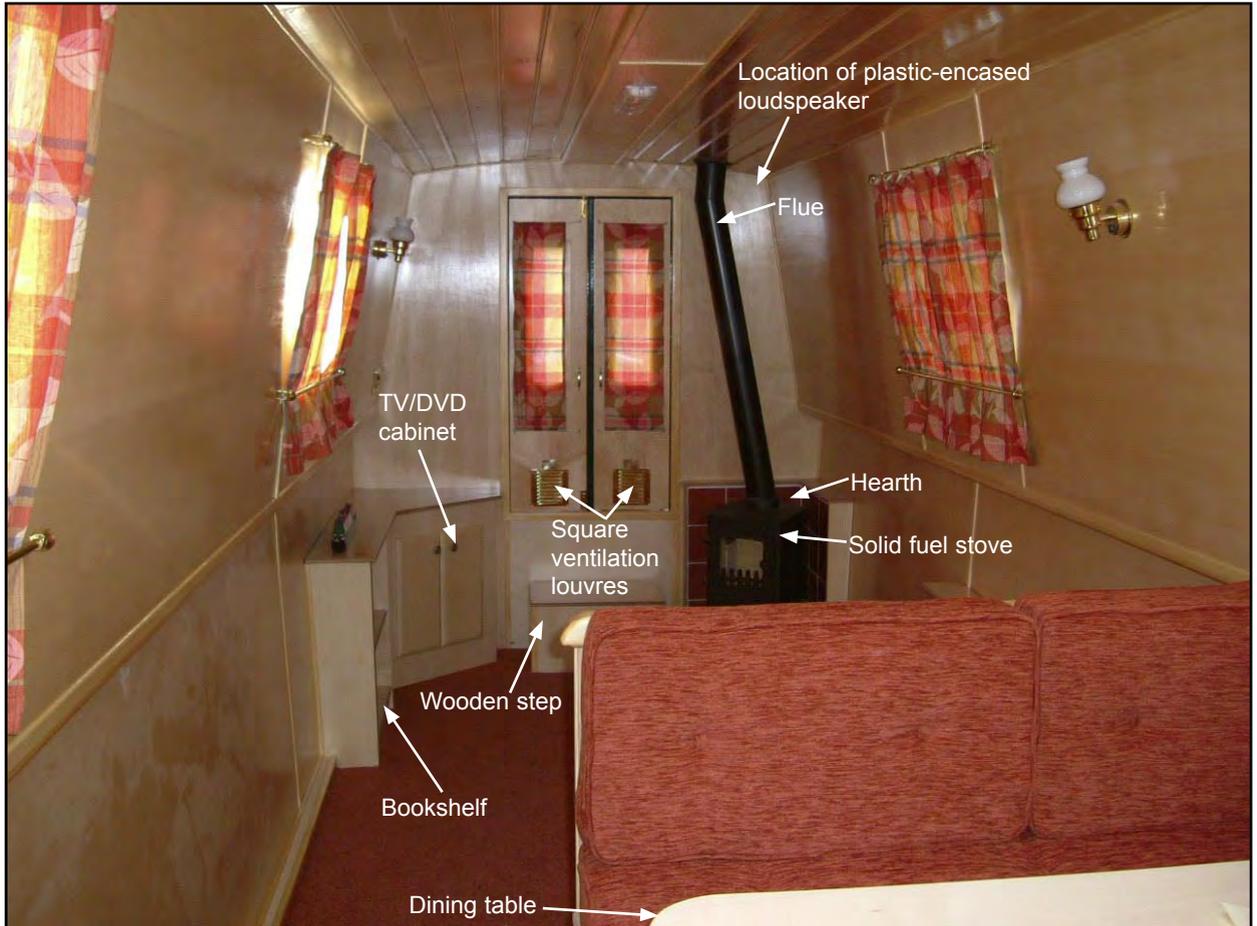
The saloon, towards the bow (shown when the vessel was new, at **Figure 4**), was carpeted with a 100% nylon carpet, provided by the owners. They had also provided a small settee, armchair, footstool and a bean bag in this area. A TV and DVD player were fitted above a wooden cupboard and bookshelf unit in the port forward corner of the boat. The bookshelf contained a large number of DVDs and paperback books. A solid fuel stove was fitted to a hearth in the starboard forward corner. A wooden step was fitted between this and the television unit leading up through the forward double access doors onto the open deck, which had a plastic canopy fitted to provide an additional covered storage area.

View of saloon area (boat as new) looking forward

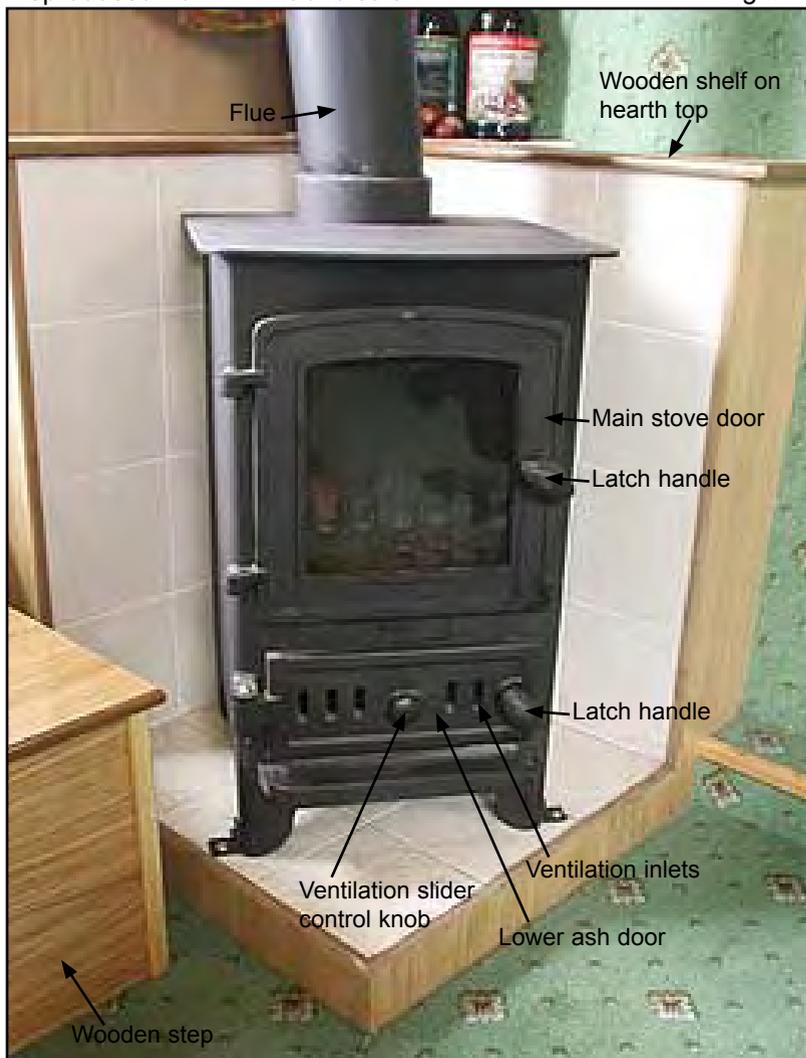
Stove installation on board another Triton narrowboat

The stove was angled on the hearth to face towards the centre of the saloon. **Figure 6** depicts the dimensions of the hearth and the clearances around the stove, and also includes the comparative recommended clearances, based on the stove manufacturer's guidance, which are described in more detail at section 1.10.3 below. The minimum clearance between the stove and the tiles was 15mm at the rear of the hearth (forward bulkhead) and 20mm at the outboard edge. The minimum projection of the hearth in front of the stove was 60mm on the stove's right side. The inboard side of the hearth finished 50mm from the wooden step leading out to the forward deck, with the stove 105mm away from this step at its closest point.
