## CONTROL OF THE MAIN ENGINE

# **SUMMARY, RECOMMENDATIONS, OPINION AND CONCLUSIONS IN RESPECT OF TWENTY-ONE SAMPLES REMOVED FROM THE FORWARD HALF OF THE CONTAINER SHIP mv MSC NAPOLI**

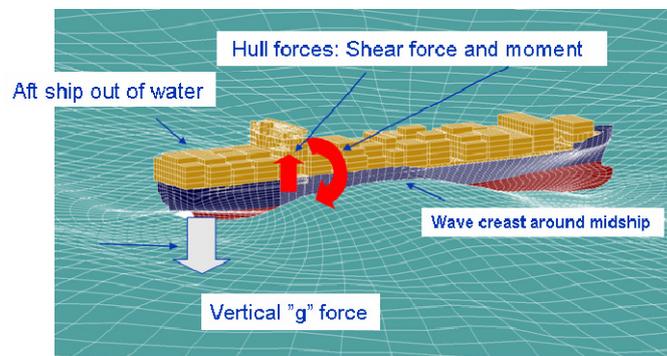
The wave loads for the vessel as presented herein are representative for the ship “frozen” in waves as illustrated in Fig. 4.1. In such a moment in time, typically with a wave crest approximately mid-ship, the aft ship is accelerating vertically upwards out of the waves due to a combined heave and pitch effect. In response to this, the hull girder will set up a significant hogging condition, giving longitudinal compressive stresses in the bottom and bilge area.

**Fig. 4.1 Ship “frozen” in waves in a moment time giving high hull girder hogging loads**

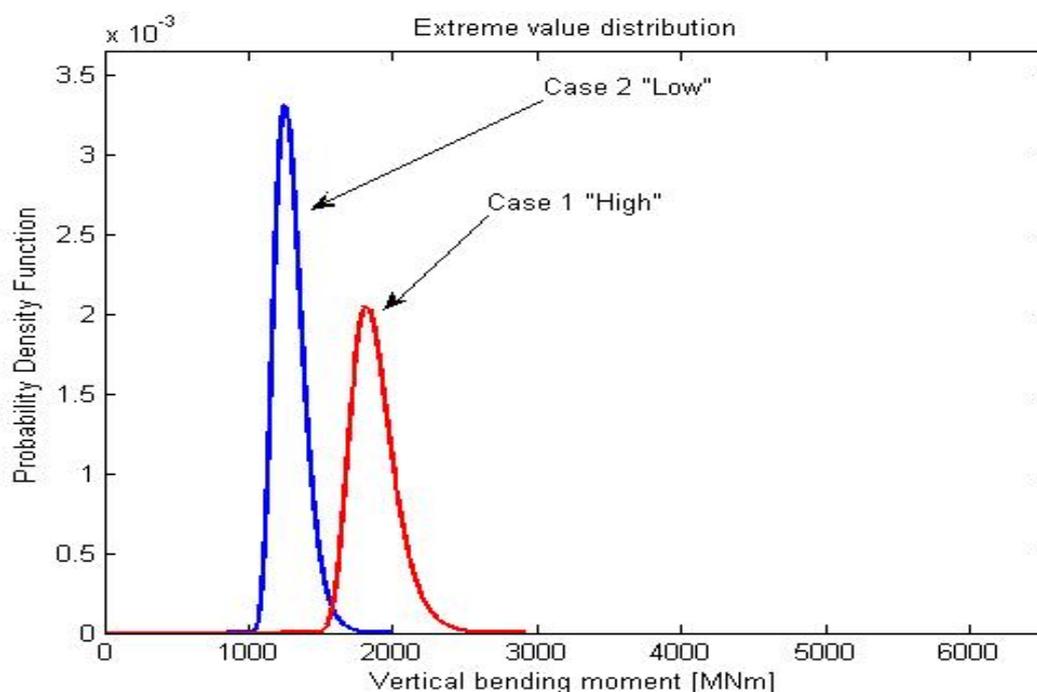
The maximum wave loads at the engine room bulkhead are illustrated as probability distributions (Rayleigh) in Fig. 4.2 for the two sea states analysed, Case 1 “high” and Case 2 “low”. It is to be noted that the probability distributions in Fig. 4.2 have been scaled down by 27% and 20 % (Case1, Case 2) according to the non-linear hogging wave effect relative to linear methods. This is done in order to reflect the real life vessel response as closely as possible.

**Fig. 4.2 Short term statistics – probability distributions for the vertical wave bending moment (VBM) at #88 for the two sea states Case 1 “high” and Case 2 “low”. Non-linear wave effects are included.**

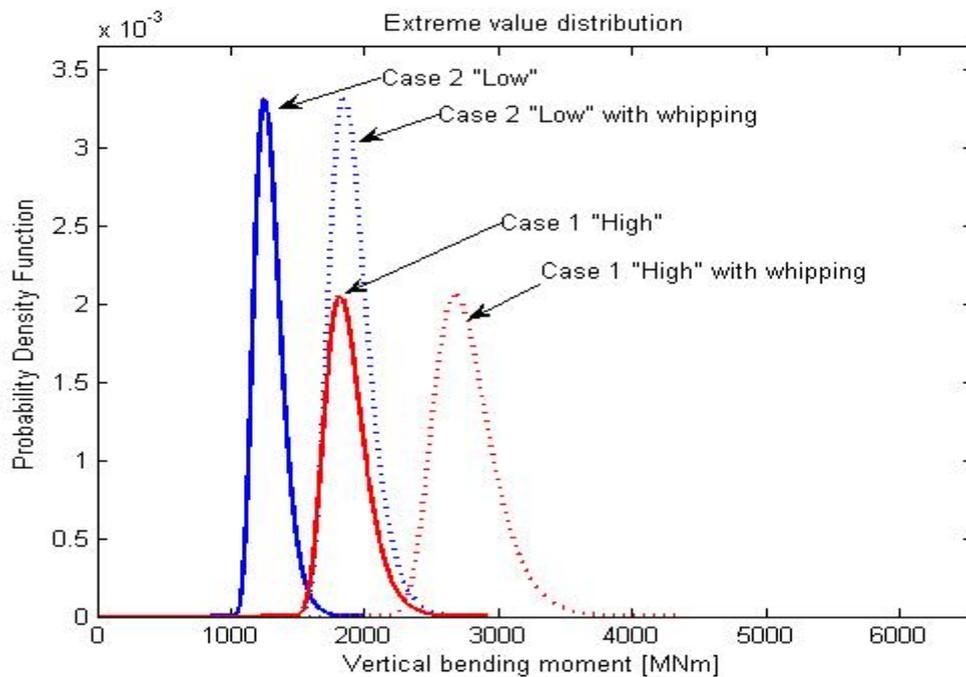
Whipping response on container vessels have been monitored on actual ships as well as in model tank experiments. All these measurements indicate that whipping is an effect to be considered for slender hull designs. However, the variations and uncertainties are large and for container vessels the additional wave load can typically be in the range of 10% to 50 % or even larger. Fig. 4.3 illustrates schematically how a whipping effect will increase a regular wave load.

**Fig. 4.3 Short term statistics – probability distributions for vertical wave bending moment (VBM) at #88 for the two sea states including a schematic whipping correction. Non-linear wave effects are included.**

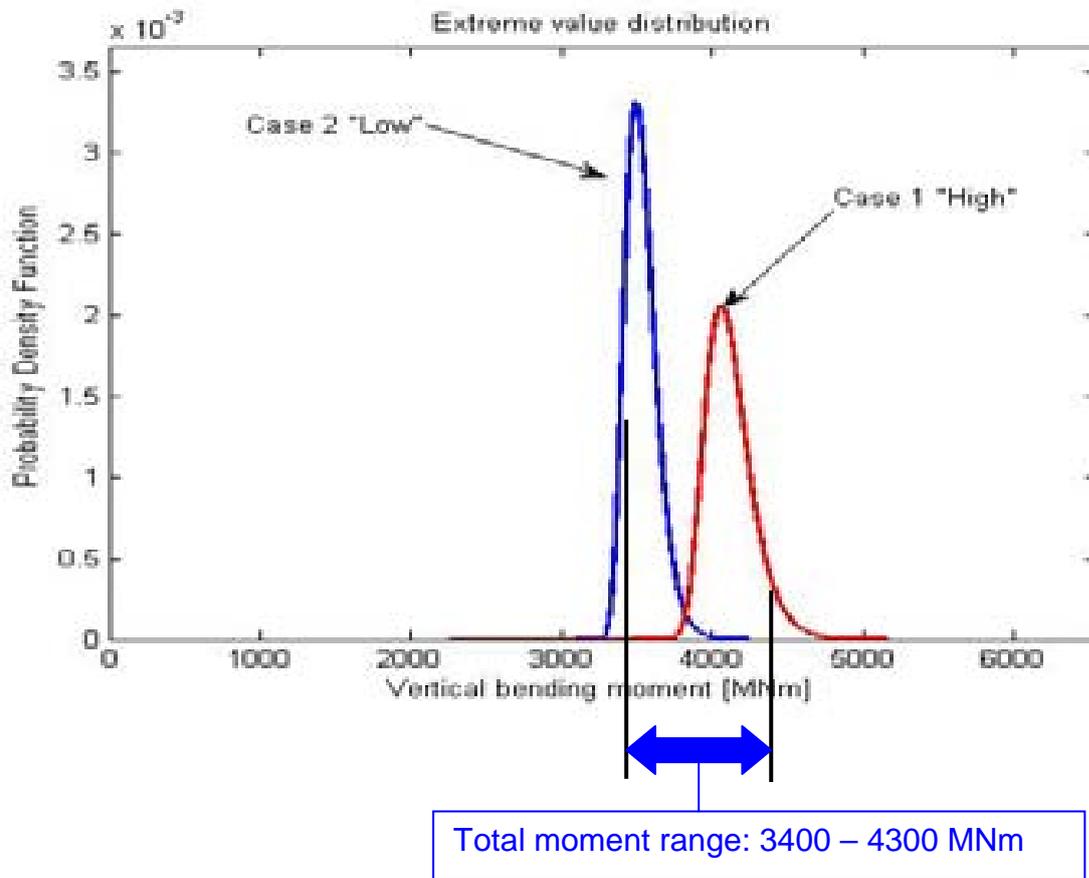
The total load range defined includes the still-water loading on top of the wave load range. The results are given in Fig. 4.4 in terms of vertical bending moment range at the engine room bulkhead (#88).

**Fig. 4.4 Total load ranges: still-water + wave load (VBM) at engine room bulkhead (#88). Non-linear wave effects are included in all curves while whipping is excluded.**

In Table 4.3 the total likely load range is summarized for overview. The total moment range defined includes the likely span of the extreme wave loads assuming Rayleigh distributed short term statistics. For the Case 1 “high” a 10% probability of exceedence value has been used for the upper limit wave load. This limit corresponds to a total moment of 4300 MNm. A similar definition of 10% probability is used for the Case 2 “low” giving a lower bound value of 3400 MNm.

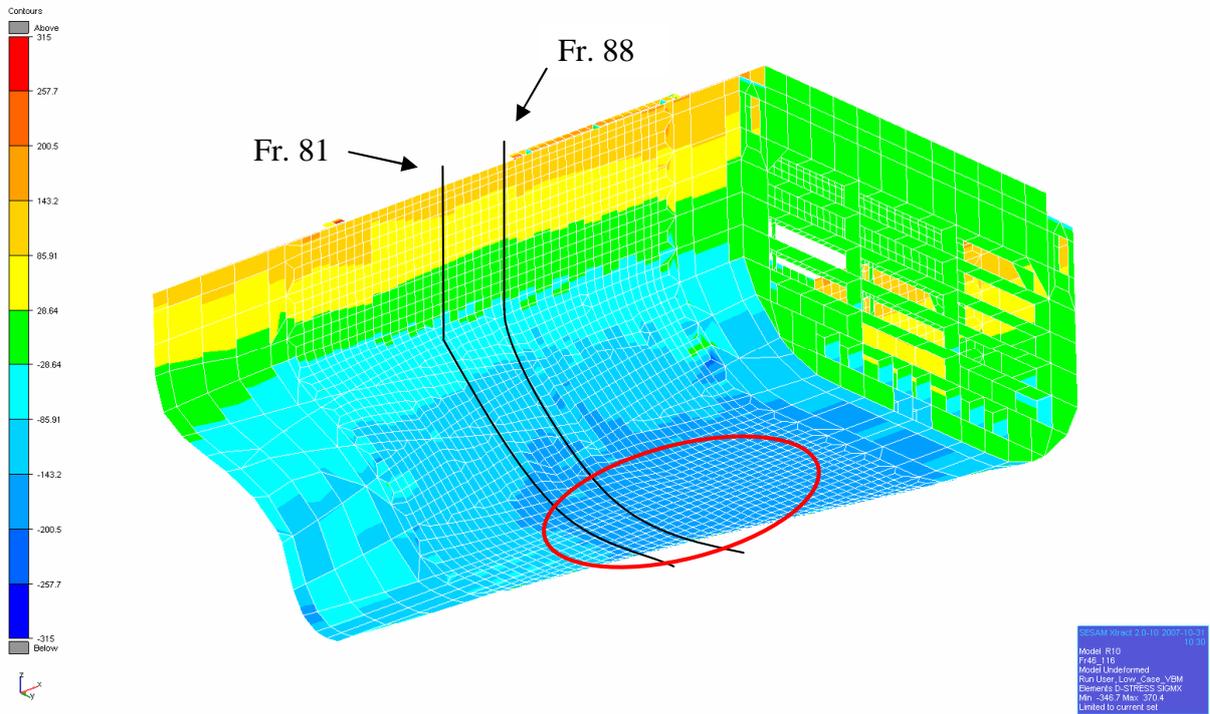
For stress result presentations, the reference load levels according to Table 4.3 are used. The stress results shown in Fig. 5.3 and Fig. 5.4 are valid for a vertical bending moment (VBM) at #88 of 3300 MNm. Similar plots are given in Fig. 5.5 and Fig. 5.6 for a VBM of 4600 MNm

All stress plots are presented against the material yield values of  $\pm 315$  MPa (grey), where red (tension) and dark blue (compression) represent stress values close to yield while orange and light blue stresses between 100 and 200 MPa. The structure around # 77 have different qualities with yield stresses varying in the longitudinal directions, with mild steel (yield stress 235 MPa) mostly aft of #77 and high strength steel (yield stress 315 MPa) forward of #77.

**Fig. 5.3 Global FE SESAM: Longitudinal stress # 46 to # 116, bottom view**  
 (VBM at # 88 = 3300 MNm)

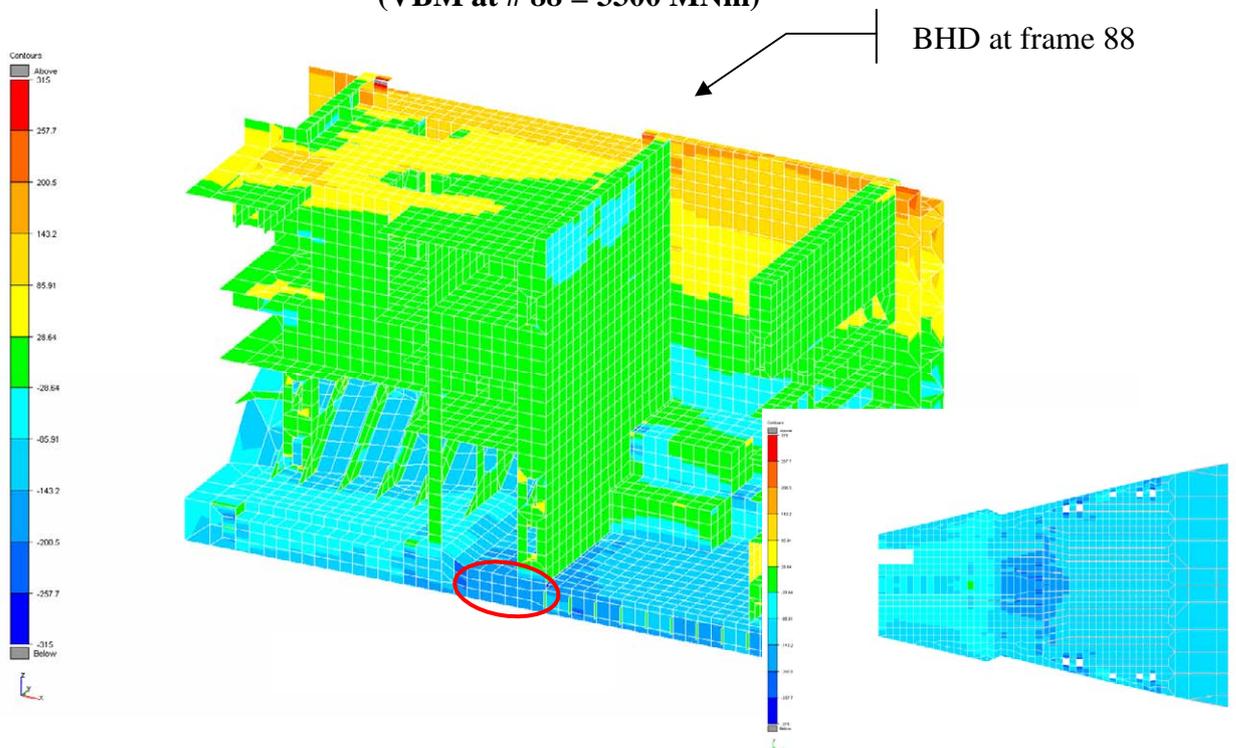
**Fig. 5.4 Global FE SESAM: Longitudinal stress # 46 to # 116, internal and tank top view.**  
 (VBM at # 88 = 3300 MNm)

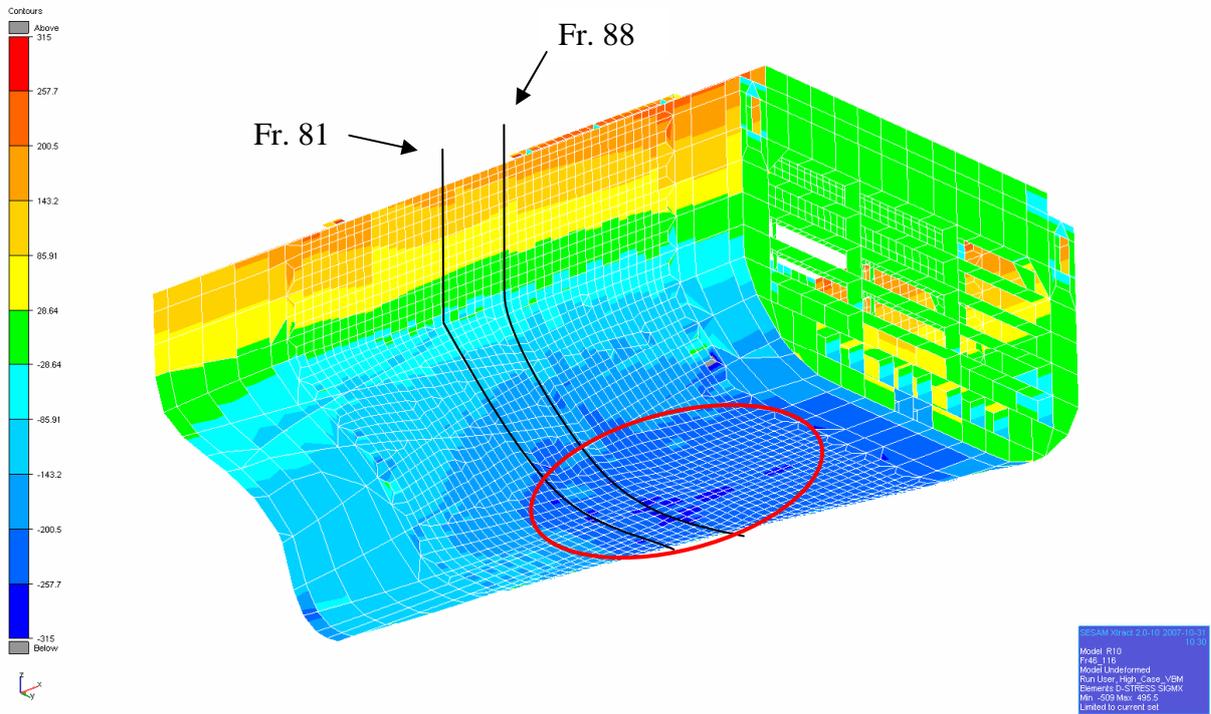
**Fig. 5.5 Global FE SESAM: Longitudinal stress # 46 to # 116, bottom view**

(VBM at # 88 = 4600 MNm)

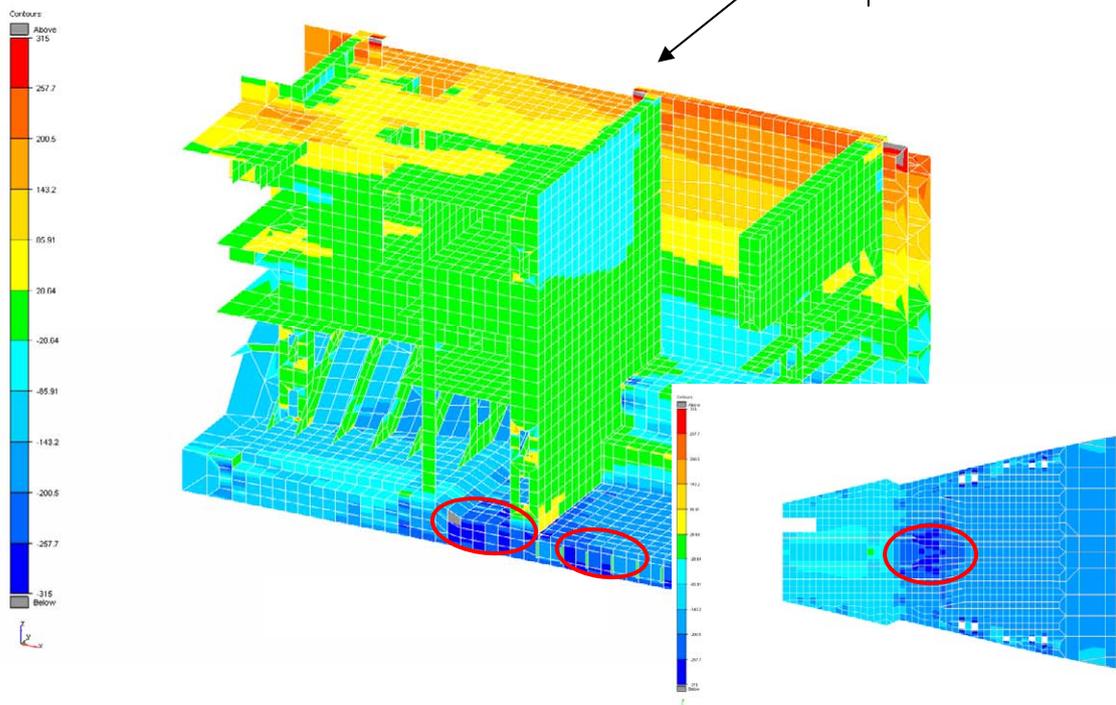
**Fig. 5.6 Global FE SESAM: Longitudinal stress # 46 to # 116, internal and tank top view.**

(VBM at # 88 = 4600 MNm)

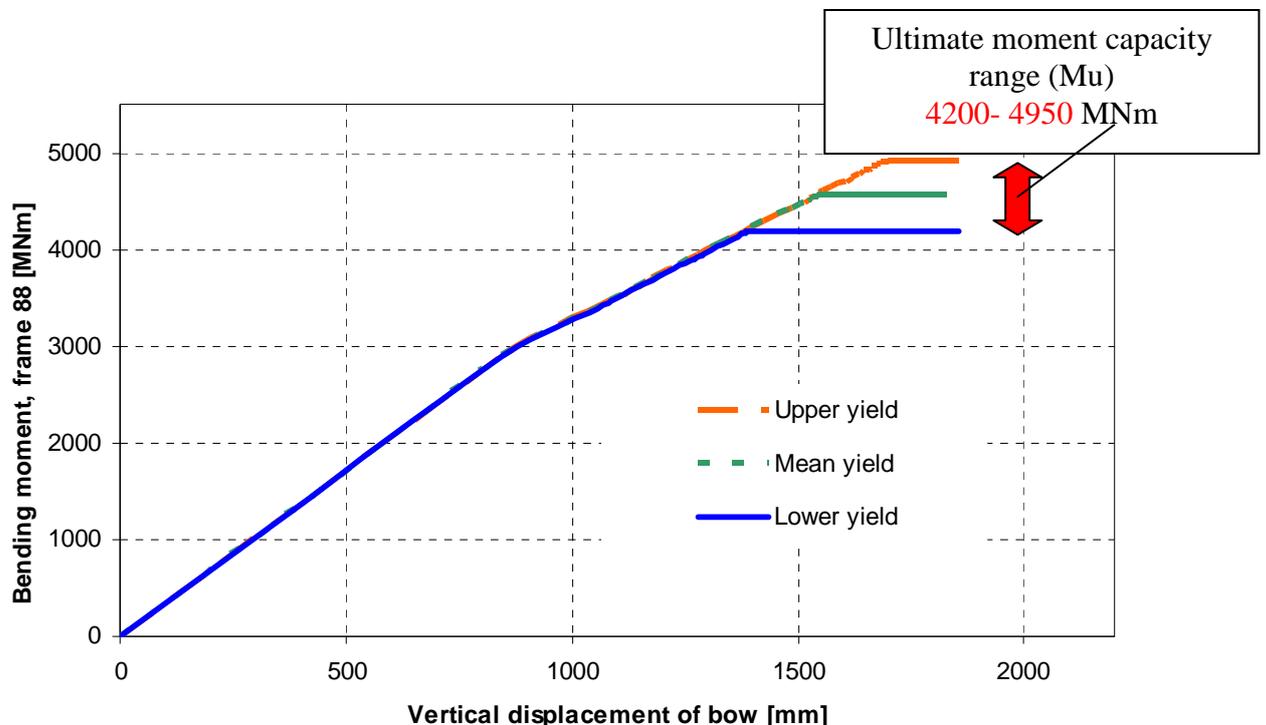
The non-linear relation between vertical moment (VBM) at engine room bulkhead (#88) and the vertical deflection at ship bow is shown in Fig. 6.8. For practical purposes it is the maximum point along the moment-deflection curve that is the most interesting parameter. This max point is the capacity of the structure, called also the ultimate collapse moment of the hull girder ( $M_u$ ), and it is tabulated separately, see Table 6.2.

**Fig. 6.8 Non-linear moment- displacement relation (Moment at # 88 against vertical bow deflection). Ultimate capacity is the max load indicated for the lower, mean and upper material properties according to Table 6.1.**

Table 6.2 gives the ultimate moment capacities summarized for each of the material categories analysed. From this the capacity range is seen to span from 4200 MNm as the lowest level to 4950 MNm as the highest level.
