Report on the investigation of
the grounding of

mv Harvest Caroline

Tanera More, Summer Isles
north west coast of Scotland

**Report No 13/2007
June 2007**

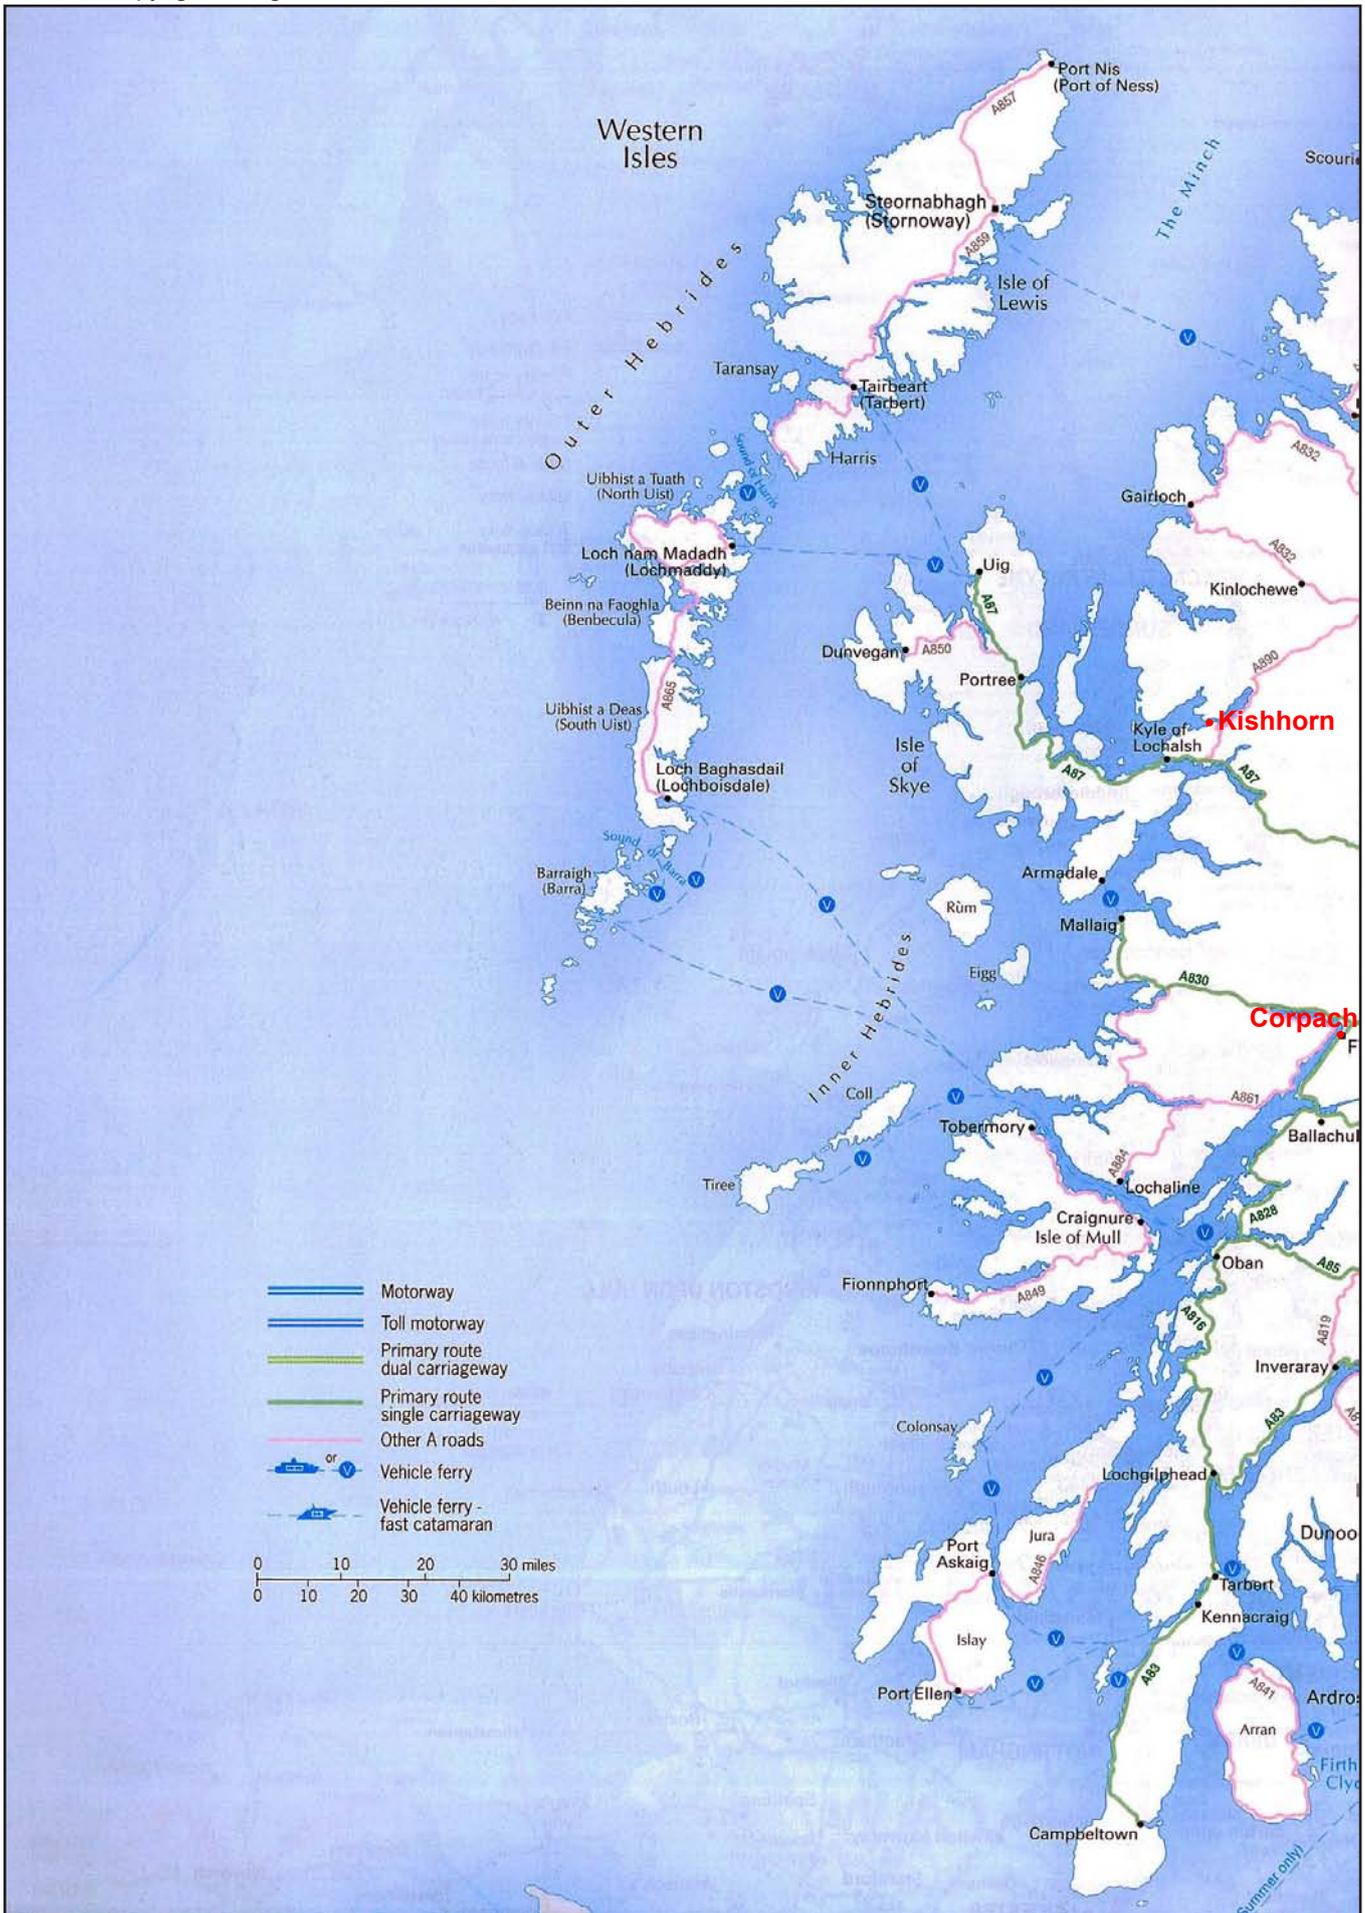
Map showing location of Kishorn

Harvest Caroline supplied fish food to over 50 fish farms on the west coast of Scotland and Hebrides. The fish food was loaded in Kishorn (**Figure 6**), and discharged at the fish farms by crane onto pontoons, or onto 'C' caps (**Figure 7**). The vessel's loading/delivery cycle was between 2 to 3 days depending on the weather conditions experienced. During darkness, the ship was routinely either at anchor, on passage, or moored alongside at Kishorn or Kyle of Lochalsh, where she fuelled. She anchored overnight on 14 occasions in October 2006.
