Report on the investigation of
the close-quarters situation between the
ro-ro passenger ferry
Maersk Dover
the tanker
Apollonia
and the container vessel
Maersk Vancouver
in the Dover Strait
on 17 October 2006

Report No 9/2007
May 2007

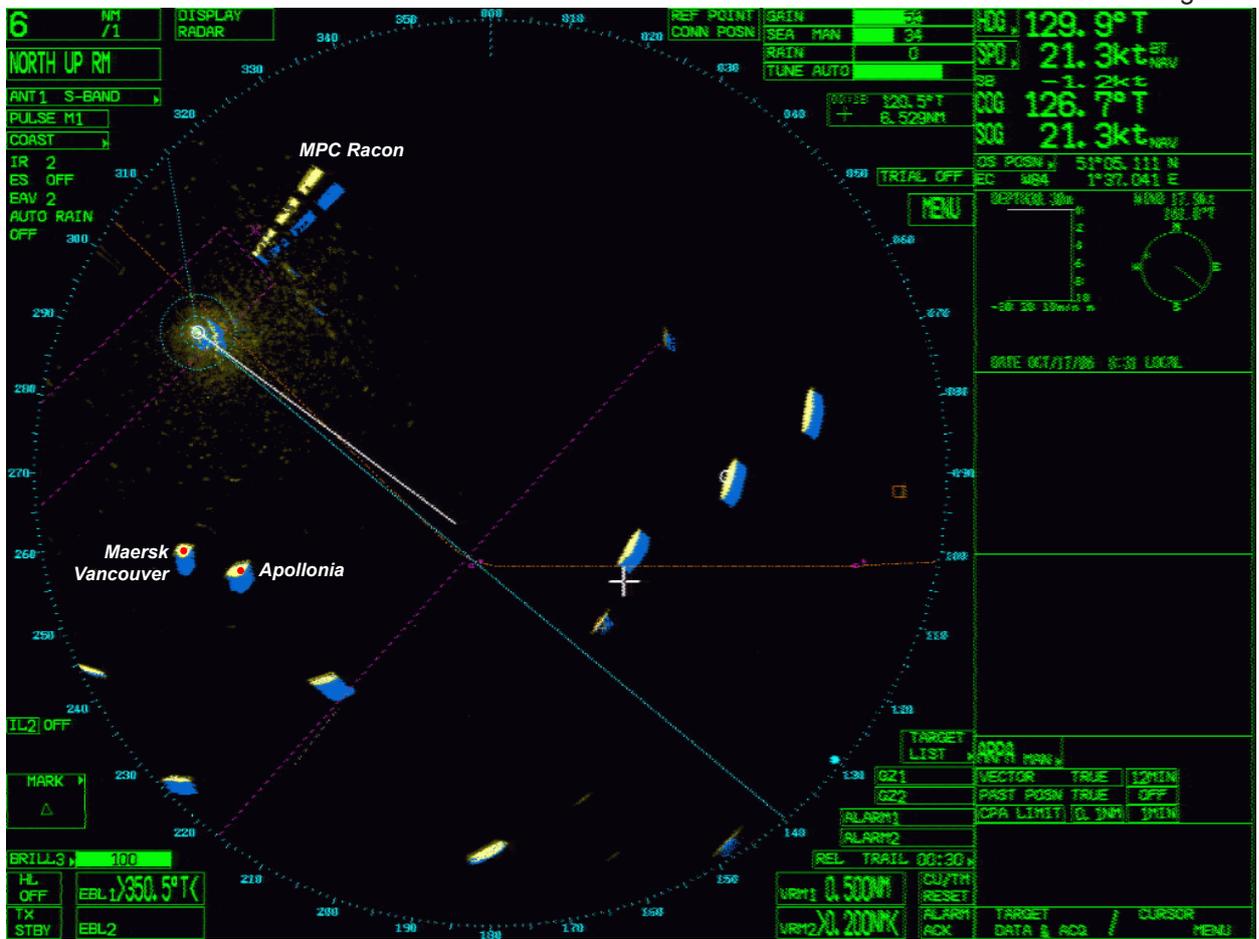
Figure 5

The 2/O recalled that he stood up from the chair footrest and faced the port bridge wing. He noted that *Maersk Dover* had just passed the MPC buoy, a key point of the passage which was routinely recorded on the voyage checklist. The 2/O obtained the position by taking a radar bearing and distance of the MPC racon response, using the port ARPA display on the 12 mile range scale. The position was entered on the voyage checklist at 0732, by the QM, who then continued cleaning the bridge. The record shows that at 0732, the MPC buoy was bearing 032°T at 1.3nm. *Maersk Vancouver* and *Apollonia* had closed to a distance of 2.5nm and 2.7nm, with speeds of 21 and 16 knots respectively (**Figure 5**), but both the 2/O and the QM were still unaware of the developing close-quarters situation.

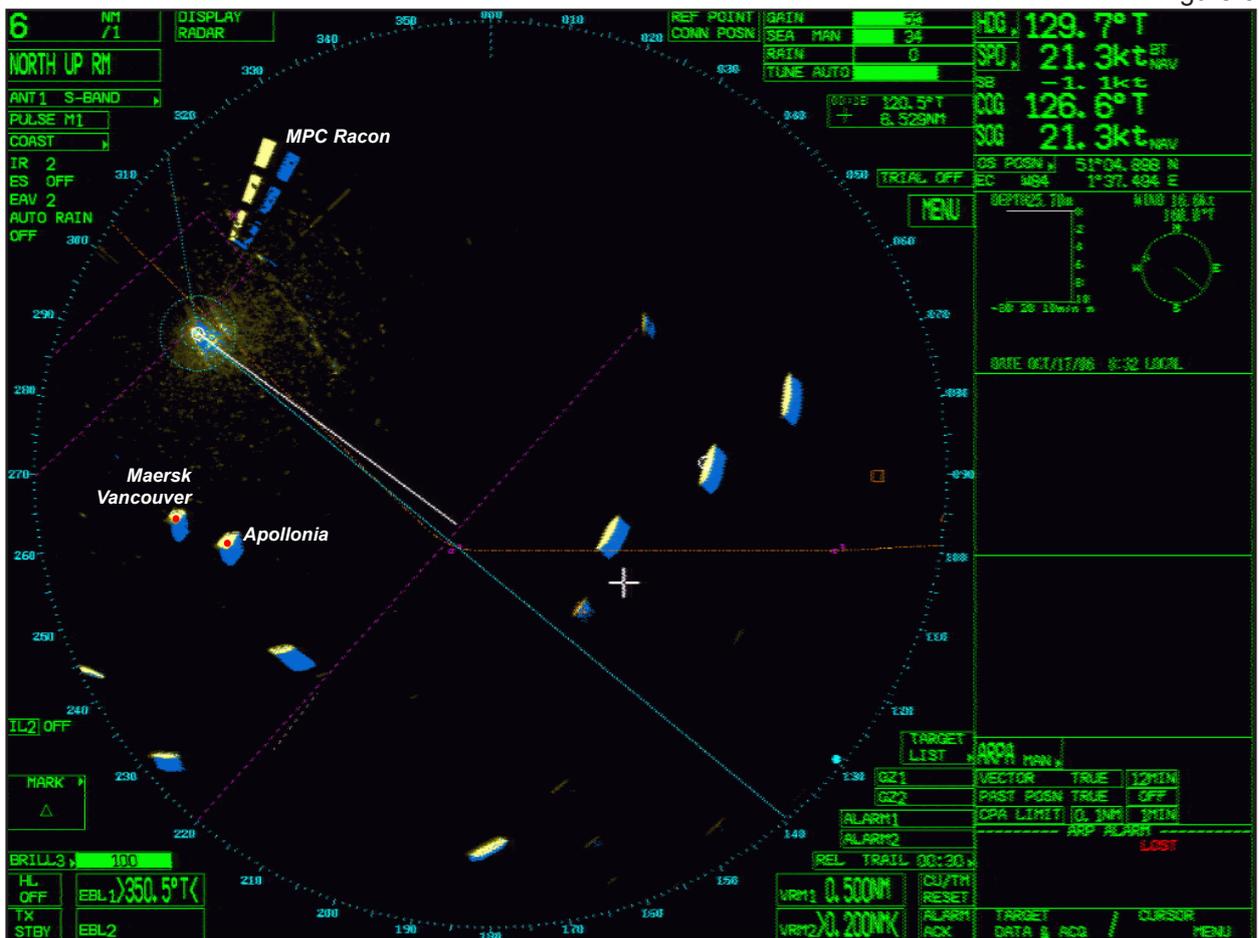
Figure 6

In accordance with the passage plan, the passing of the MPC buoy signified that there was 1 hour of the voyage remaining before the vessel's arrival at Dunkerque West. Consequently, at 0732.5, the 2/O commenced calling Dunkerque West (port control) to report the vessel's ETA. He made two transmissions using the port VHF radio, without receiving a reply. The QM confirmed that the VHF channel 73 was selected, and the 2/O made a further call to Dunkerque West at 0733.5, which was acknowledged, and informed them that *Maersk Dover* would be arriving in 1 hour. The QM continued cleaning the bridge (**Figure 6**). At 0733.5 a call from *Apollonia* to *Maersk Dover* was not heard by either the OOW or the lookout.
