Report on the investigation of the grounding of the jack-up barge

***Octopus***

Stronsay Firth, Orkney Islands

**Report No 18/2007**  
**August 2007**

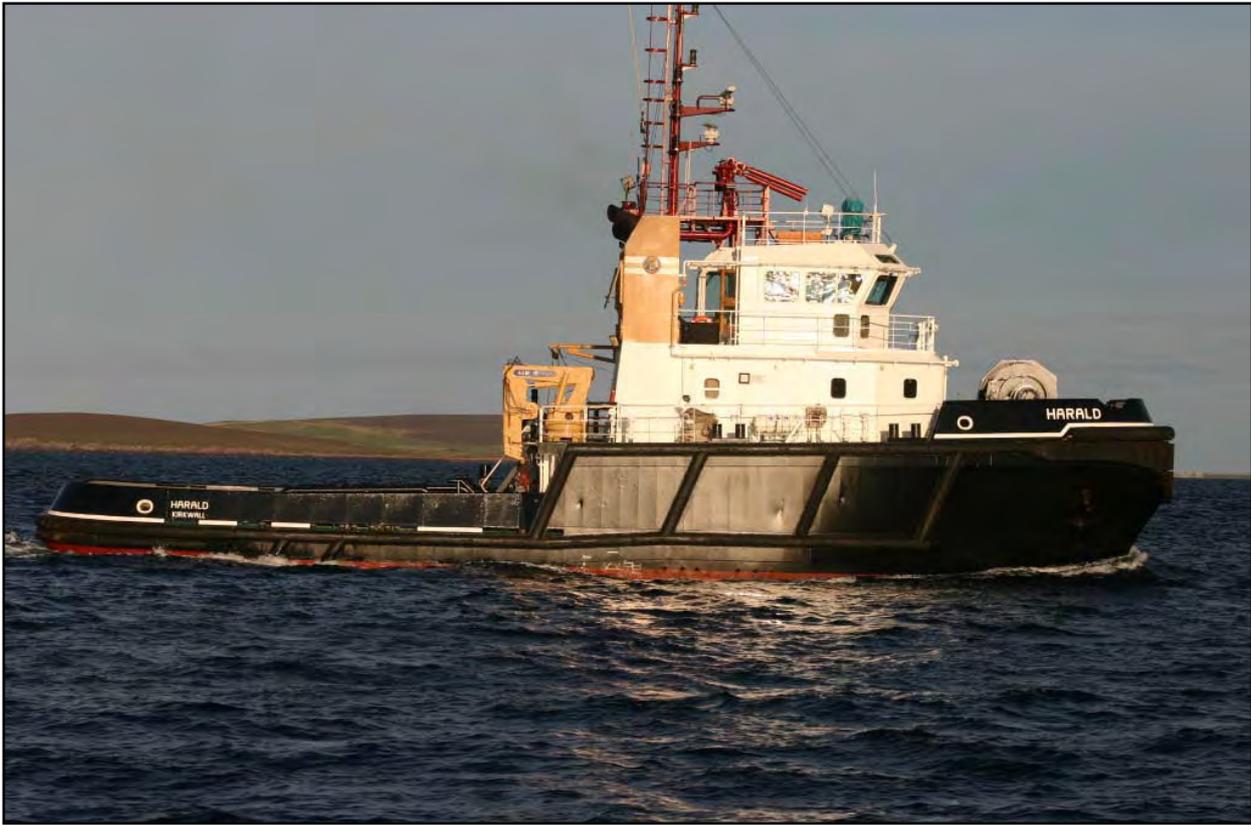
Figure 1

*Harald*

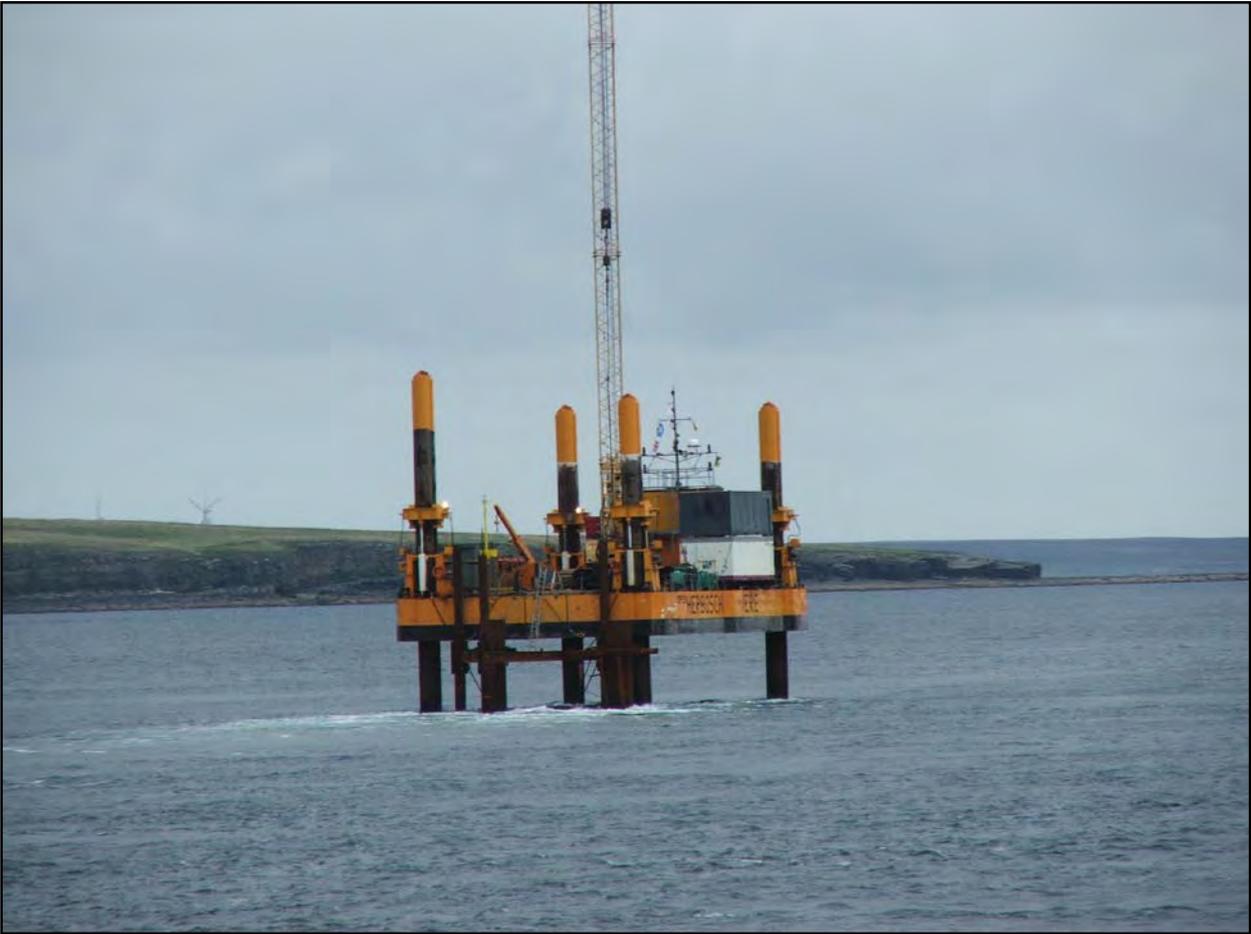
Figure 2

Jack up-barge *Octopus*

Damage	:	4 barge legs buckled causing substantial cost and project delays.
--------	---	---

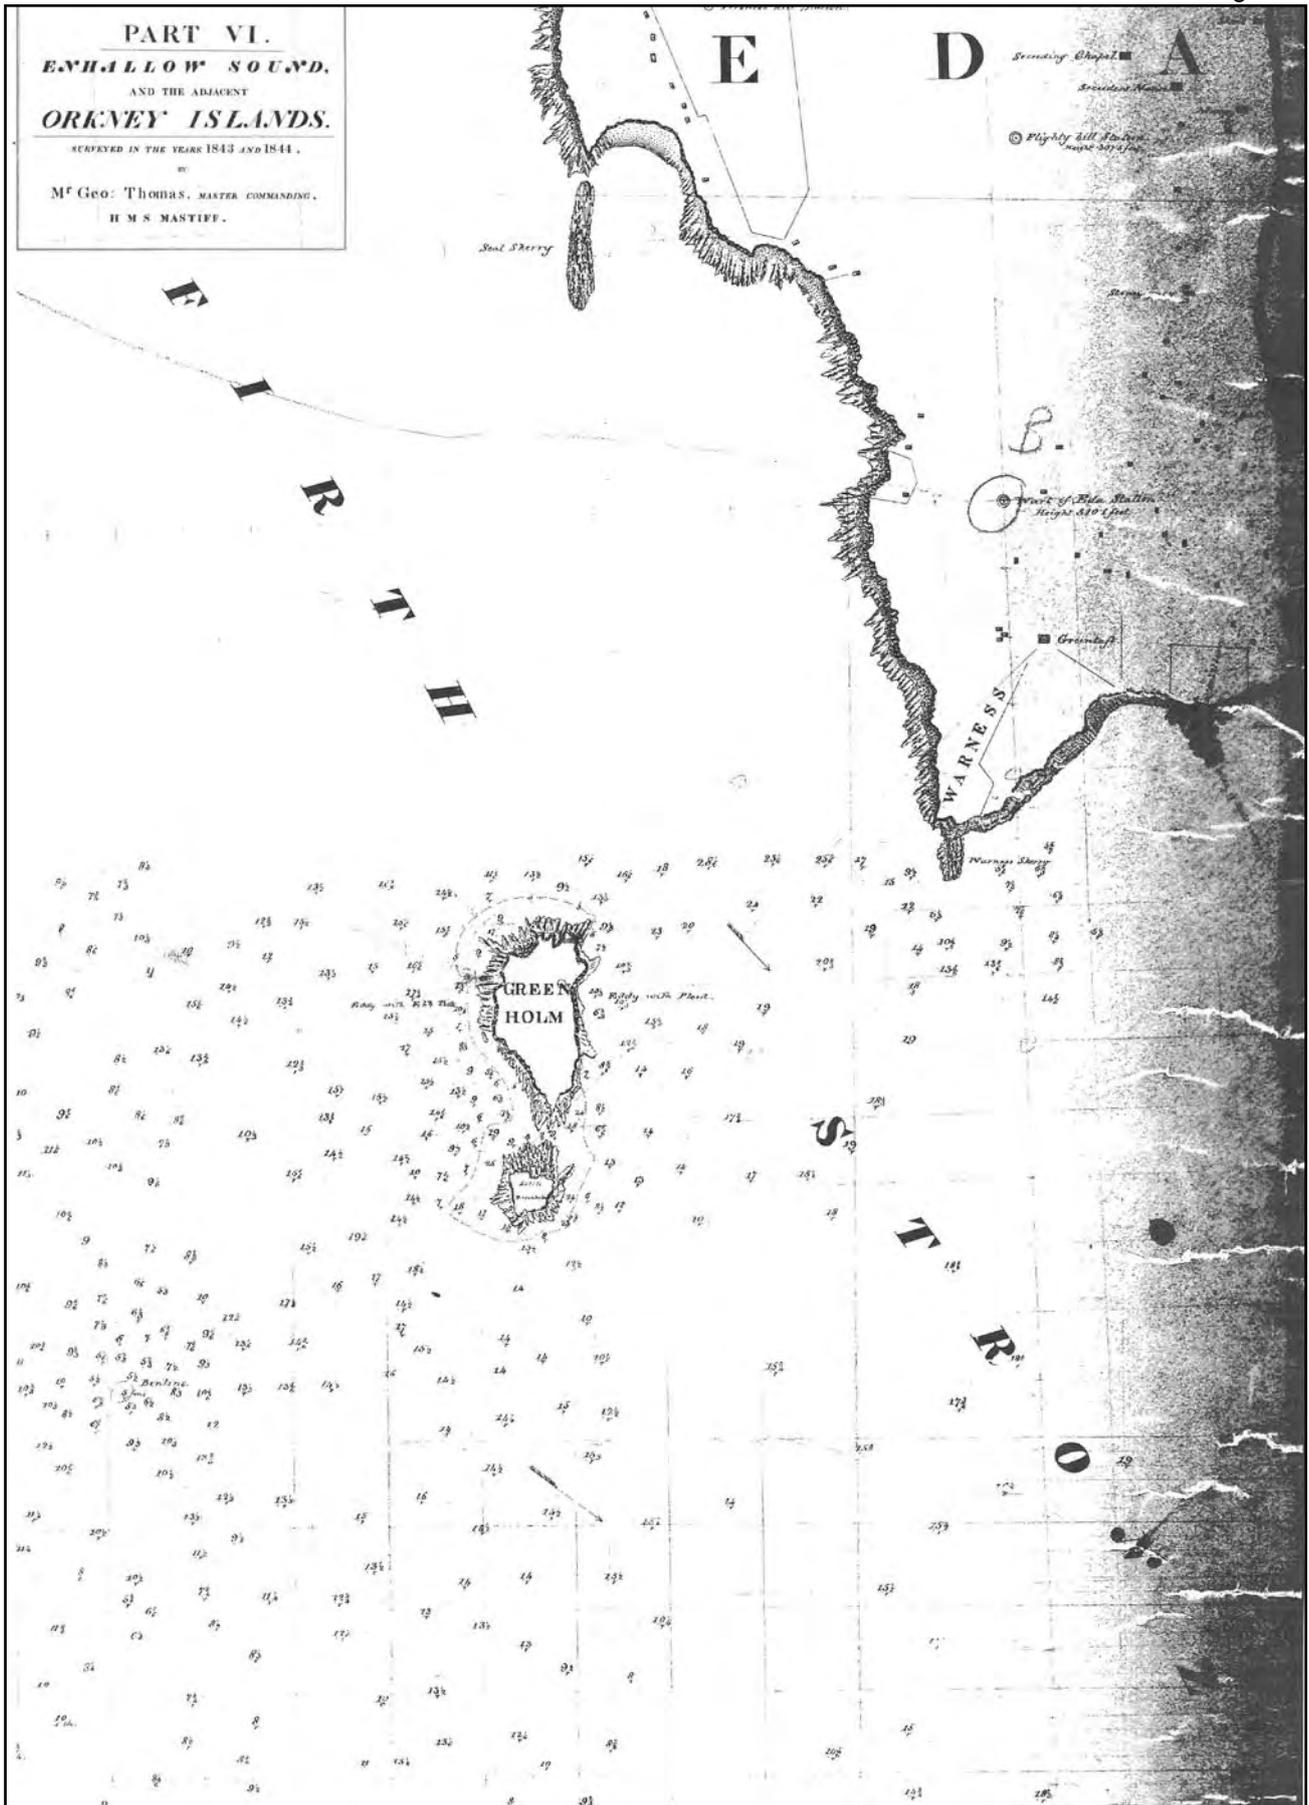
Figure 9

The source diagram for BA Chart 2250 (**Figure 8**) shows the area to have been surveyed during *British Government Survey (leadline) 1839-1848*. Lieutenant Commander George Thomas, master commanding, was on board HMS *Mastiff* when the survey of the grounding area was carried out in 1843 and 1844. The original survey record fair sheet (**Figure 9**) showed that the survey results were correctly transferred to the chart, and that the 7.1m bank was missed due to the sampling nature of the leadline survey undertaken.

Extract of survey fair sheet of 1843/4
