Report on the investigation of
the major injuries sustained by a deckhand on board

fv *Danielle* BM478

on 6 June 2006

**Report No 5/2007
March 2007**

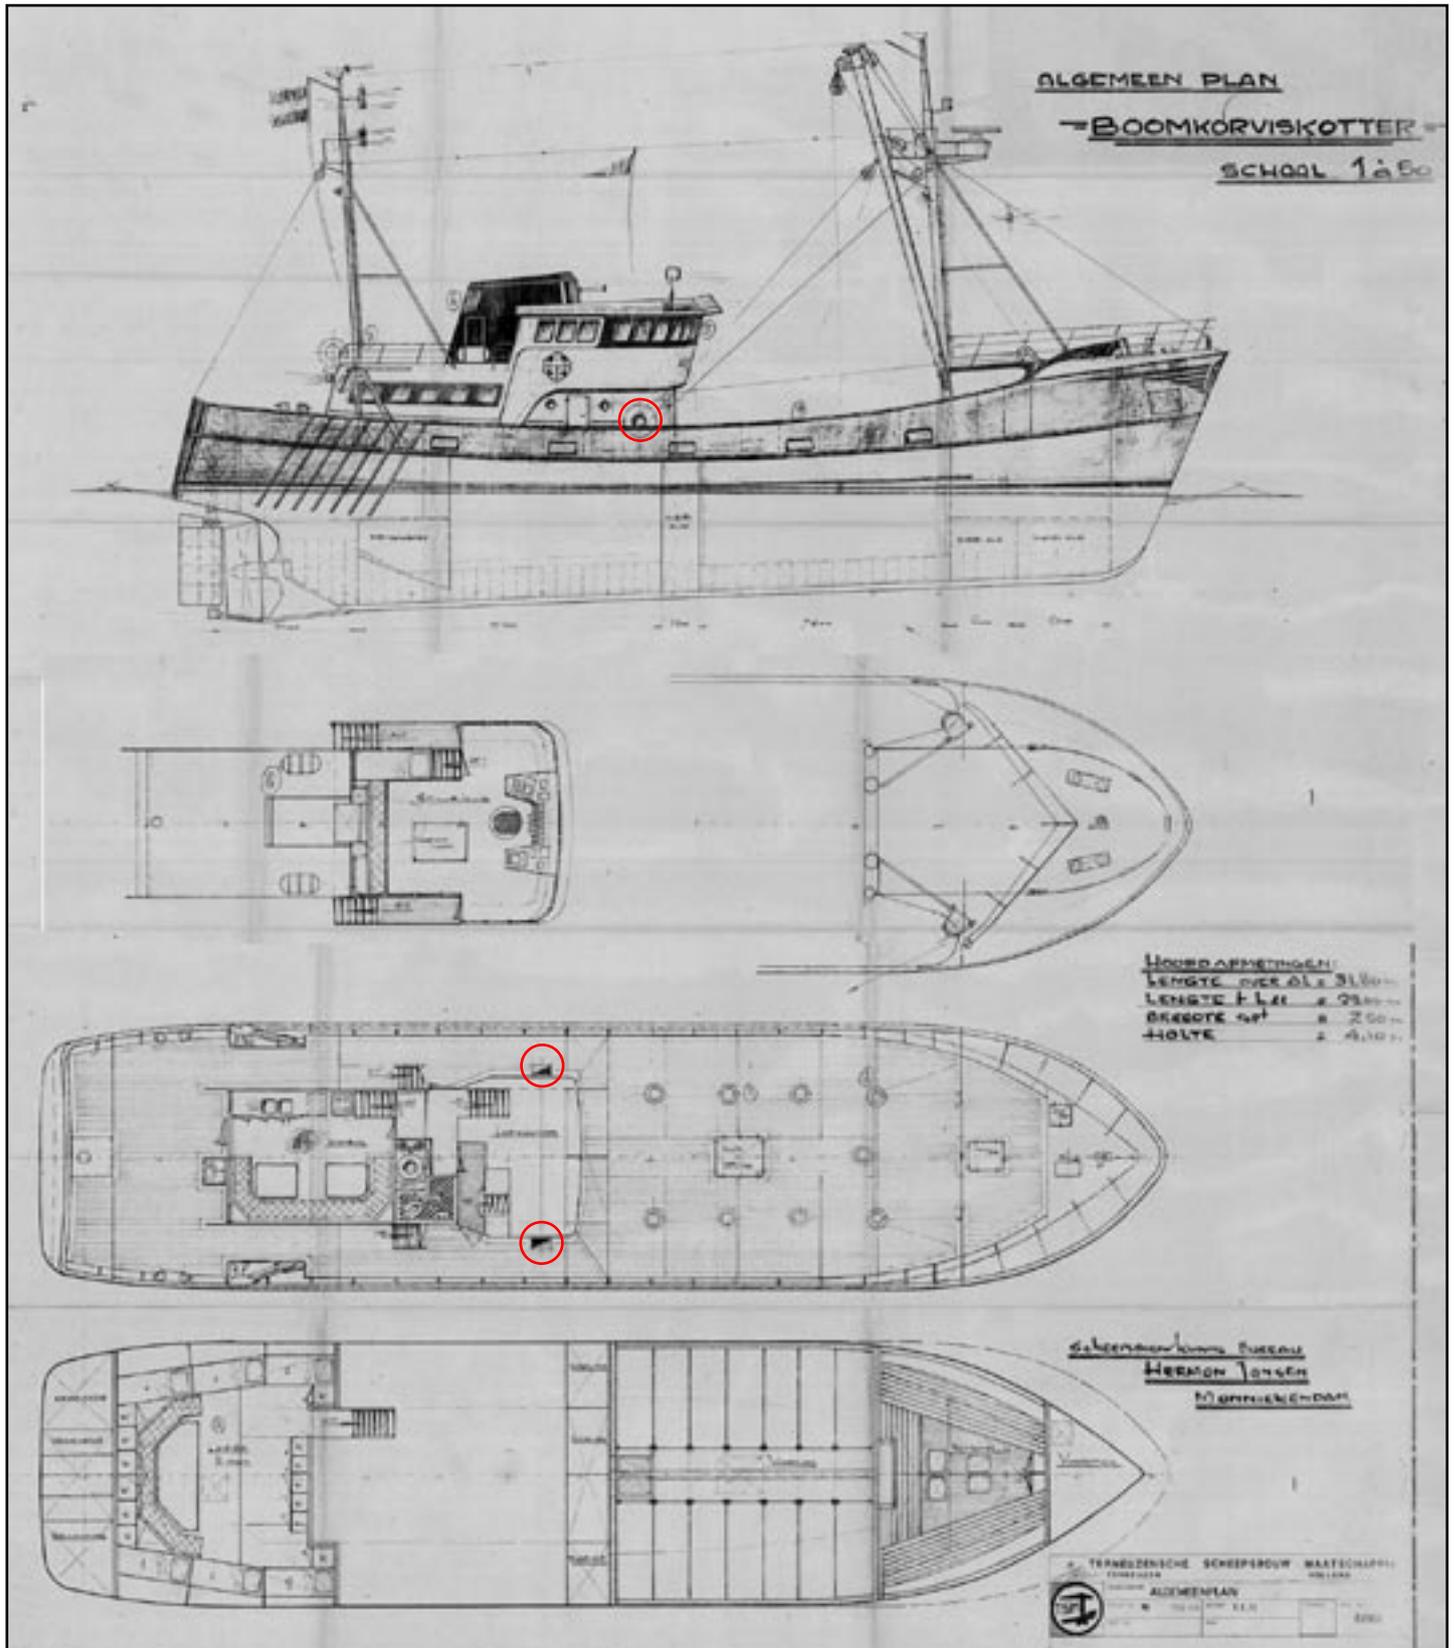
Figure 2

General Arrangement drawing

○ Location of whipping drums

The as-built general arrangement drawing for the vessel is included at **Figure 2**. This depicts a typical beam trawler design, with an aft deckhouse/superstructure incorporating an enclosed winch house at main deck level, and a forward working deck, with covered whaleback. The winch house was extended a further 0.7m forward than shown in the original drawings, at an unknown date.

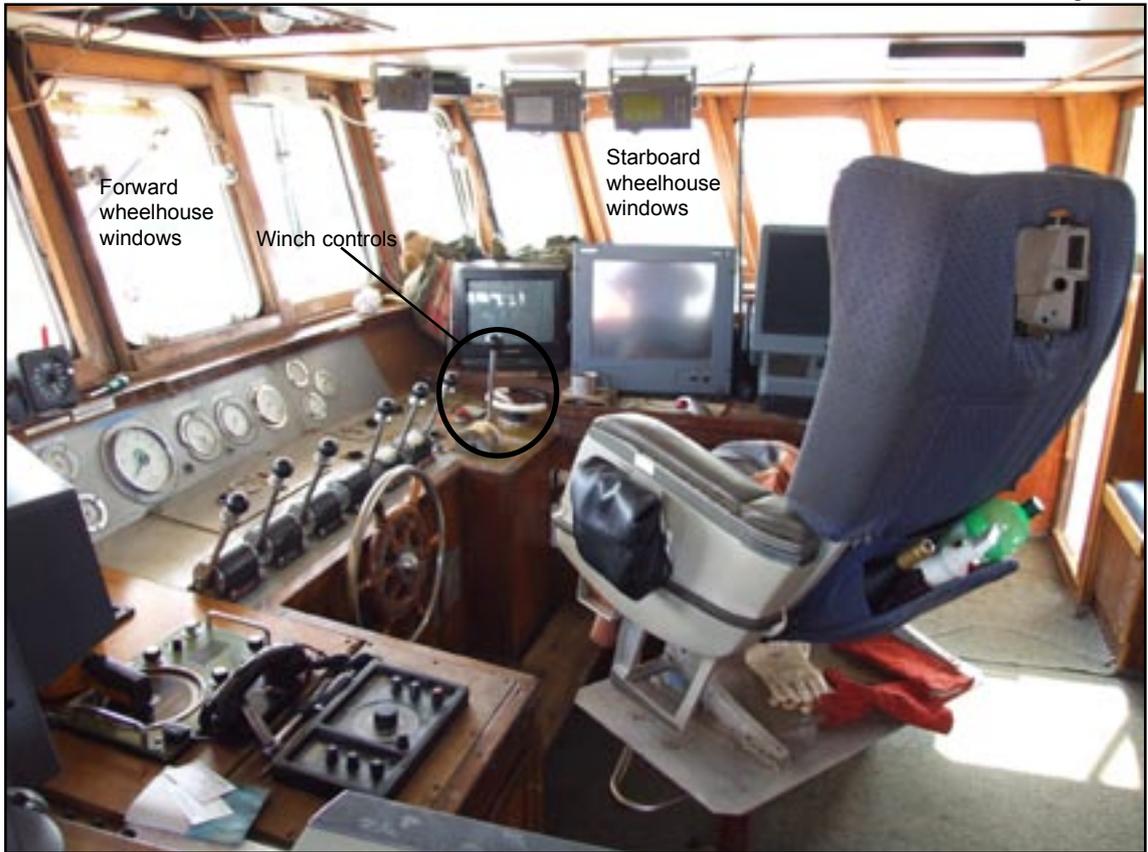
Figure 4

Wheelhouse, looking forward and to starboard

The controls for the winch are located in the wheelhouse, as depicted in **Figures 4 and 5**. These incorporate a dial, for altering the speed of the winch, and an emergency stop and reset button. The normal setting for “tipping” resulted in the whipping drums rotating at around 27 rpm, with the port drum rotating anti-clockwise, the starboard drum clockwise.

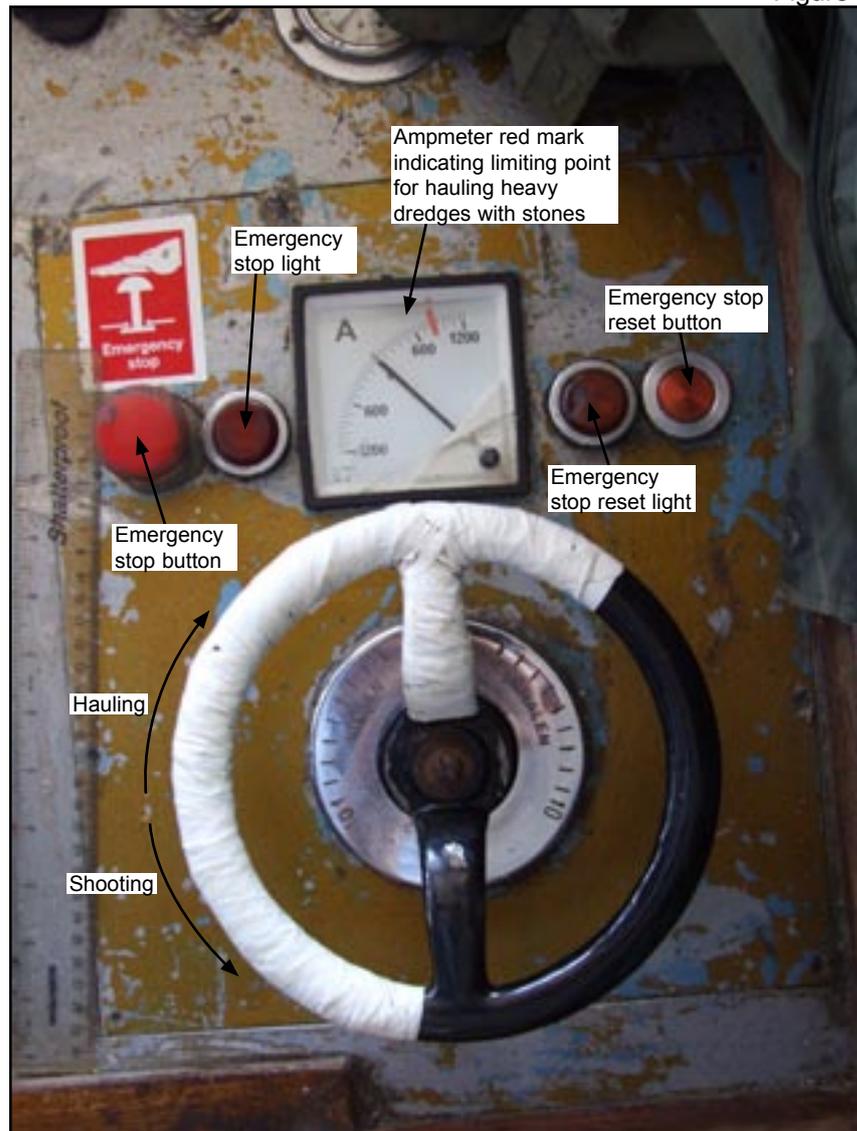
Figure 5

Close-up view of winch controls

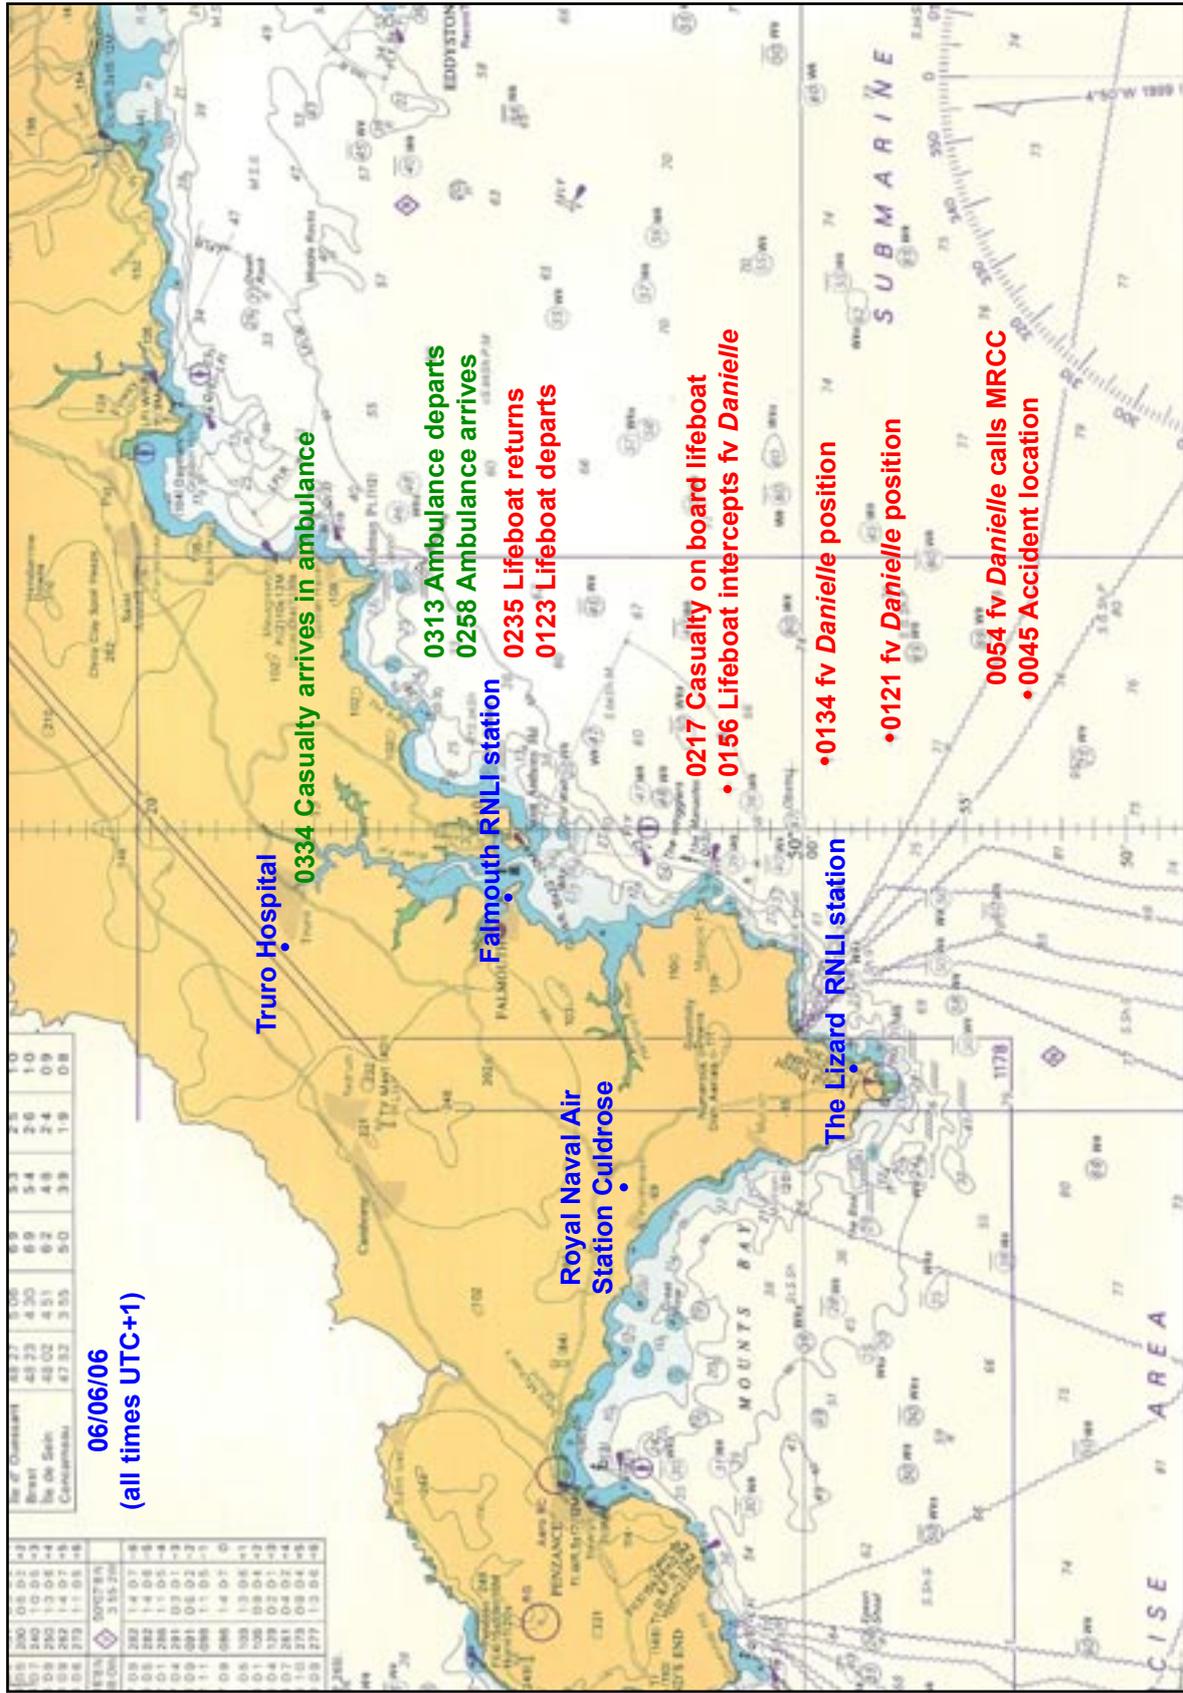
Figure 13

Chart showing accident timings and locations

At 0134, the MRCC contacted *Danielle* for a further update, and the skipper stated that the deckhand was complaining of breathing difficulties, was heavily perspiring, and that his condition had probably worsened. *Danielle's* position at this time is shown at **Figure 13**.

At 0258, the ambulance arrived at the Boathouse, and the on board paramedic immediately began treating the deckhand and preparing him for transfer to hospital. The ambulance departed at 0313 with the by now unconscious deckhand embarked, and arrived at Truro hospital at 0334 (see **Figure 13**).

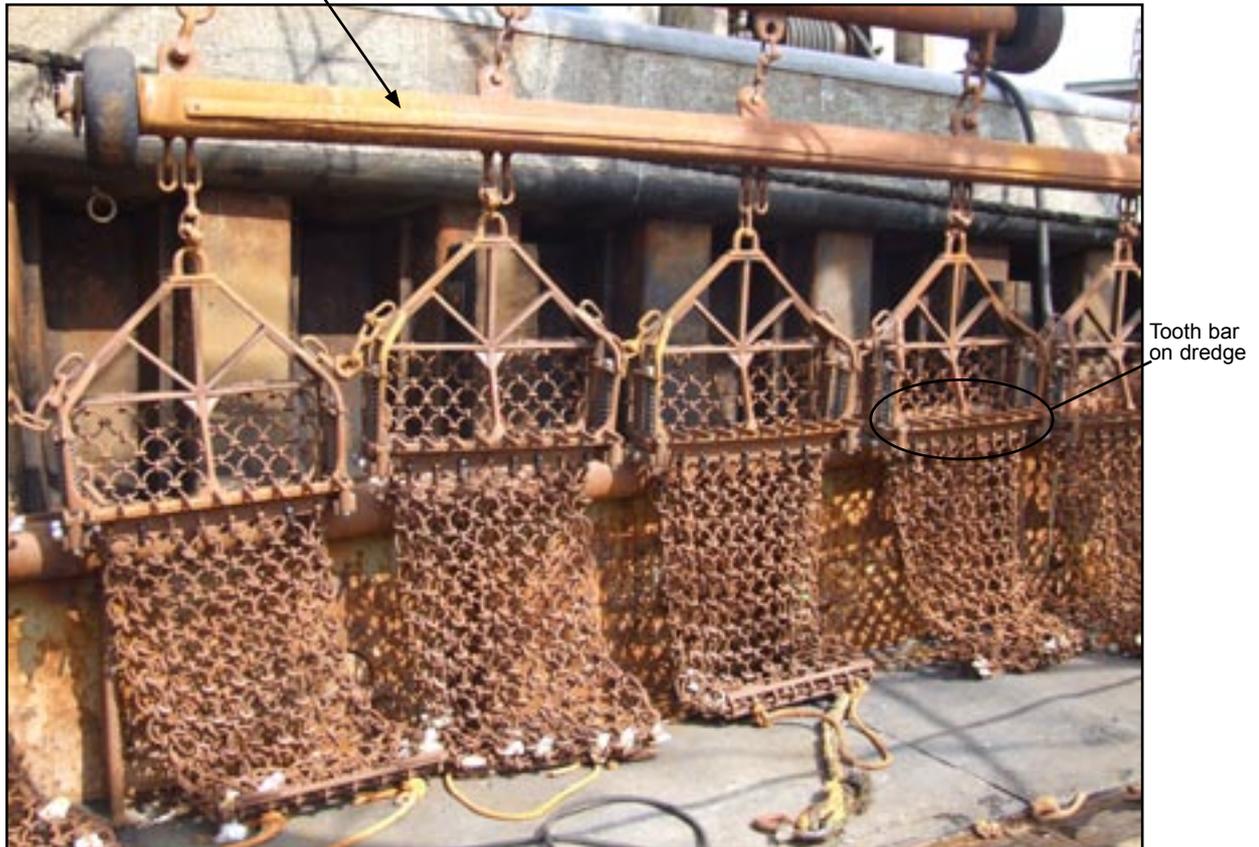
Figure 19

Port side scallop dredges on *Danielle*
