Report on the investigation of
the engine room fire on board
the passenger cruise vessel

The Calypso

6 May 2006

Report No 8/2007
April 2007

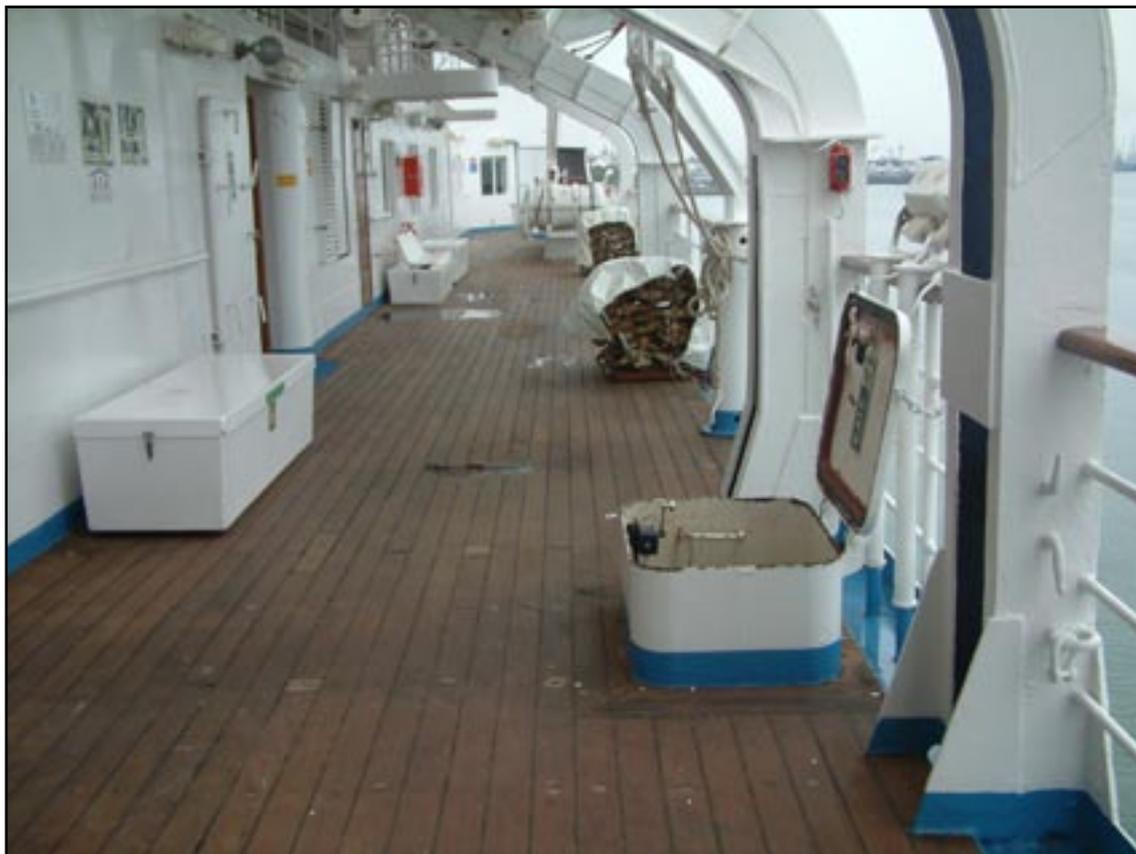
CO₂ space hatch

The CO₂ compartment hatch was opened by the chief electrician and safety officer, but only the chief electrician entered and climbed down a vertical ladder below the hatch entrance to the Rendezvous deck where the CO₂ bottles were located (**Figure 3**). The safety officer was unable to enter the space as he was encumbered by the breathing apparatus he was wearing. An engine room alarm sounded as a warning that the hatch had been opened.

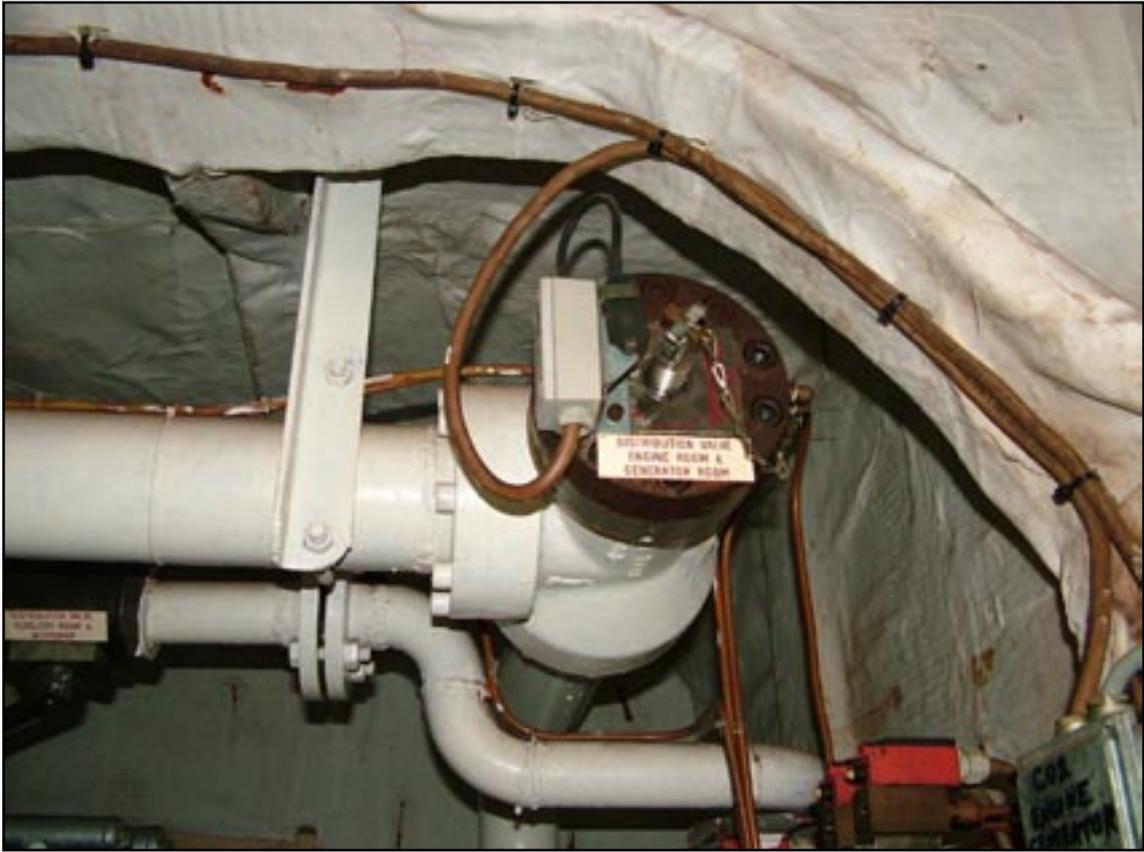
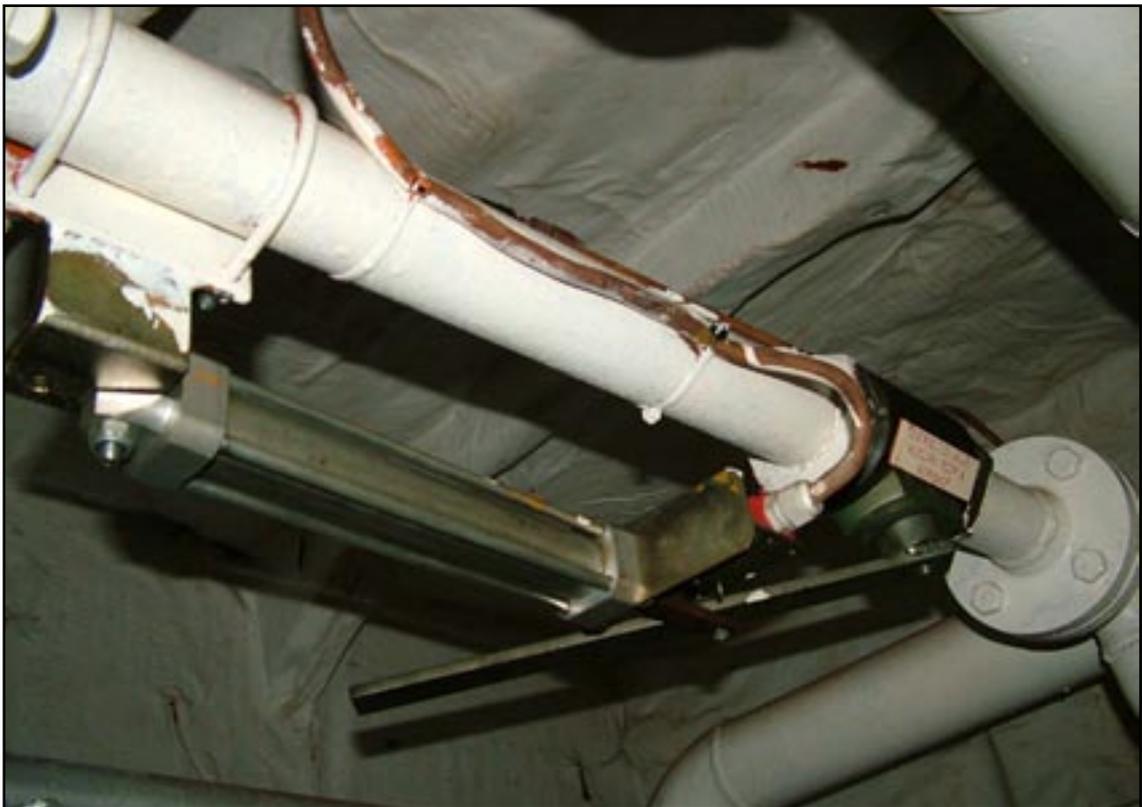
Distribution valves

Control levers - in released condition

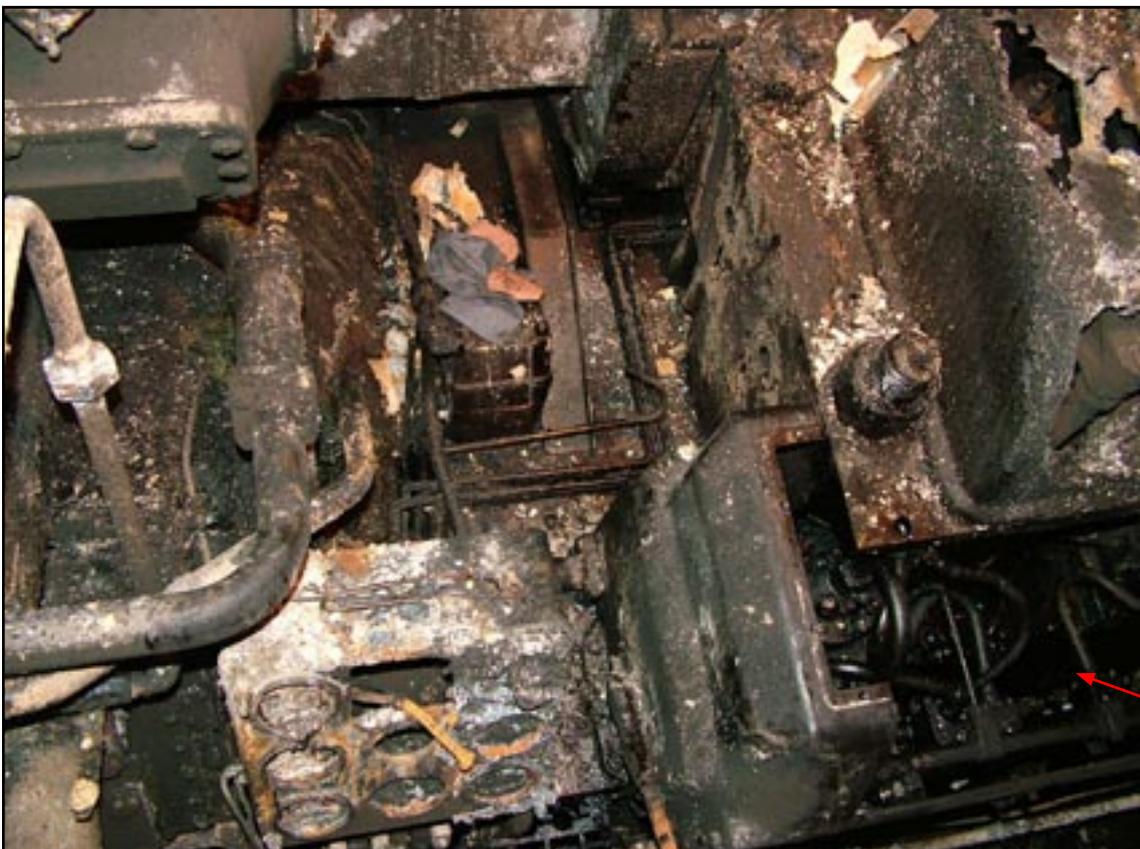
Figure 12

In the centre of each engine's 'Vee' were cylinder exhaust pipes, encased in lagged boxes leading to the twin turbo chargers (one for each bank of six cylinders) mounted at the forward end of the engine. Along the outer part of each cylinder bank was a "hotbox", within which were the high pressure fuel injection pumps, high pressure (HP) fuel pipes (connecting the HP pumps to the fuel injectors) and low pressure (LP) fuel rail (**Figure 12**). The LP fuel pipes (supply and return) within the "hotbox" were joined using four bolt flanges. Covers enclosed the "hotbox" to prevent an escape of fuel should a leak occur and also to maintain temperatures within. The covers were secured in place. Leakage of fuel from any components within the hotbox was contained and collected at the lower part of the space, before draining, via a tundish, to a drain tank. A single high level alarm was fitted to this tank.

Hotbox

Forward end of hotbox of starboard engine

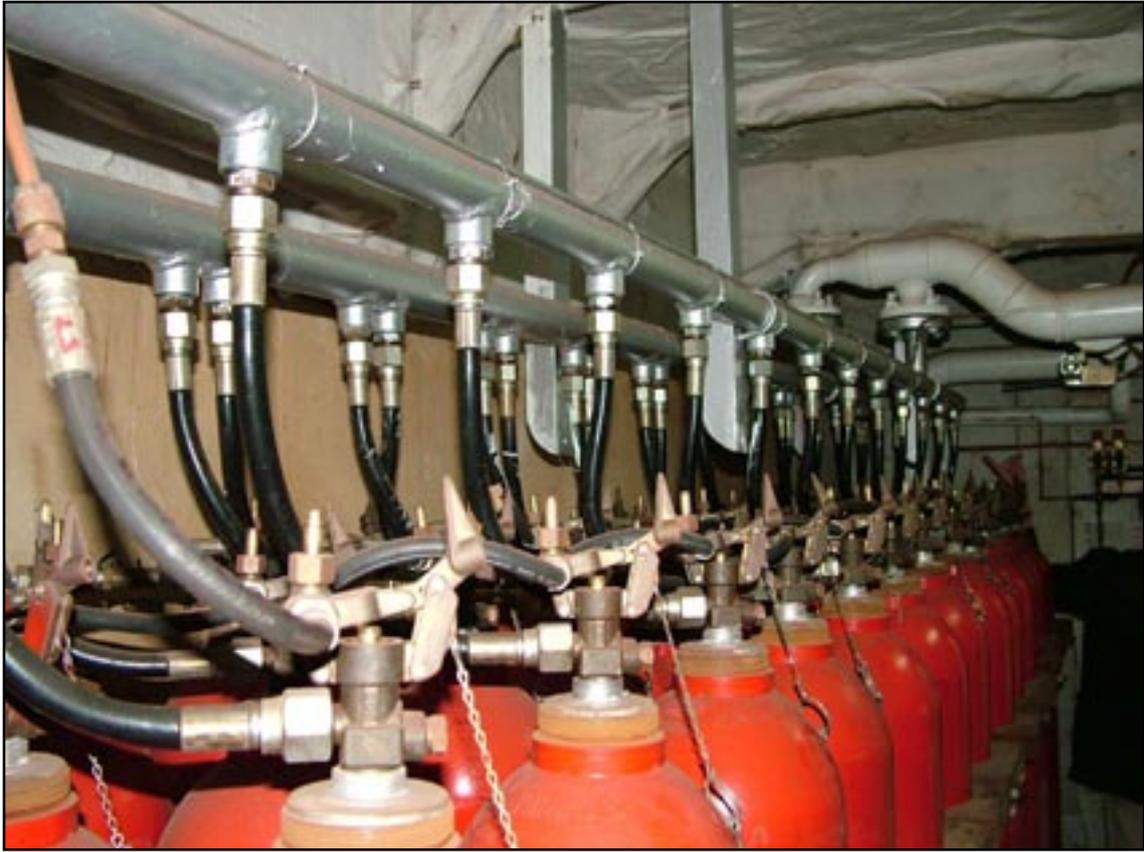
Figure 16

The CO₂ system in the CO₂ room originally comprised only the inboard (45 x 30kg) bank of cylinders, manufactured by “Minimax” (**Figure 16**). As part of the major conversion from car ferry to passenger ship in 1993/94, the CO₂ system was altered and a further bank of 21 x 45kg CO₂ cylinders was installed by “Ginge-Kerr” on the outboard side of the space (**Figure 17**).

Minimax cylinders

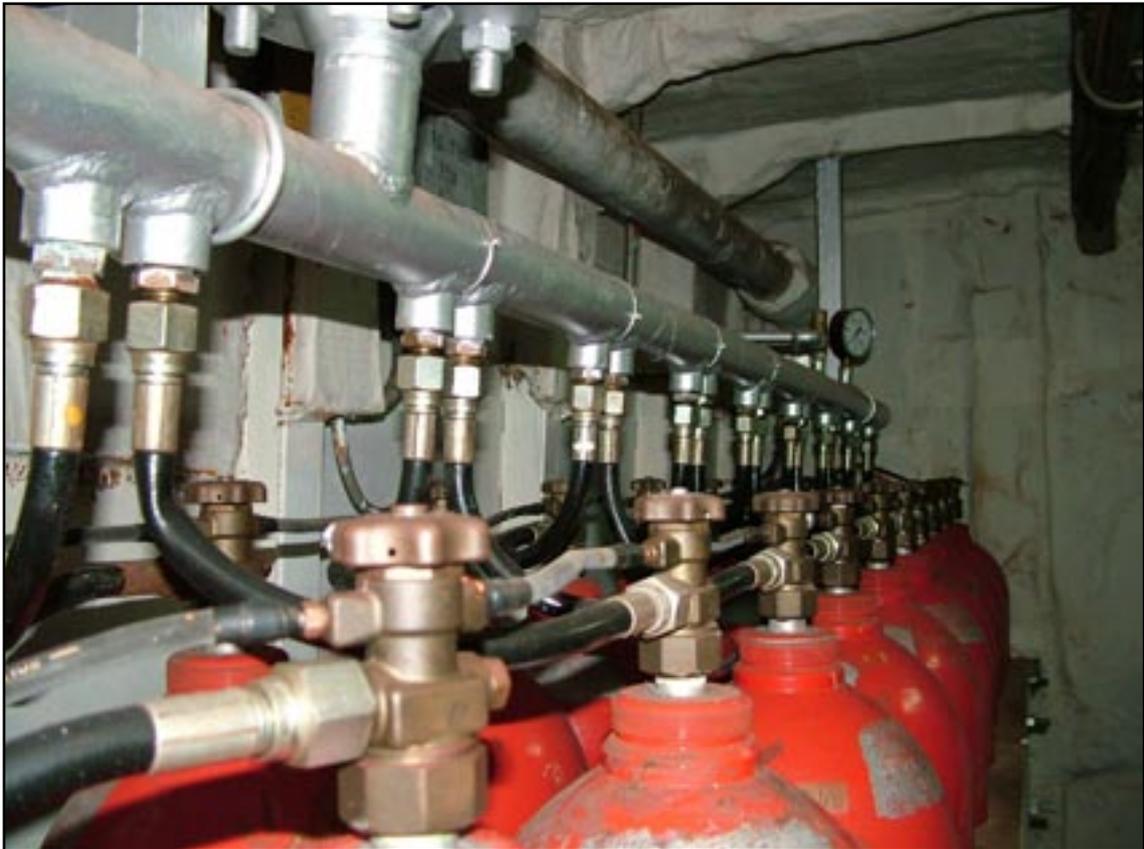
Figure 17

Ginge-Kerr cylinders

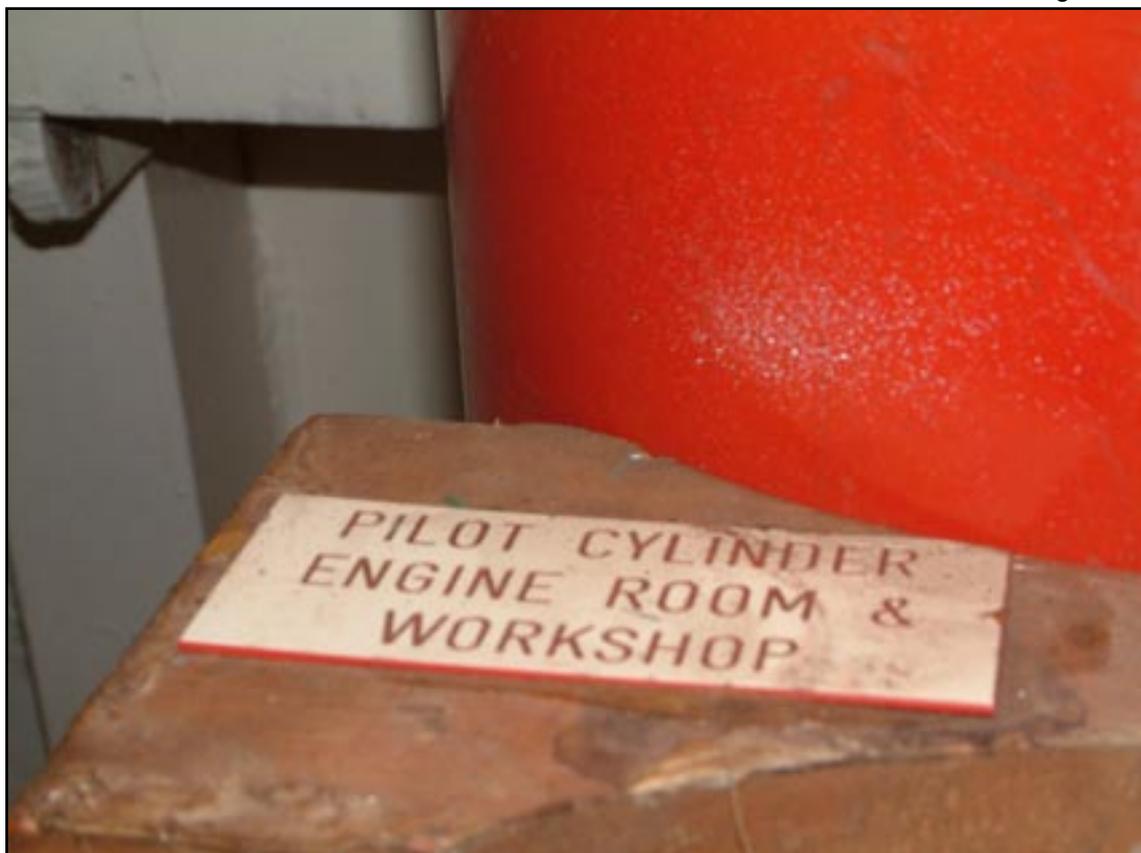
Pilot cylinder label

The modification to the system by Ginge-Kerr included two, 45kg, manually operated, pilot cylinders as part of the outboard bank of cylinders. Each pilot cylinder was intended to release the relevant number of cylinders for its specified protected space. Each pilot cylinder had a label identifying its purpose (**Figure 18**).

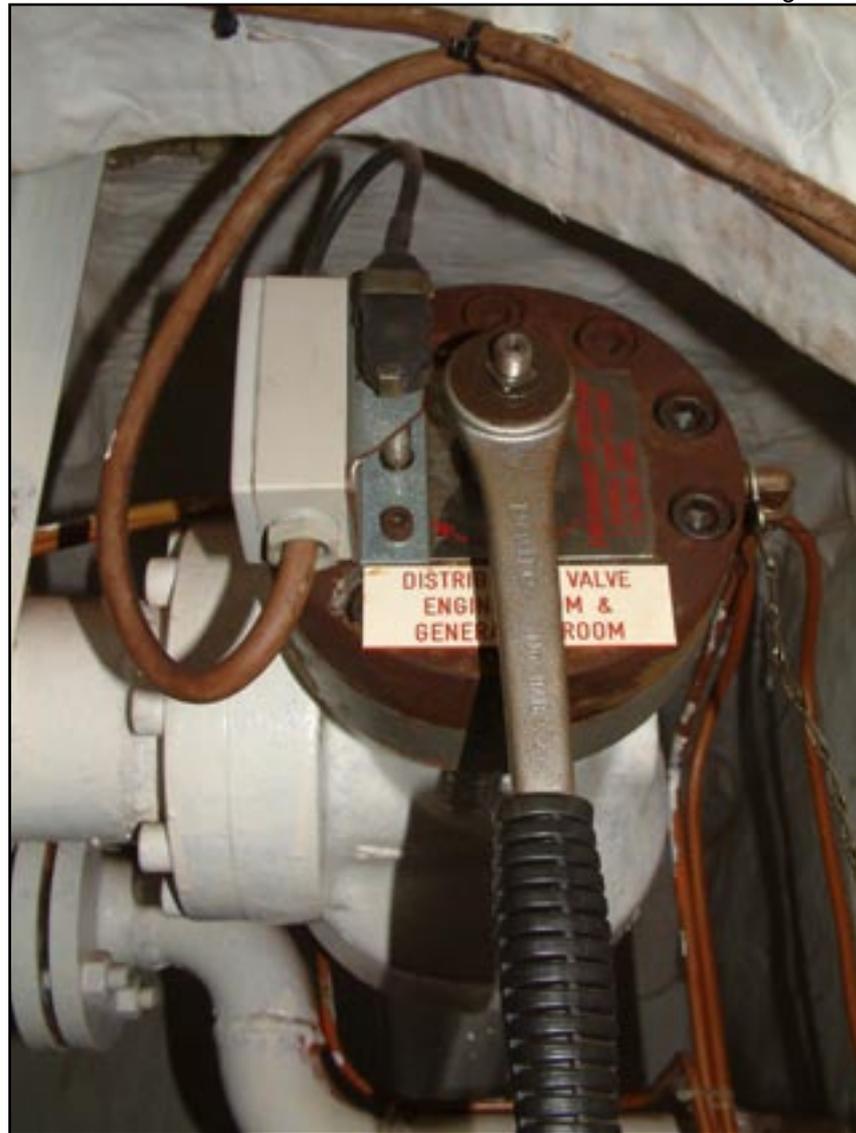
The release of the CO₂ into the two spaces was subject to the operation of pneumatically controlled distribution valves in the two take-off lines from the manifold. The 90° distribution valve for the engine room was piston operated, had a working pressure of 100 bars, and was provided with an indicator pin and switch to show when open. In an emergency, the valve could be opened using a dedicated ratchet handle (**Figure 20**). The distribution valve for the boiler room was opened by a pneumatically controlled cylinder specifically suited to open ball valves. The cylinder had a working pressure range of 10 -100 bar. In an emergency, a handle, extending from the ball valve pivot, could be used to operate the valve manually (**Figure 6b**). Both distribution valves were labelled.

Engine room distribution valve with manual handle attached

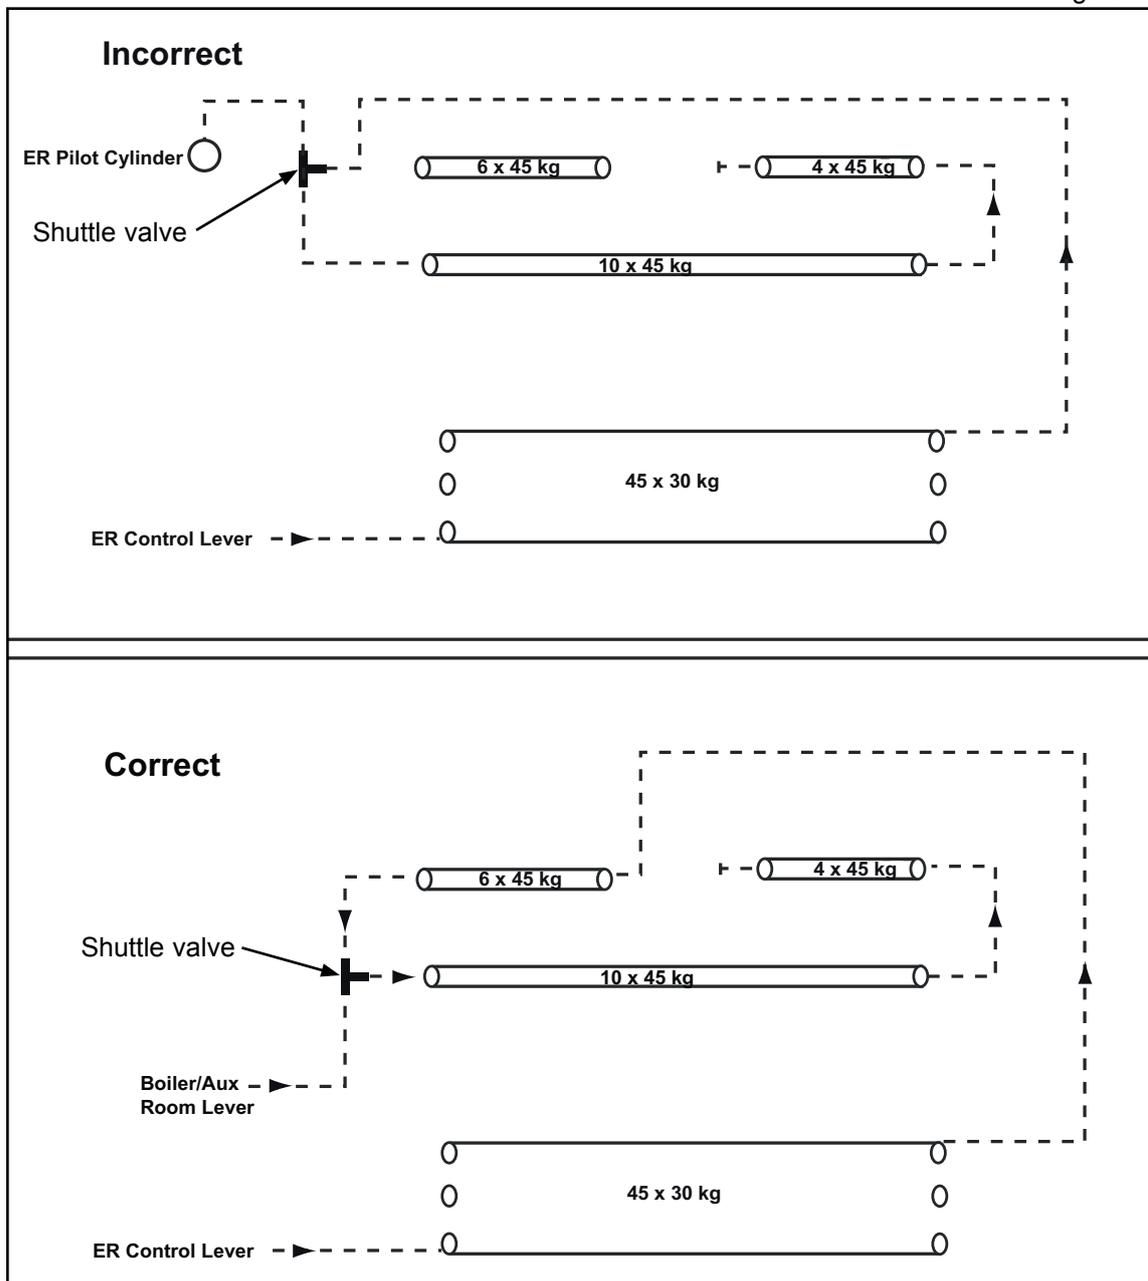
Figure 28

The small bore copper control pipework linking the control switches and CO₂ cylinders included an actuator shuttle valve, in the form of a “T” piece, located near the pilot cylinders. This allowed control gas to pass from either end of the main line of the “T” and leave via the middle port. The shuttle valve was intended to allow the correct number of cylinders to be released depending on whether the engine room or boiler room was to be injected with CO₂ (see **Figure 28**).

The inspection also revealed that the actuator shuttle valve (“T” piece) in the pilot line had been incorrectly fitted, probably from when the system was installed in 1994 (**Figure 28**). This meant that, even if the system for the engine room had been activated correctly, only six of the outboard bank of cylinders would have been released instead of all of them (a total of 51 cylinders instead of all 66). The incorrect fitting of the shuttle valve had not been noticed in any inspections since the system was fitted in 1994. This indicates a general shortfall by both the service agents and ship staff.
