Report on the investigation of  
the loss of one man overboard  
from the sailing yacht

***Pastime***

17 March 2006

**Report No 25/2006**  
**September 2006**

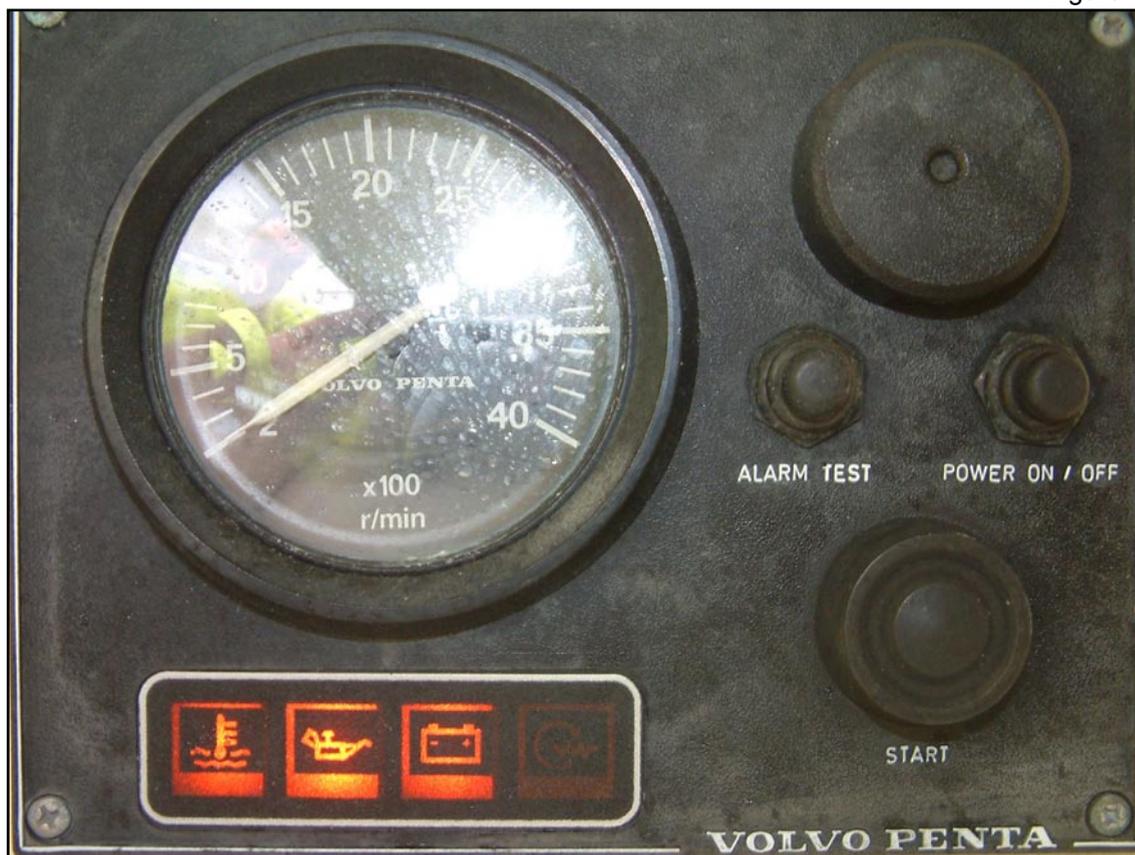
Engine control panel

Externally, the engine and sail-drive unit were found to be in good overall condition during the post accident survey carried out for the MAIB. The systems were found generally leak-free, and the controls functioned as intended. There were some traces of rubber deposits on the face of the engine block and alternator fan. These originated from the alternator drive belt, and indicated previous belt slippage.

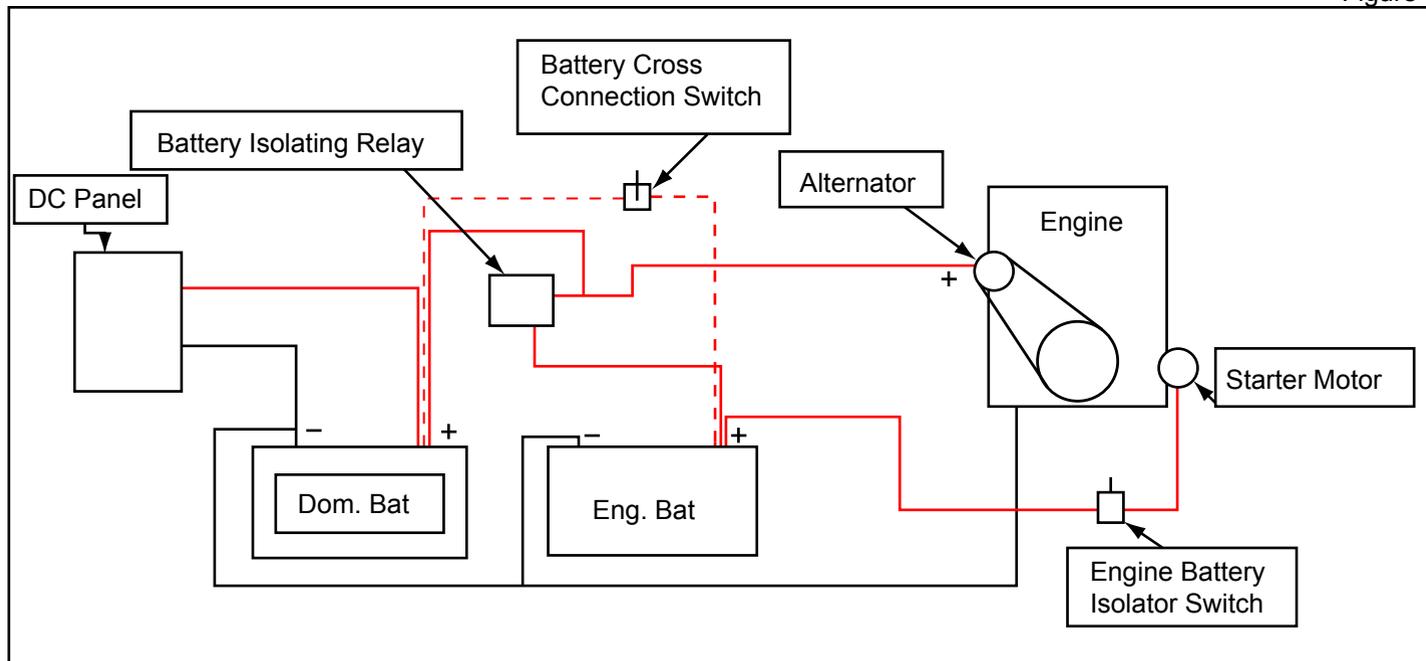
Figure 8

Pastime's electrical circuit diagram

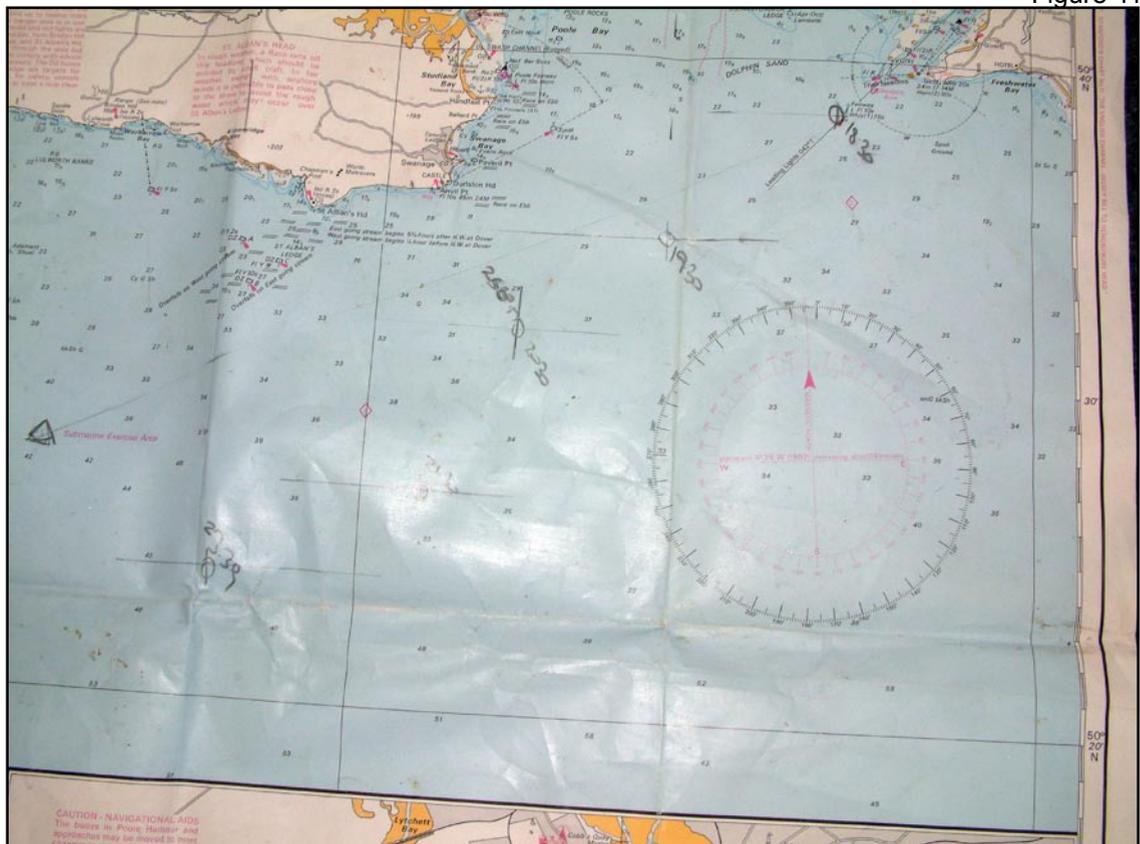
Figure 11

The navigational expertise displayed, shows a fairly rudimentary understanding of the principles involved. Good technique was followed in that the position was regularly plotted. However, after plotting each position, the EP should have been updated for the actual course and speed made good. This would have allowed the navigator to re-assess the heading to steer to maintain the planned track, and to assess his progress along it. In this case, *Pastime* was setting south away from the planned track, and no attempt was being made to counter this set and drift (see Figure 11).
