Report on the investigation of the serious  
injury to a member of the crew of the LASH vessel

***Spruce***

at Victoria Docks, Hartlepool

**Report No 27/2006  
October 2006**

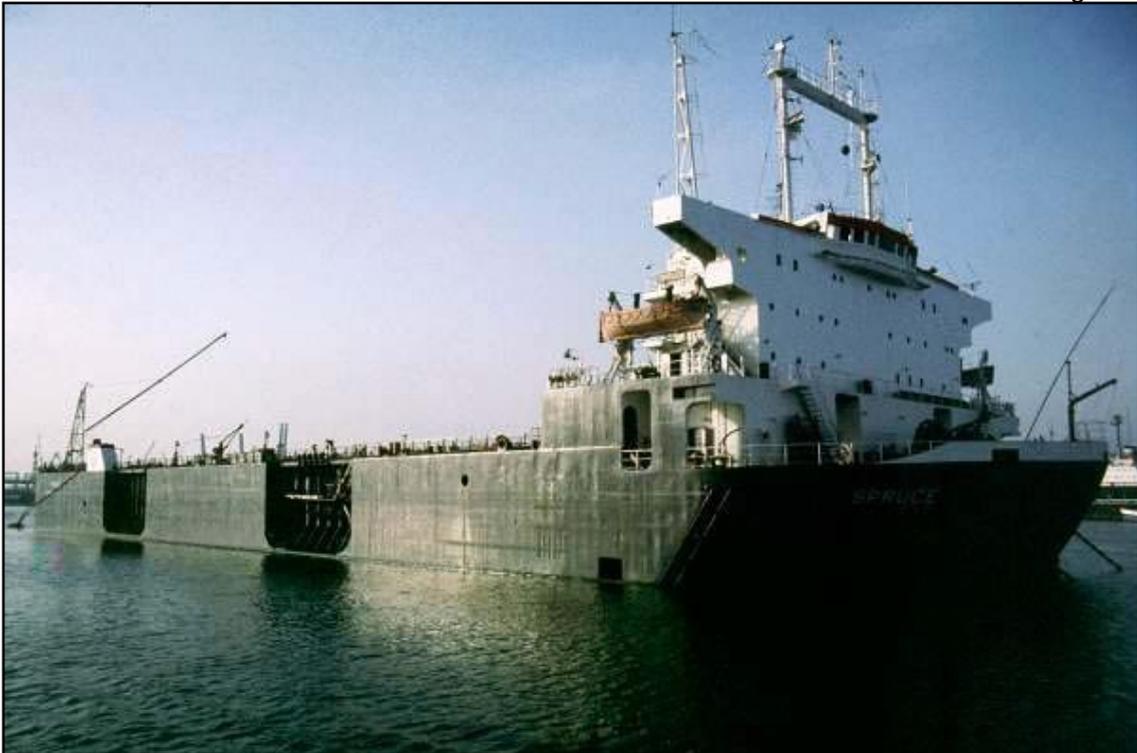
Figure 1

*Spruce* in seagoing condition

*Spruce* had a single hold which was completely open to the sea at the after end. The vessel was ballasted down to enable barges to be floated in or out, and then de-ballasted to “ground” the barges in the hold for transport (**Figures 1 and 2**).

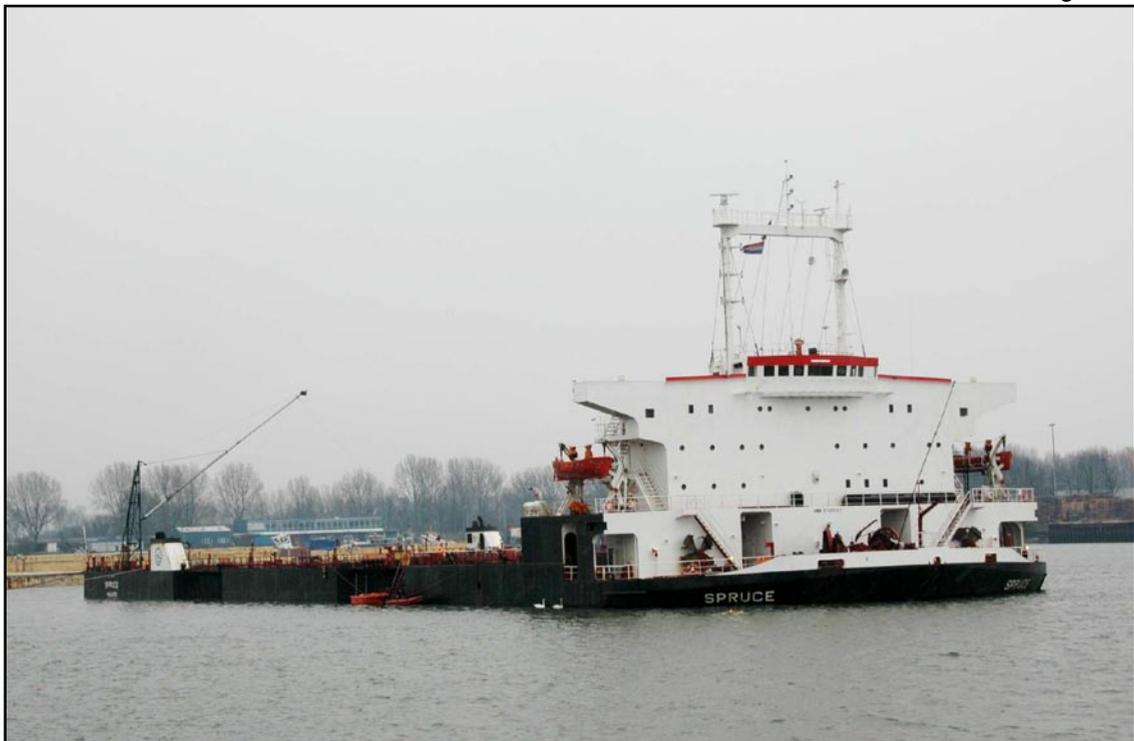
Figure 2

*Spruce* ballasted prior to loading/unloading of barges
