Report on the investigation of
the grounding of

Berit

Trindelen Bank, near Gedser

Report No 17/2006
July 2006

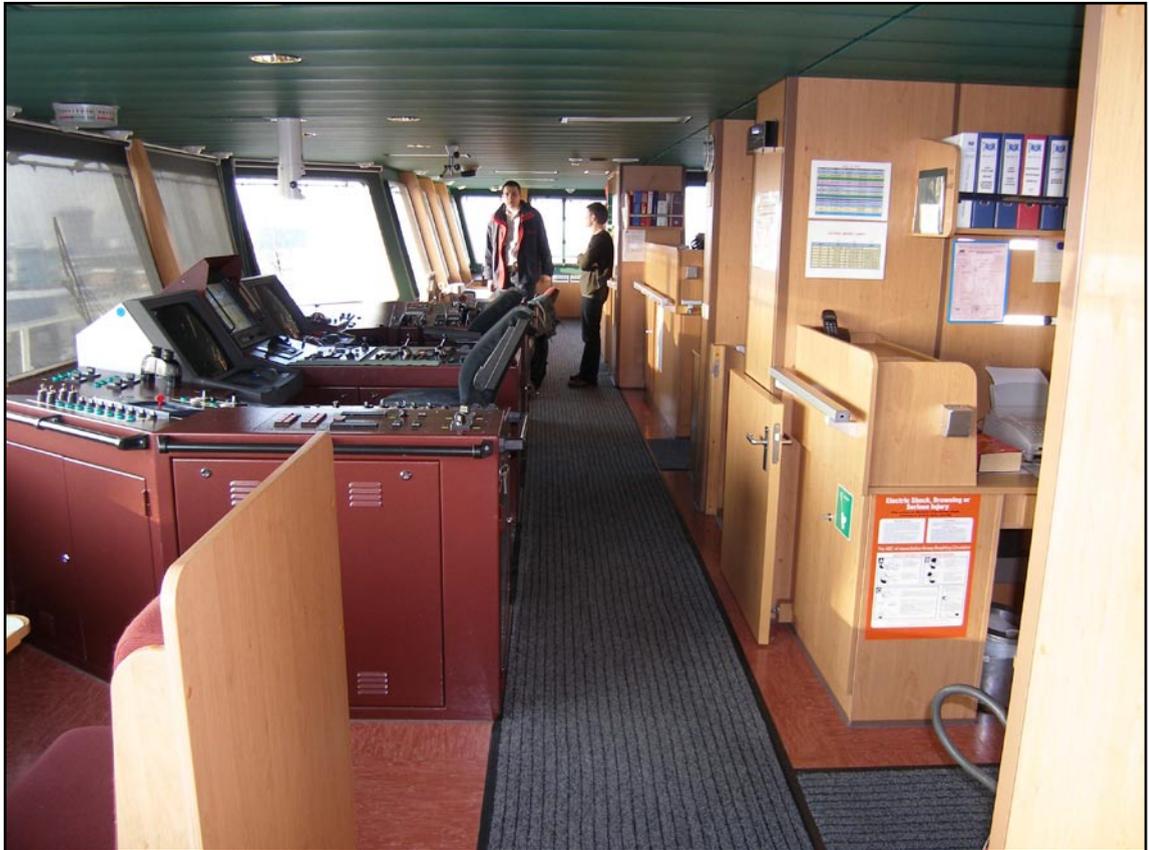
Figure 5

Berit's bridge was spacious, had enclosed bridge wings, and a centre consol with 2 chairs for the watchkeepers. A navigational area with a forward facing chart table extended aft of the bridge on the starboard side, and a communications area filled the corresponding space on the port side (**Figure 5**).

Bridge viewed from port side

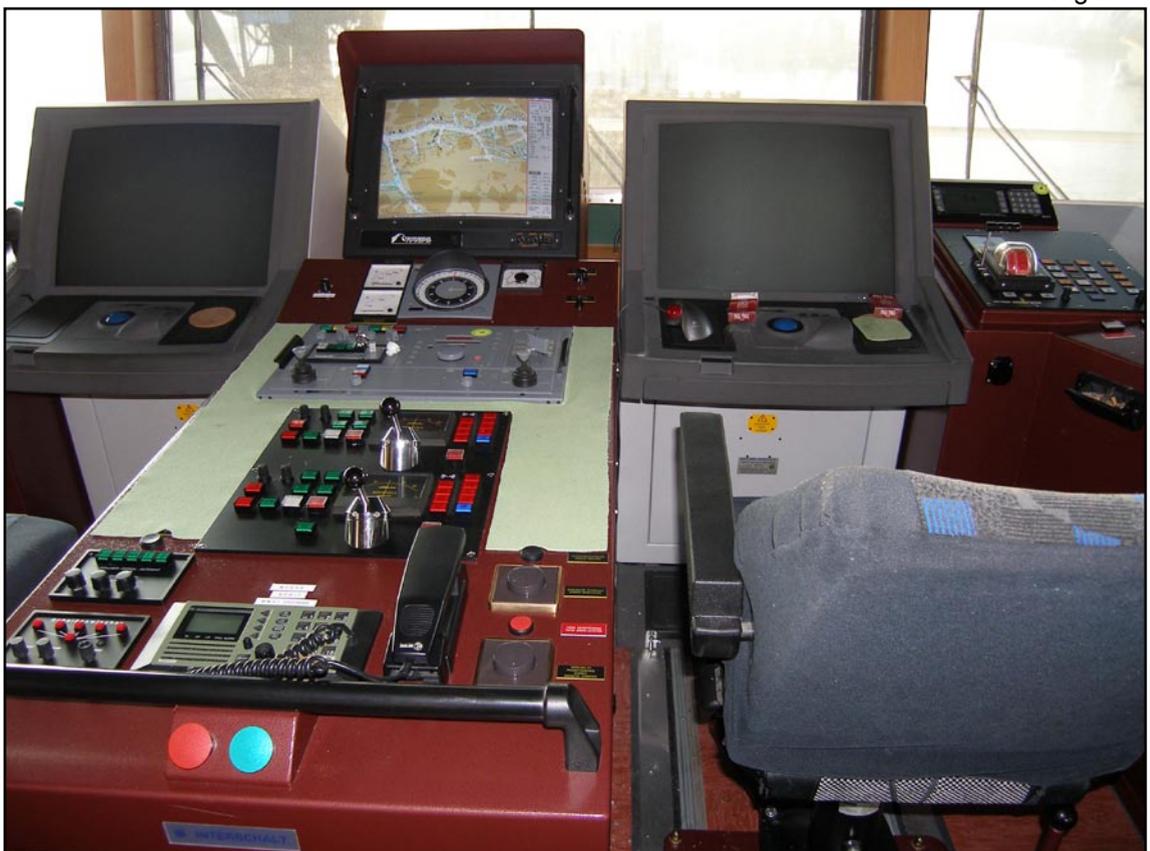
Figure 6

The equipment on the bridge was comprehensive and modern, as might be expected on a new container ship such as *Berit*. Two radar displays were fitted on the centre control console, with chairs sited immediately behind them (**Figure 6**). The starboard radar was normally used while on passage, as it had an ARPA capability. A display for the 'Transas' electronic charting system (ECS) was positioned between the two radar displays. One of the vessel's two GPS sets was fed into the ECS providing position and waypoint information. The GPS units themselves were mounted above the chart table in the navigation area. The ECS alarms were not activated. However, when a waypoint was approached the GPS would sound an alarm. The GPS alarm was quiet and would self cancel after a short period of time. The ECS was not fed with an optional radar picture input.

Centre console
