Report on the investigation of the  
capsize of the fishing vessel

***Noordster Z122***

13 December 2005

**Report No 30/2006  
November 2006**

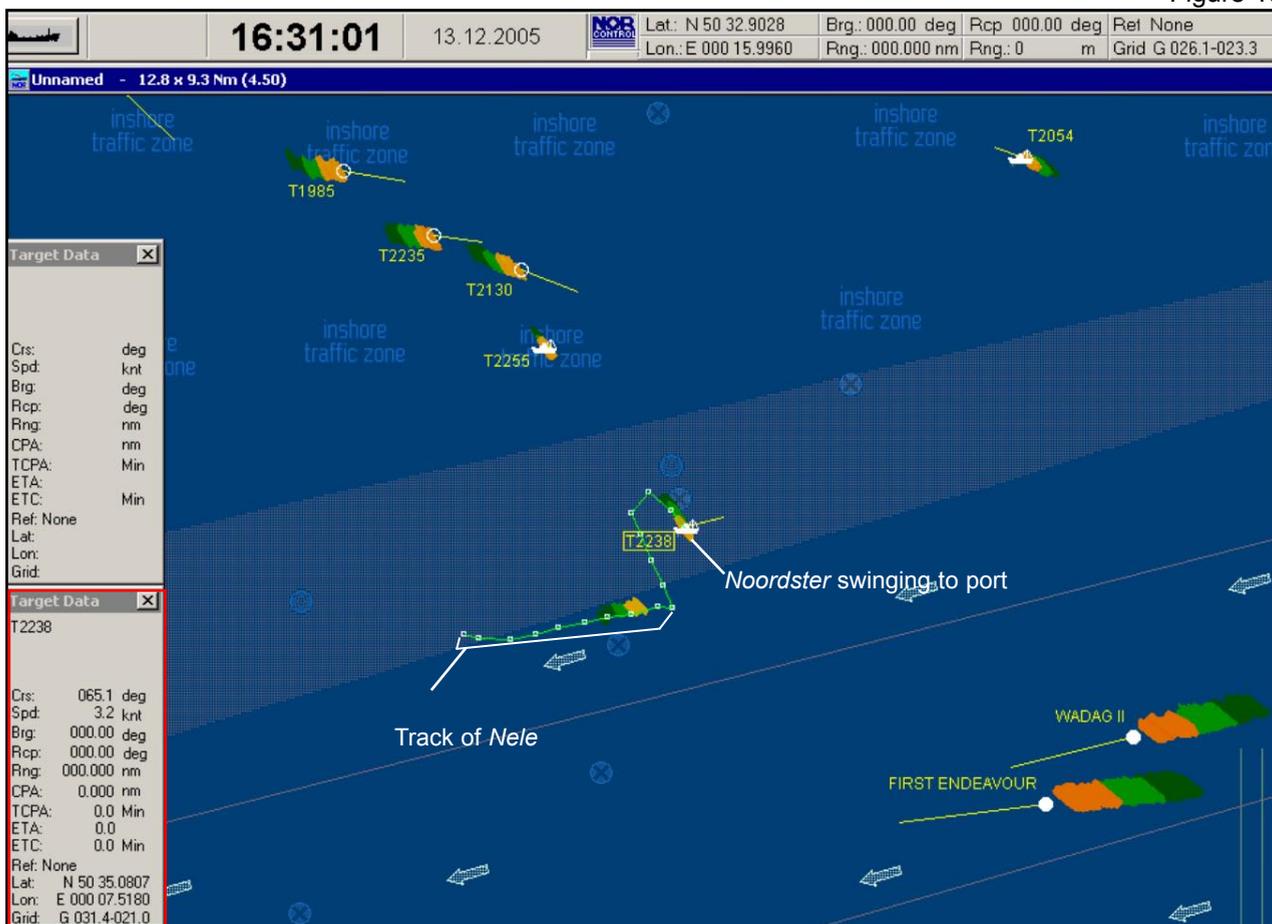
Figure 13

At 1630, in position 50° 34.19 North and 000° 06.34 East, *Noordster* came rapidly to port to a heading of about north-east, and her speed dropped quickly (**Figure 13**). By 1635, she was stopped.

Revised target data for Noordster after target swap with Nele

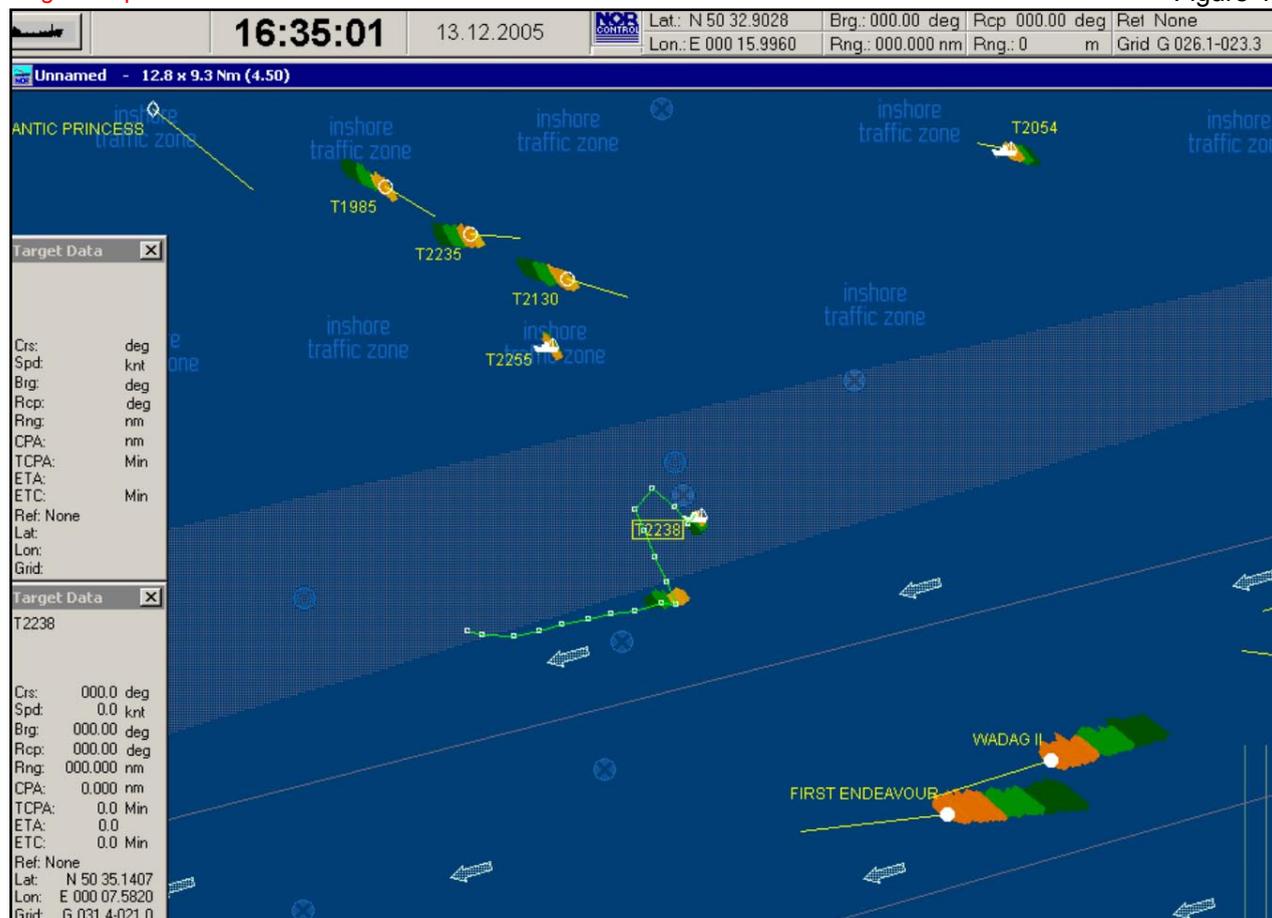
Figure 14

The radar target of *Noordster* remained nearly in the same position until 1658, when it disappeared from the CNIS radar recording (**Figure 14**). Her position at that time was 50° 35.14 North and 000° 07.56 East.

Noordster - Static in position 50° 35'N 000° 07'E

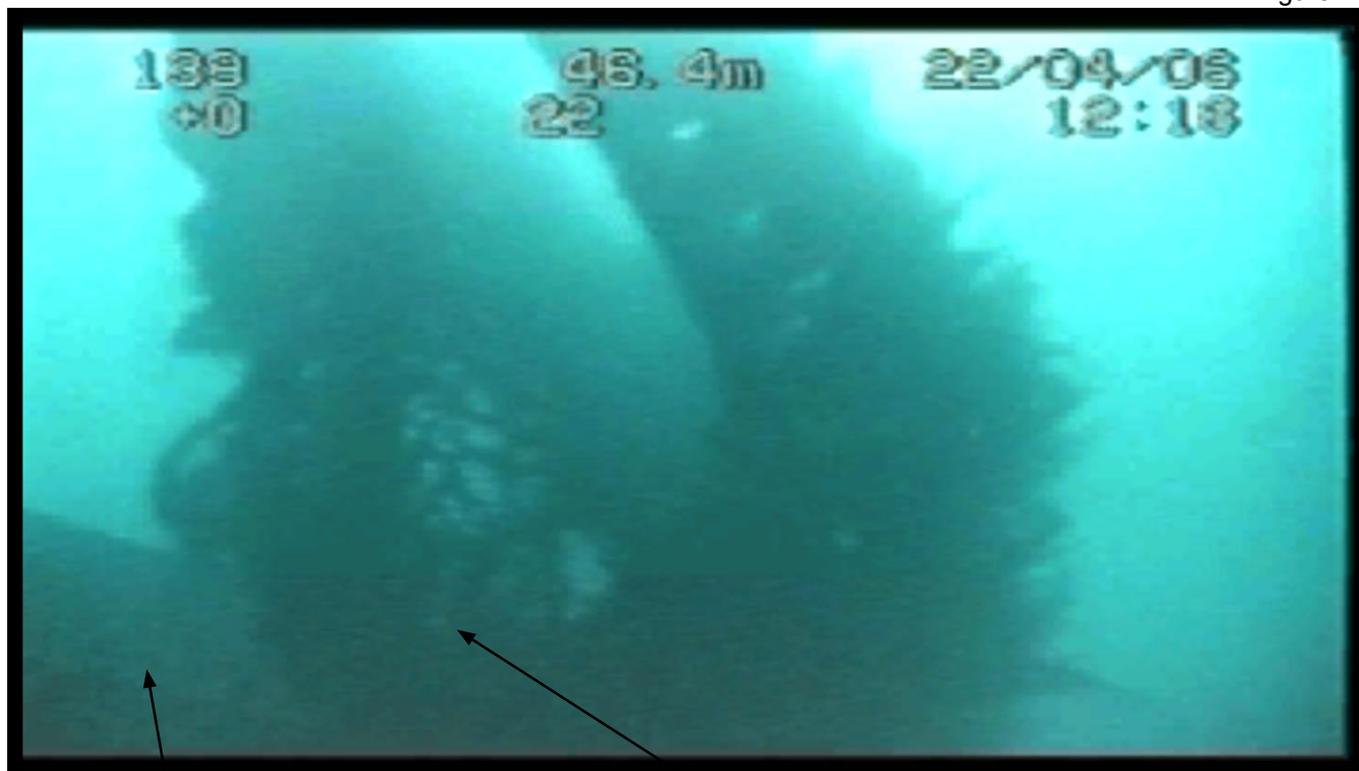
Figure 19

Starboard gunwhale

Starboard net

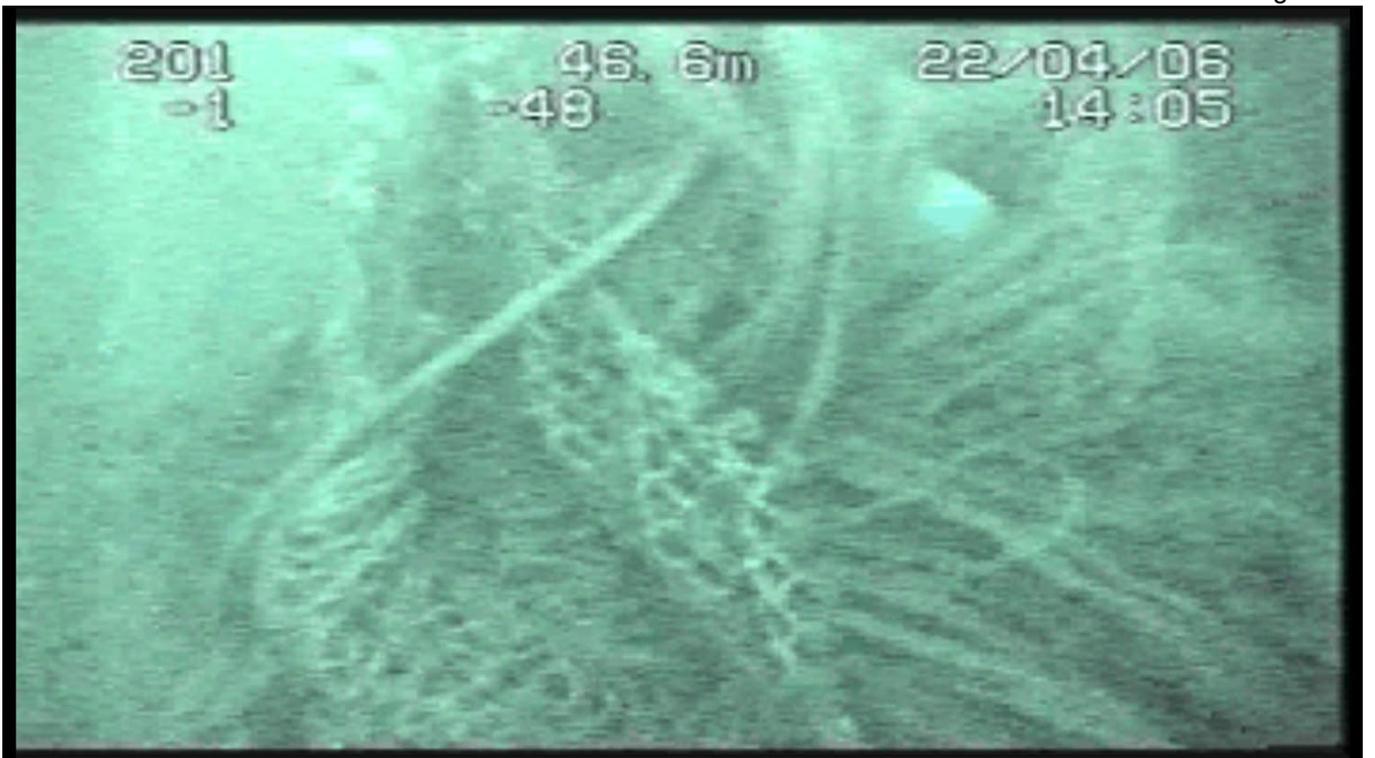
Figure 23

Port net

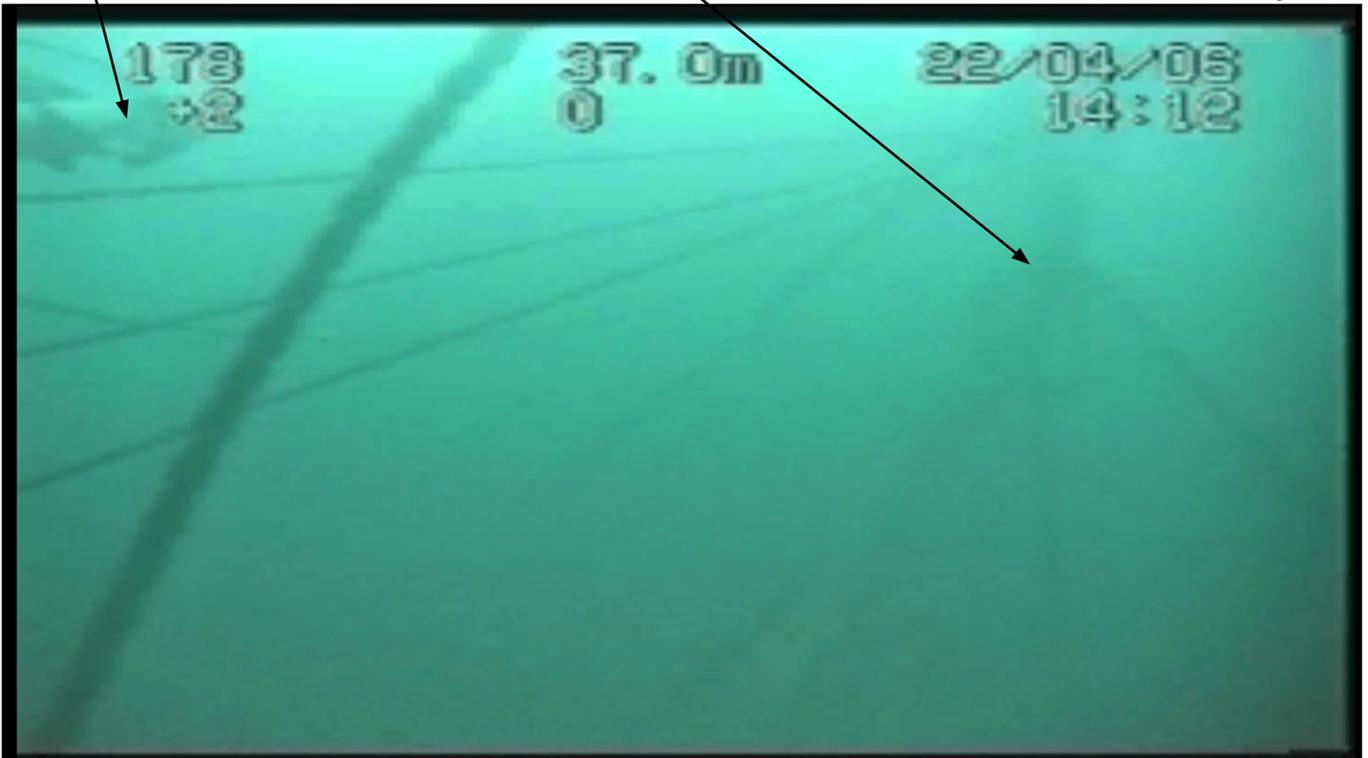
Figure 25

The light mast at the top of the forward gantry had been bent over to starboard, and the lower section of the mast steelwork had fractured. A mooring rope had become entangled around the mast. The forward stay for the starboard derrick was taut.

Relative positions of light mast and starboard derrick
