Report on the investigation of  
the collision between **Arctic Ocean** and **Maritime Lady**,  
capsize of **Maritime Lady** and contact with wreck of  
**Maritime Lady** by **Sunny Blossom**, and its subsequent grounding  
in the Elbe River  
5 December 2005

**Report No 2/2007**  
**February 2007**

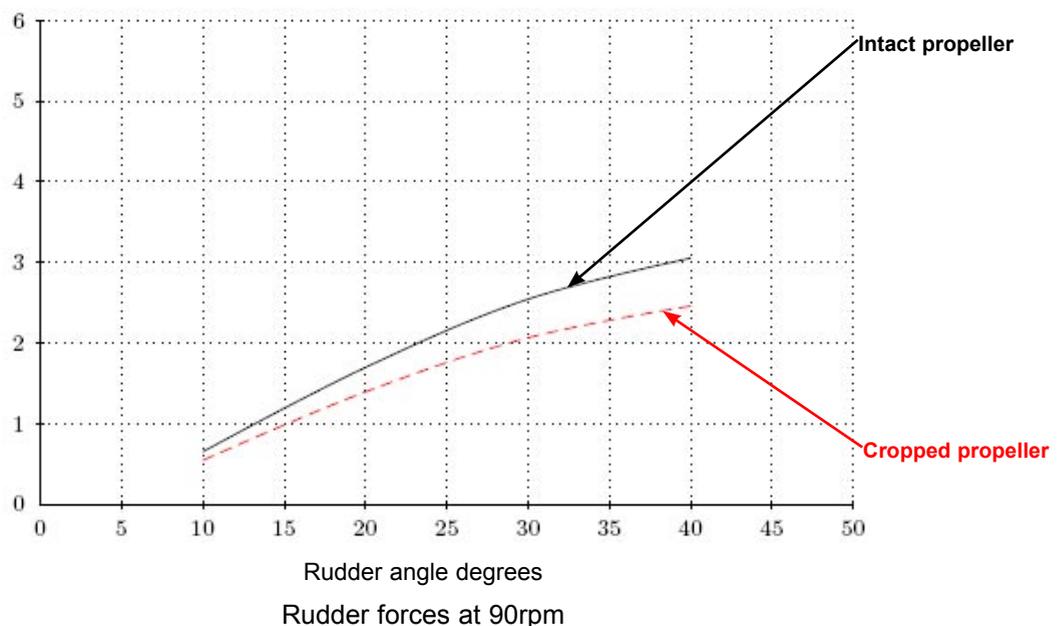
Figure 17

- Cropping of two propeller blades reduced the slipstream over the rudder and transverse rudder force. At 90rpm (full ahead) and 30° of rudder, the calculated reduction was from 254kN to 205kN (**see Figure 17**).
