Report on the investigation of
the capsize and foundering of the
fv Harvest Hope PD120
40 miles north-east of Peterhead
on 28 August 2005

Report No 21/2006
August 2006

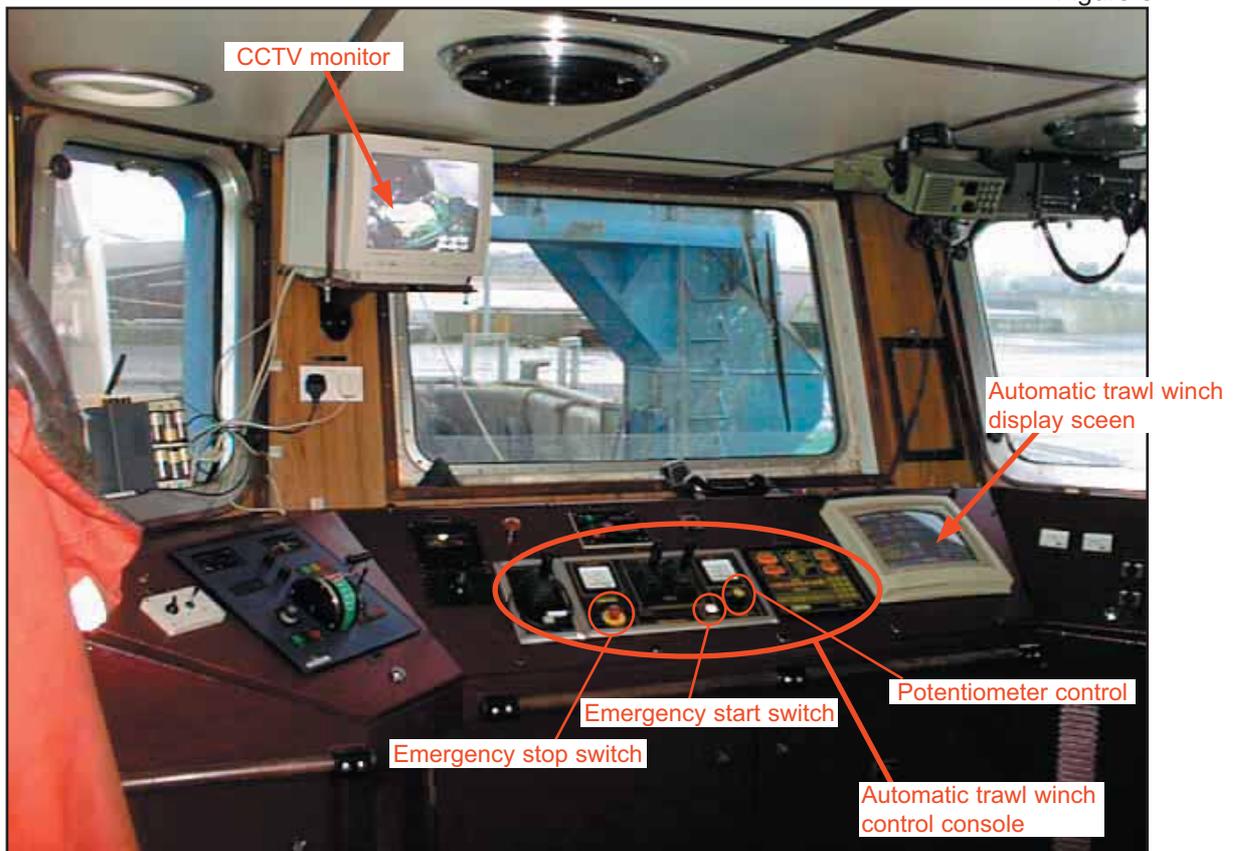
Figure 5

After approximately 2 hours, the vessel's speed started to reduce and the "auto-trawl" system on the port trawl winch began to pay out. The skipper immediately recognised that the trawl gear had become fast on the seabed, and stopped the vessel, while raising the alarm to the crew. He then moved aft in the wheelhouse from the forward console, as shown in **Figure 4**, which was used during towing operations, to the winch control console at the aft end of the wheelhouse, depicted in **Figure 5**.

Wheelhouse of *Harvest Hope* looking aft (February 2003)

An "emergency start" switch (**Figure 5**) is integrated in to the PTS 3000 system. If there was a PTS controller failure, this switch would have engaged the clutch on the Hytec gearbox and started the "main" pumps, but it would have had no effect until the low level alarm had been reset. The "emergency start" switch was not activated by the skipper during the incident.

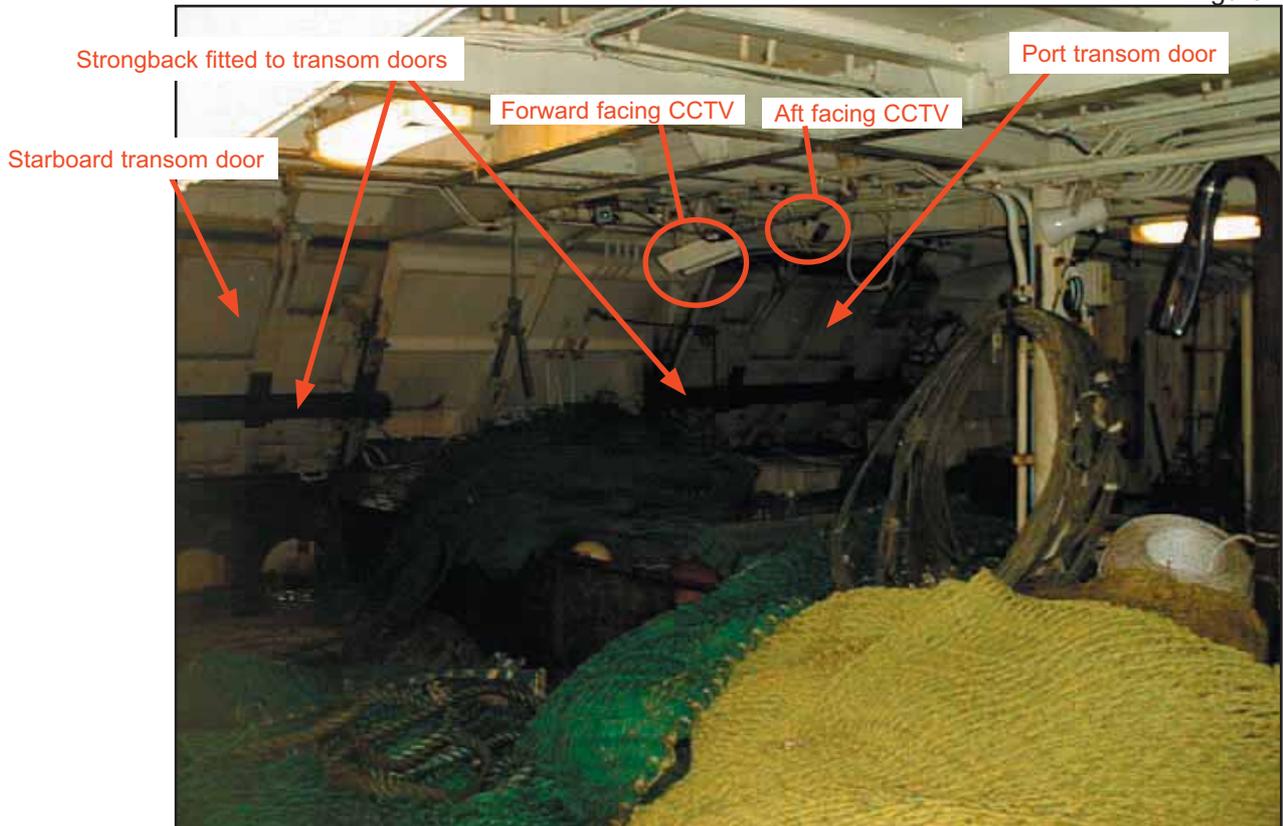
Figure 7

Net drum space on *Harvest Hope*, looking port aft (February 2003)

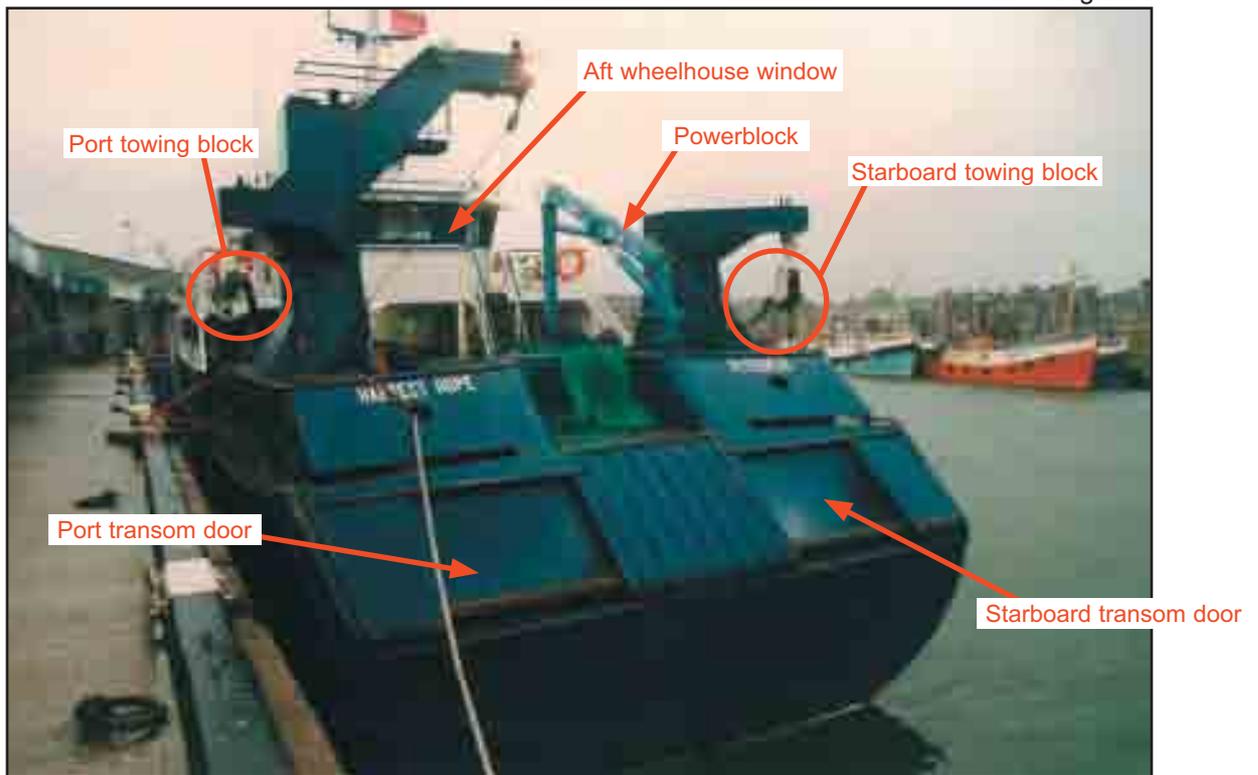
Figure 8

Stern view of *Harvest Hope*, when built

With these brakes now on, the vessel was effectively fastened to the seabed from the towing block suspended from the port gallows (**see Figure 8**) and there was no easy means of releasing the trawl warp. The skipper therefore asked the mate to get the electric grinder and extension lead from the starboard alleyway on the main deck, and cut away the trawl gear, as the vessel’s primary petrol-driven grinder was ashore being serviced.

With the water level rapidly rising on the port side of the net drum space, and the tension on the port trawl warp acting from the towing block suspended from the gallows, as shown at **Figure 8**, the vessel began to heel to port.

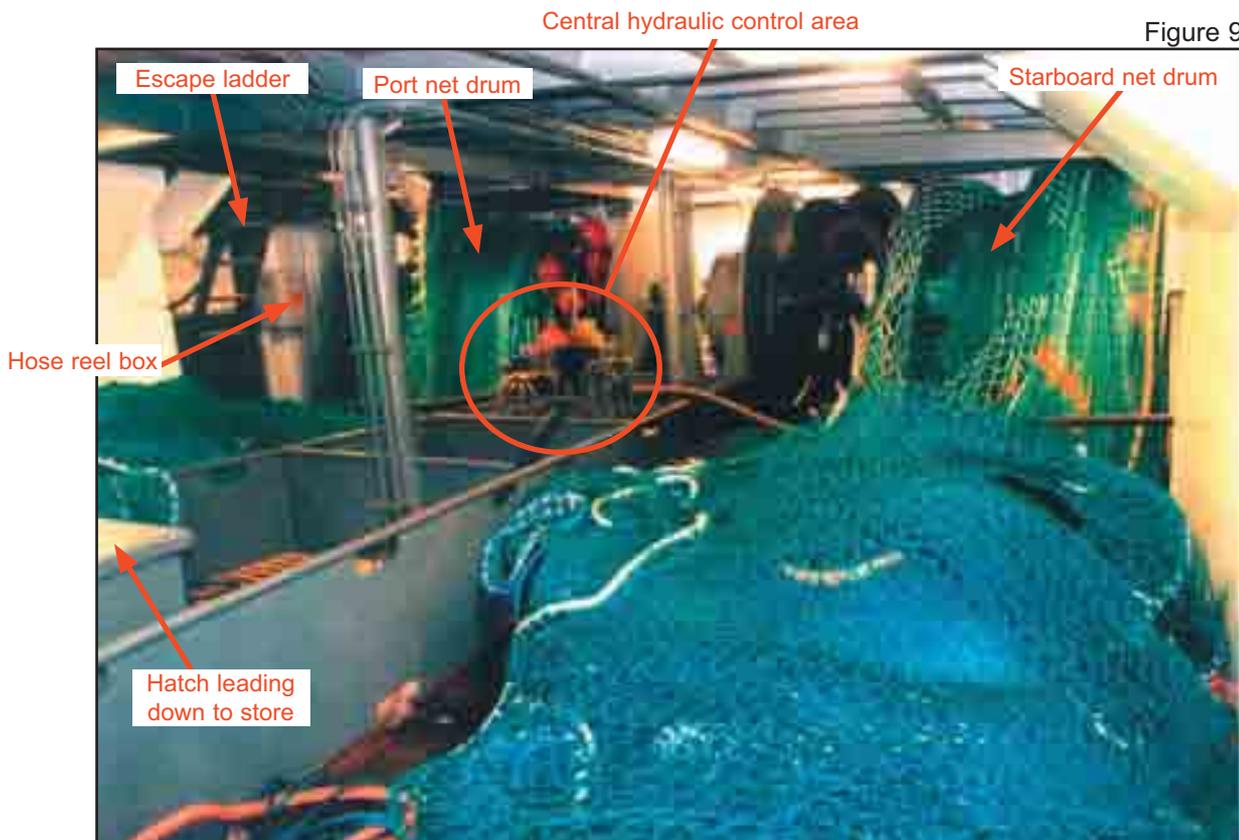
Figure 9

Net drum space of *Harvest Hope*, looking forward (when built)

Just after the ram broke free, one of the deckhands arrived in the net drum space to assist with closing the door. On observing the situation, he immediately waded across to the port side, and climbed the ladder (see **Figure 9**) to the escape hatch to try to get a rope from the power block on the upper deck down onto the door. He found the mate was already up there.

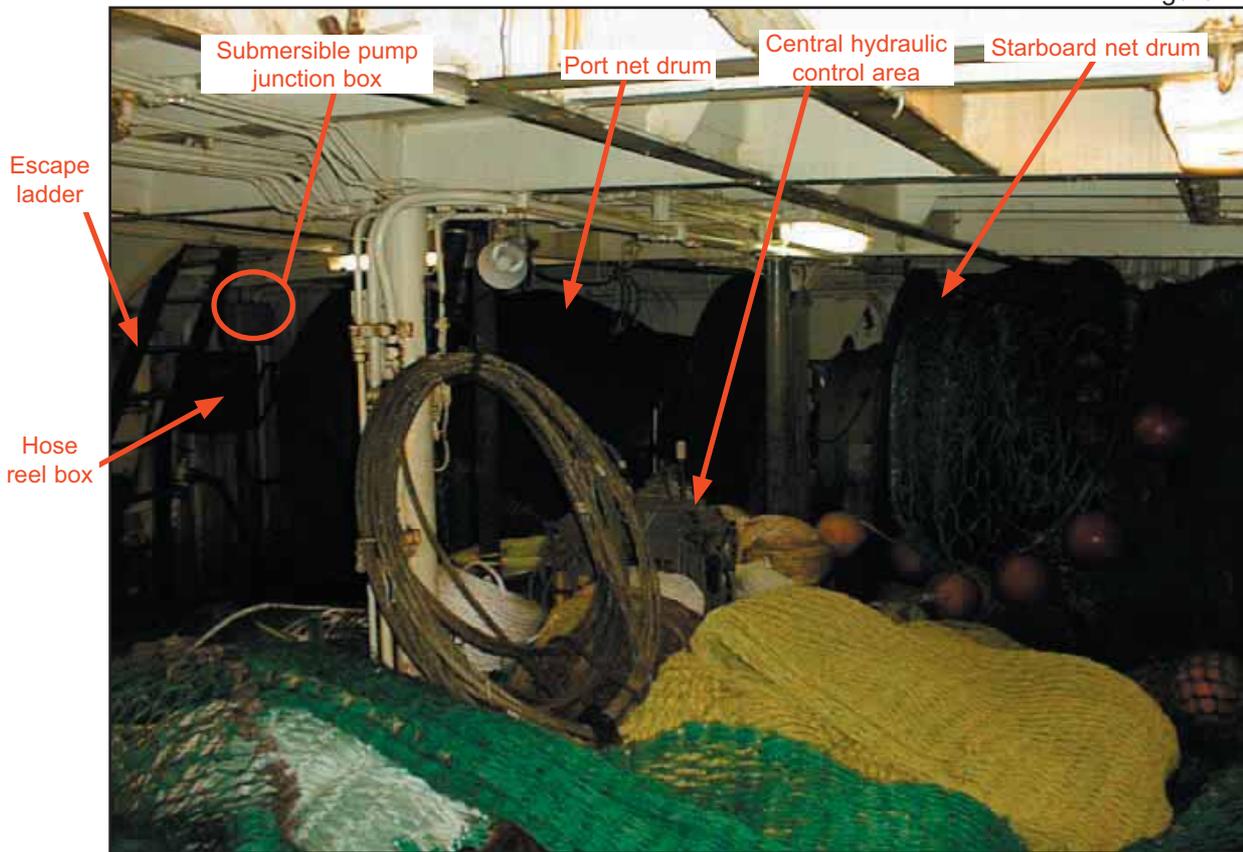
Figure 15

Realising the dangers of progressive flooding into the accommodation spaces, the skipper asked the engineer to go and close the galley and mess windows. By the time he arrived there, he found the mess full of water up to the level of the television set (**see Figure 12**) and water pouring in through the galley window (**see Figures 13 and 14**). While in the galley area, the engineer also observed a flash outside the window, which he believed to be from the junction box for the submersible pump, installed just below deckhead level aft of the port net drum (**see Figure 15**). Following this flash, there was no further confirmation of the port submersible pump operating.

Net drum space on *Harvest Hope*, looking forward (February 2003)

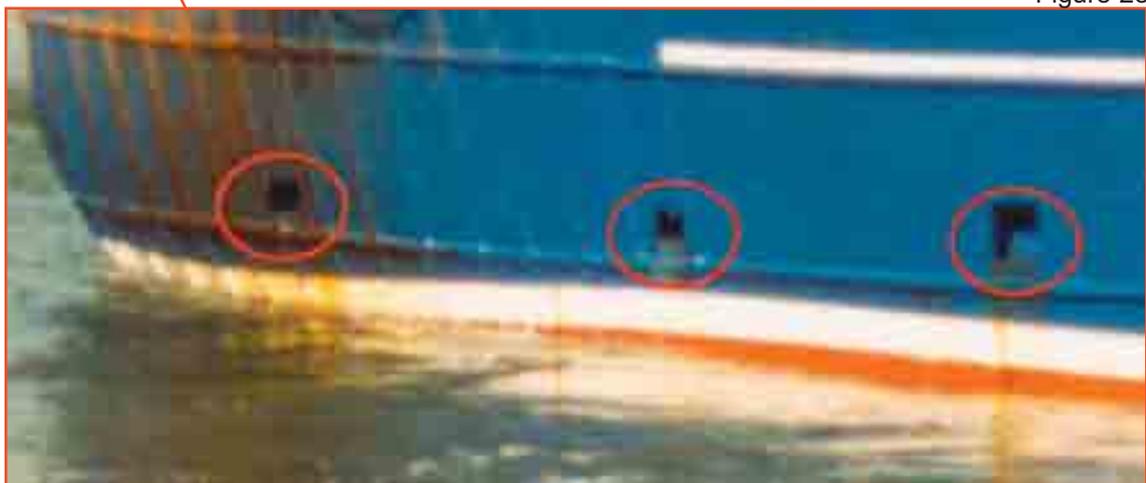
Figure 28

Close-up of hull in way of net drum space on *Harvest Hope* in 1999

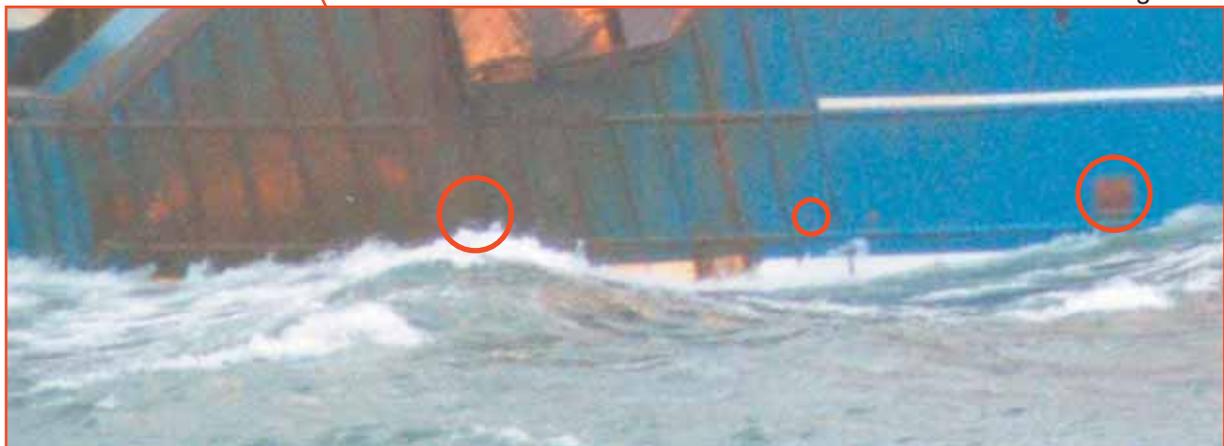
Figure 30

Close-up of hull in way of net drum space on Harvest Hope in 2003

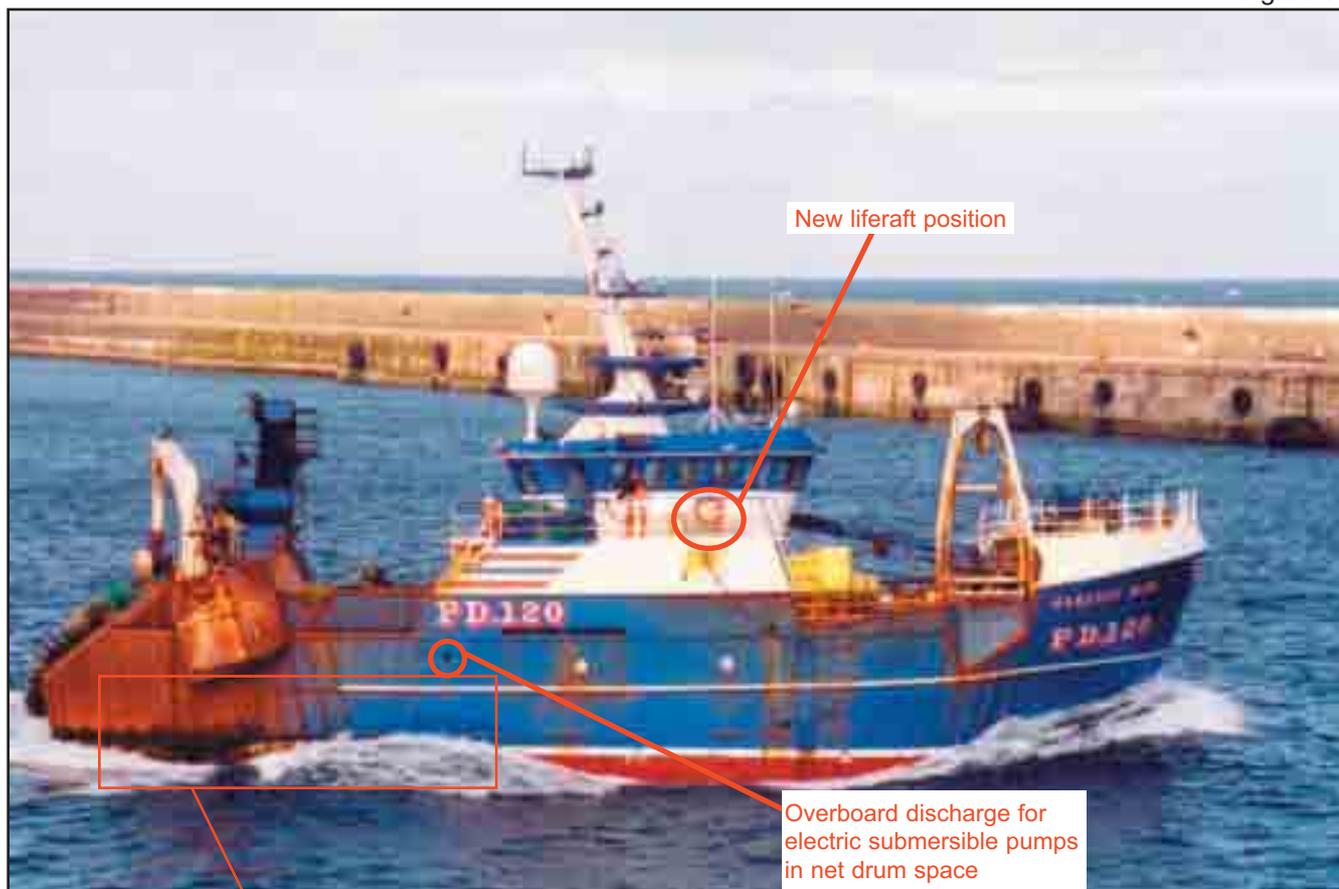
Figure 31

New liferaft position

Overboard discharge for electric submersible pumps in net drum space

Harvest Hope leaving Peterhead in 2005

The liferafts were stowed in their cradles, port and starboard, alongside the wheelhouse. **Figure 31** confirms that these had recently been moved slightly forward of the original position shown in **Figures 2** and **27**. The final stowage positions and original location for the starboard liferaft were behind 1.0m high non-collapsible railings. The original port stowage location was, however, behind a section of folding railing used for gangway access to the vessel, as shown at **Figure 34**.

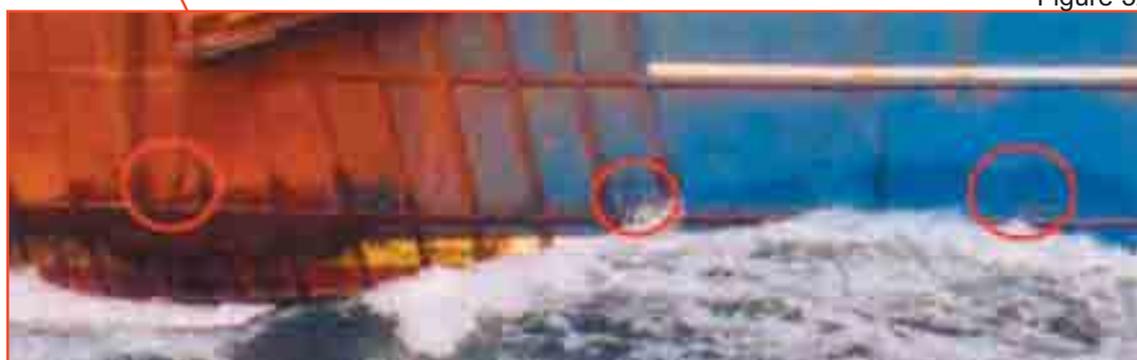
Figure 32

Close-up of hull in way of net drum space on *Harvest Hope* in 2005
