Report on the investigation of  
the starboard boiler explosion resulting in  
one fatal and one serious injury on board the  
Liquid Natural Gas tanker

***Hilli***

10 October 2003

**Report No 4/2007**  
**March 2007**

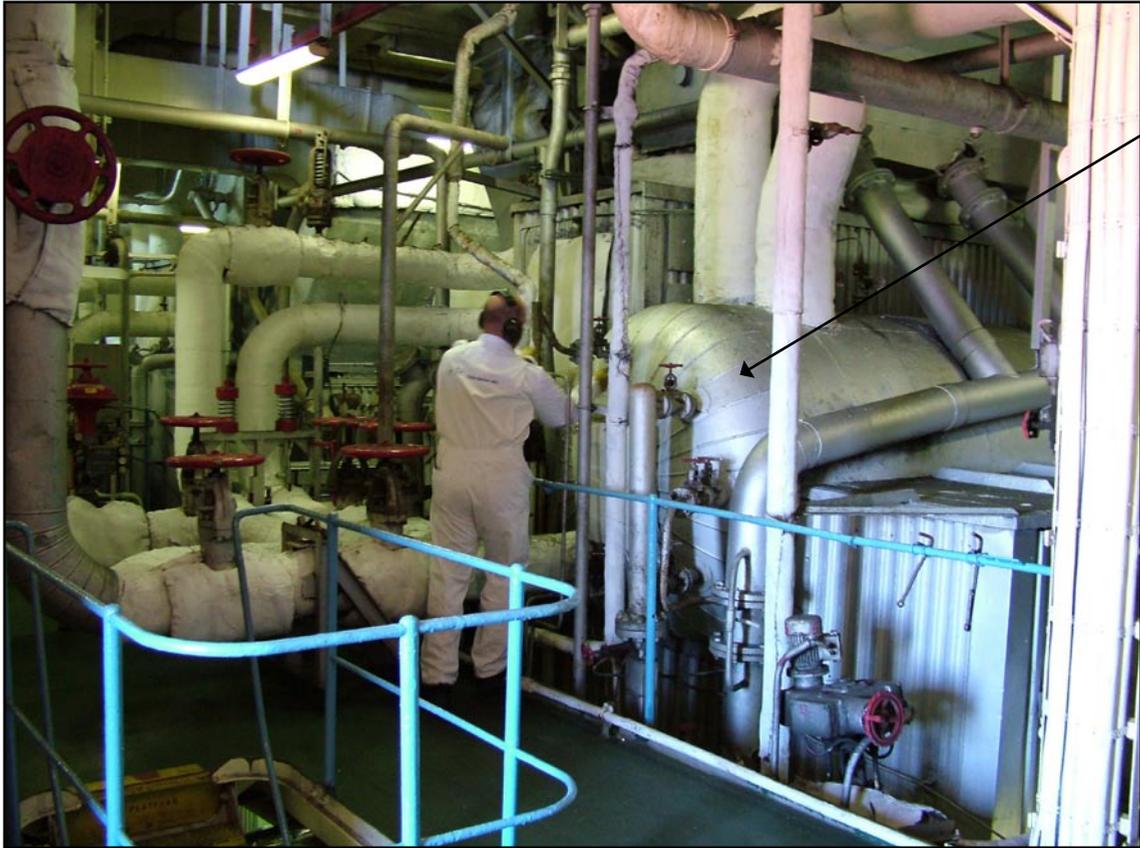
Figure 3

Forward view of the starboard boiler steam drum top plate level

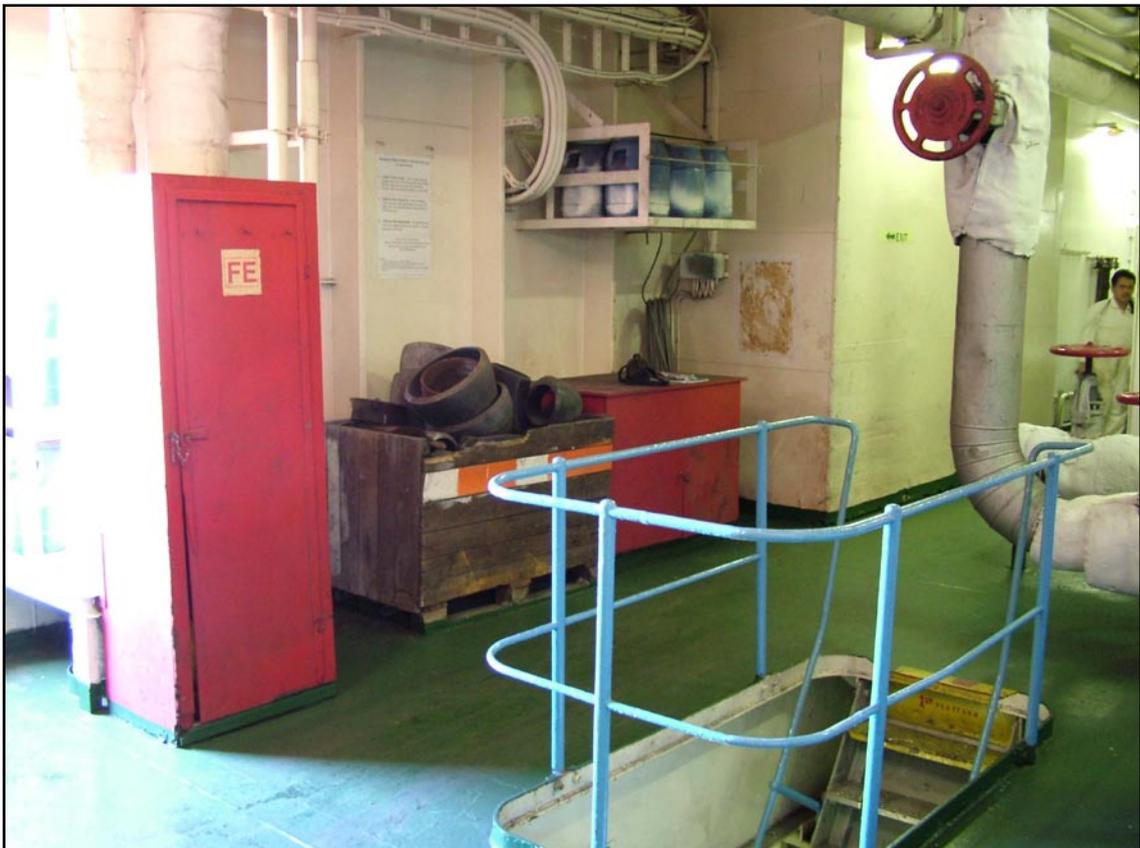
Figure 4

After view of the starboard boiler steam drum top plate level

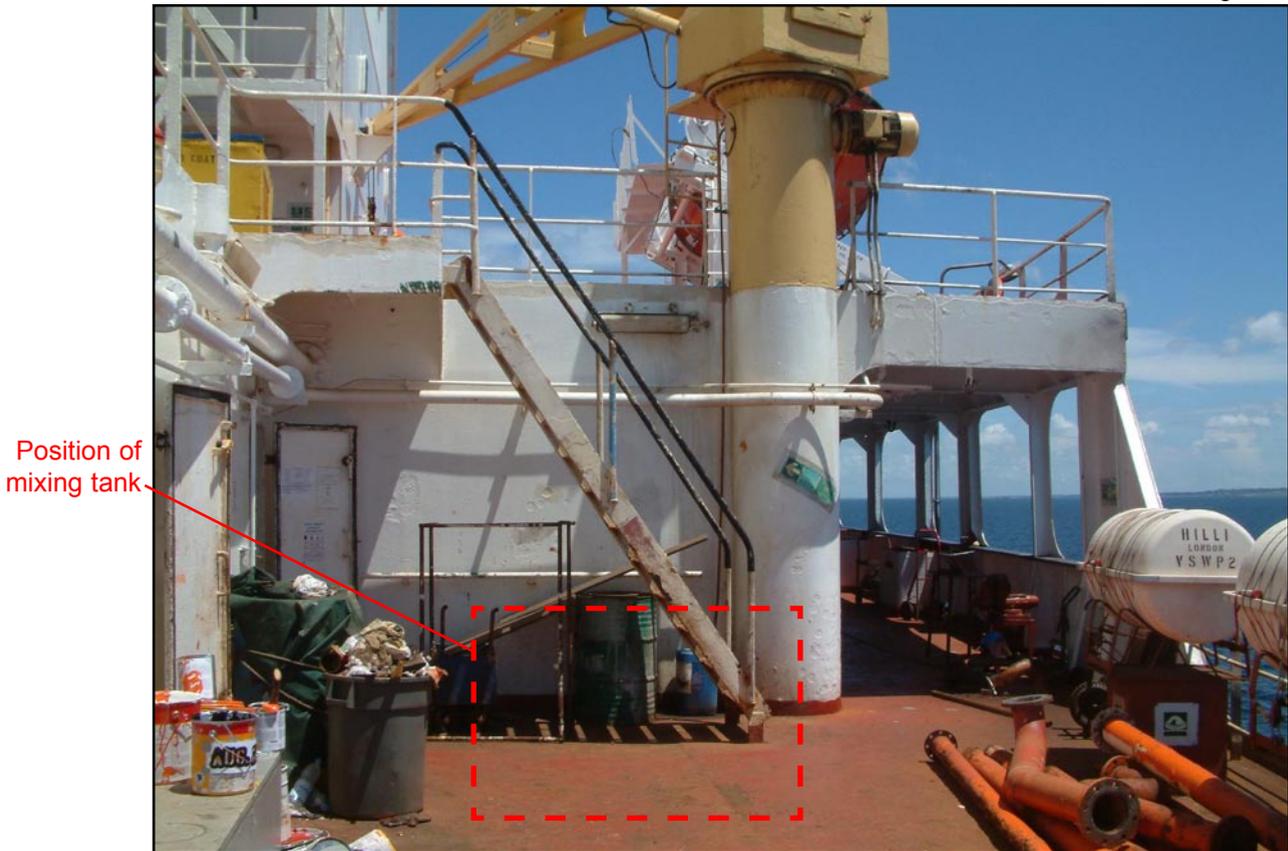
Figure 6

Position of the water/acid mixing tank on the starboard side of the main deck

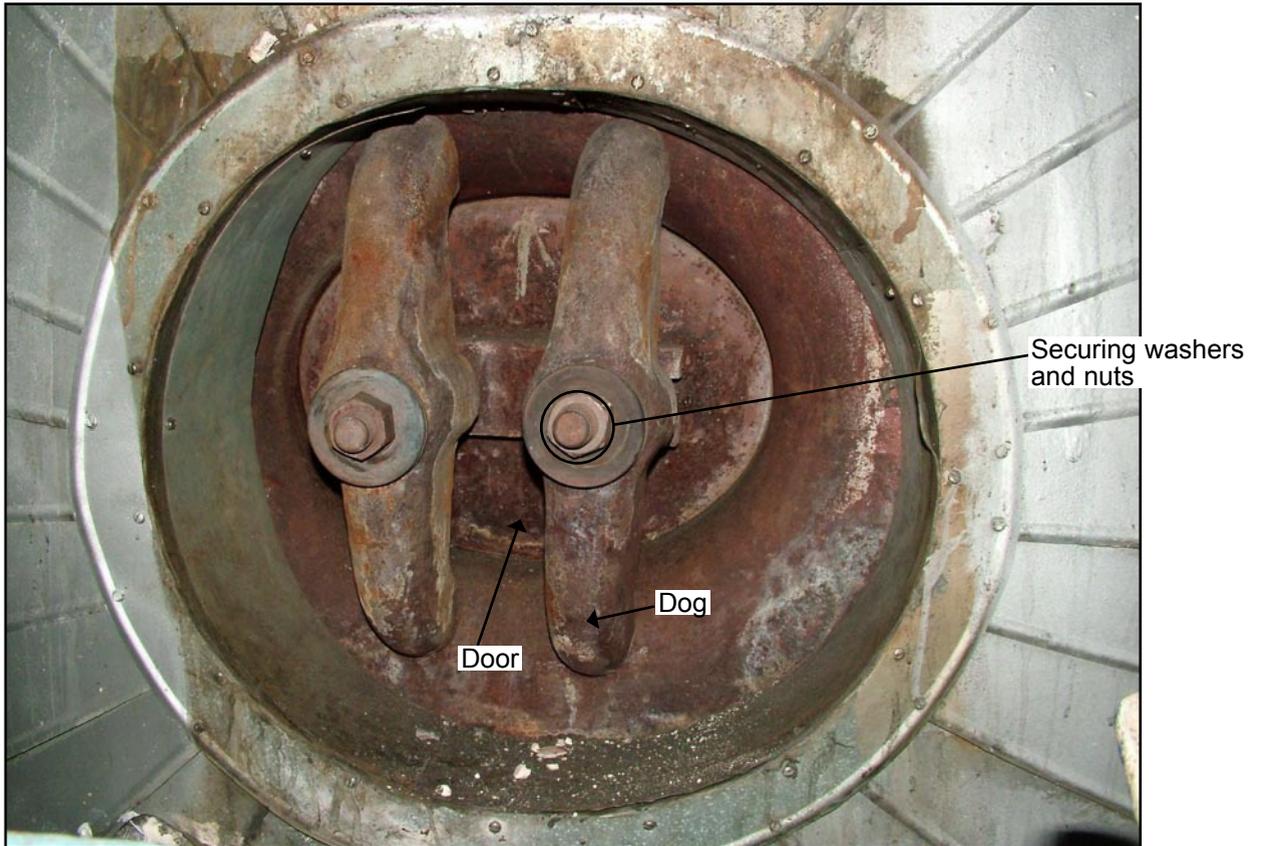
Figure 7

As Mr Walton and the overseer went to the Engine Control Room (ECR) for refreshments, two HPML workers went to the steam drum and removed the nuts and washers on the dogs, before removing the dogs themselves (**Figure 7**). At about 2152 they pushed the hinged door into the steam drum (**Figure 8**). As they forced the door inwards, they noticed a distinct suction, as the door opened and air was drawn into the steam drum. Neither of the workers noticed anything else untoward, and there were no unusual smells or vapours which aroused their suspicions. They then positioned a yellow, HPML halogen lamp on a guardrail, near to the steam drum, before going to the ECR to inform Mr Walton that the door had been opened. After that, both men went up to the main deck to take further refreshments.

Starboard boiler steam drum, door arrangement

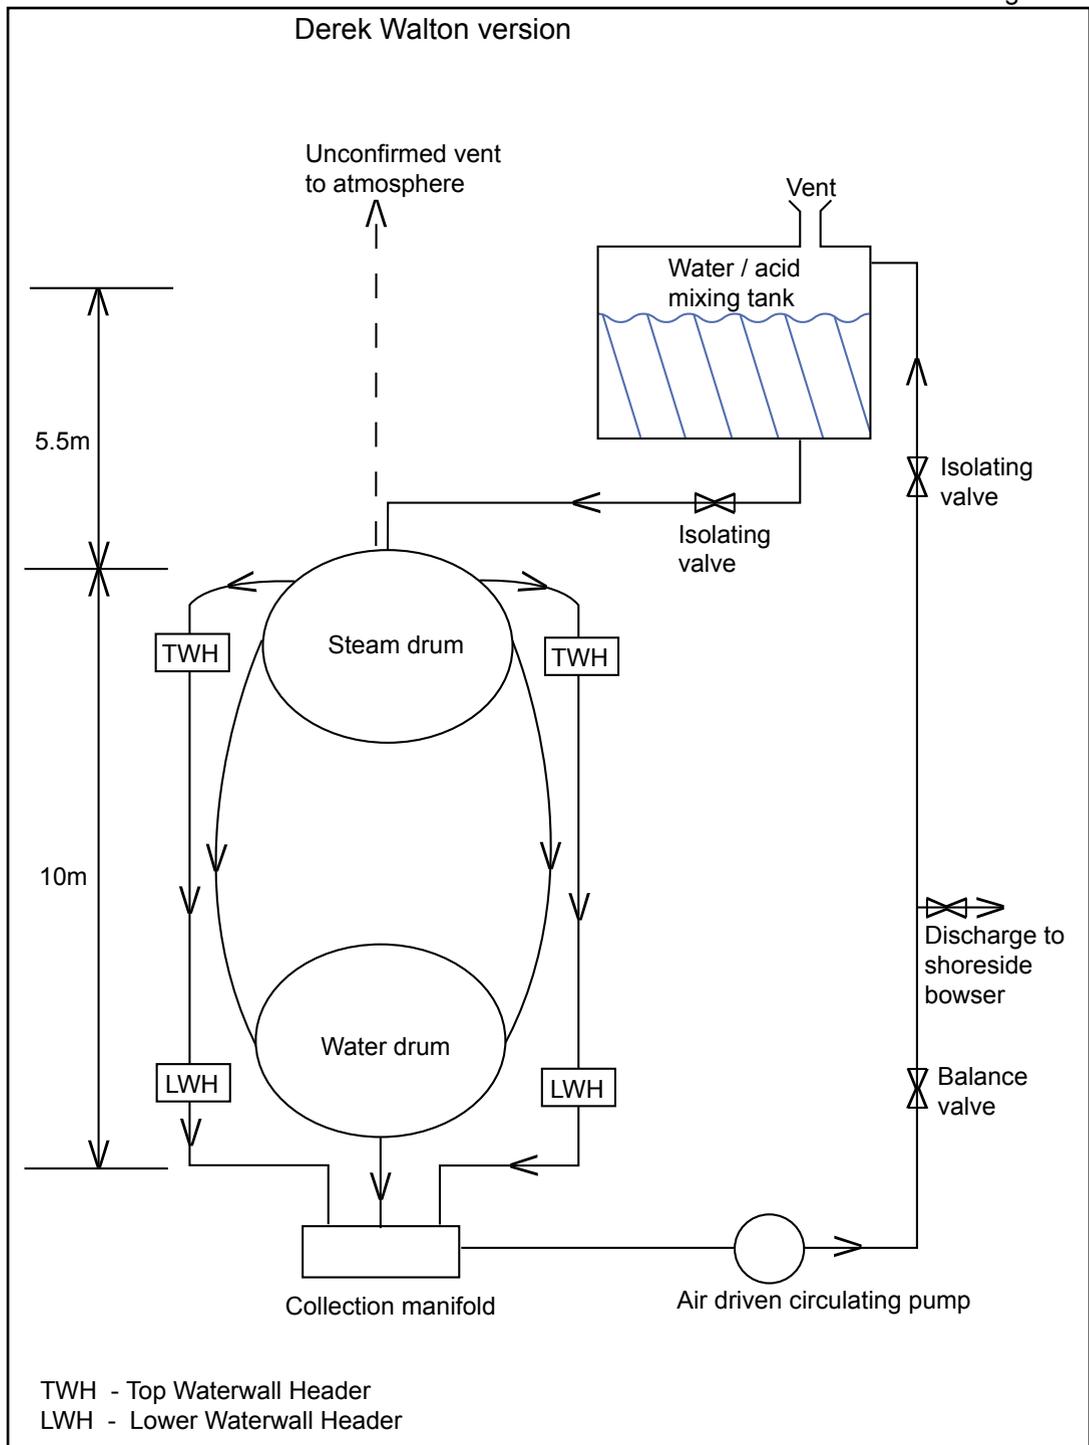
Figure 11

The starboard boiler cleaning equipment was provided by HPML, with the exception of the steam generator which was sourced by GBSL. The cleaning equipment was connected to the starboard boiler as illustrated in the schematic at **Figure 11**, and as confirmed by HPML's on site Assistant Technical Director and day foreman. The configuration was identical to that used by Mr Walton in El Ferrol, and was as described at **Annex A**.

Schematic of the boiler cleaning water/acid circulation

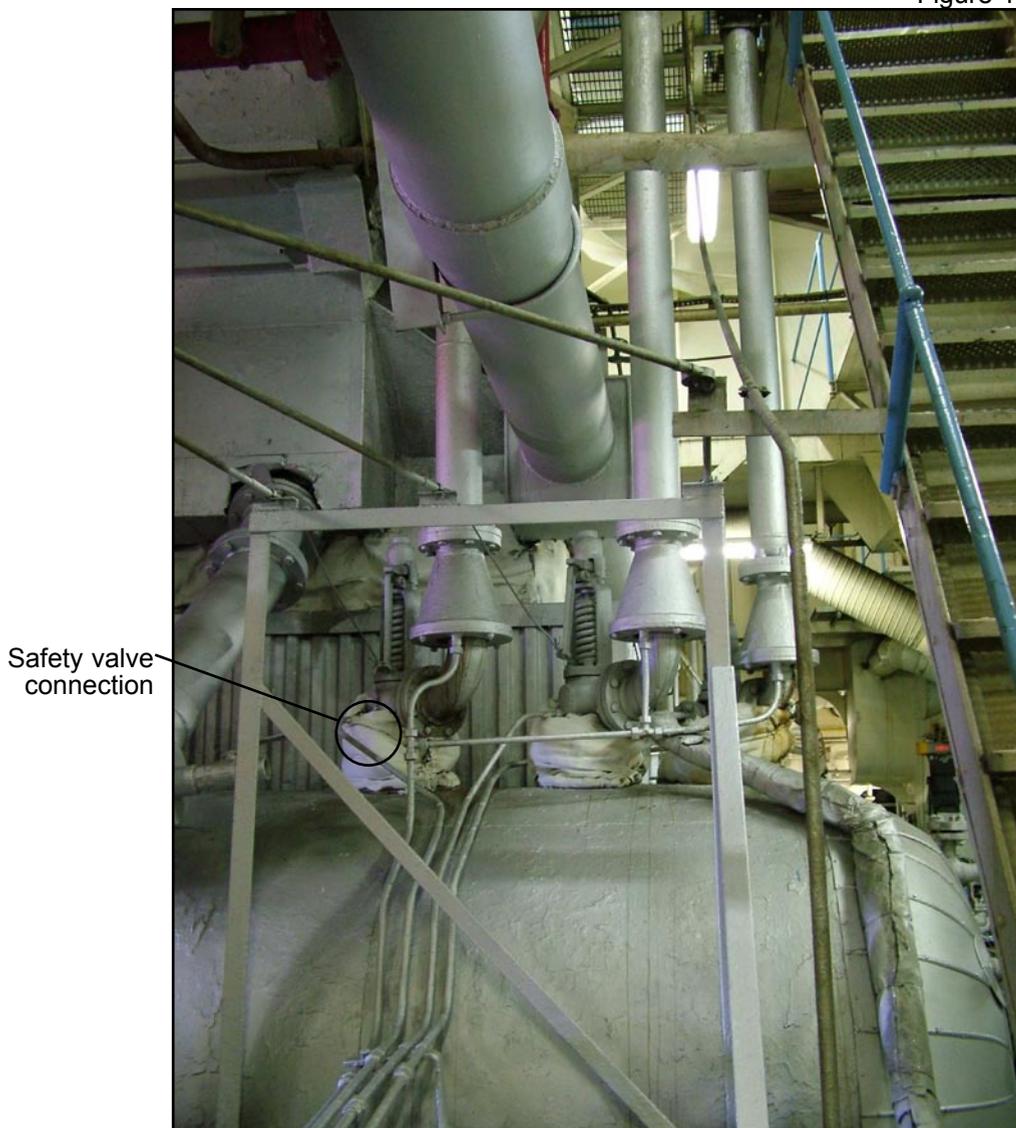
Figure 12

A water/acid mixing tank, with a non-gastight top, was situated at the after, starboard side of the main deck approximately 5.5m above the top of the steam drum. A plastic hose connected the mixing tank to the steam drum via one of the removed safety valve flanges (**Figures 6, 11 and 12**).

Starboard boiler steam drum safety valve – position of water/acid connection

There are only two probable connections that would have been made to ventilate the boiler. The first would have entailed connecting a flexible hose to the second safety valve's 100mm bore flange (**Figure 12**) on the steam drum, and leading it to a position on the upper deck. This is considered unlikely. Most of those interviewed could remember only one hose fitted to the safety valves, and this would have been the gravity feed hose from the water/acid mixing tank.

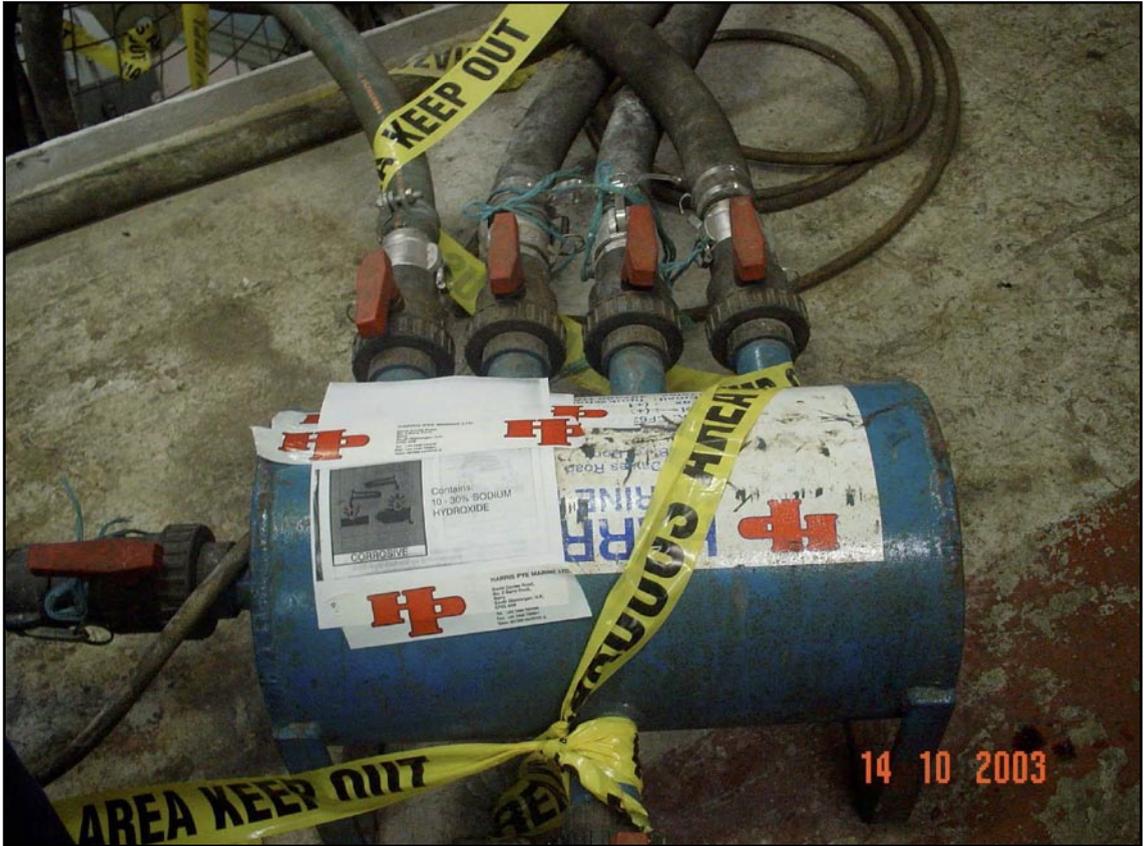
Figure 13

Reinforced 75mm flexible hoses were connected to the run down valves of the bottom water wall headers and water drum. These hoses were led to a common manifold (**Figure 13**) from where a centrifugal, air-driven pump (**Figure 14**) took a suction and returned the acid/water mix back to the mixing tank via a flow control valve. A number of ball valves were fitted to the connections to allow the system to be isolated in the event of leakage and to enable the mixture to be discharged to a shore side bowser.

Manifold and connecting hoses

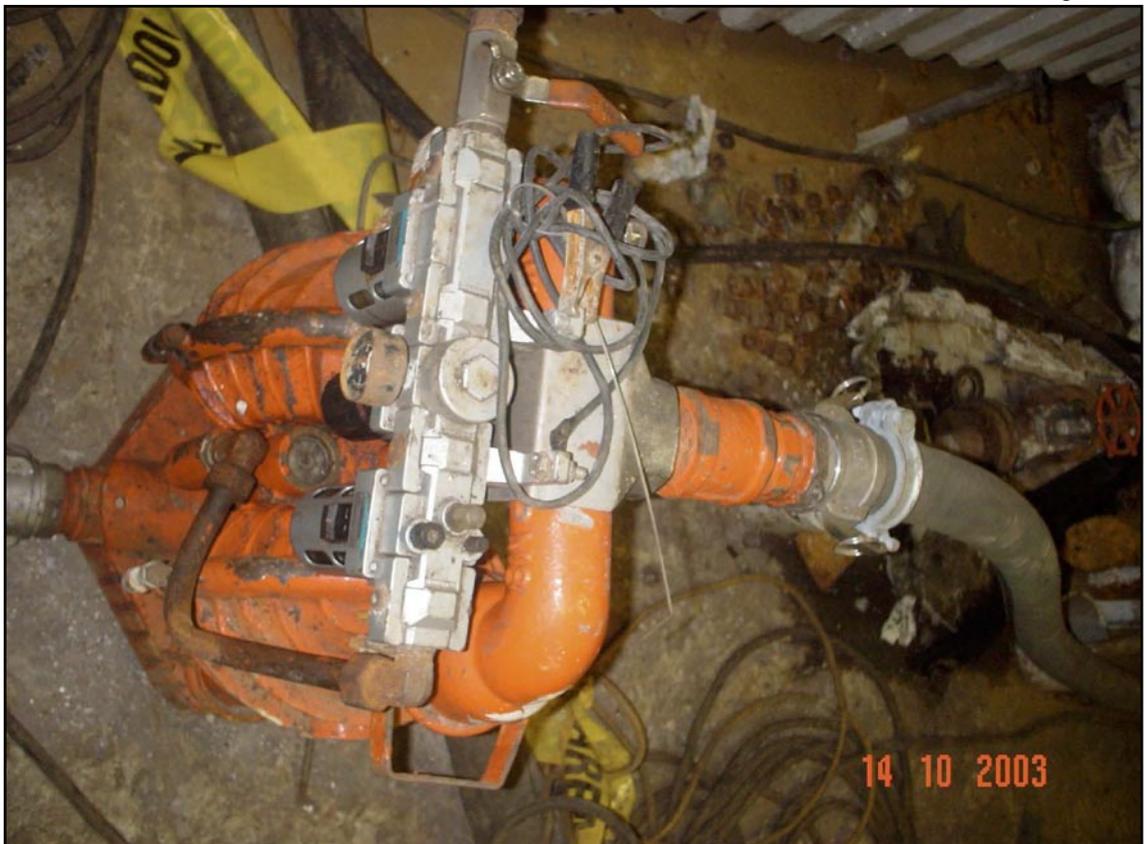
Figure 14

Air driven centrifugal circulating pump
