Report on the investigation of
the grounding of the
inter-island passenger vessel

Trident VI

in Percée Passage, off Herm Island
near Guernsey in the Channel Islands

**Report No 01/2004
January 2004**

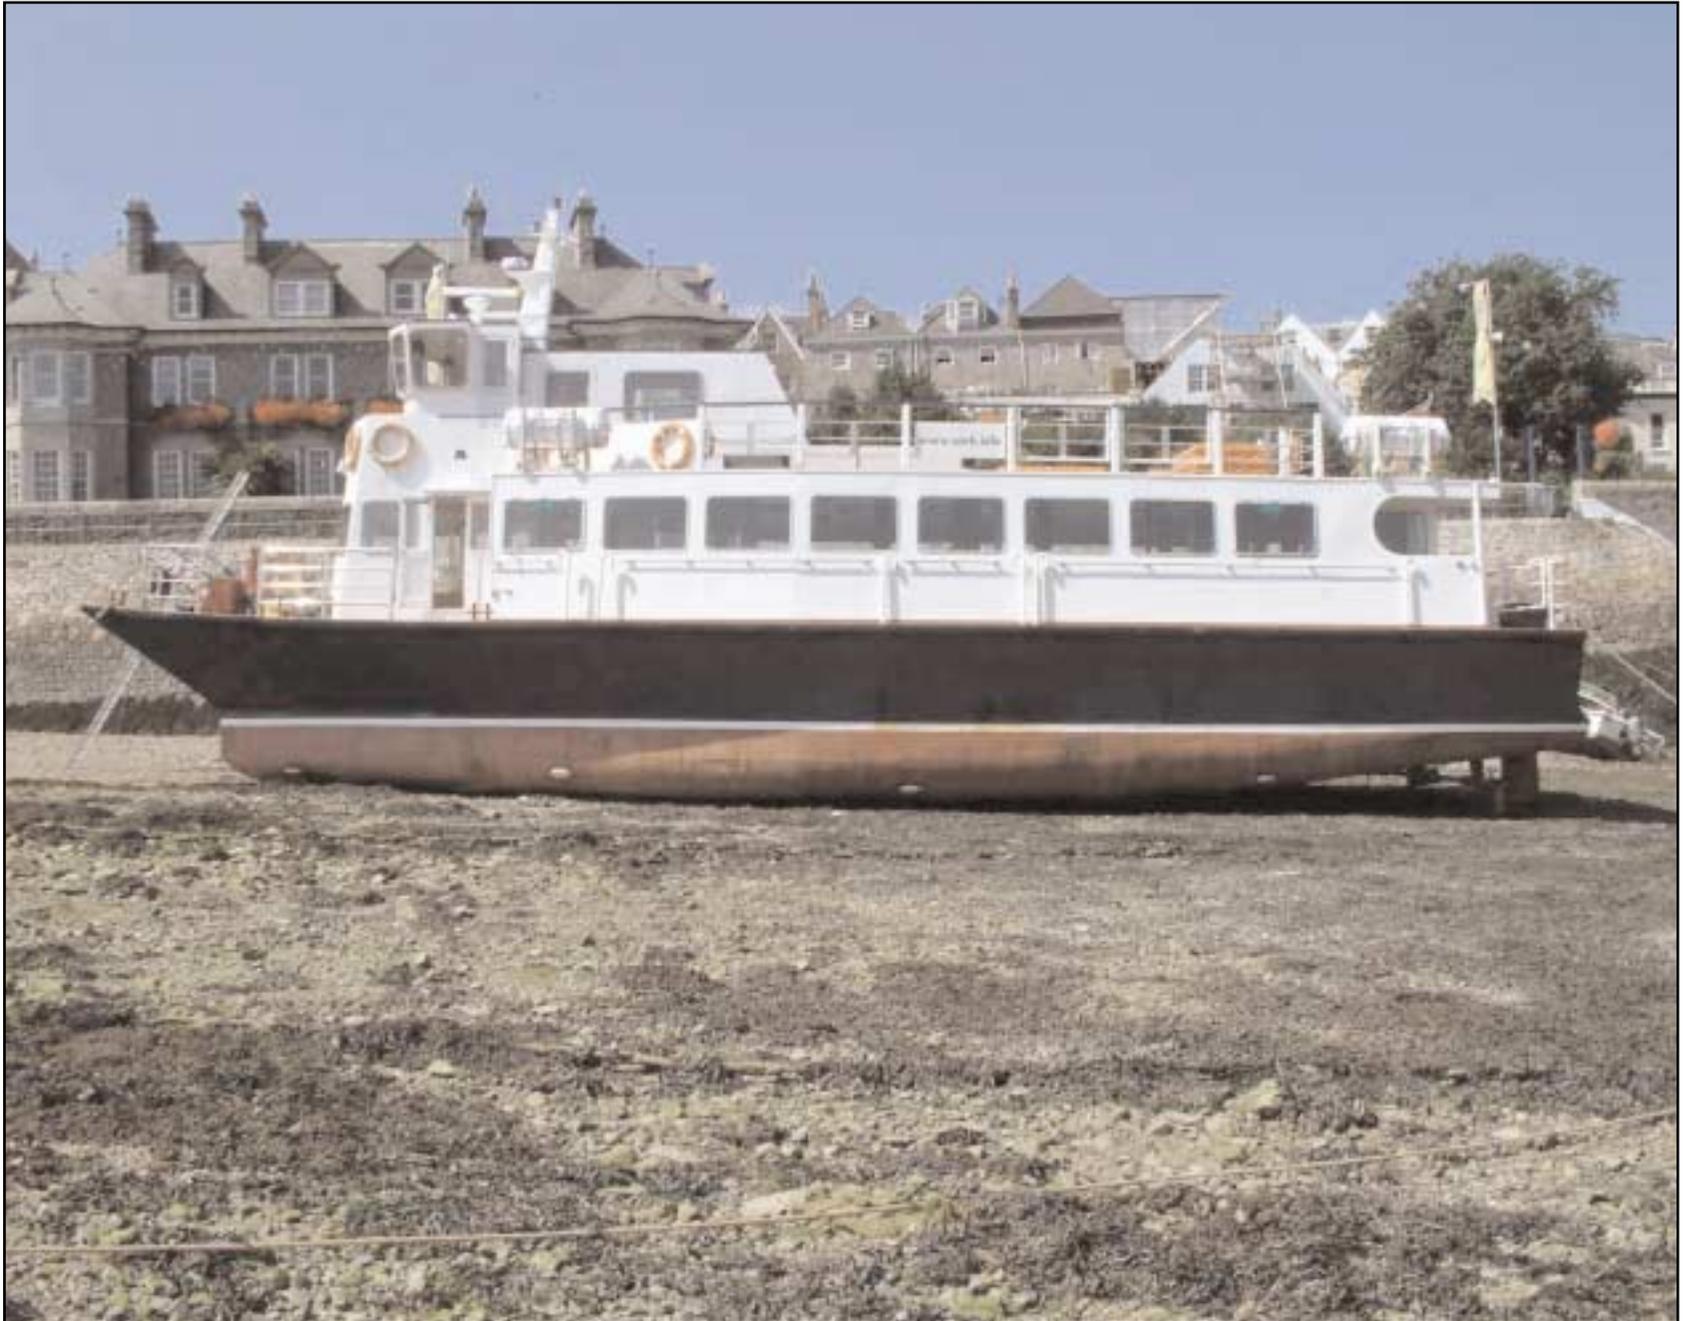
Trident VI at the Careening Hard in St Peter Port harbour

One of the RNLI crewmen on board *Trident VI* steered her back to St Peter Port, following the RNLI lifeboat. He commented on how difficult it was to steer. She was placed on the Careening Hard in St Peter Port at about 0200 (**see photograph 3**).

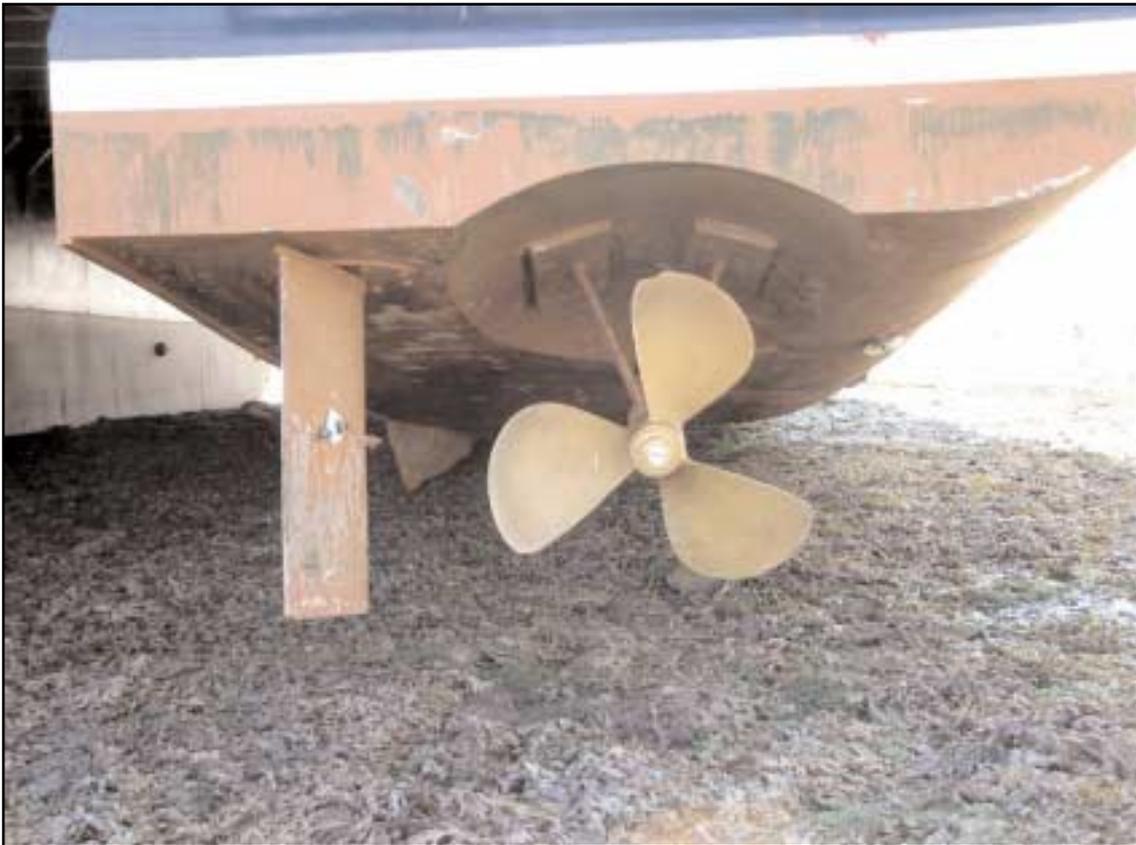
Photograph 4

The vessel was a twin-hulled catamaran, with twin screws and twin rudders. The propellers were in a soft tunnel, with the rudders set inboard of each one by 740mm, to enable both the propeller shaft and the propeller to be extracted in one piece. No part of the rudder overlapped the propeller disc (**see photographs 4 and 5**). This unusual configuration made her handling difficult at less than full speed, although, by manipulating the two engines, she was highly manoeuvrable while going alongside.

An end on view of the rudder / propeller arrangement

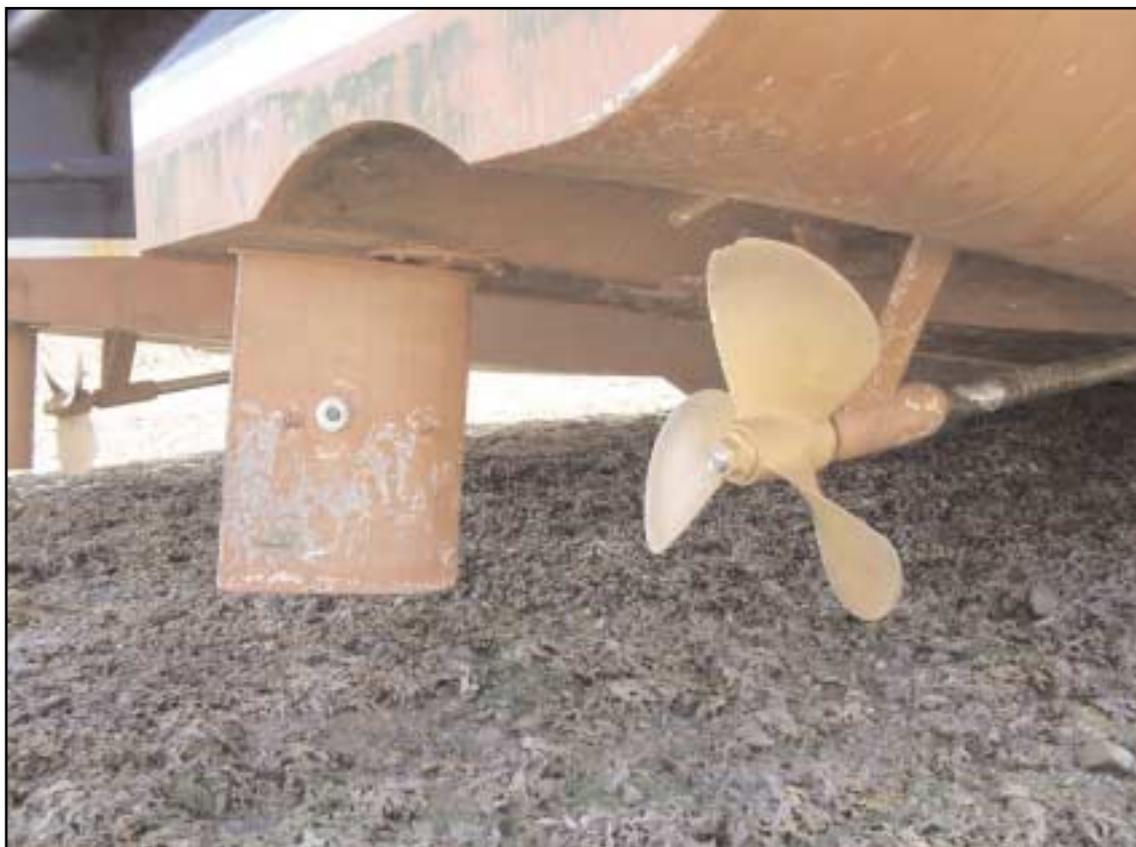
Photograph 5

A side on view of the rudder / propeller arrangement
