Report on the investigation of  
the loss of  
***Kirsteen Anne***  
Firth of Lorn  
31 December 2002  
with the loss of her two crew

Marine Accident Investigation Branch  
First Floor  
Carlton House  
Carlton Place  
Southampton  
United Kingdom  
SO15 2DZ

**Report No 19/2003  
July 2003**

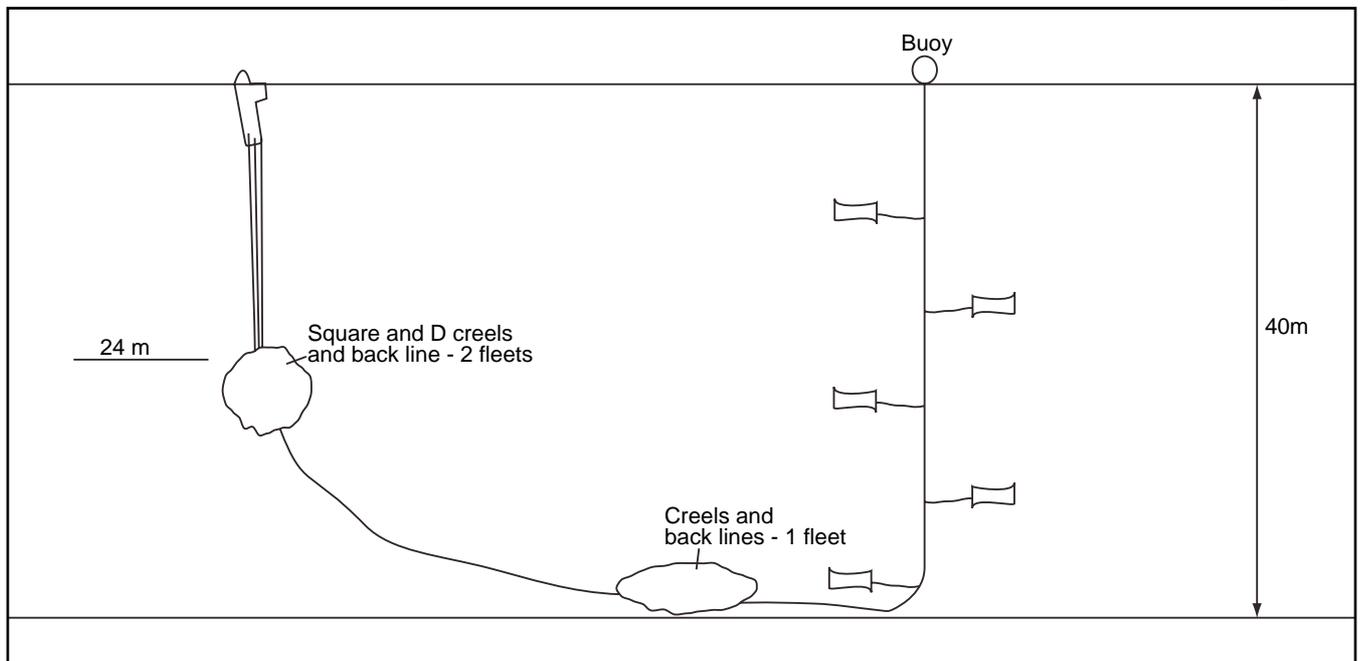
Figure 3

The Strathclyde police diving unit conducted an underwater search of *Kirsteen Anne* and her fishing gear during 1 and 2 January, and a search of the seabed on 3 January. The vessel remained partly submerged and was tethered to the seabed by the fleets of creels she had been carrying. A diagram showing the disposition of the creels in relation to the vessel and the seabed is shown at **(Figure 3)**. During the search of the vessel, the deck covers to the rudder space and bilge were found on deck on the port side of the stern transom **(Figure 4)**, and the GRP engine cover was missing.

Diagram showing the disposition of the vessel and fleets of creels - not to scale

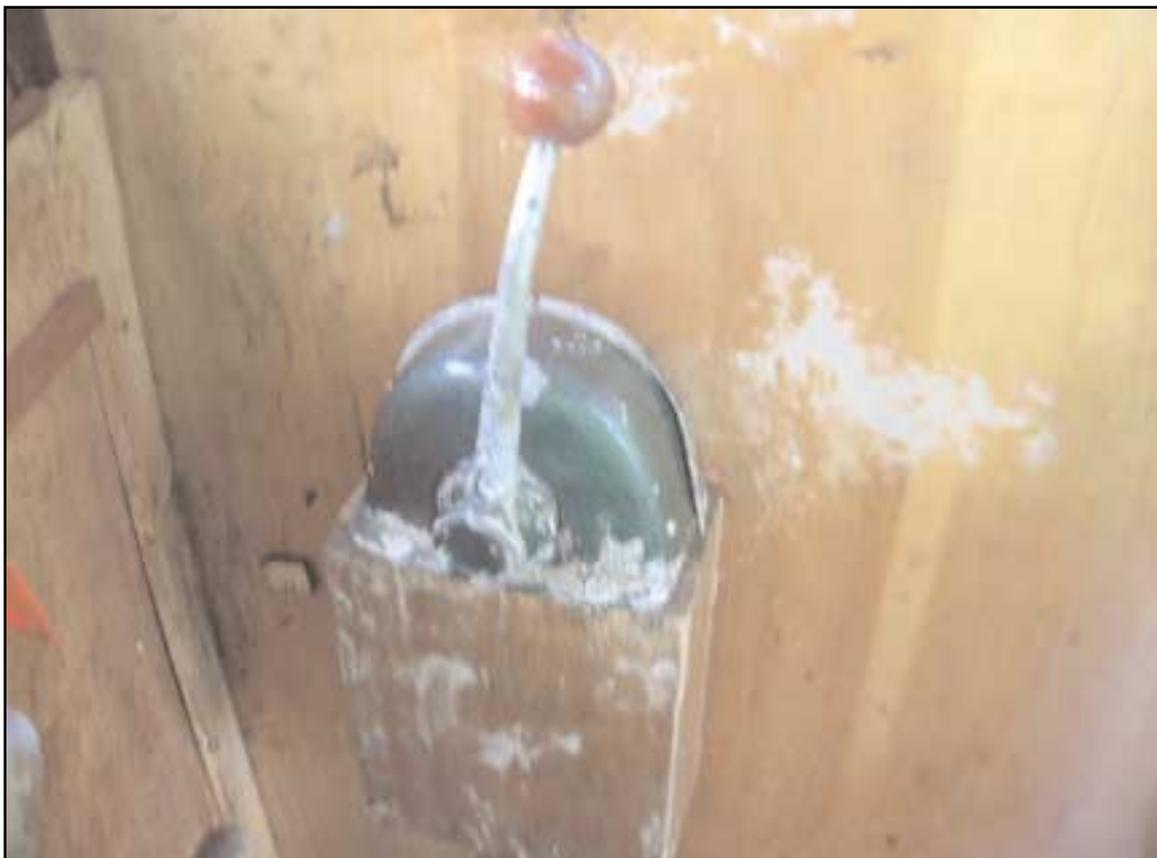
Figure 7

- The bilge pump switch was in the off position, as was the navigation light switch.
- The VHF and GPS power switches were 'on'.
- The engine control lever in the wheelhouse was in a central position, indicating the engine was idling or stopped (**Figure 7**).

Photograph showing the position of the engine control lever

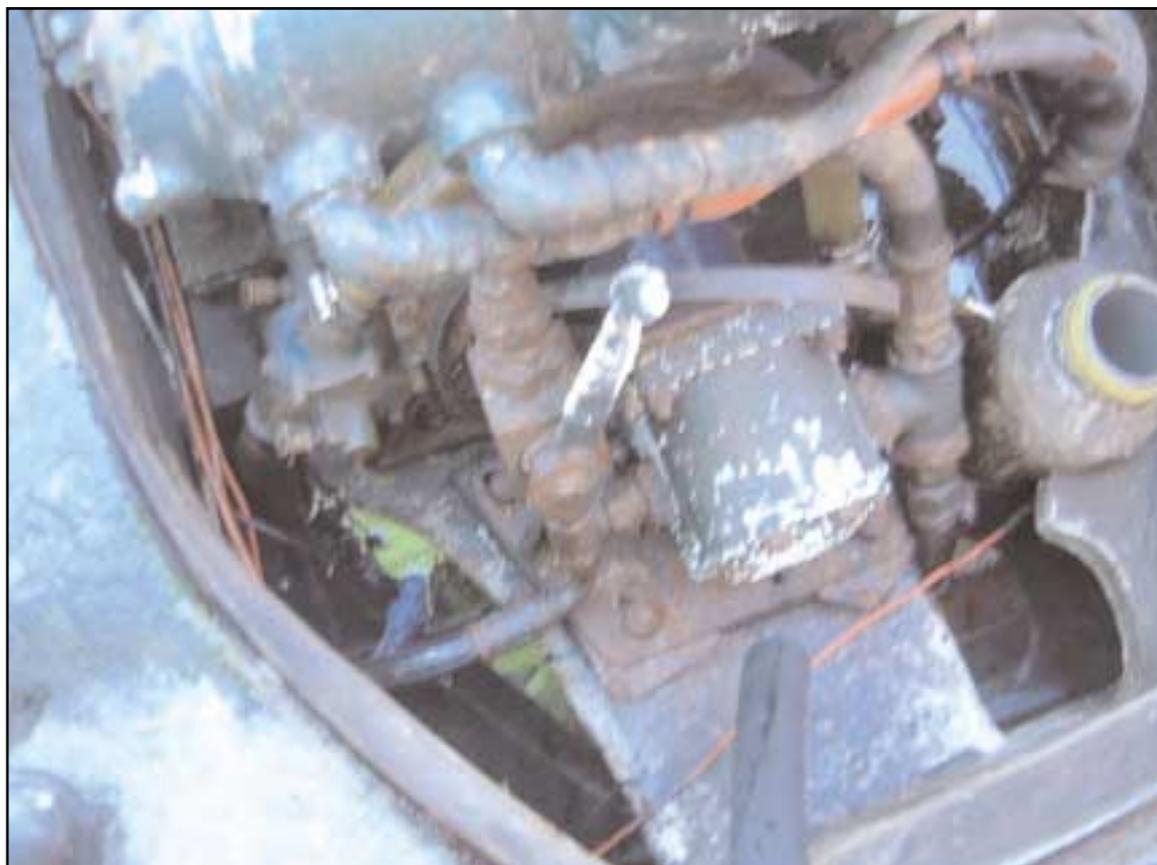
Figure 8

- Both the master control switch, and the engine ignition switch, were in the 'on' position.
- The lever controlling the hydraulics to the creel-hauler, which was mounted on the main engine, was in the off position (**Figure 8**).

Photograph showing the position of the hydraulic control lever

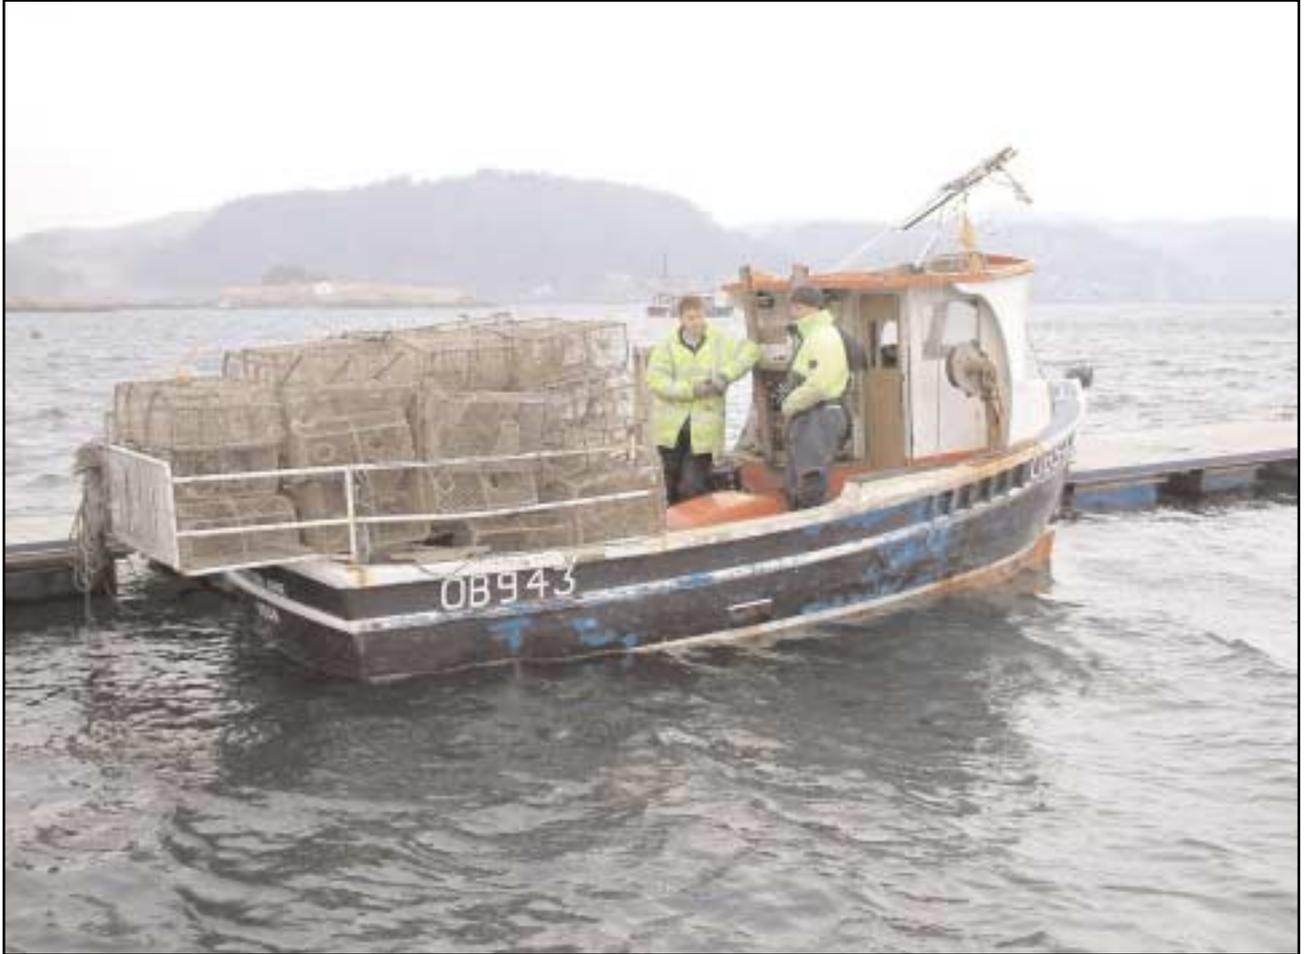
Photograph showing *Kirsteen Anne* in her estimated loaded condition
