Report on the investigation of

a lifeboat accident on

mv *Galateia*

Report No 25/2002
July 2002

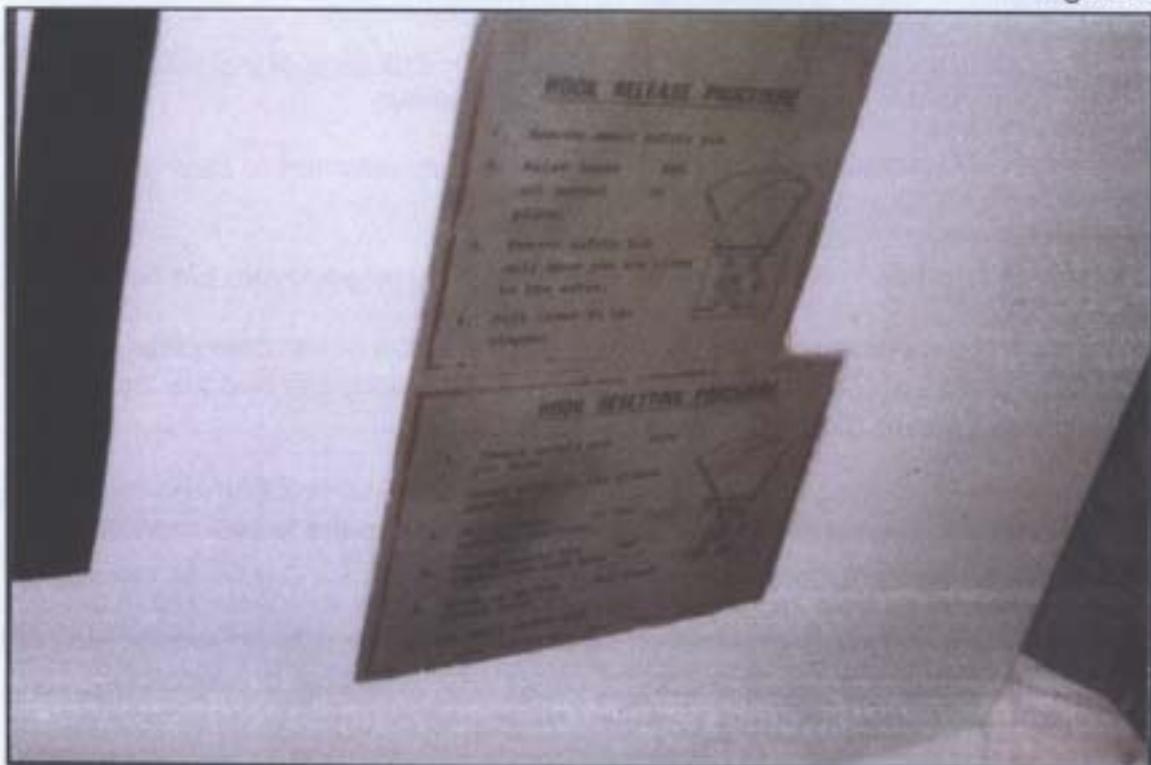
Figure 2

Operating instructions pasted on inside of lifeboat canopy

2.3.1 The lifeboat release instructions pasted on the inside of the lifeboat canopy were not very clear, nor were the item numbers clearly legible. In fact, some of the item numbers had completely worn off. As these are critical in identifying the order in which the procedure is to be followed, their loss greatly increased the chances of a mistake being made. The warning notice, which was part of the instructions supplied by the manufacturing company to the MAIB, was not included in the procedural notices pasted on the internal lifeboat canopy. That notice included a pictorial illustration of the correct cam plate position, as well as the correct position of the locking pin before lifting. The lifeboat manufacturers subsequently confirmed that this "Warning" notice was sent out in August 1997 to all users who could be identified. *Galateia's* owners could not be found at that time and, therefore, no notice reached them, hence the omission. That omission has since been rectified and "Warning" notices have been sent to the vessel for inclusion in the safety manual and to be pasted on the inside of the lifeboat canopies.

While waiting for the exercise to start, neither the master nor the chief officer read or studied the instructions and procedures pasted on the lifeboat canopy. Although those instructions were well worn and difficult to understand, it was still possible to see that there was a second small safety pin mentioned in the procedure. That fact alone should have caused them to delve deeper into how the whole operation worked. Unfortunately, they also failed to study the ship's safety manual - this also contained detailed instructions as to how the system was operated and how it worked.

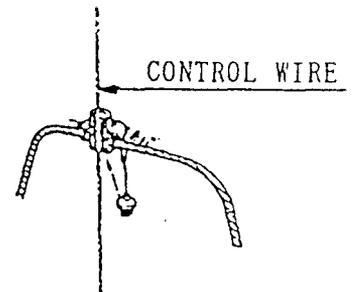
- ※ This hook release device is capable of releasing the boat from the falls at any height, on or above sea level. Exercise extreme caution to avoid accidental or premature release.

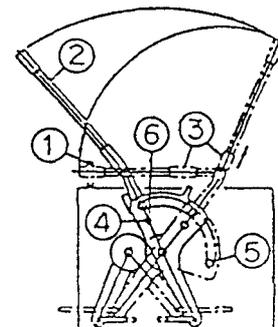
RESETTING PROCEDURE

- 2.2.1 The primary cause of the simultaneous release of the hooks when at the davit head was the absence of the locking pin in the quadrant (**see Figure 4**) [lock hole (5)].

The locking pin, which is referred to in the release procedure as a safety pin, needs to be fitted in position (5) before the lifeboat is lifted. When in that position, the quadrant is incapable of moving, or being moved, to the release position. On this occasion the safety pin was left in position (6), a position which secures the operating arm to the quadrant. In this position, with the quadrant directly connected to the release mechanism of the hooks, any movement of the operating arm could cause the hooks to open.
