Report on the investigation of
the grounding of
Lagik
at Port Sutton Bridge on
13 December 2000

Marine Accident Investigation Branch
First Floor
Carlton House
Carlton Place
Southampton
United Kingdom
SO15 2DZ

**Report No 42/2001
December 2001**

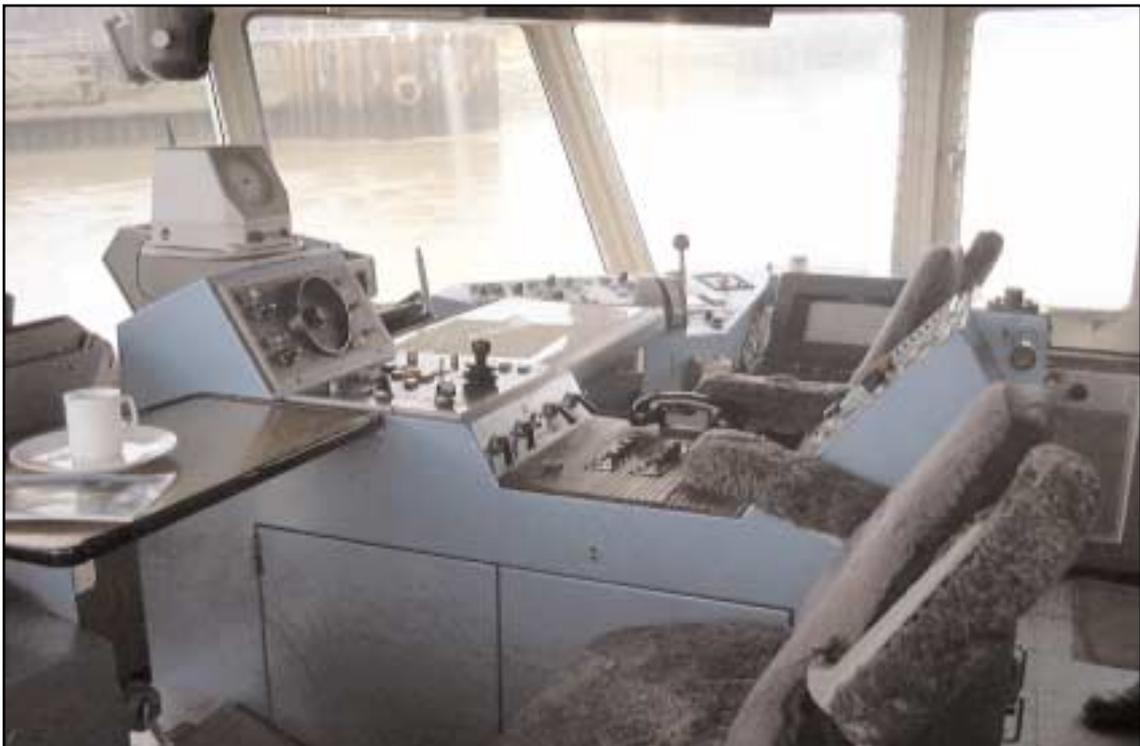
Figure 3

The pilot took over the conduct of the navigation and sat down in the chair on the port side of the bridge console. He was controlling the helm himself and giving engine orders to the master. The master sat on the starboard side chair. Nobody else was present on the bridge (**see Figure 3**). The mate and a seaman stood by on the forecandle and two seamen stood by aft. The anchors were ready for letting go if required.

Lagik's bridge

The vessel was starting her turn to starboard into the swinging basin, with the pitch at zero, speed around 1.5 knots, the helm amidships and the bow thruster working to starboard, when the master took over the helm. The pilot was not sure if the master had relieved him of the conduct of the vessel. The pilot concluded that he had, whereas the master considered he had not. The master was concerned that the vessel had insufficient momentum to be able to turn successfully in the prevailing conditions.
