**Report on the investigation of the  
capsize and foundering of the fishing vessel  
*Angela*  
in the North Sea  
on 6 February 2000**

Marine Accident Investigation Branch  
First Floor, Carlton House  
Carlton Place  
Southampton  
SO15 2DZ

**Report No 14/2001**

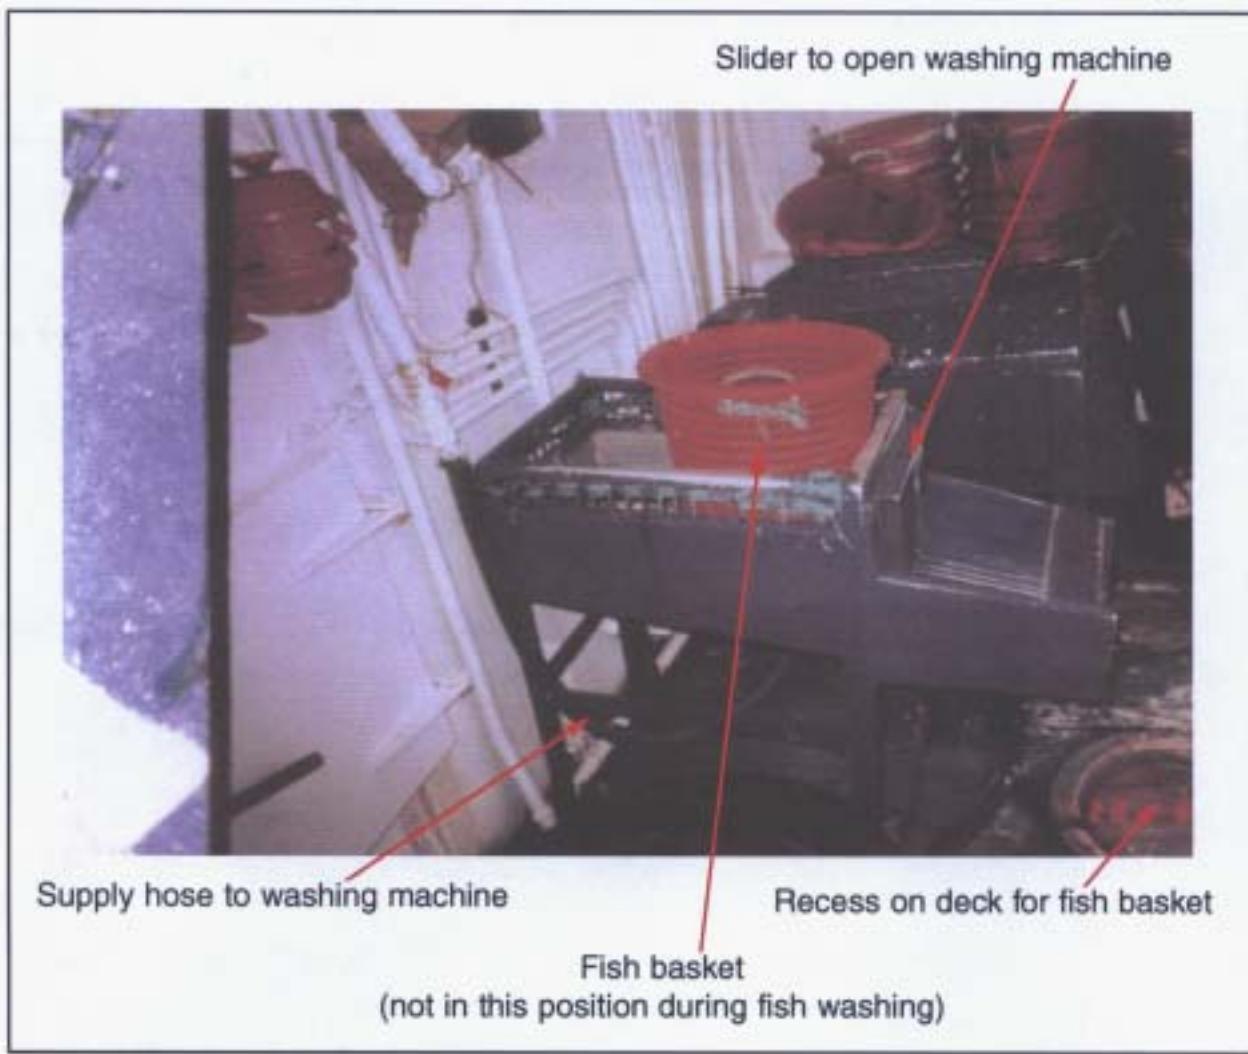
Figure 4

The gutted fish were kept in plastic baskets before being tipped into the washing machine. A fish washing machine on another vessel is shown in (**Figure 4**). The unit comprises an open topped container, into which gutted fish are placed for washing. The seawater supply is fed into the bottom, which swirls the fish around, and washes away any dirt and offal. When they are sufficiently clean, the front of the machine is opened and the fish are allowed to spill into an empty basket placed on the deck. The fish washing machine was always used for prawns, but baskets of gutted fish were sometimes washed, simply by playing the hose on the baskets.

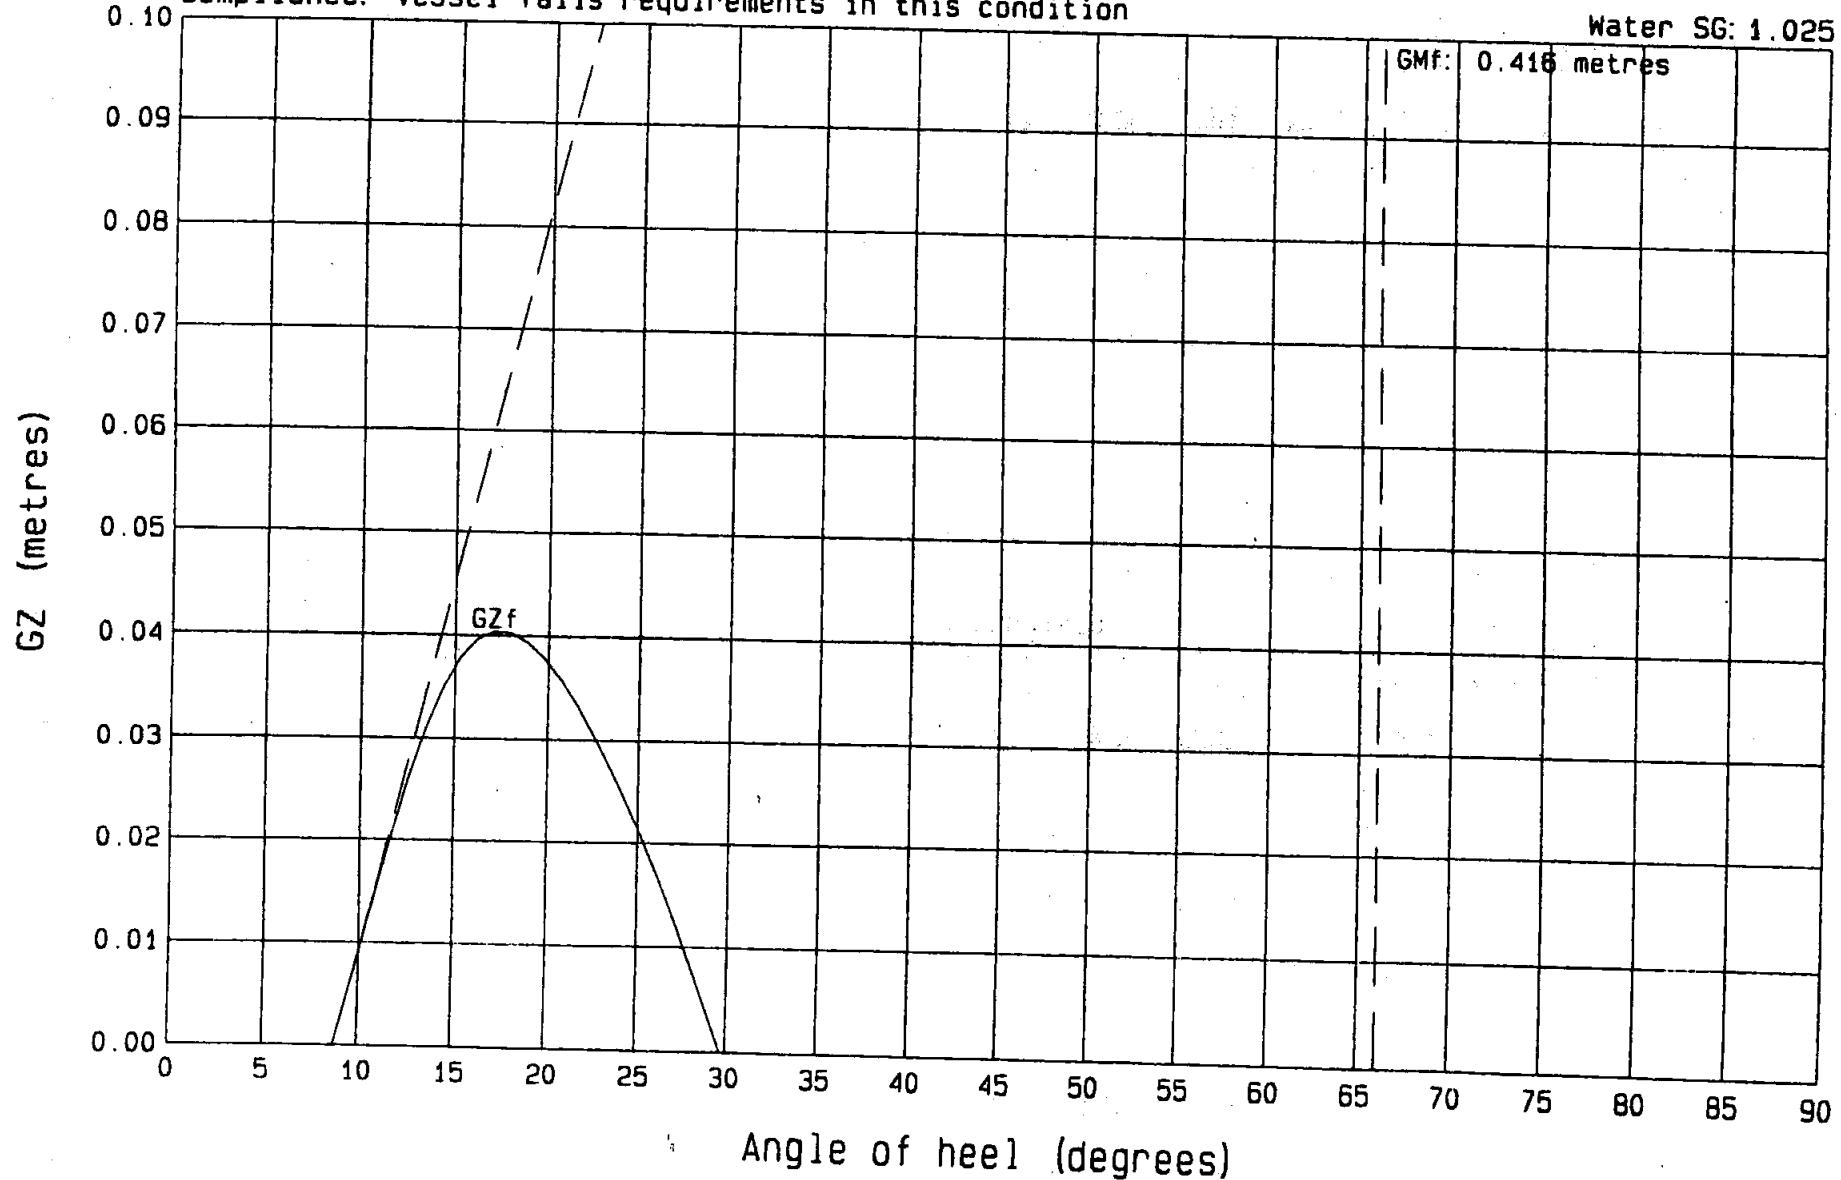
State.....: Hull without added appendages

Compliance: Vessel fails requirements in this condition

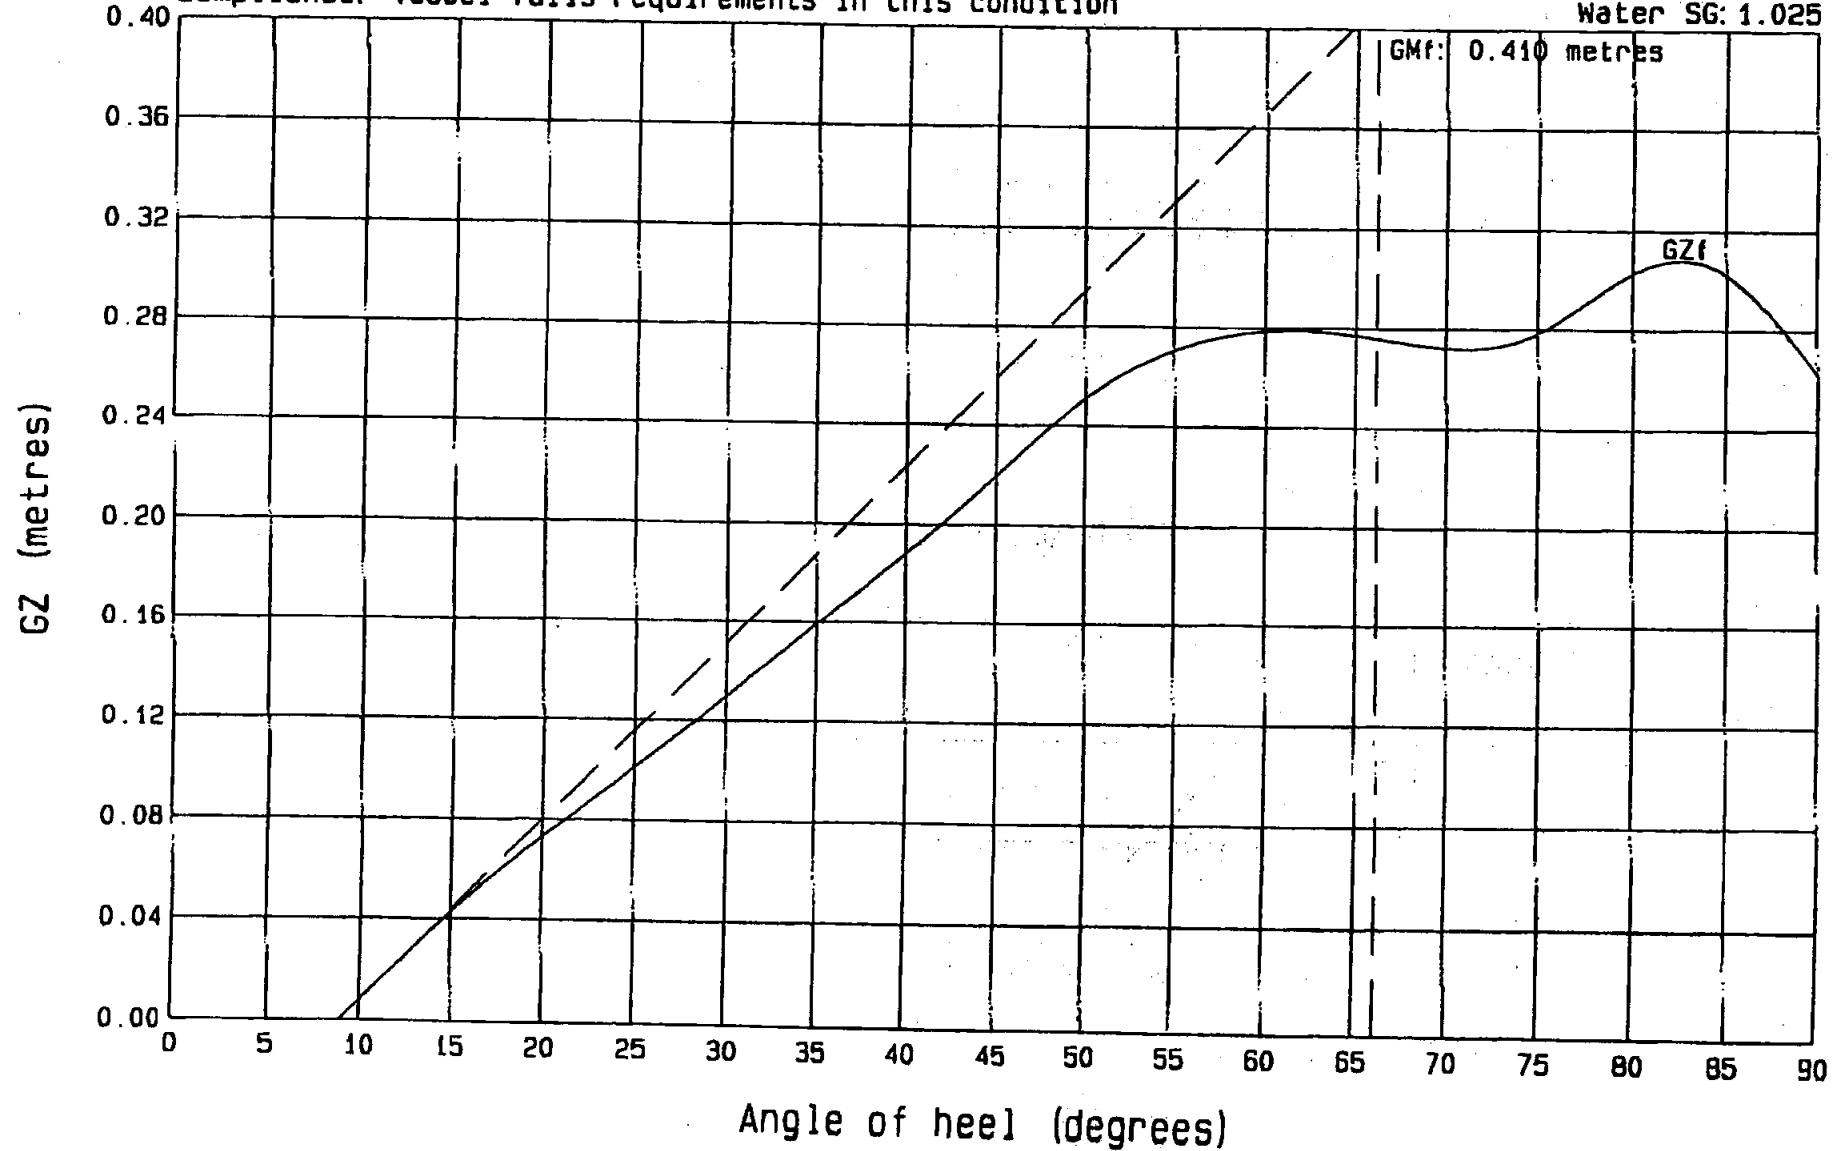
**ANNEX B - Vessel's stability condition -  
with watertight shelter**

Compliance: Vessel fails requirements in this condition

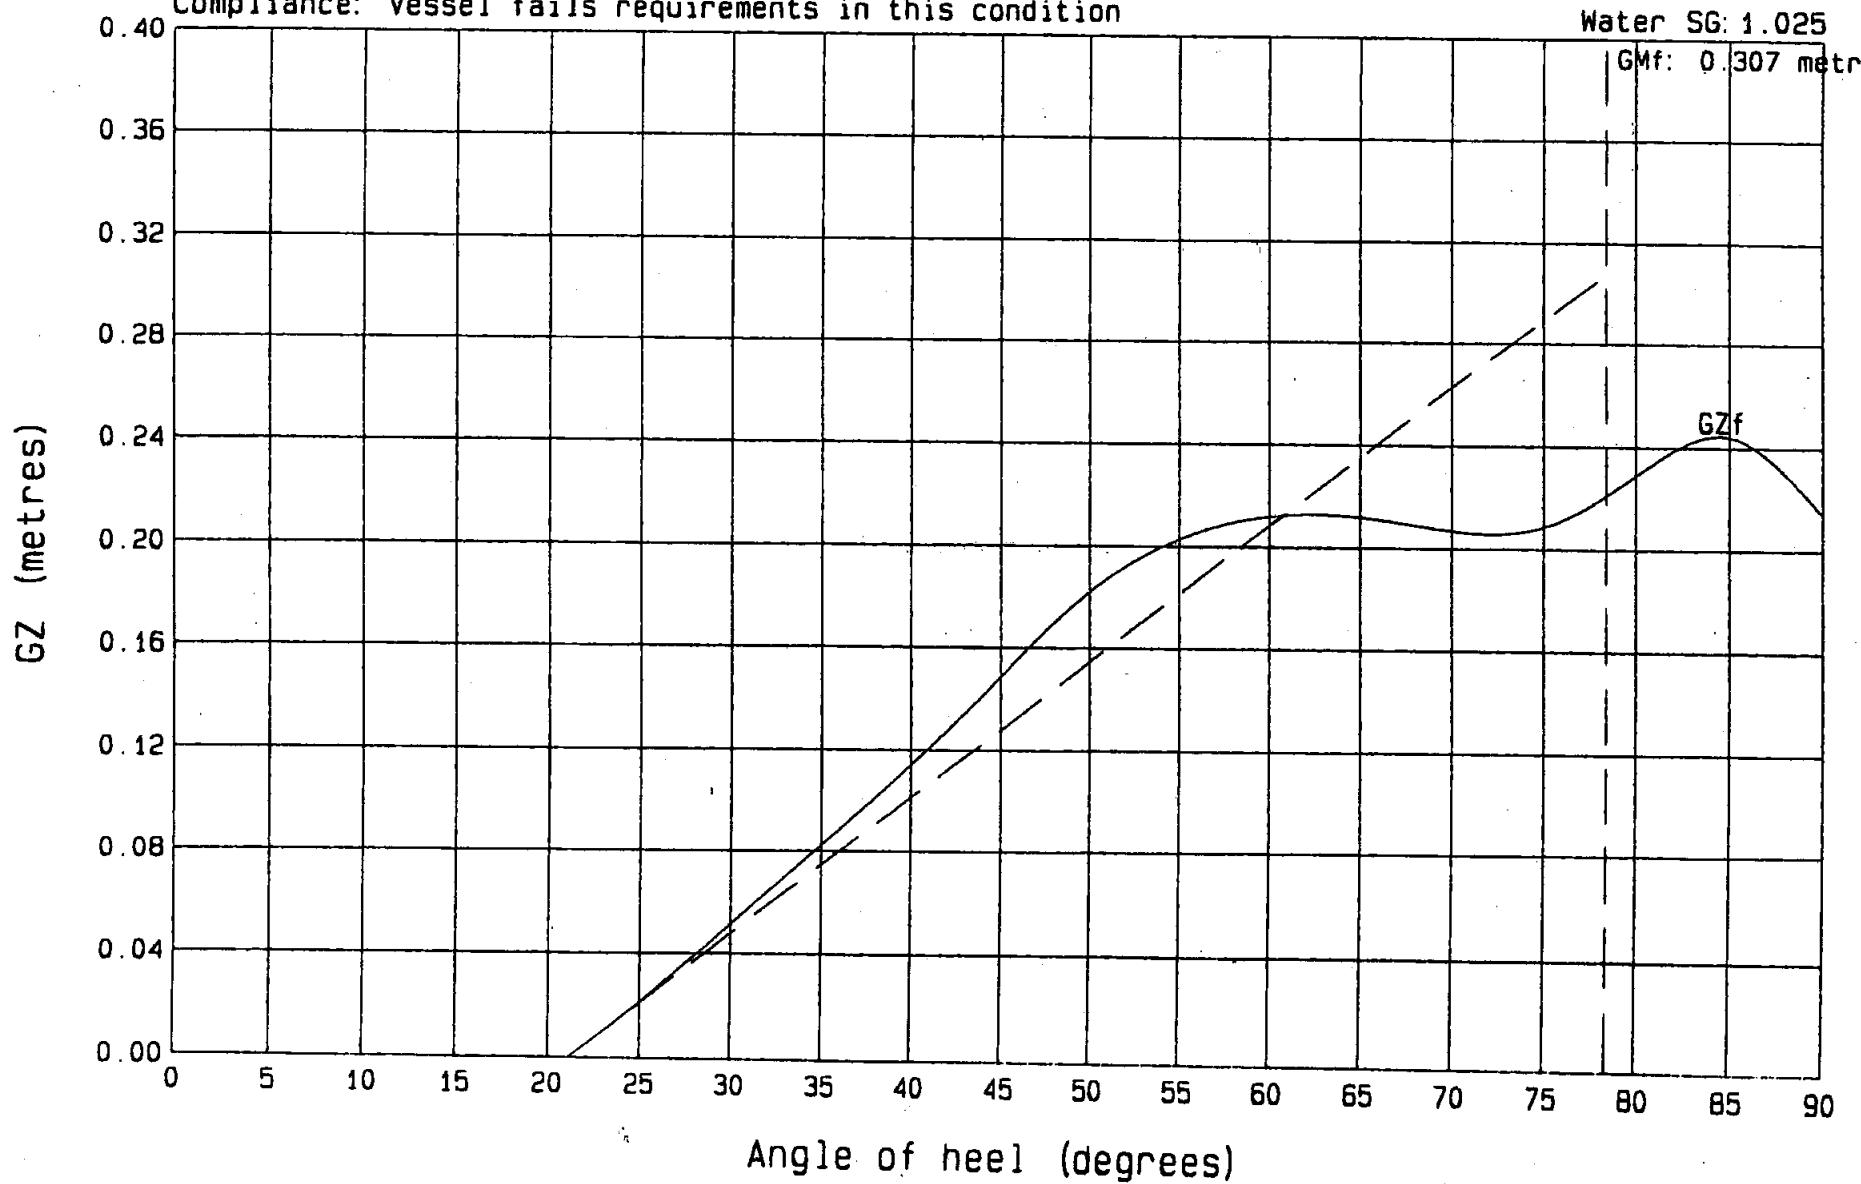
**ANNEX C - Vessel's stability condition - with watertight  
shelter and 4 tonnes of seawater**

GMf: 0.307 metres

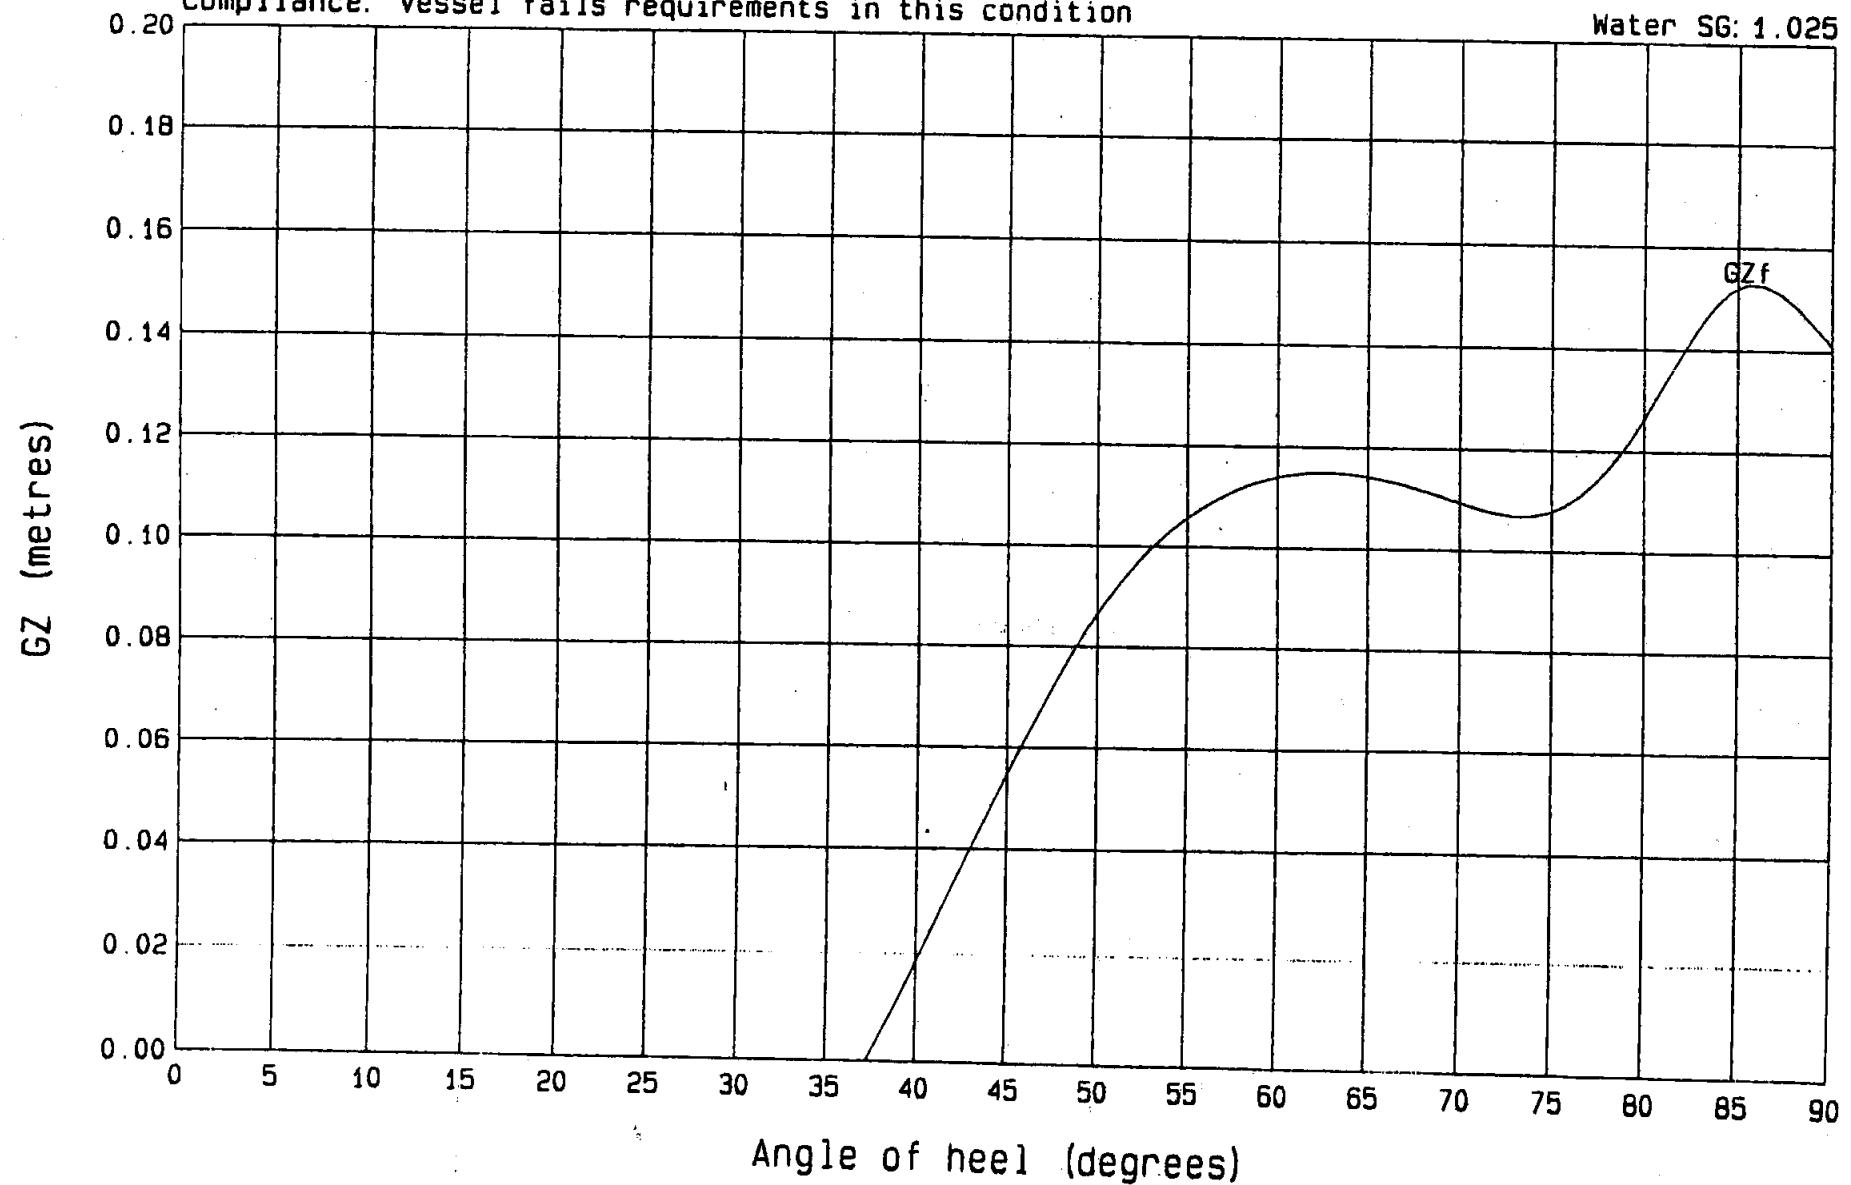
**ANNEX D - Vessel's stability condition - with watertight  
shelter and 10 tonnes of seawater**

Compliance: Vessel fails requirements in this condition
