**Report on the investigation of  
the loss of the fishing vessel  
*HARBOUR LIGHTS*  
off Polperro, Cornwall  
on 8 January 2000  
with the loss of one life**

**Report No 27/2000**

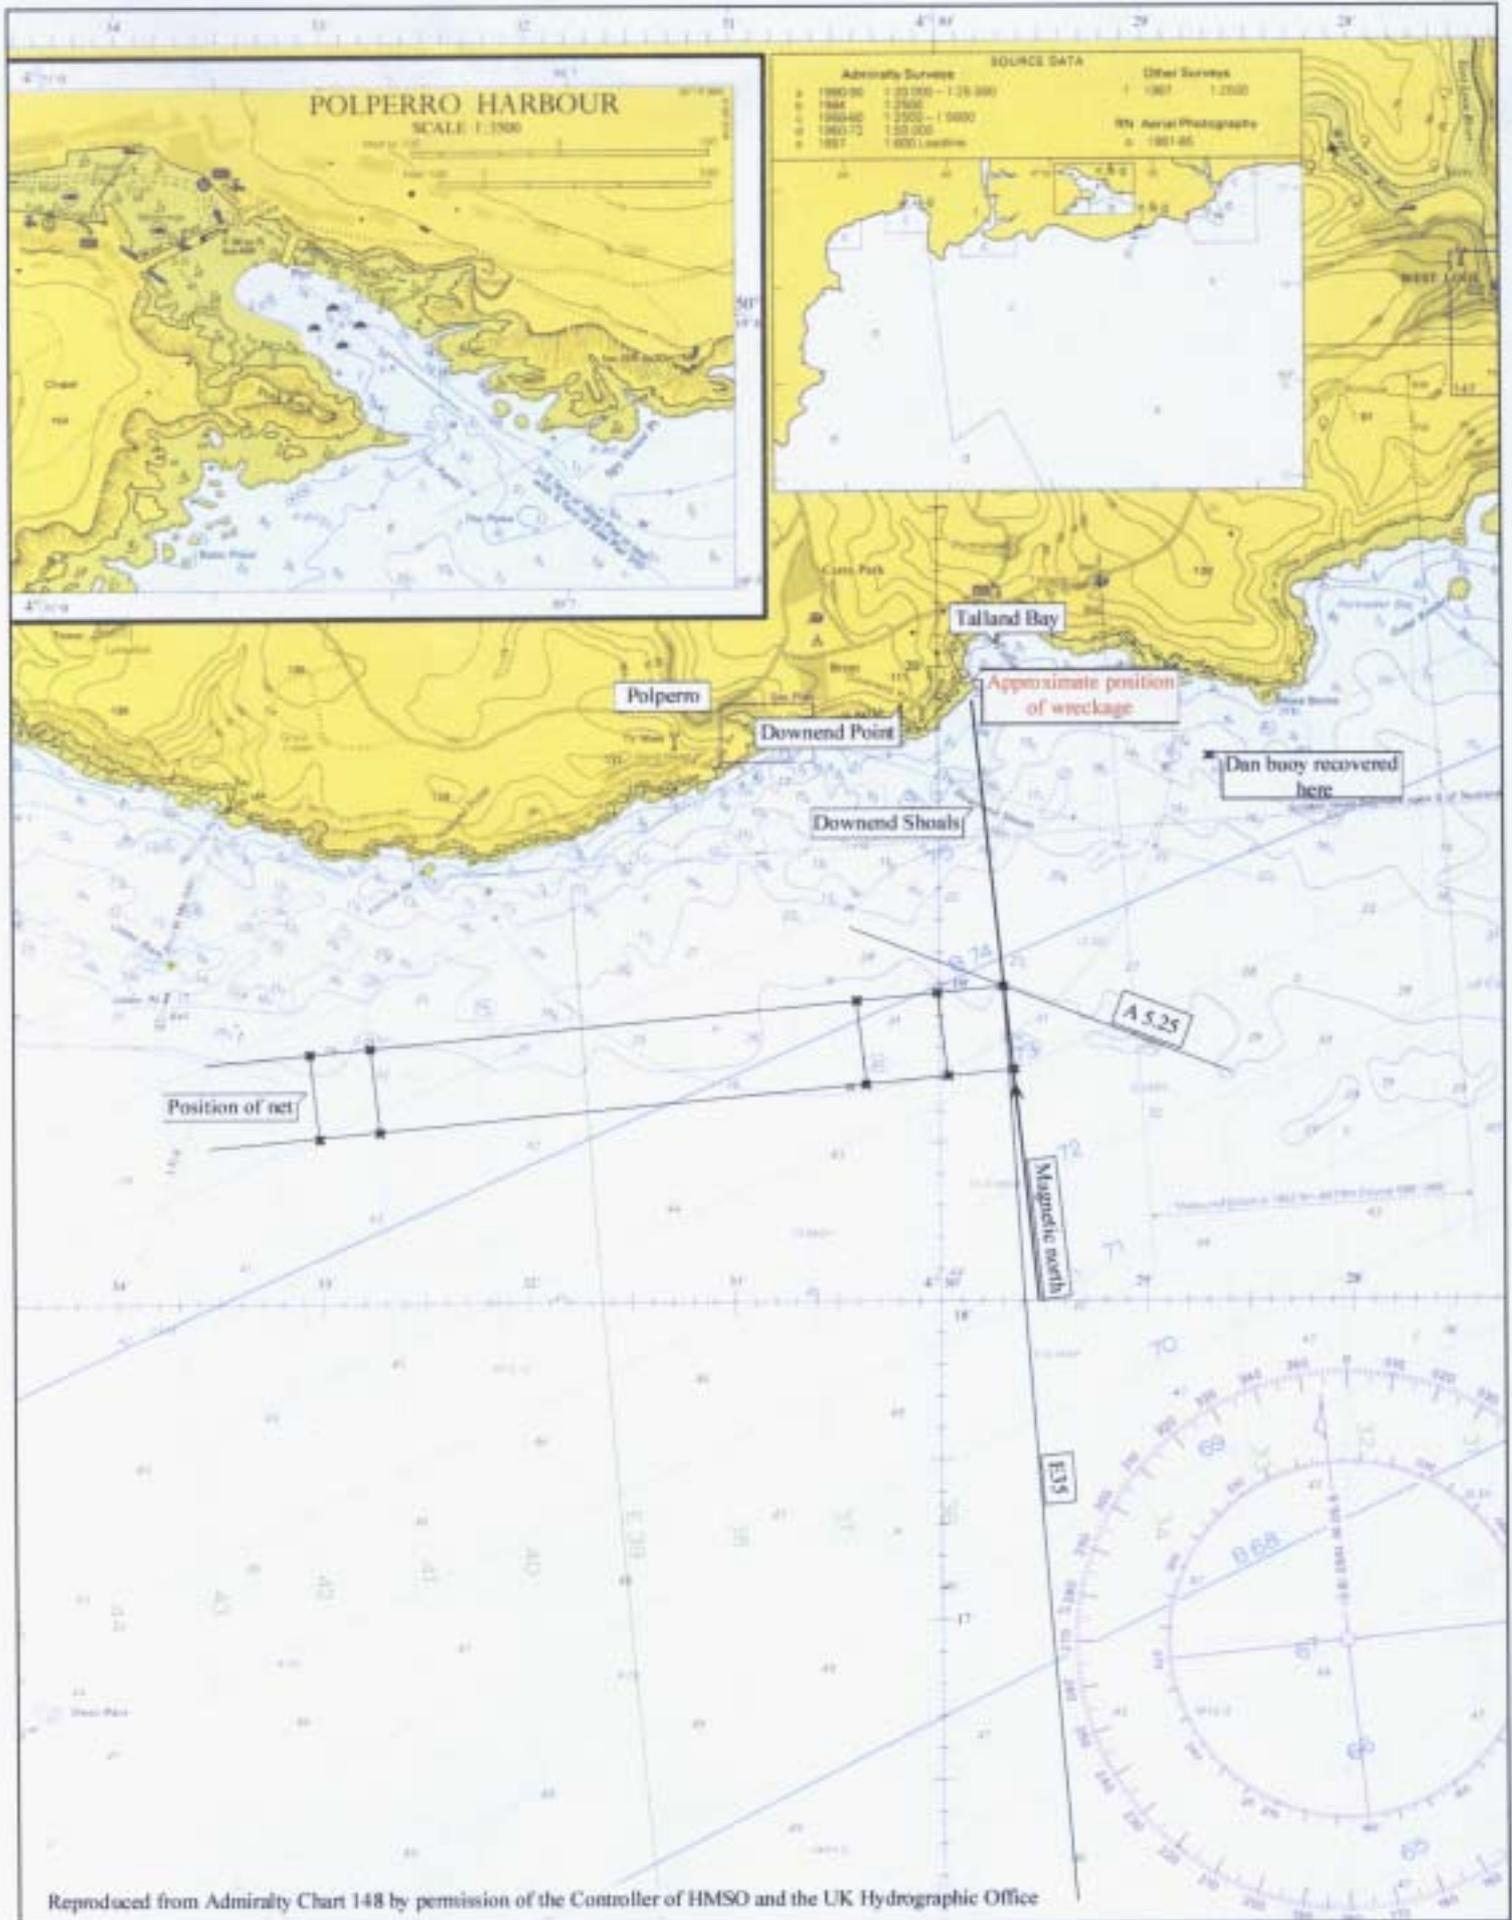
Figure 3

On the day of the accident five bottom gill nets, positioned as shown in **(Figure 3)** were being worked. These would have been shot while heading north at about 4 to 5 knots; the vessel was steered by auto-pilot. When shooting, the first dan was thrown over, followed by the first weight, then the net was pulled out of the net bin; a similar bin is fitted to the fishing vessel *Palores* **(Figure 4)** owned by Mr Pengelly. Finally, the last weight, followed by the last dan were thrown over, to complete the deployment of a net. A diagram of a gill net is shown in **(Figure 5)**. Fish are caught by the gills in such nets, which require no bait. When the net is hauled, the fish are removed and stowed in a hopper; the net is then shot again. Each net takes about an hour and a quarter to work. Usually a short break is taken for lunch.

Polperro fishermen recovered the nets from the positions shown in **(Figure 3)**. The north end of the most easterly net was recovered from position 50° 19.034'N 004° 29.666'W, which was

The fishing vessel *Satin* picked up the detached dan buoy in the late evening of 8 January. The recovery position was close to the Hore Stone, east of the line between where the last net was deployed and the wreck site (**Figure 3**). The wind and tide that evening would have taken a free-floating dan buoy in that direction.
