**Report on the investigation
of the parting of a mooring line
while the Bahamian registered tanker
Alfa Britannia
was berthing at Tranmere oil terminal
causing injuries to crew on board a gig-boat
on 18 November 1999**

Marine Accident Investigation Branch
First Floor, Carlton House
Carlton Place
Southampton
SO15 2DZ

Report No 1/2001

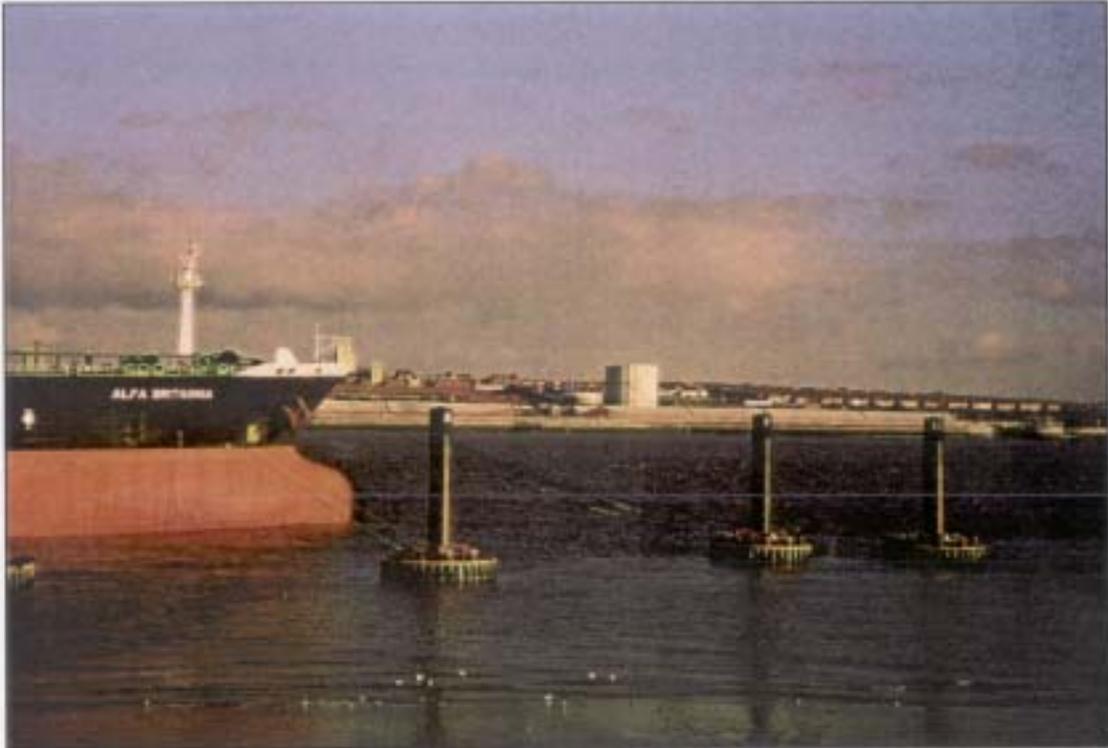
Photograph 1

The bow of *Alfa Britannia* and three of the mooring dolphins at Tranmere oil terminal

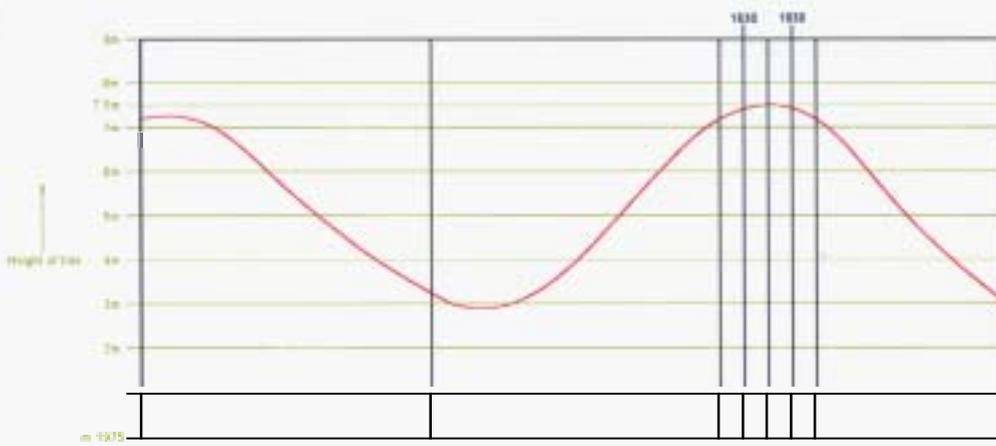
The graphical recording of the actual height of tide (see **Diagram 2**) shows that high water occurred at 1900. It was estimated that the clock was about 3 minutes slow, so the actual time would have been 1903; 12 minutes after predicted high water. The graph also shows that the maximum height of tide was 7.5m, which was 0.3m less than predicted.
