Report of an Investigation
of a steering failure and subsequent
collision with Lambeth Bridge of the
Class V passenger vessel

mv Symphony

on the River Thames
on 4 October 1999

Report No 18/2000

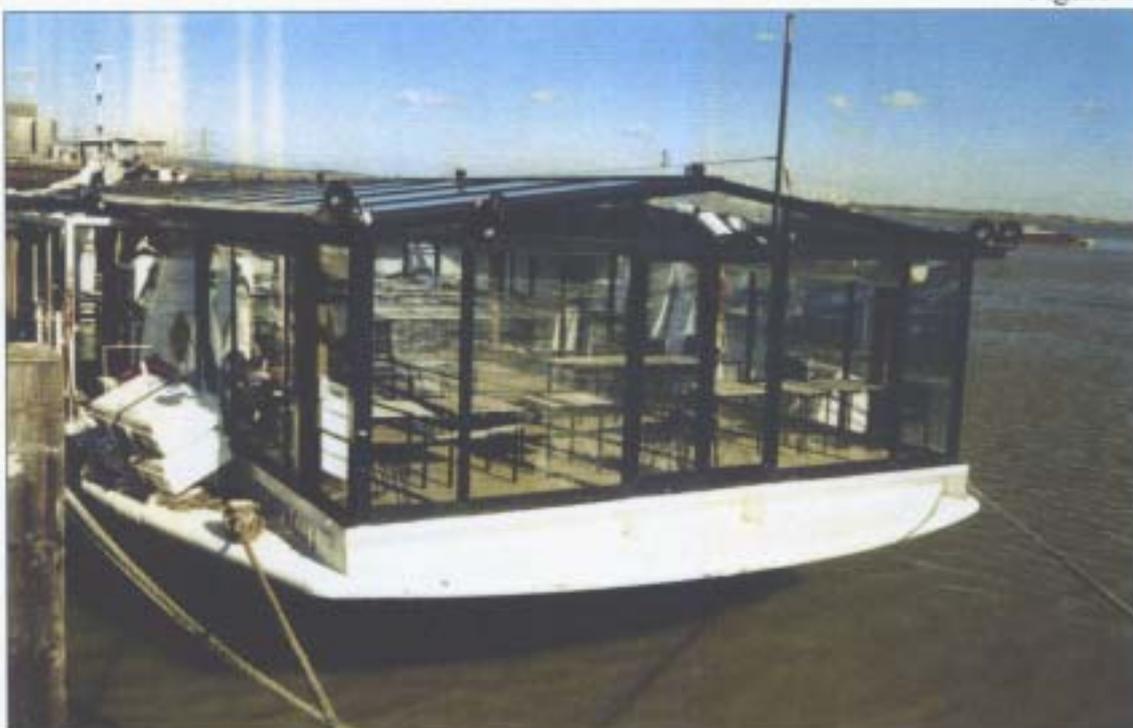
Figure 4

General view of bow

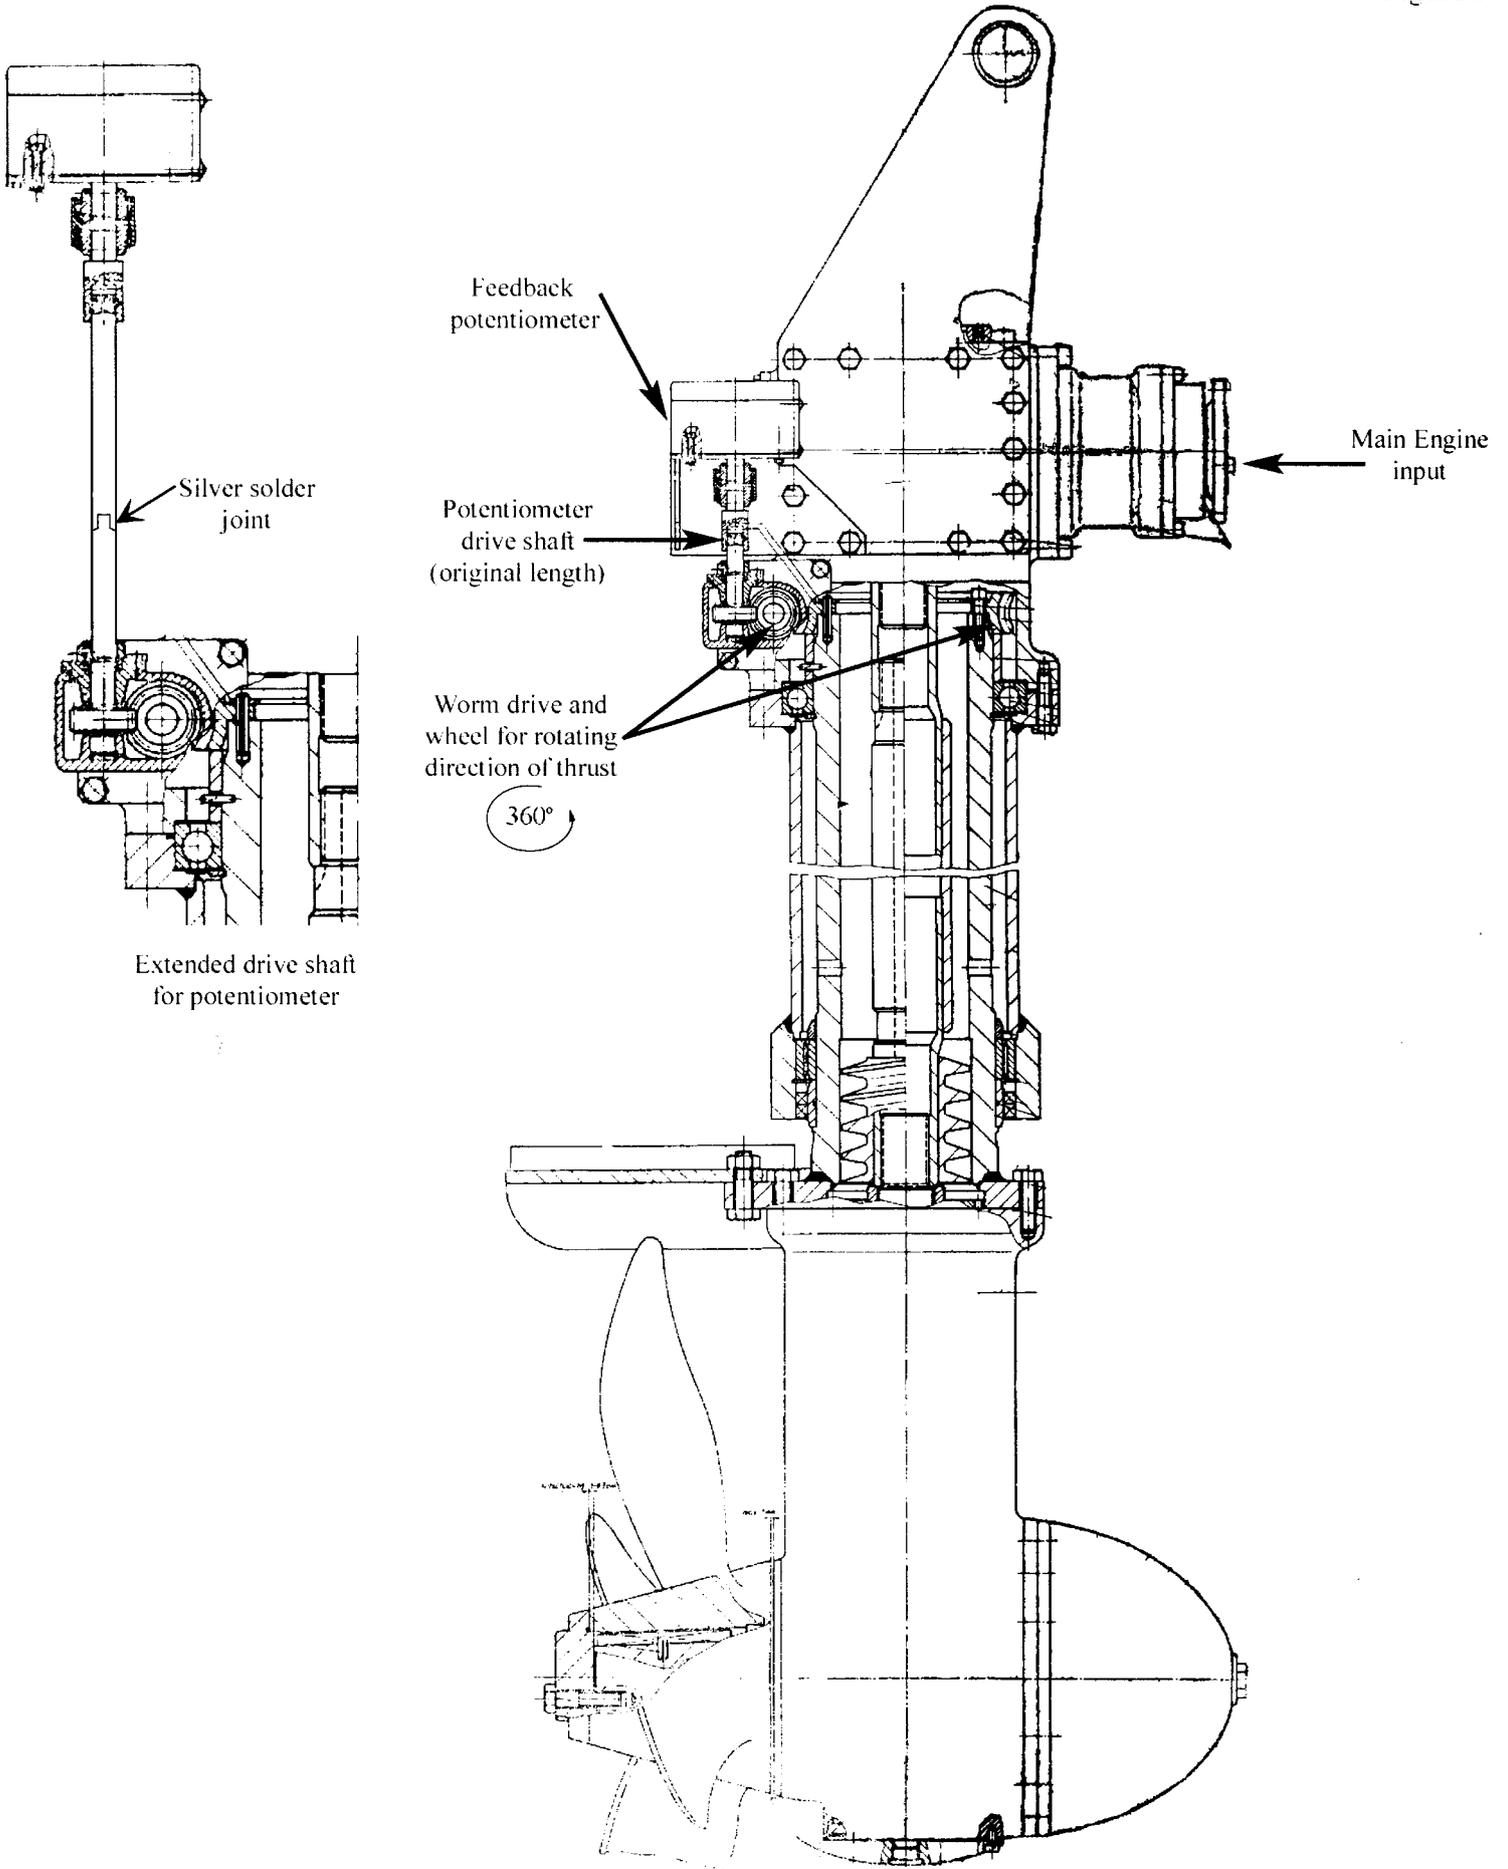
SCHOTTEL UNIT PROPULSION LEG

A subsequent investigation confirmed that there had been a steering failure on the starboard Schottel unit. The drive shaft for the feedback potentiometer had sheared, disabling the wheelhouse indicator. Under this condition, although the propulsion unit continued to operate, the lack of any stop signal from the feedback potentiometer caused the steering unit to rotate slowly throughout 360°. With no wheelhouse indicator, the master did not know the steering unit was rotating (or in what direction). The propulsion control and alarm system gave no indication as to what the failure was.

As the azimuth wheel rotates, it causes a small shaft, connected to another potentiometer, to generate, and send, an electrical feedback signal to the solenoid valve and wheelhouse position indicator. As the Schottel unit reaches the required operating angle, pressurised oil is shut off and the hydraulic motor stops. The unit will remain in that position until the direction wheel is moved. Any failure of the feedback signal will not only cause the unit to continue to rotate, but the position indicator in the wheelhouse will remain in the original position.

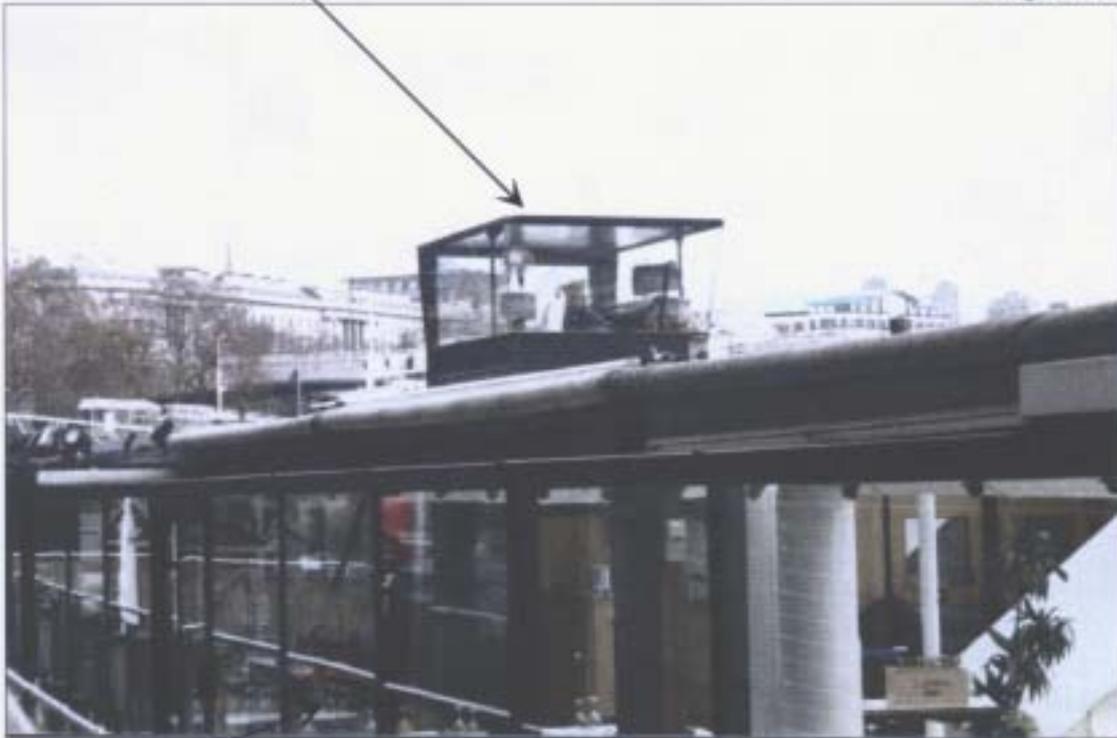
Figure 12

View of wheelhouse showing extent of all round visibility
