Report on the investigation
of the Grounding and Loss
of the Fishing Vessel

RACHEL HARVEY

Peninnis Head, Isles of Scilly

Report No 23/2000

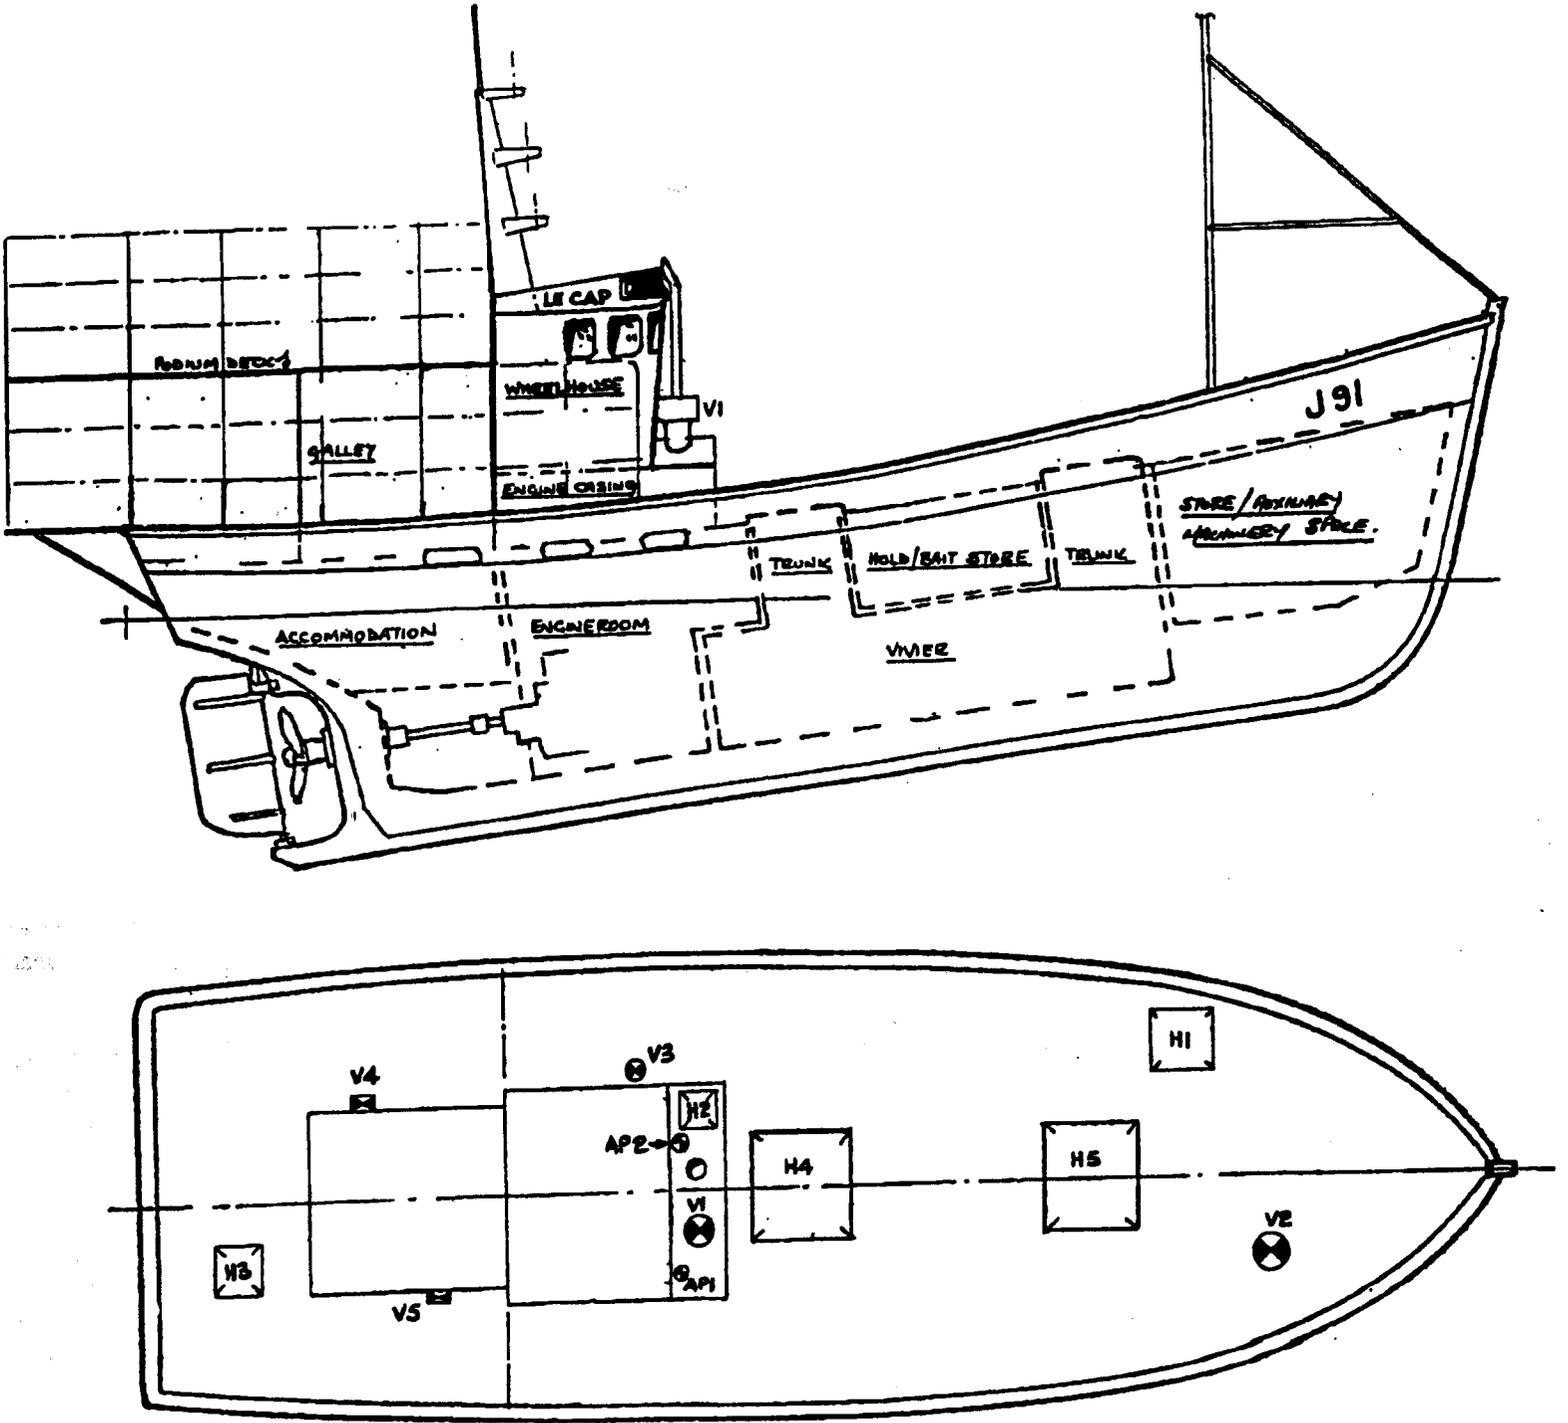
Figure 2

The liferaft was stowed on the port side of the podium. The main engine exhaust was forward on the wheelhouse top; it discharged aft towards the liferaft. The lifejackets were all stowed in the crew cabin (**Figure 2 - general arrangement**). The lifejackets were fitted with lights that could be activated by pulling a toggle.

General arrangement (before canvas shelter was fitted)
