**Report of the investigation of
the capsize of a school boat
on Fountain Lake, Portsmouth
with the loss of one life
on 16 September 1999**

Marine Accident Investigation Branch
First Floor Carlton House
Carlton Place
Southampton
SO15 2DZ
Report No 6/2001

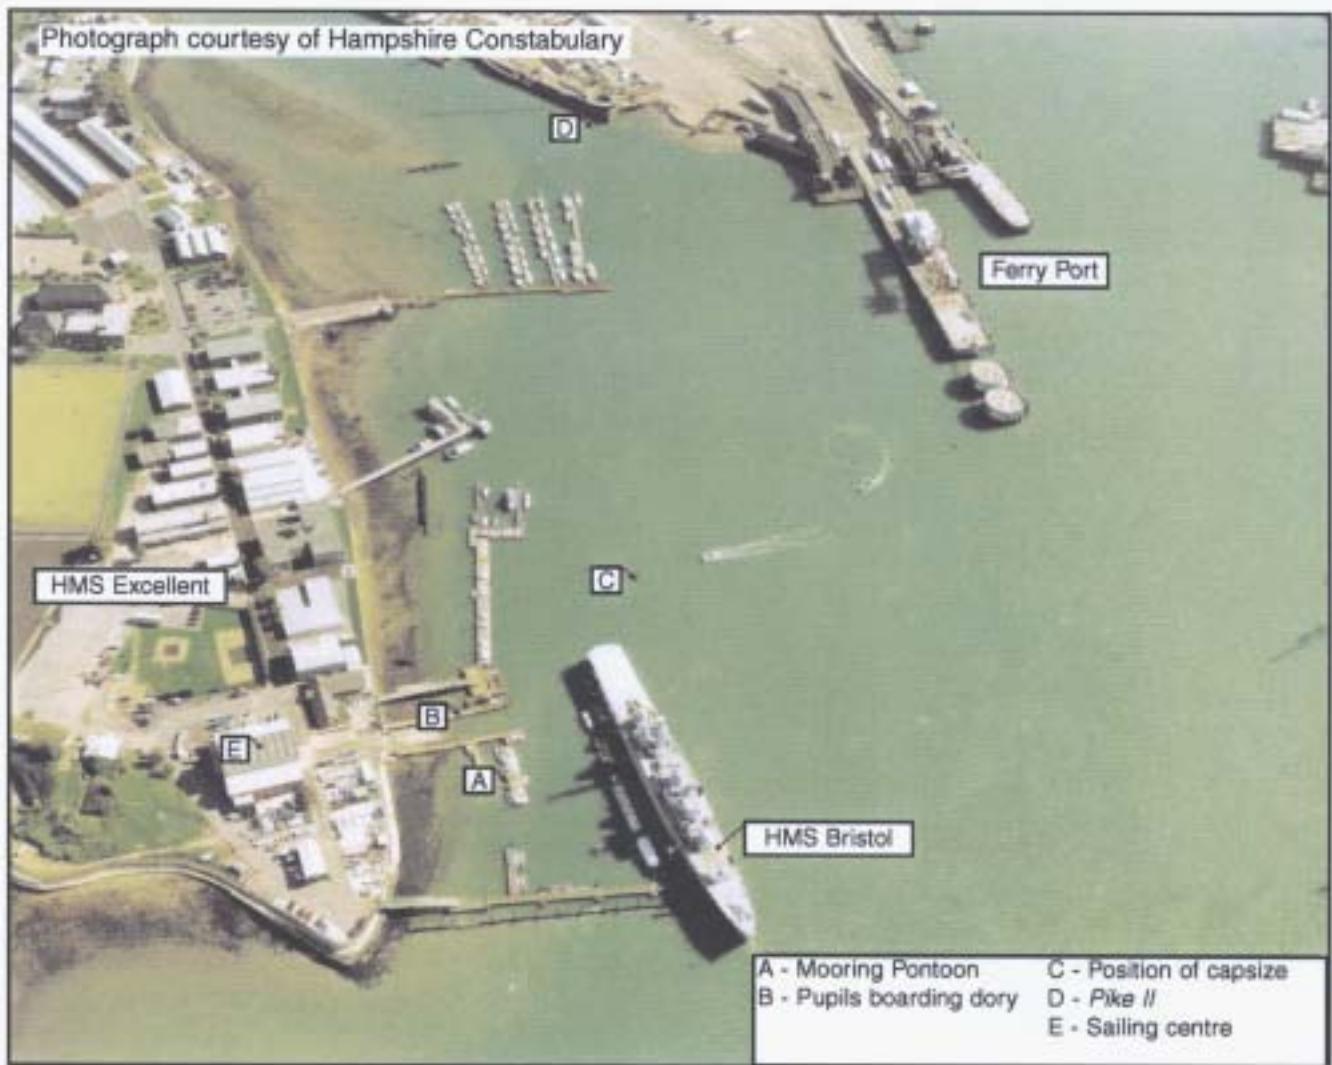
Figure 1

Date of Accident	:	16 September 1999
Time of Accident	:	1545 UTC (1645 BST)
Type of Accident	:	Swamping and capsize
Place	:	Fountain Lake about 75m off the pontoon HMS Excellent, Whale Island, Portsmouth, Hampshire (Figure 1)
Weather Conditions	:	Beaufort wind force 4 to 5, moderate to fresh breeze
Damage	:	Boat recovered without damage
Injuries	:	One pupil lost her life
Pollution	:	Minimal - from petrol can

Moments later, and when some 75m from the pontoon, the dory rolled to port and capsized (**see Figure 1**). The occupants were pitched into the water.
