Report on the investigation of
a collision between the yacht
Bluebell of Warsash
and an unidentified ship
about 23 miles south of the Needles, Isle of Wight

7 August 1999

Report No 20/2000

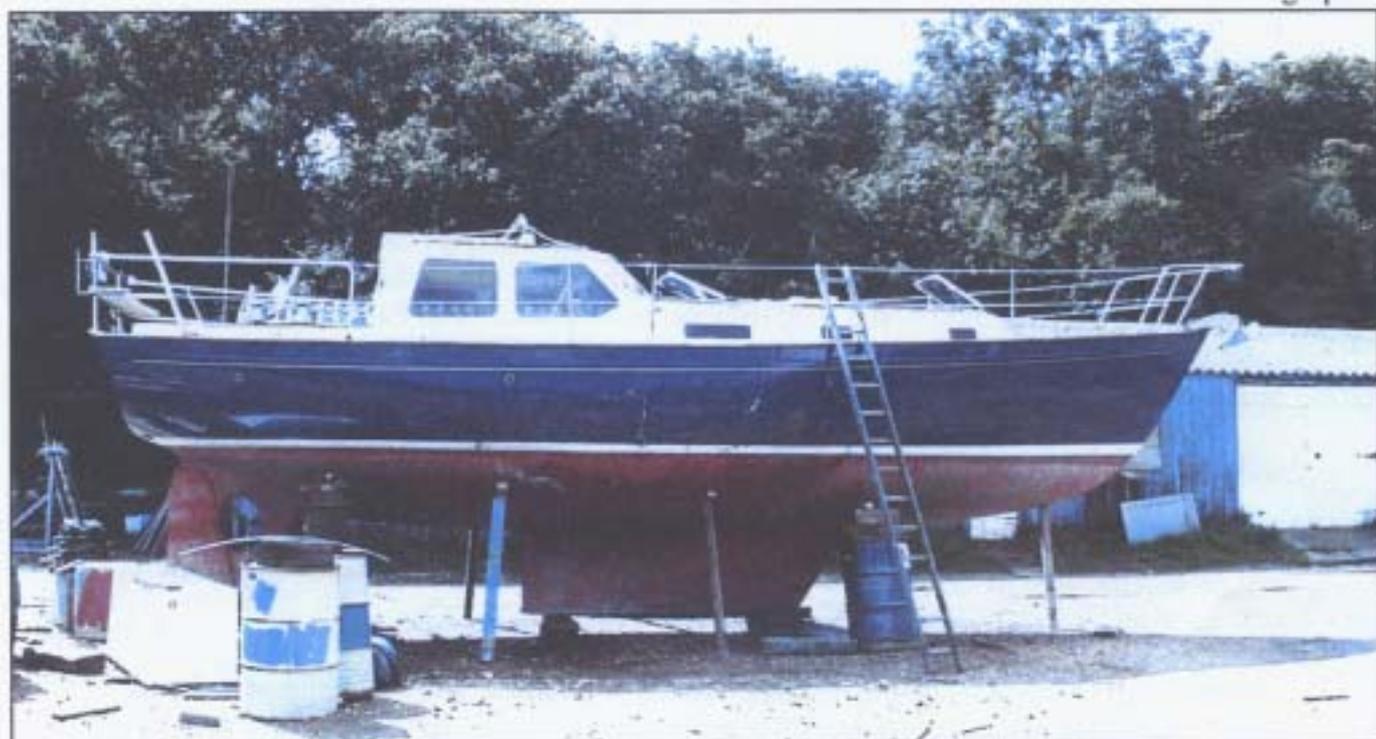
Photograph 1

Bluebell of Warsash in a boatyard at Yarmouth, Isle of Wight

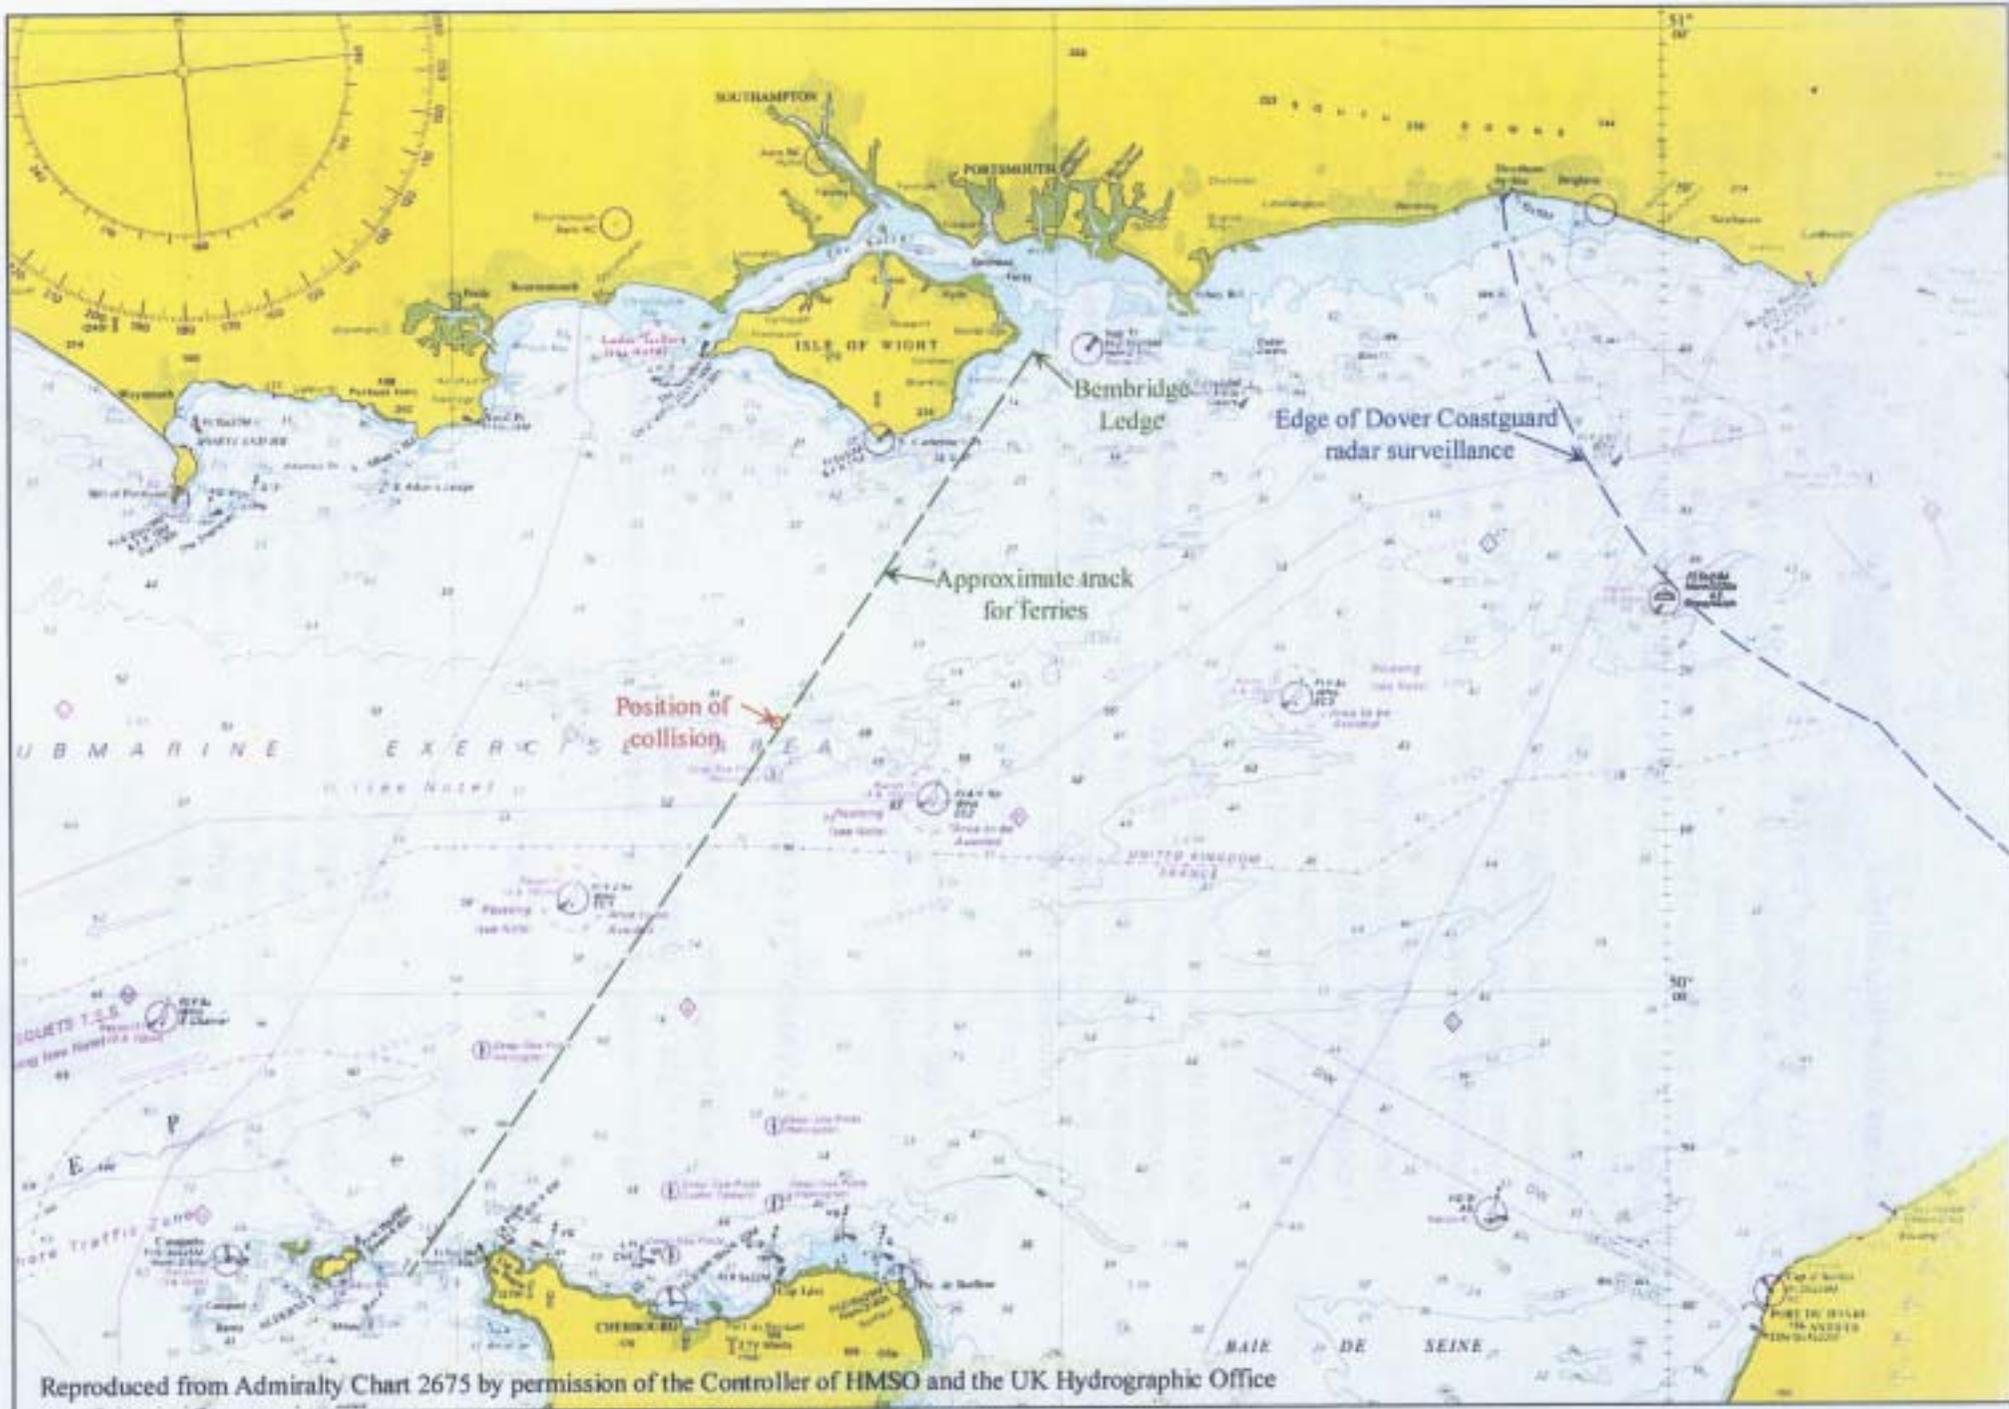
The accident occurred towards the northern edge of the south-west recommended direction of traffic flow, between the Dover Strait traffic and the Casquets traffic separation schemes (see Chart extract 1). The main direction of traffic flow between these two schemes is about 072°/252°. From the yacht's watchkeepers' description of the direction of travel of the colliding ship, it is reasonable to assume that she might have passed through the Dover Strait earlier in the day.

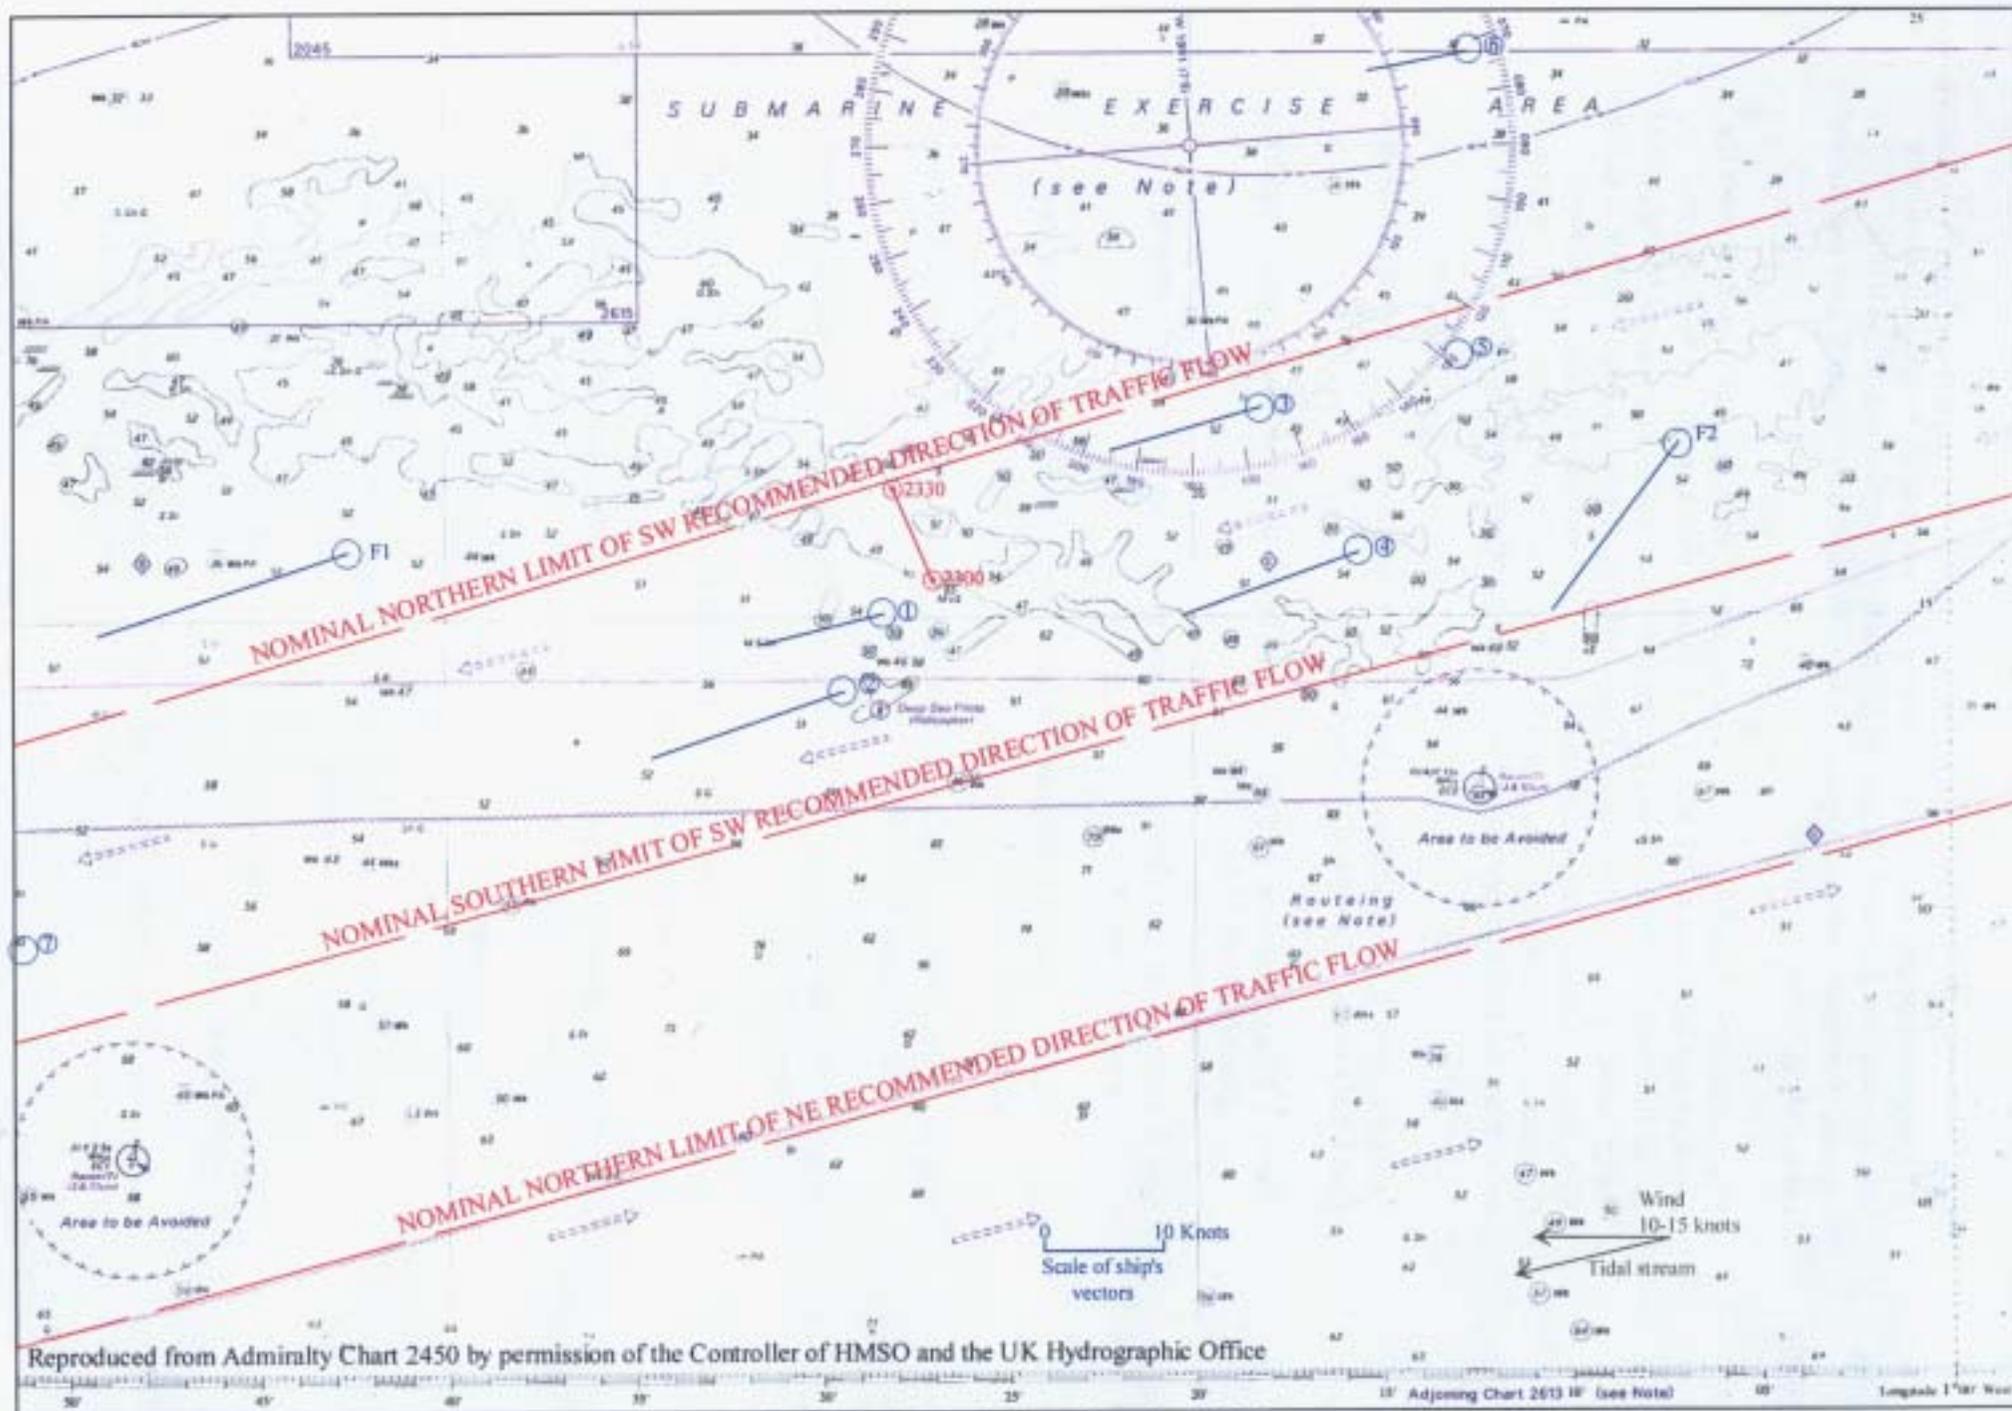
From the plots, it was found that a number of ships were in the vicinity of the collision (see **Chart extract 2 overleaf**). These were:

Of the nine ships identified above, ship 1 seemed to best fit the description given by the two watchkeepers, since it was similar in type and size, and had a bulbous bow.

Approximate positions of ships plotted to 2330
