Report on the investigation of the fatal accident to
a motorman on board the ro-ro cargo ship
Sea Centurion
at the Portsmouth Naval Base
on 18 May 1999

Marine Accident Investigation Branch
First Floor
Carlton House
Carlton Place
Southampton
SO15 2DZ

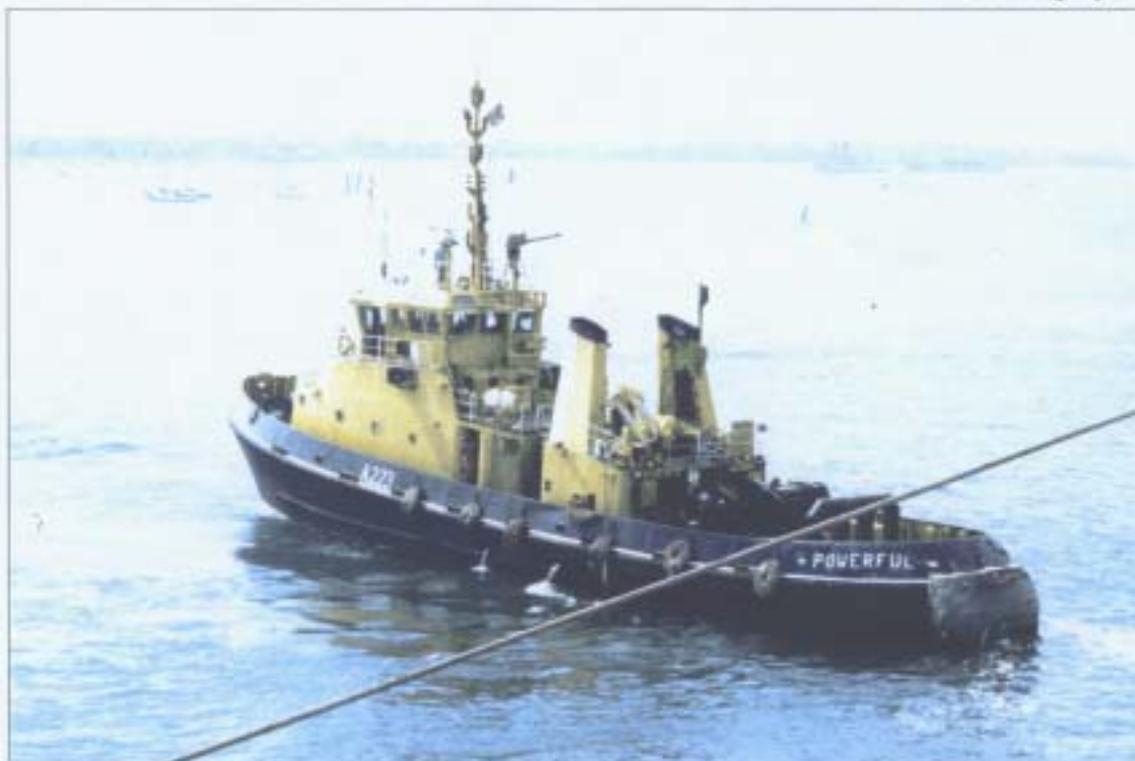
Photograph 5

She is a 30.8m long, twin-unit tractor tug of the *Adept* class and was brought in to the Royal Maritime Auxiliary Service (RMAS) fleet in 1985. She was built for harbour work, and has a coastal towing capability with a nominal bollard pull of 27.5 tonne. She has two Ruston diesel engines geared to two Voith Schneider propulsion units (**see annexe**) and has a service speed of 12 knots. She has operated exclusively in Portsmouth since entering service (**see photograph 5**).

Tug Powerful

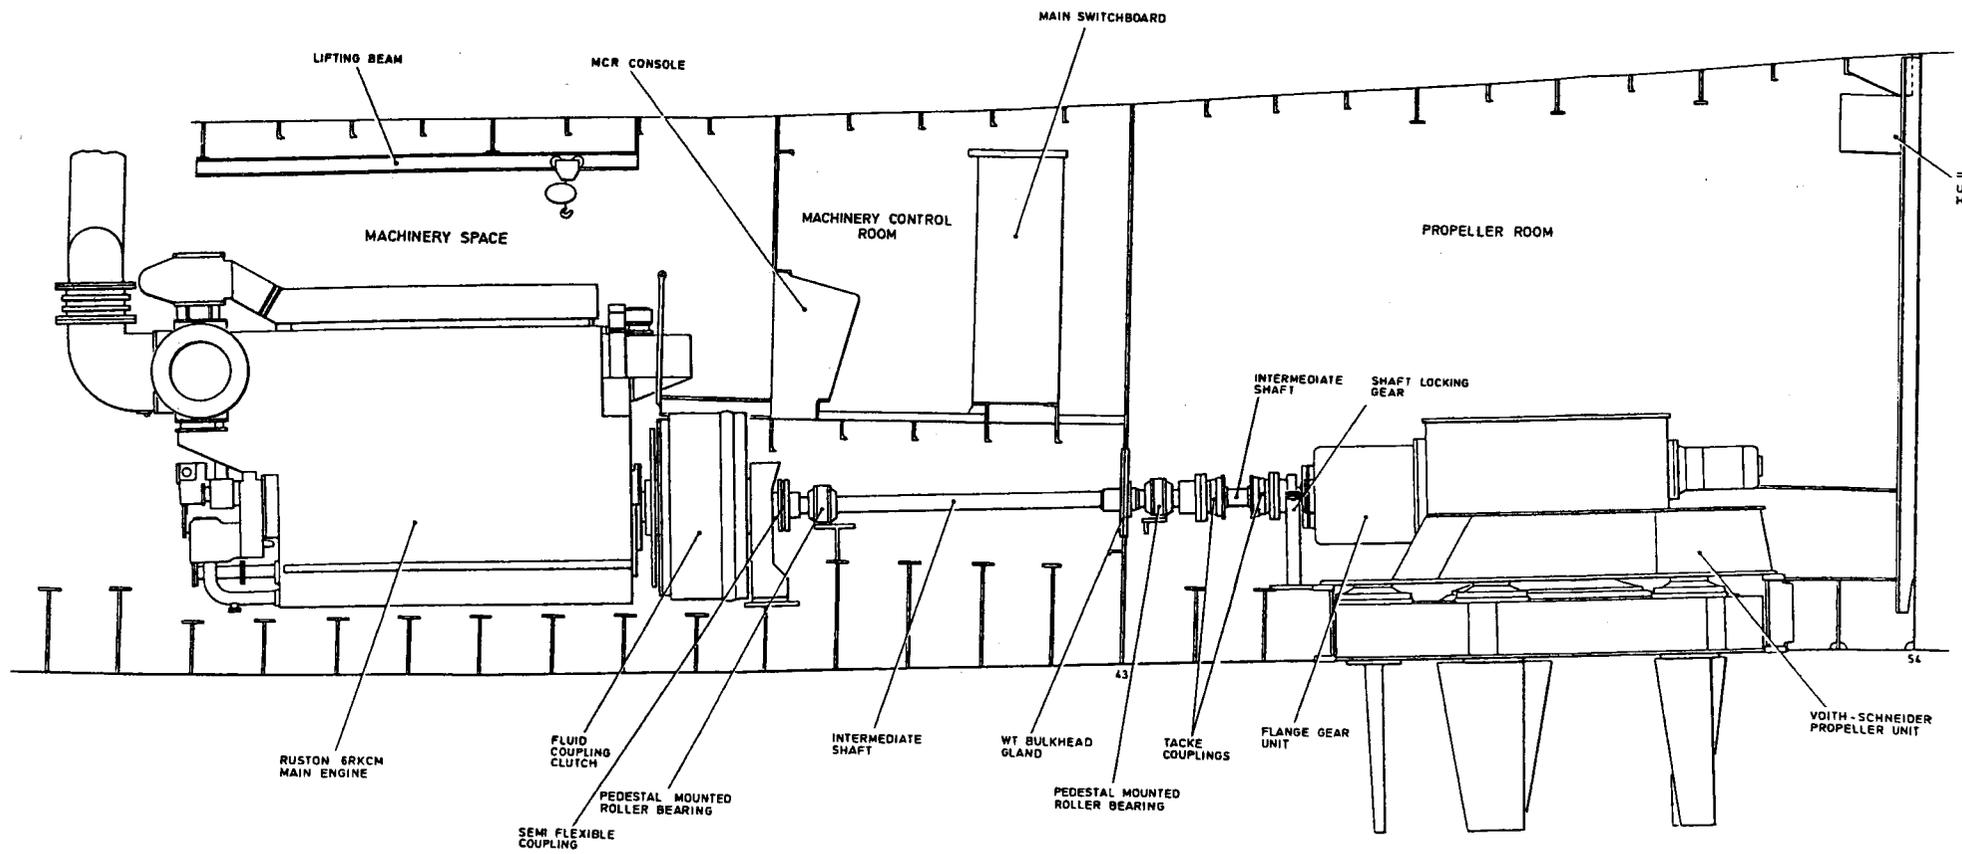
A Voith-Schneider propulsion unit
