**Report of the Inspector's Investigation into
the death of one person on the fishing vessel**

***GEESKE* BM140**

while fishing off Beachy Head

on 9 December 1998

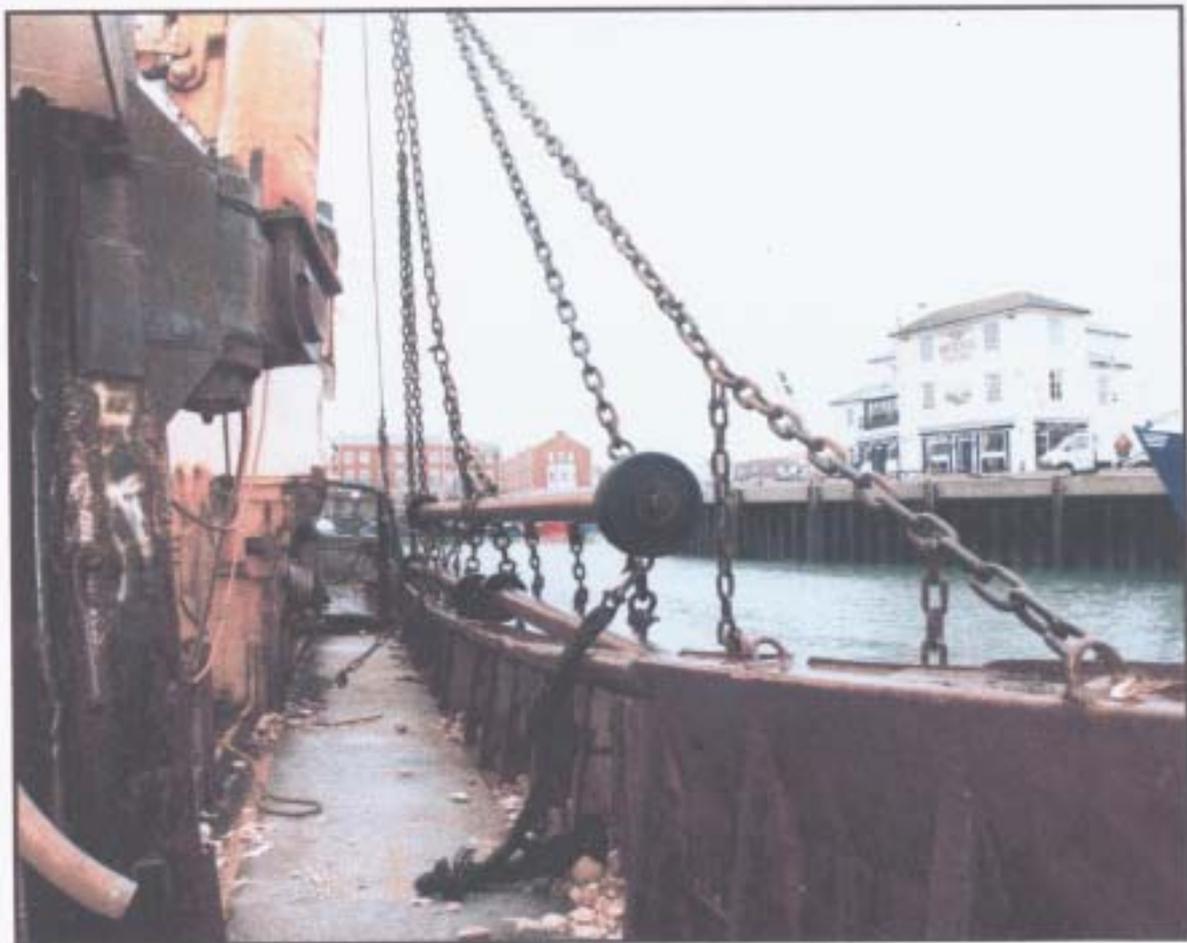
Figure 7

At the end of a tow the fishing gear was raised by hauling on the warps. As the gear reached the surface the derricks were raised; this caused the gear to twist so that it became parallel with the side of the vessel and with the poles level to the gunwale (**Figure 6**). Lines forward and aft were then attached, and the gear was pulled up tight against these to steady it (**Figure 7**). One end of the pulling-in chain was then attached to the centre of the gear, while the other end was attached to the pulling-in rope, which ran through a block on the deck and then aft to the starboard whipping drum; the whipping drum was used to pull the gear inboard, and at the same time, the warp was released so that the gear dropped down on the deck (**Figure 8**). At this stage the chain-mail bags (the dredges) were hanging over the gunwale.

Fishing gear alongside
