Report of an Investigation
into the death of a donkeyman on
mv *P&OSL KENT*
on 10 November 1998
off the Port of Dover

MAIB 1/10/186

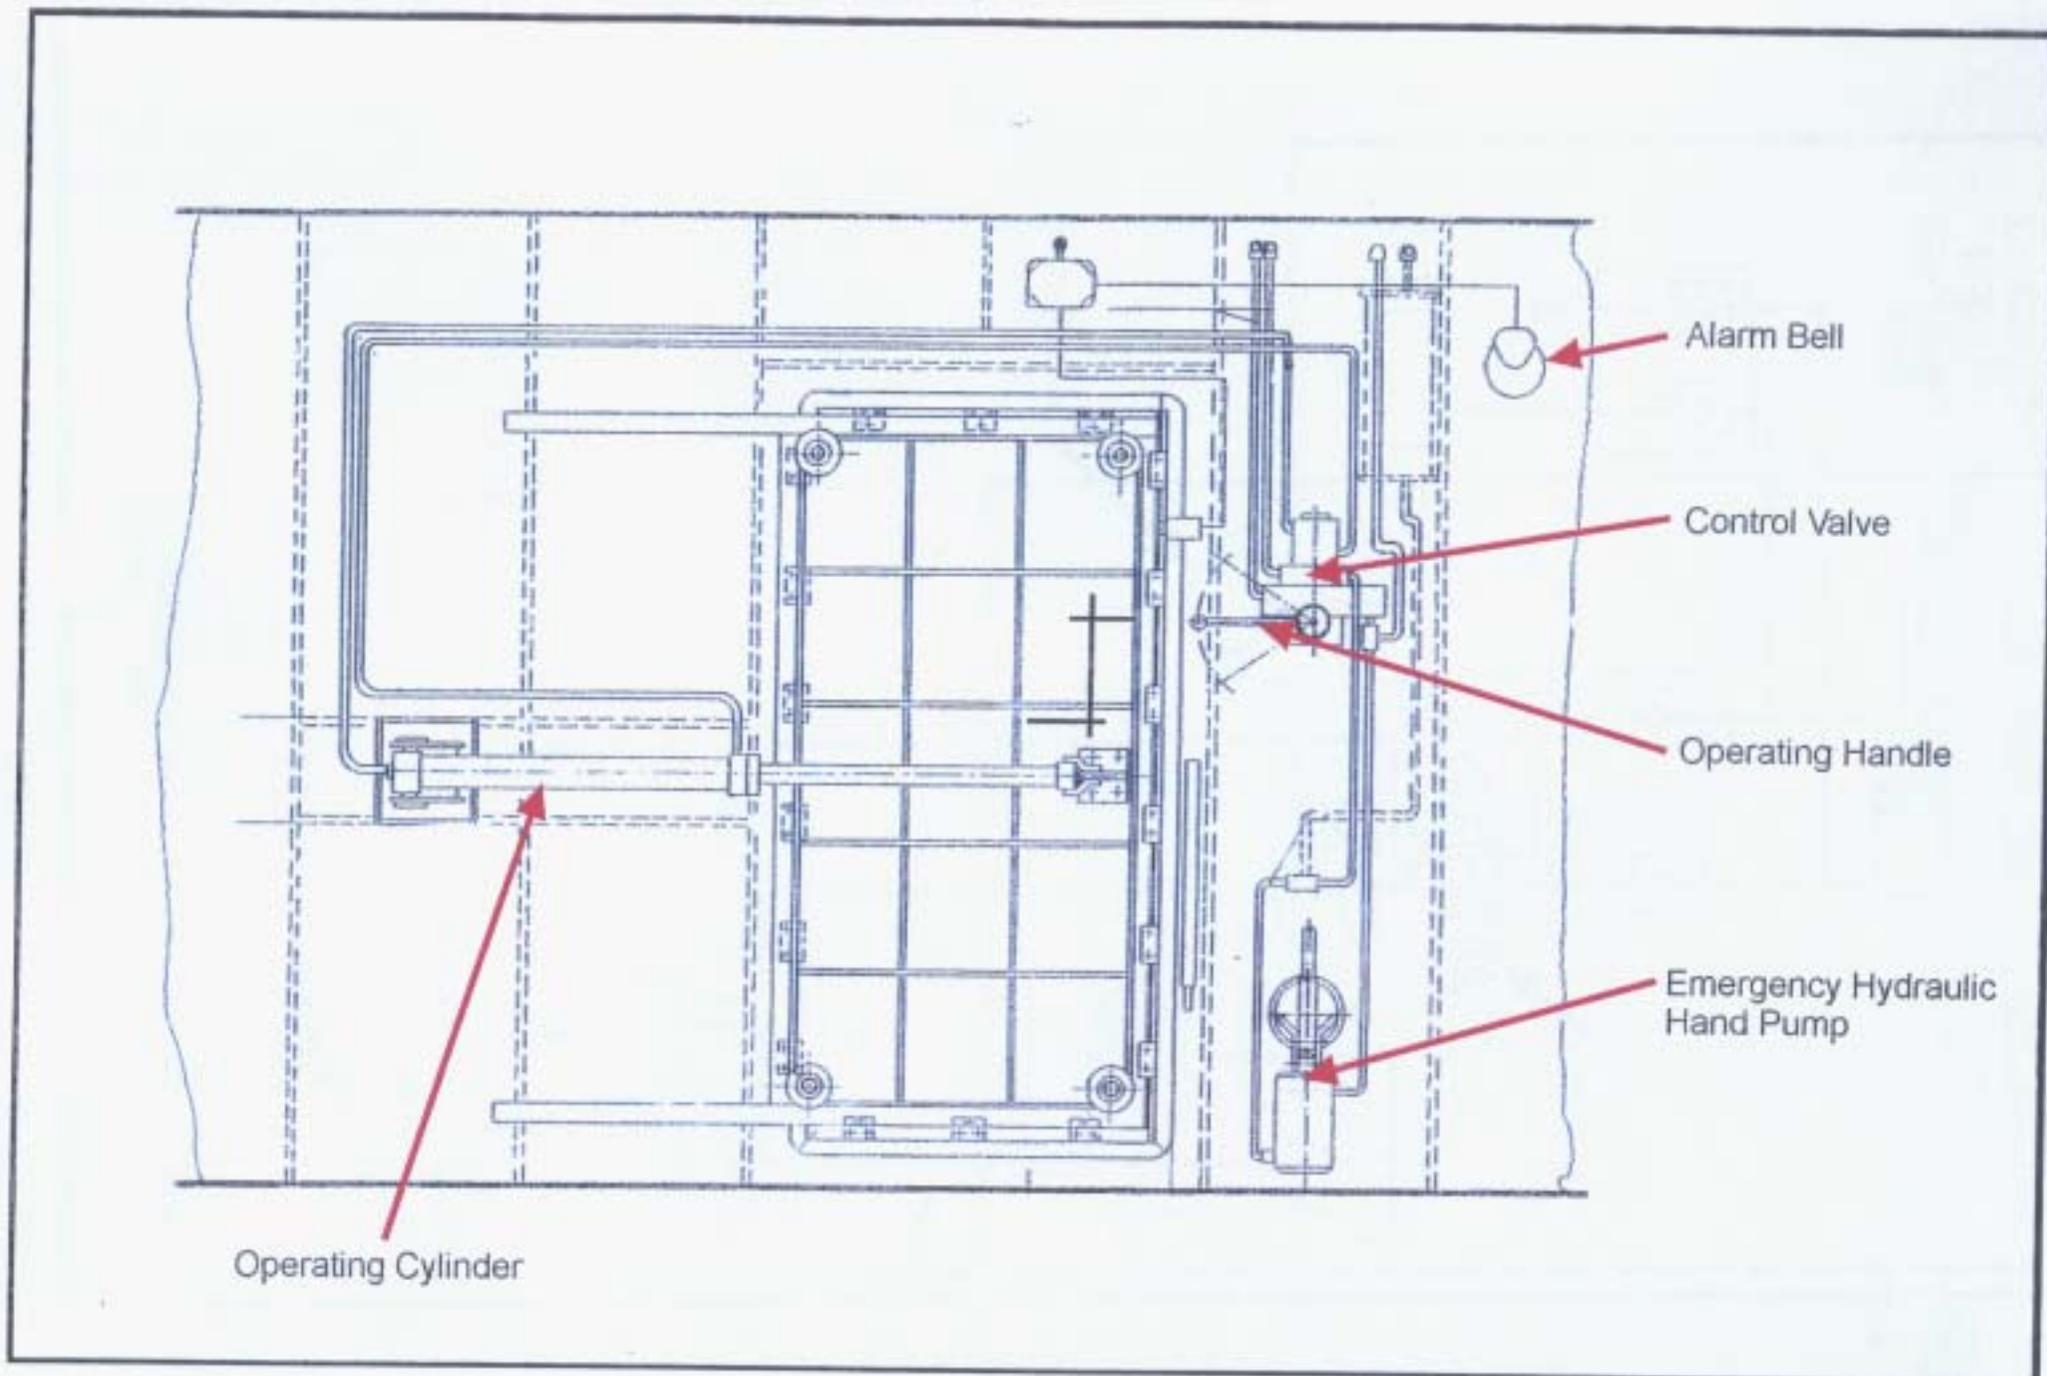
View of Typical Watertight Door Fitted in *Pride of Kent*

The control station for operation of the watertight doors is on the bridge with indicator light panels there and in the engine control room. Each watertight door is fitted with a flashing warning light and an audible alarm which operate when the door is opened or closed in the "Door Closed" condition. When in "Local Control" these alarms do not sound. The watertight doors are in two heights, 1900mm and 1940mm, but vary in width from 1250mm to 600mm. No 6 watertight door, the one involved in the incident, is 1900mm high and 900mm wide.

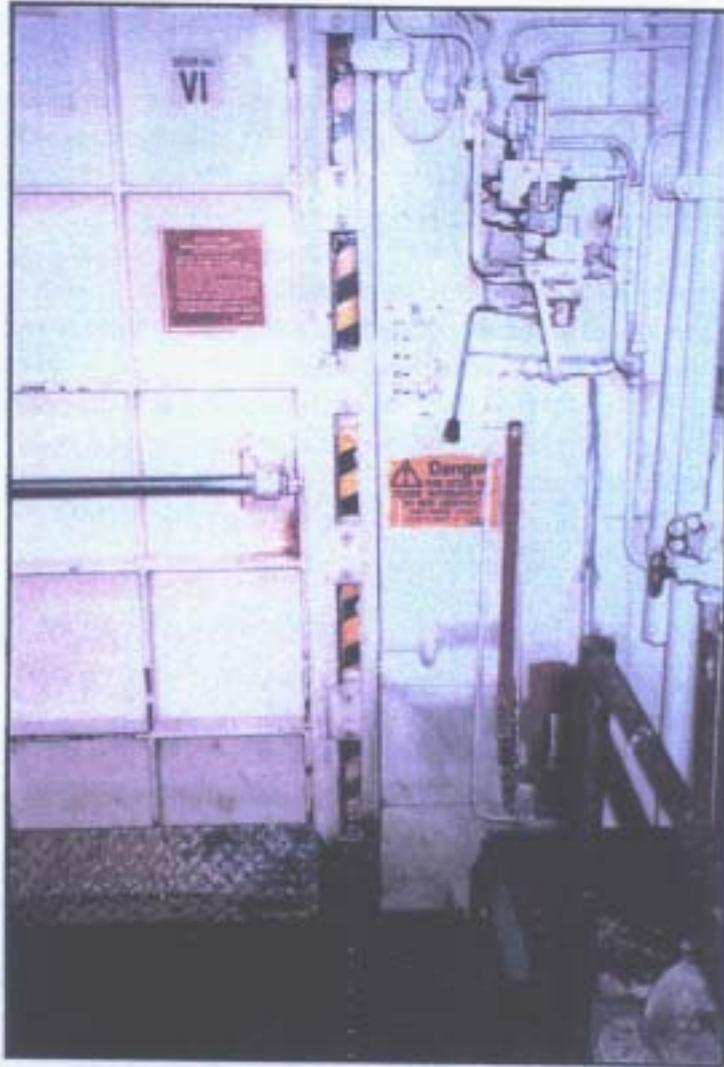
Photograph 1

1.3.2 The fourth engineer left the ECR and passed through the main engine compartment into the generator room using No 7 watertight door in the process. Once in the generator room, he went past the port inner generator and saw the third engineer working on the camshaft doors. As he reached the end of the generators and turned to starboard, he immediately saw a bag of salt caught in No 6 watertight door. This watertight door is between the generator room and the separator room.

At about 1800 on 10 November 1998, he was found by the fourth engineer found him trapped in No 6 watertight door. He was released from the doorway by normal operation of the door controls and laid on the floorplates in the generator room. The fourth engineer noticed at that time that he had a red mark running diagonally across his body from the left shoulder downwards.

Watertight door No.6 viewed from generator room.
