Report on the Investigation
on the Capsize of the
UK Registered Fishing Vessel
CATRINA NN194
South of Newhaven
on 13 October 1998

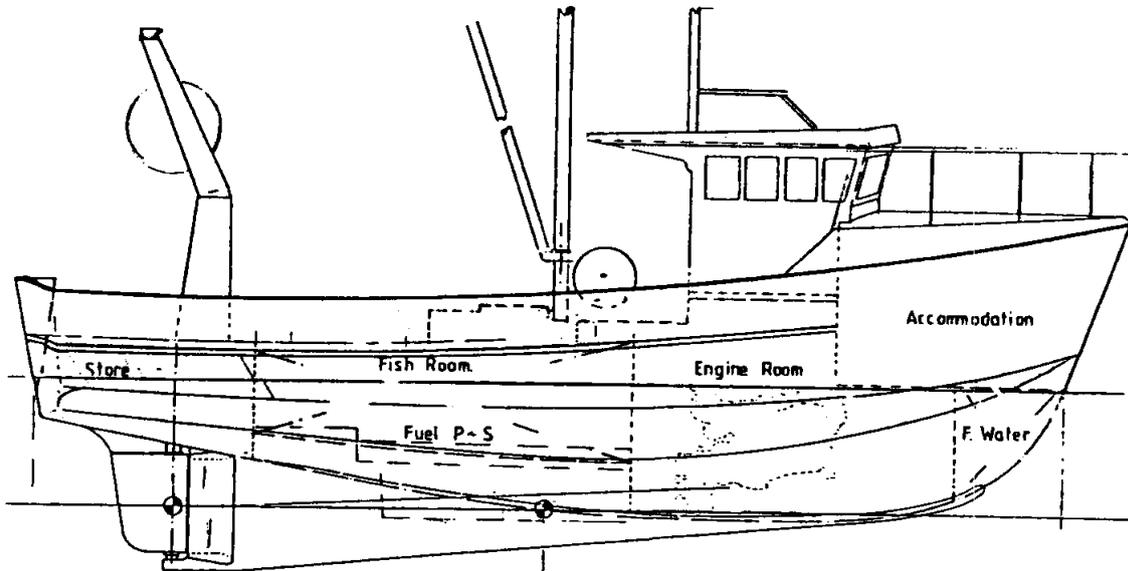
STABILITY CONDITION.

WITH NET ON DRUM

50% FUEL

ITEM	WT (t)	VCG (m)	(M)	LCG (m)	(M)	FSM)tm)
LIGHT SHIP	39.03	1.99	77.59	4.460	174.07	
CREW WHSE	0.24	3.40	0.82	7.500	1.80	
SCALLOP GEAR ON DECK	0.90	2.35	2.12	5.70	5.13	
NET ON DRUM	0.60	5.21	3.13	-0.10	-0.06	
MISC FISHING GEAR	0.30	2.60	0.78	4.50	1.35	
ICE	1.50	1.10	1.65	3.60	5.40	
CATCH 6 BOXES	0.24	0.80	0.19	3.50	0.84	
FRESH WATER	0.97	1.12	1.09	10.40	10.09	0.000
FUEL P&S ENG RM	0.28	1.38	0.39	6.30	1.76	0.000
FUEL MAIN	2.60	1.15	2.99	3.85	10.01	0.080
	0.00	0.00	0.00	0.00	0.00	0.000
	0.00	0.00	0.00	0.00	0.00	
	0.00	0.00	0.00	0.00	0.00	
TOTAL	46.66	1.944	90.73	4.51	210.40	0.080

DRAUGHT	1.585 M					
LCG	4.509 M	TRIM LEVER		-0.009 M		
LCB	4.518 M	TRIM MOMENT		-0.414 M		
LCF	4.025 M					
MCT	0.513 TM CM	TRIM		-0.008 M		
KM	2.815 M	WATERLINE LTH		12.900 M		
VCG	1.944 M	DRAUGHT FWD		1.582 M		
GM SOLID	0.871 M	DRAUGHT AFT		1.588 M		
CG' CORR.	0.002 M					
GM FLUID	0.869 M	KG =		1.946	METRES
