Report of investigation into

Fire in main galley of

Edinburgh Castle

on 21 August 1998

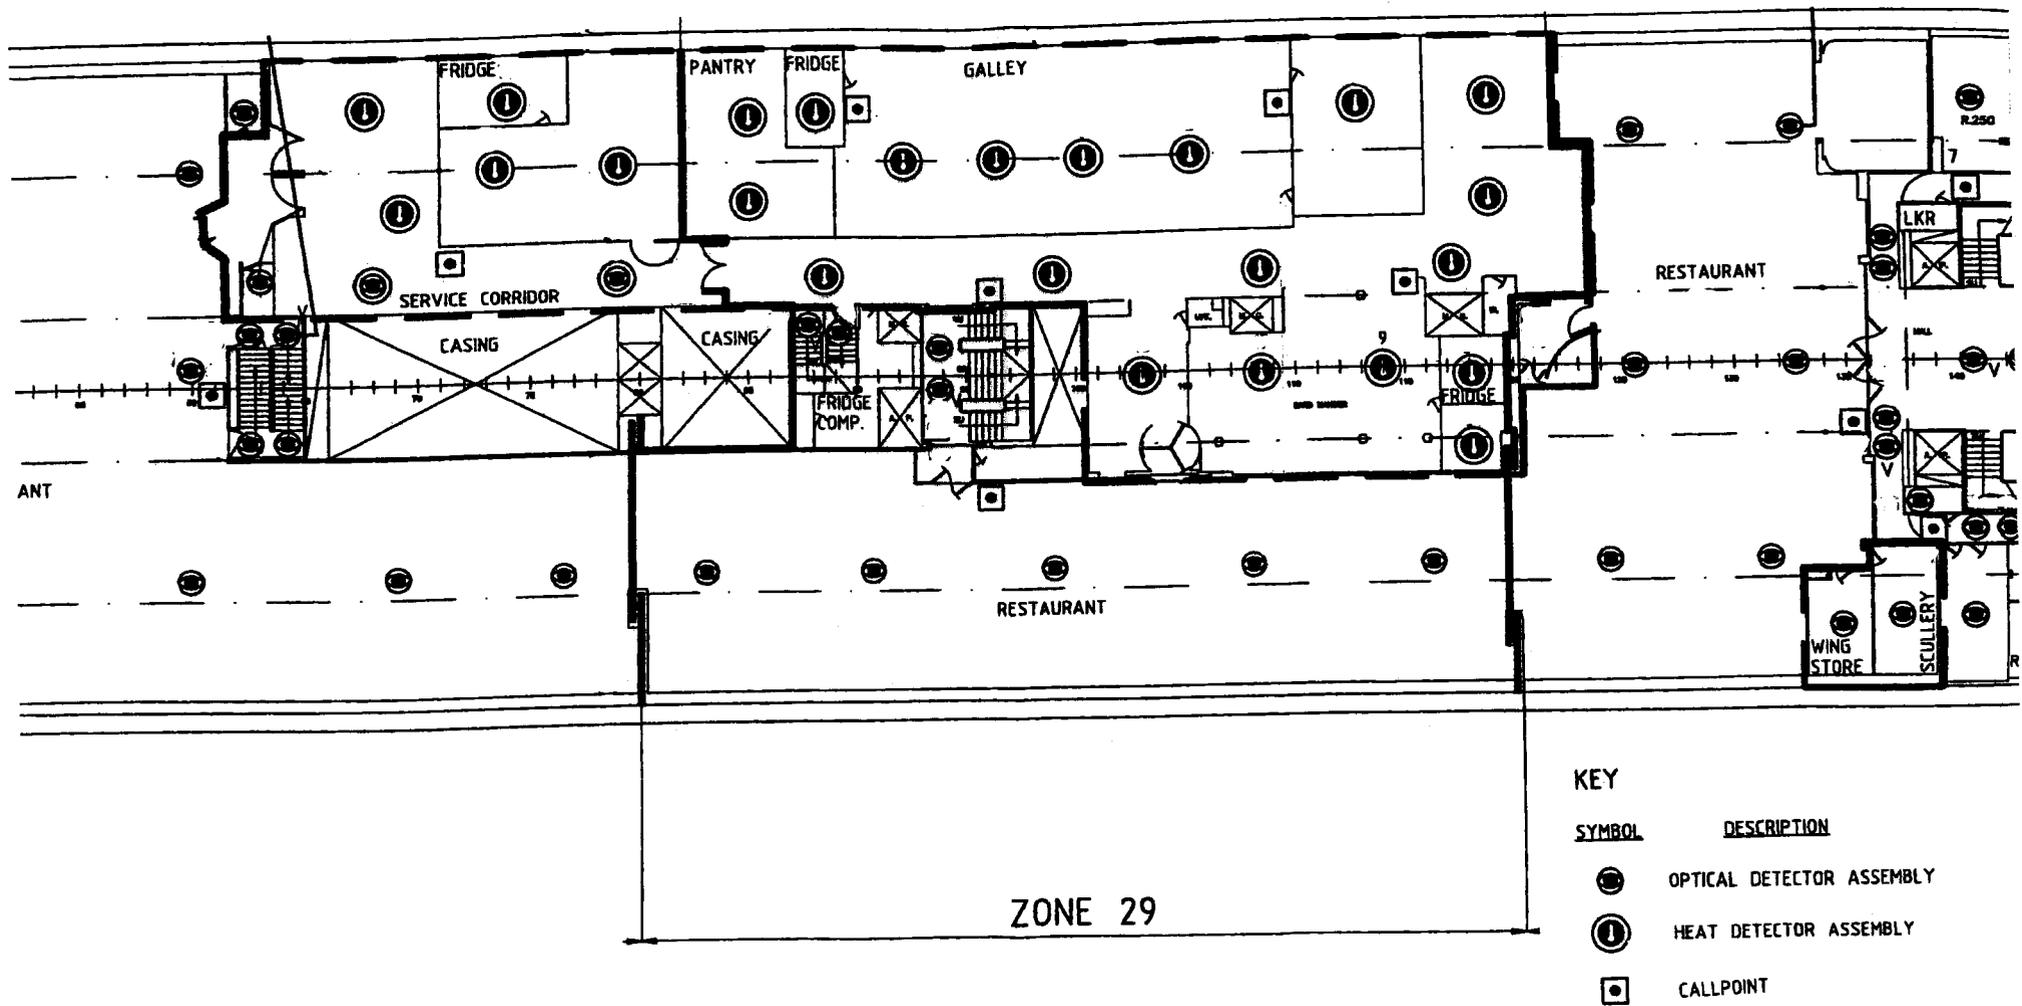
Figure 6. Fire Detection and Alarm system for Galley/Restaurant

The main galley on Deck 7 was served by loop K of the fire detection and alarm system. All 19 system detectors within the main galley were of the heat sensing type. Additionally there were four manually operated callpoints in this space (**Figure 6**).

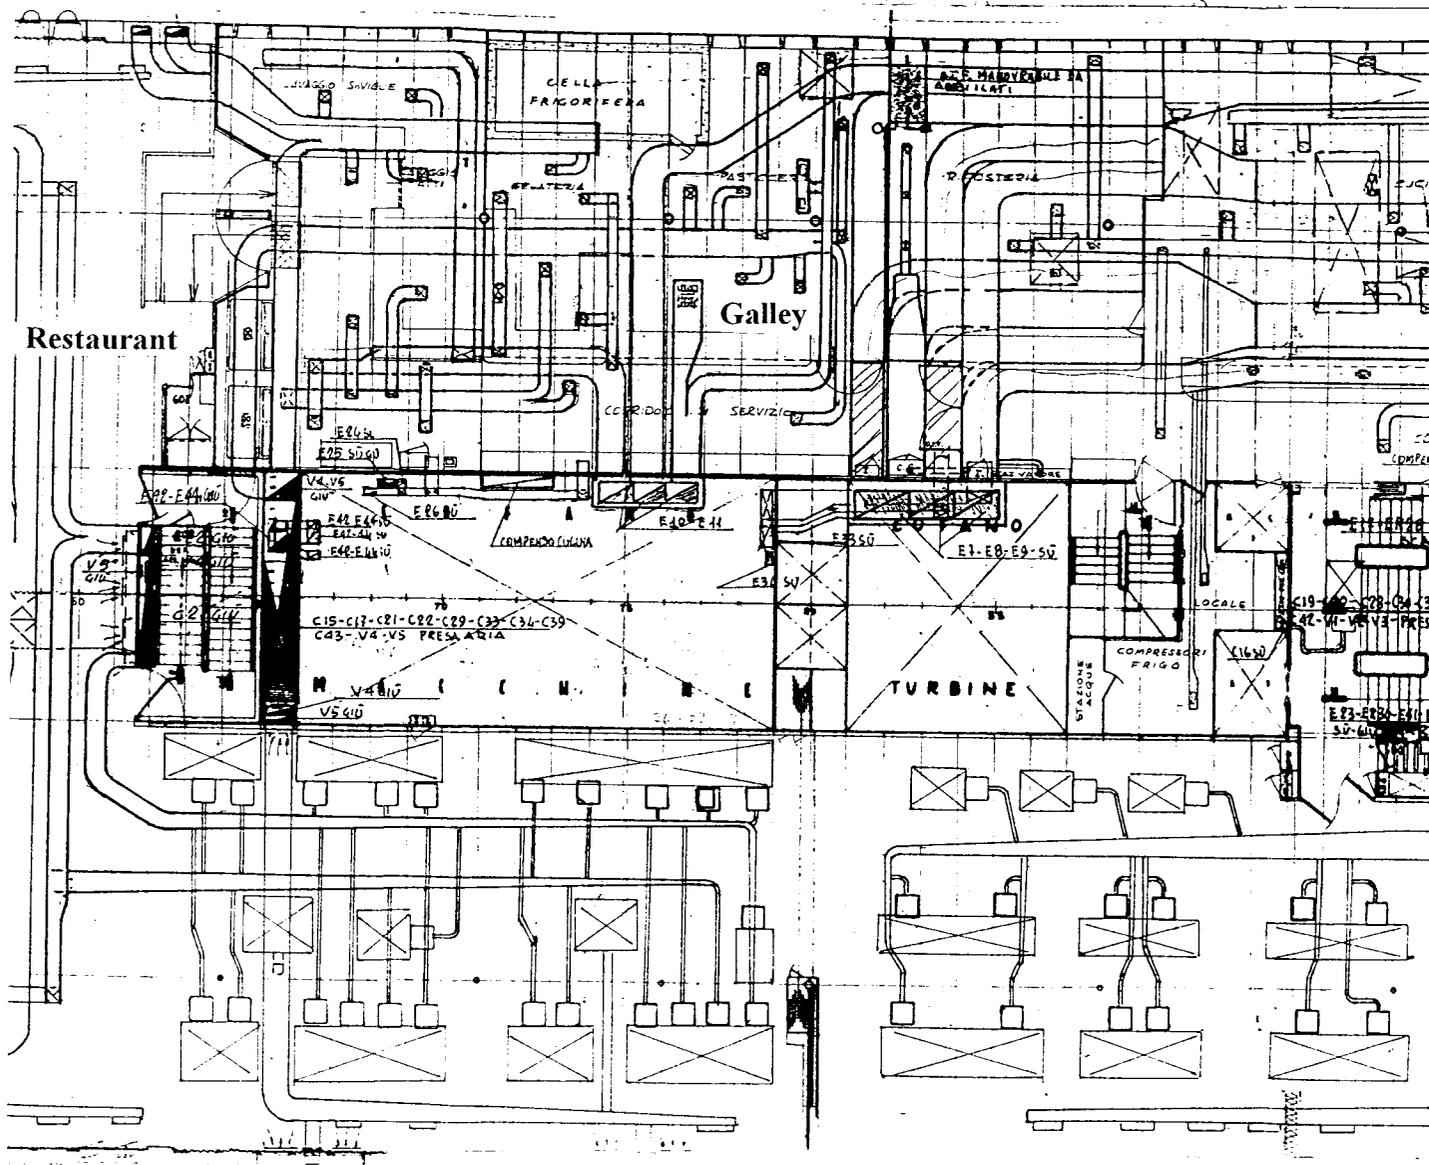
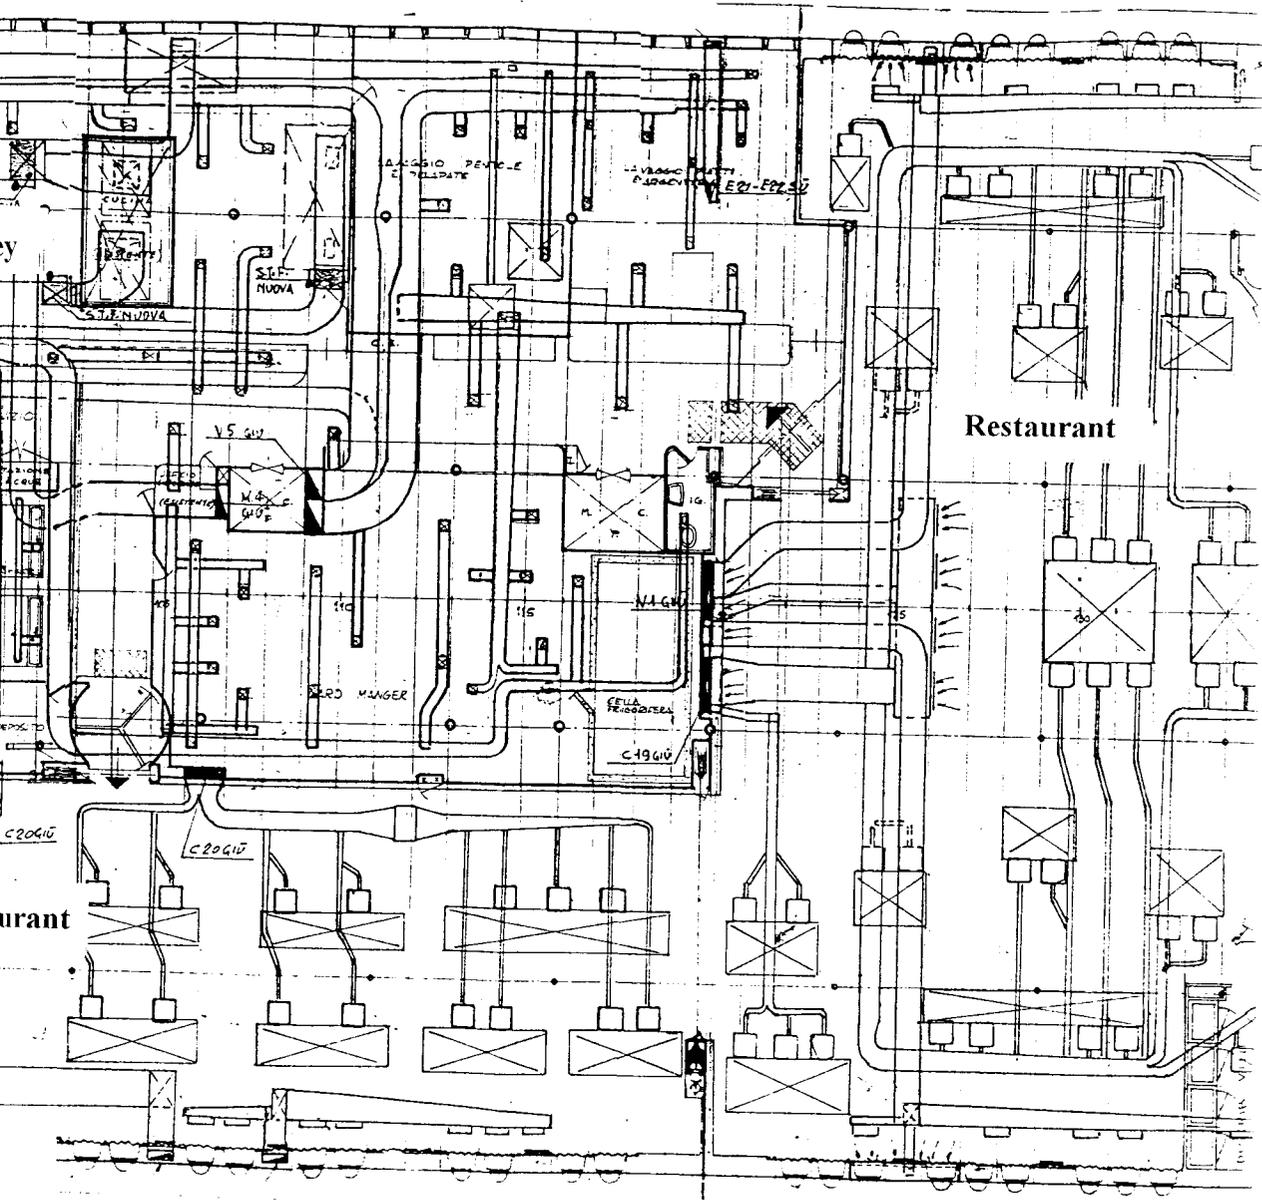
Figure 7. Main Galley and Restaurant

The vessel's emergency fire plan showed three dampers in the main galley (**Figure 2**). No identification labels or other marking were shown, either on the emergency fire plan or other drawings of the ventilation system (**Figure 7**).

None of the identified ventilation dampers within the main galley, or marked on the fire plan, were positioned at the boundary of the galley.
