**Report on the investigation
of the foundering of the narrow boat
Drum Major
with the loss of four lives at Steg Neck lock
near Gargrave, North Yorkshire
on 19 August 1998**

Marine Accident Investigation Branch
First Floor
Carlton House
Carlton Place
Southampton
SO15 2DZ

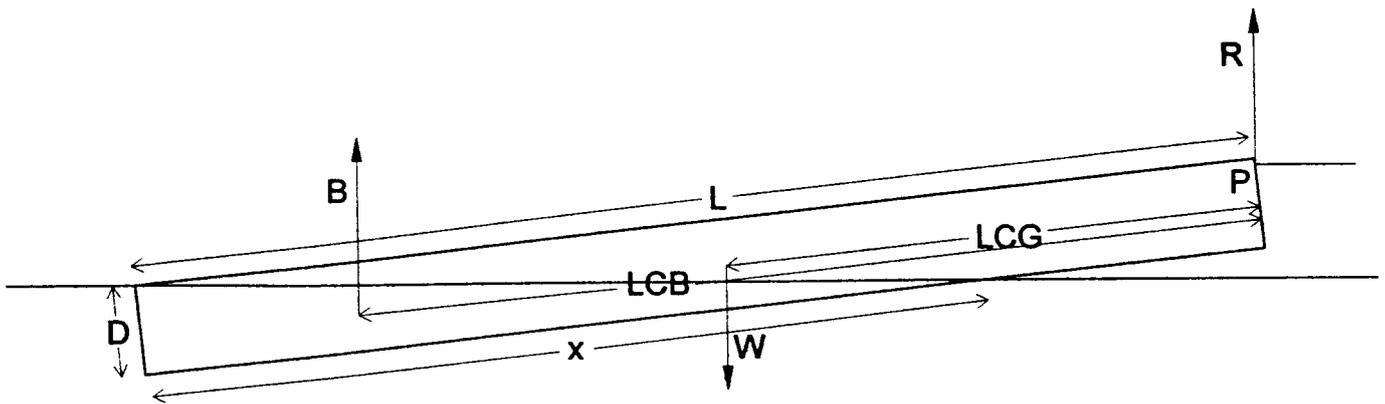
DRUM MAJOR - CALCULATION FOR TRIM

R	=	Force holding bow up	
L	=	Length of narrowboat	= 18.5m
W	=	Weight of narrowboat	= 16.0 tonne
ρ	=	Density of water	= 1000 kg/m ³
B	=	Buoyancy force from water	
b	=	Breadth of boat	= 2.07m
θ	=	Angle of trim	
D	=	Depth to top of cockpit	= 1.16m

Taking moments about P, the pivot point.
(Neglecting $\sin \theta$ terms)
