INSPECTOR'S REPORT
ON THE CAPSIZE OF THE
fv SALLY JANE SM74
ON 27 JULY 1998

Sally Jane, a twin beam trawler of 11m registered length, capsized at about 1300 on 27 July 1998 while alongside in the Aldrington Basin of Shoreham harbour. At the time the crew were repairing both sets of fishing gear which had been hauled up to the derrick heads. The crew of three abandoned the vessel when they saw it was going to capsize. Weather conditions were good and were not a factor in the accident. No one was injured.

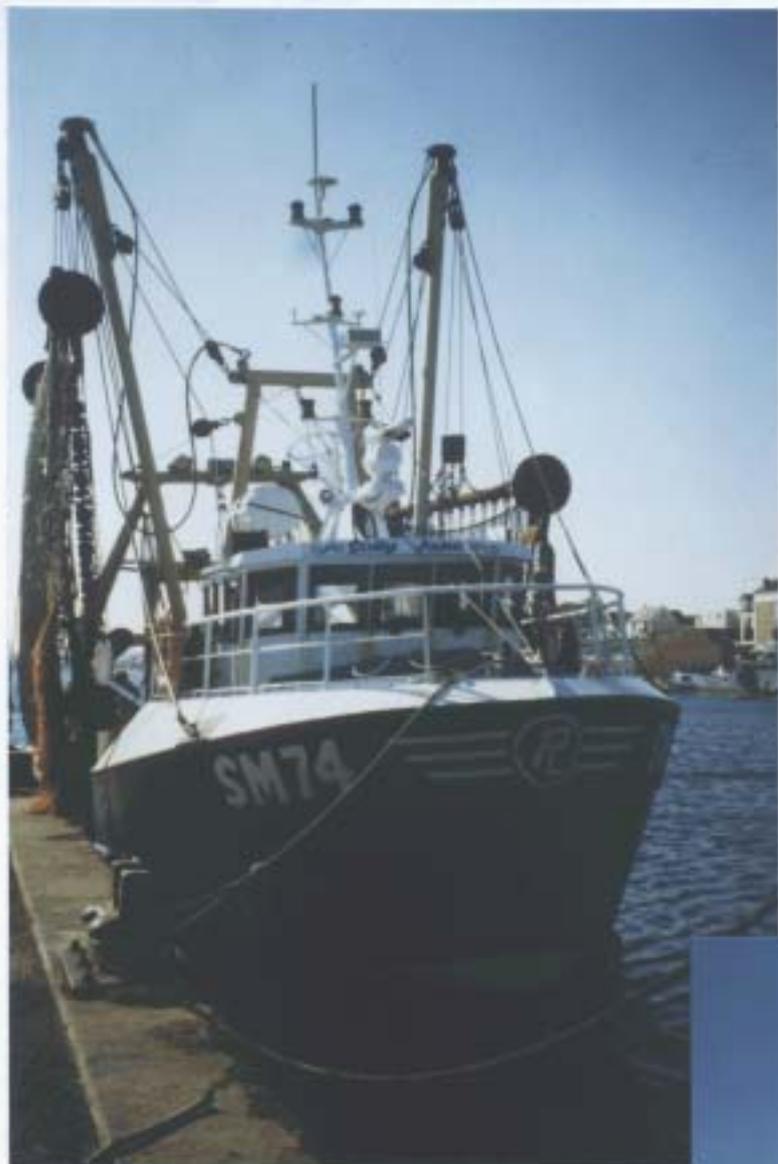
Sally Jane - alongside
in the Aldrington Basin

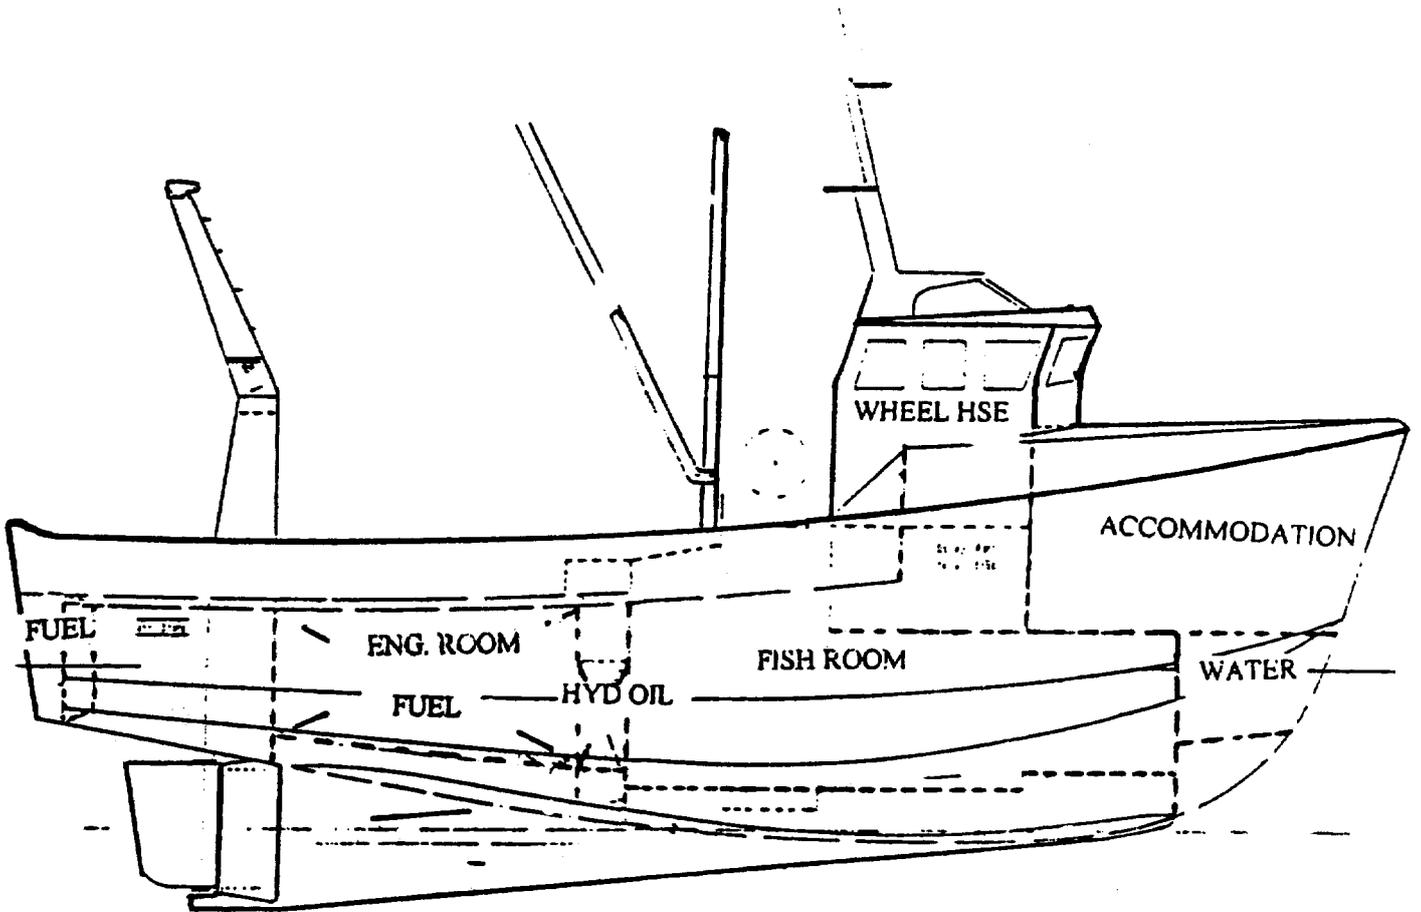
Layout of *Sally Jane*

The instructions on working the vessel, contained in the stability book, reduced the quantity of fuel carried in the aft tank by half, limited ice to 1.75 tonne and the number of fish boxes to 100. With these restrictions, the vessel met the stability criteria recommended by MCA (**Annex 1**).

The owner has also instructed the skipper that fuel and water tanks must be full before attempting to haul the trawl gear to the derrick heads for repair.

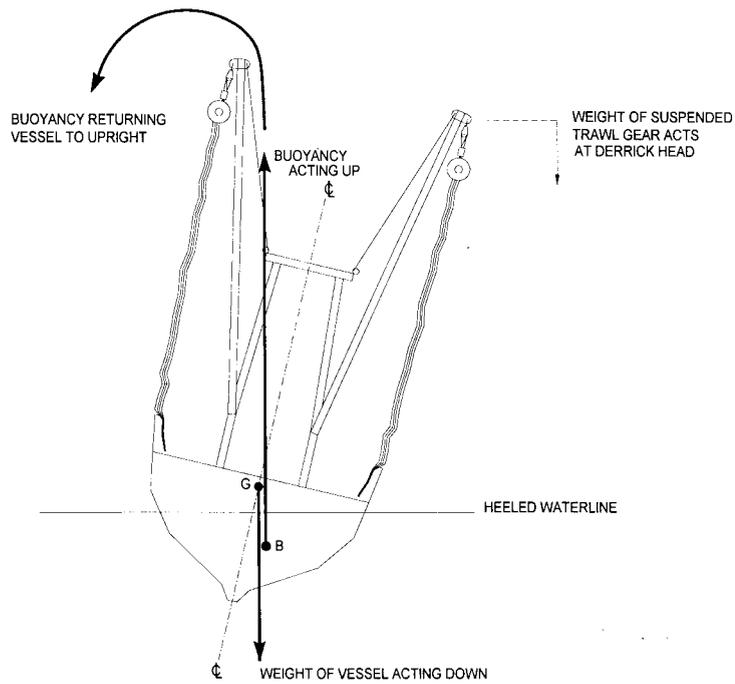
THE TWO POSSIBLE CAUSES FOR THE CAPSIZE.

NO CAPSIZE - VESSEL IN HER ORIGINAL SAFE CONDITION

THE VESSEL HAD OPERATED SAFELY FOR 8 YEARS,
SHE CAPSIZED BECAUSE SOMETHING HAD CHANGED
