NAME OF VESSEL
REMA

At 0221 the Belize registered MV Rema broadcast a Mayday on VHF ch16 its position approximately 22 miles NE of Whitby. A search of the area using RNLI lifeboats, RAF helicopters and several Merchant vessels located the wreck of the vessel but its 4 crew were not found and considered to have perished with the vessel.

The purpose of this investigation was to perform calculations to explore the extent of flooding that would be necessary to sink the "Rema" in a manner that was consistent with the known circumstances of the casualty and the evidence available from the wreck. If possible, the investigation was to attempt to narrow in on the position and extent of damage that, at least on the balance of probabilities, is likely to have been involved.

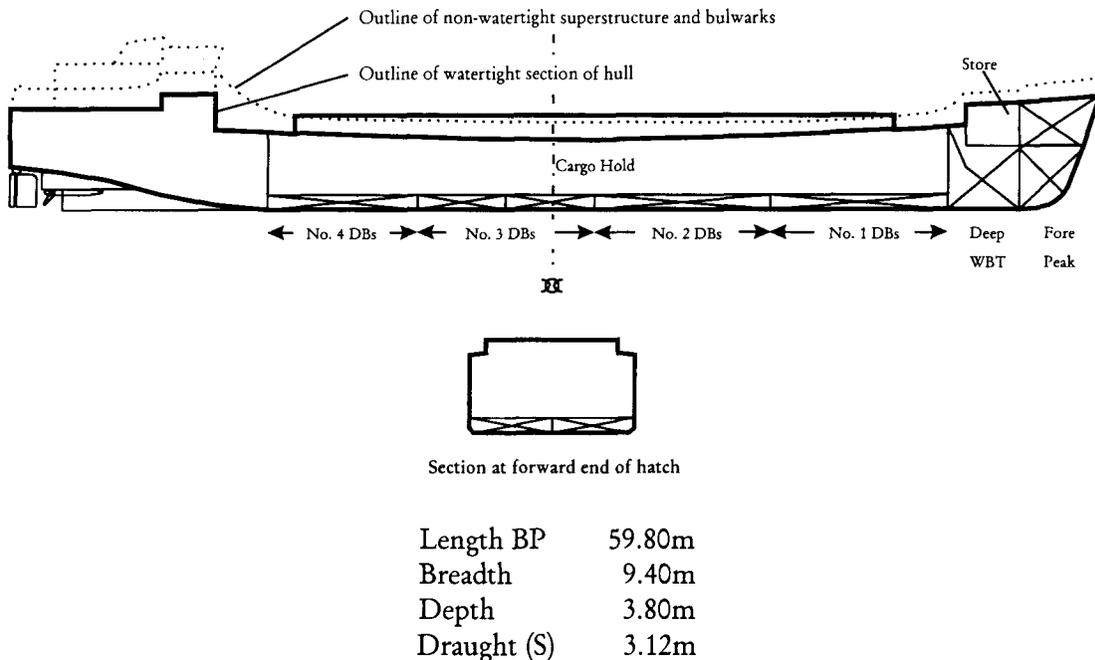
Figure 1. Main Arrangements of M.V. "Rema"

It can be seen that "Rema" had a substantial ballast capacity. This was of the order of 500m³, 270m³ of which was in the form of double bottom tanks lying entirely below the cargo hold.

Figures 1 and 3 show the extent of main hull that was considered water-tight in the calculations. For trimming by the bow the first positions for possible rapid down-flooding was identified as the forward corners of the cargo hatch lying at 5.175m above the keel line, $\pm 3.75\text{m}$ from the centre-line and 19.35m forward of amidships. In the assumed condition at the time of the initiation of the flooding it can be seen that the free-board to these down-flooding points would have been 1.84m and the heel angle required to immerse these points would have been 26 degrees.

No flooding of spaces aft has been considered in view of the evidence from the wreck that indicated that the vessel had plunged by the bow. Similarly, flooding of the forward store space and the upper fore-peak tank (see Figure 1) was not considered in the flooding scenarios since the evidence from the wreck suggested strongly that these spaces imploded during the sinking, therefore indicating that they were largely dry before the final plunging¹.

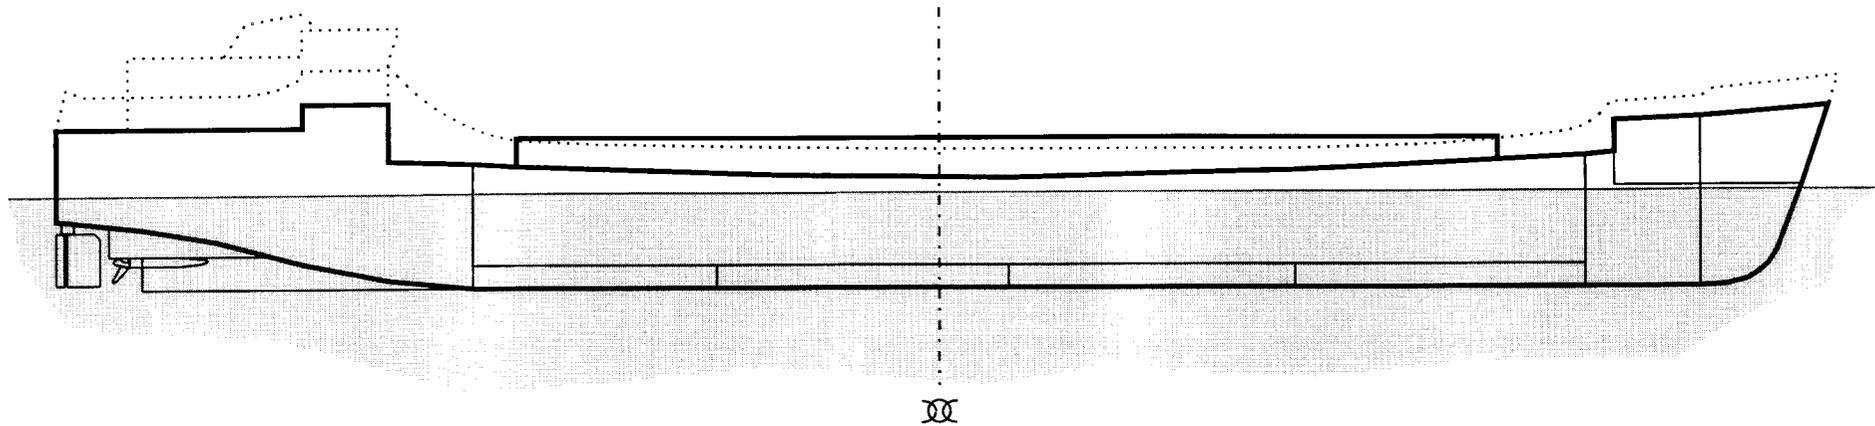
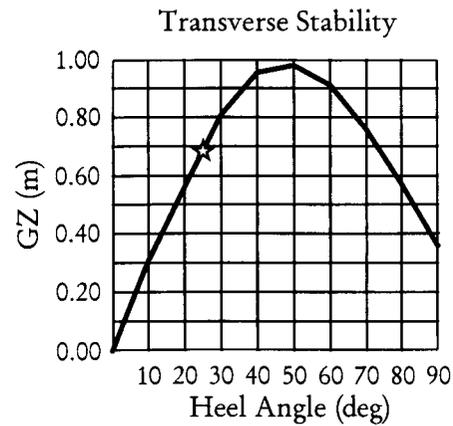
Figure 3. "REMA" Departure Condition

Figure 3, then, shows pictorially the floating attitude and resulting transverse stability of the "Rema" in the departure/casualty condition described in Table 1a. It can be seen that the vessel would have had appreciable stability, and this would have been largely influenced by the comparatively low centre of gravity of the cargo. Since stone chippings tend to have a large angle of repose (of the order of 55 degrees) and as a cargo is not liable to liquefy, it was considered very unlikely that shifting of cargo would have been involved in any initiating process in the casualty or, indeed, that it would have contributed in any way to the sinking sequence until the trim and/or heel had become large.

Draught Fwd: 3.35 m
 Draught Aft: 3.25 m
 Trim by bow: 0.10 m

Equilibrium $GM_{(fluid)}$: 1.77 m

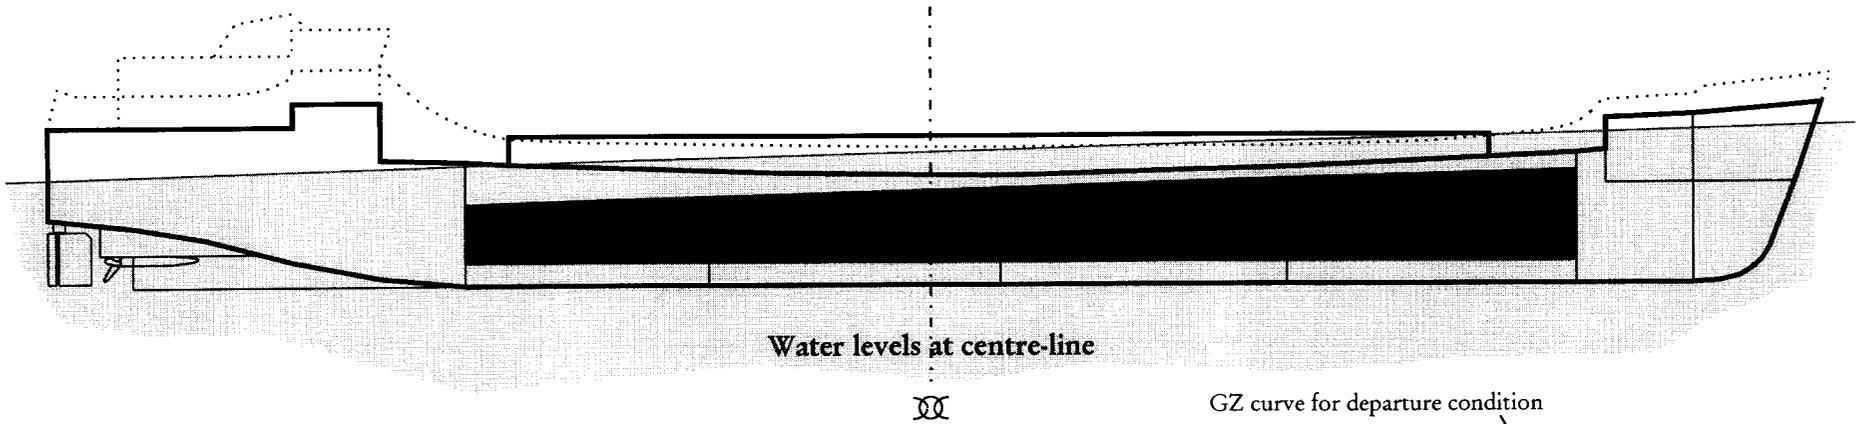
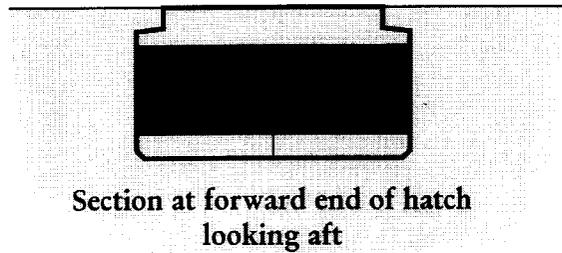
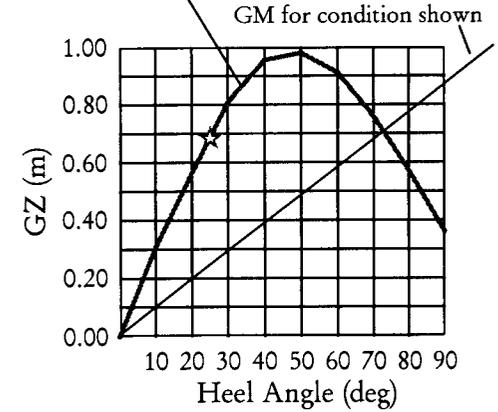
Figure 4b. CASE A:- Hold flooded to cause immersion of hatch edge

In all flooding simulations carried out it can be seen that the mean draught progressively increased (as expected of course), as did the trim by the head since most of the flooding was centred forward of amidships. Figures 4 and 5 show pictorially the progressive change in attitude of the vessel for CASE A and CASE G through to the point of sinking. These were considered to be the most likely flooding scenarios of those considered since they involved the minimum extents of bottom damage.

Draught Fwd: 5.51 m
 Draught Aft: 3.77 m
 Trim by bow: 1.74 m
 Heel angle: 0.00 deg
 GM_(fluid): 0.57m

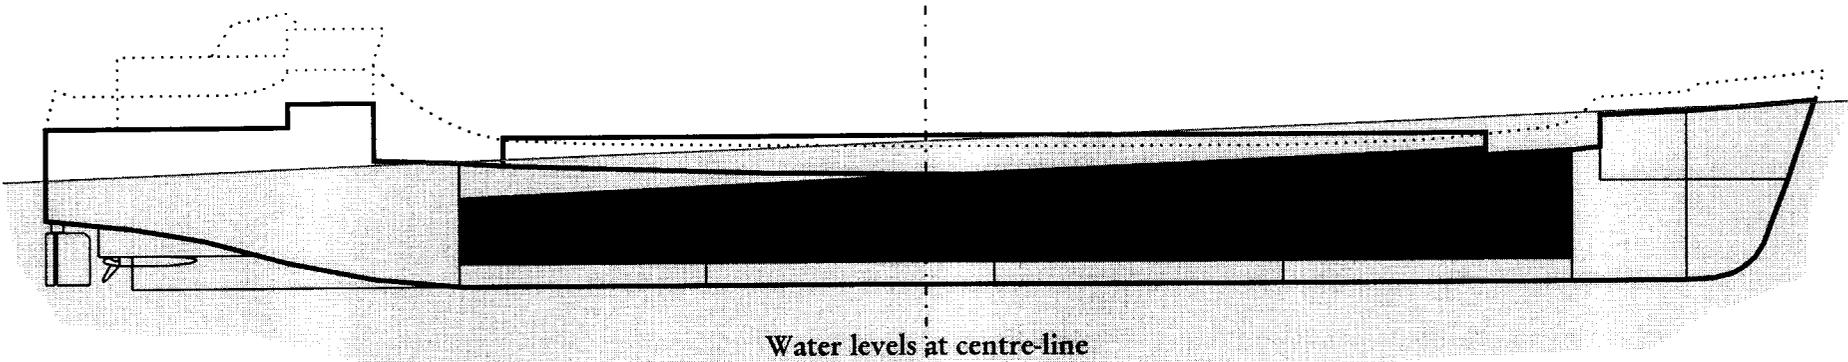
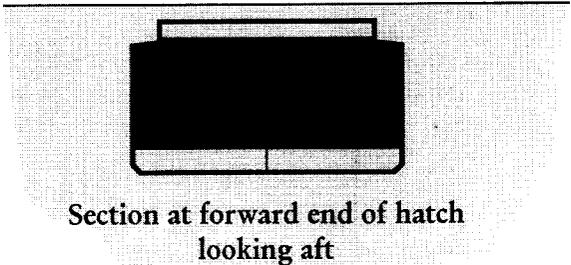
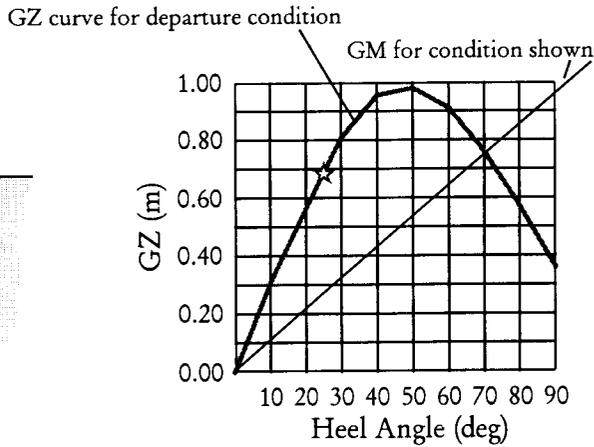
Figure 4c. CASE A:- Hold flooded to point of sinking

Draught Fwd: 6.21 m
 Draught Aft: 3.77 m
 Trim by bow: 2.44 m
 Heel angle: 0.00 deg
 $GM_{(fluid)}$: 0.64m

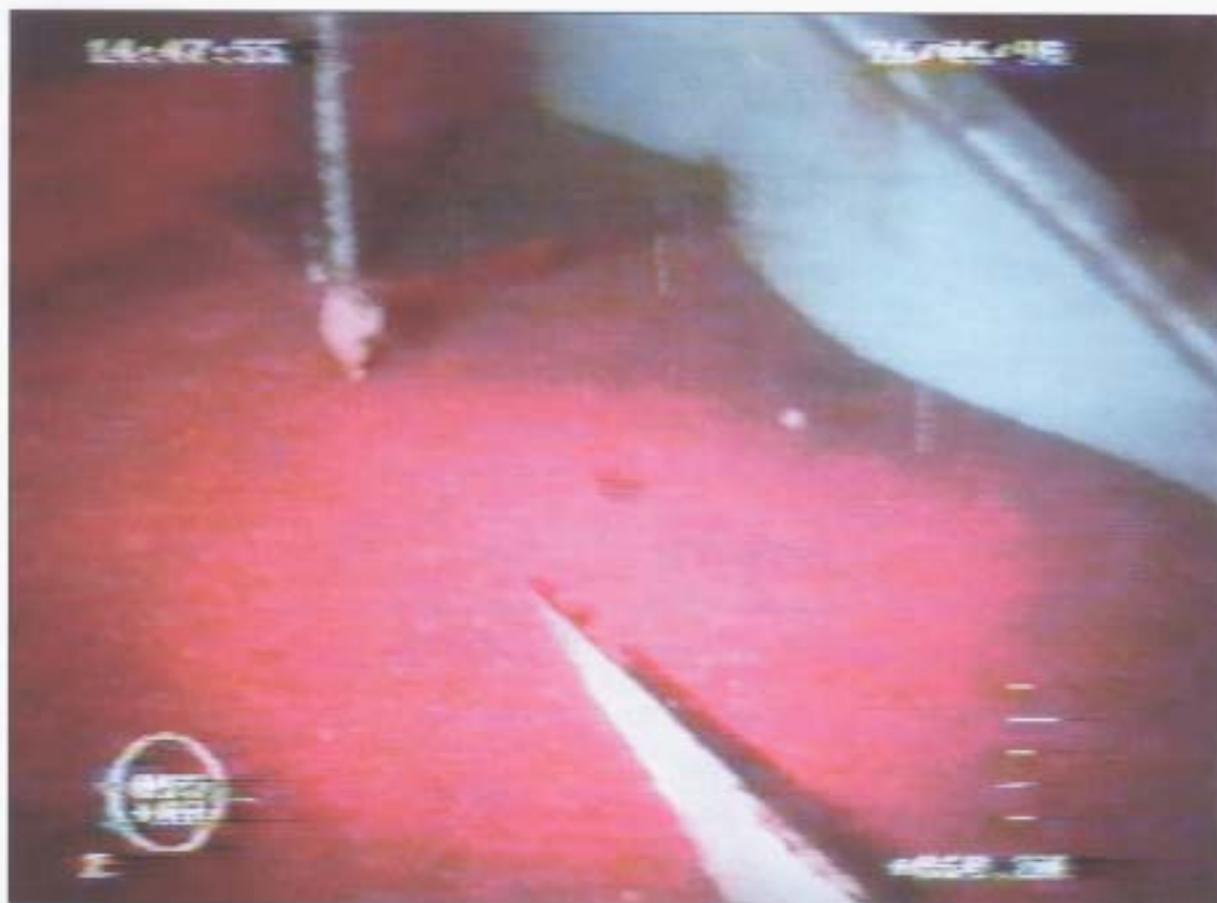
Starboard corner of main deck forward and forecastle — note residue of cargo

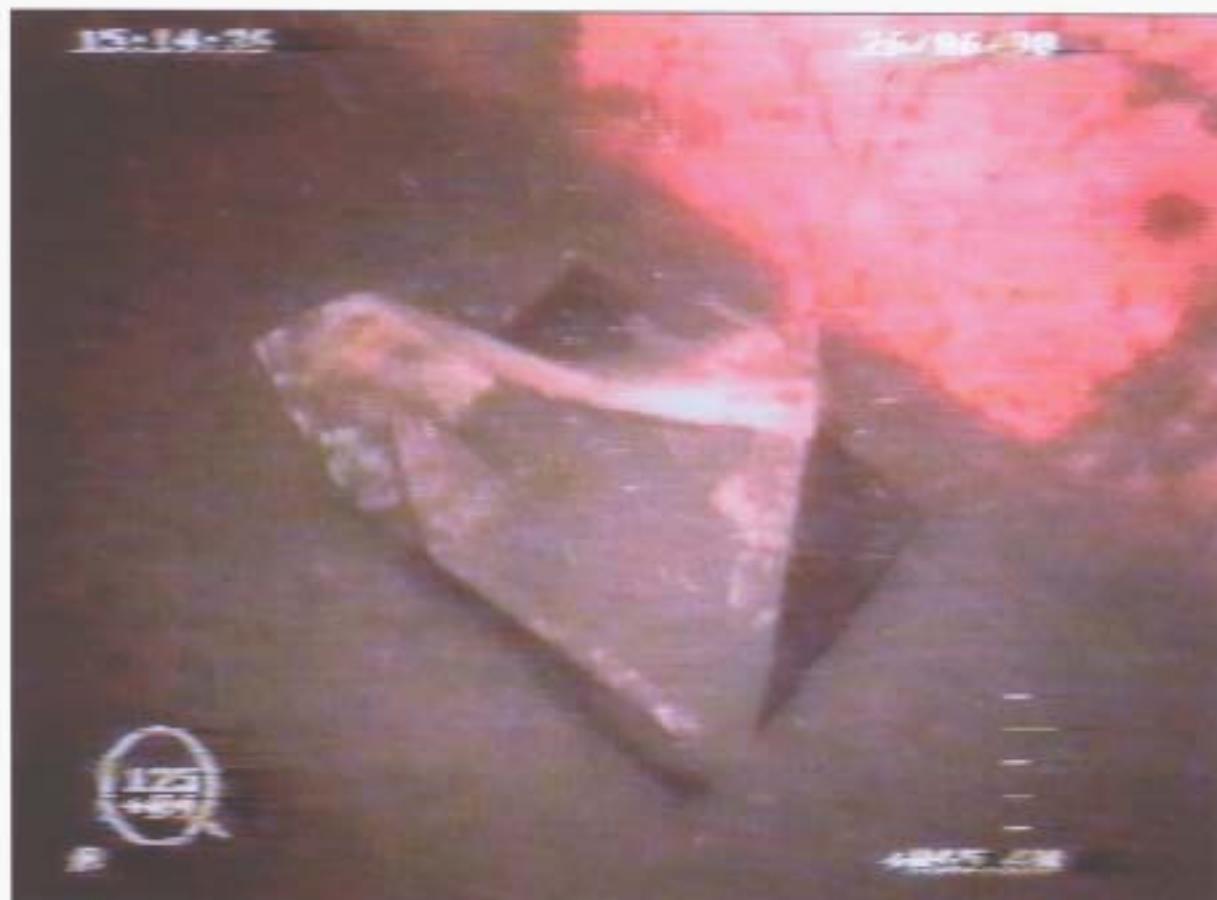
View of hold aft bilge suction (starboard) next to engine bulkhead — note crumpled bilge hat cover

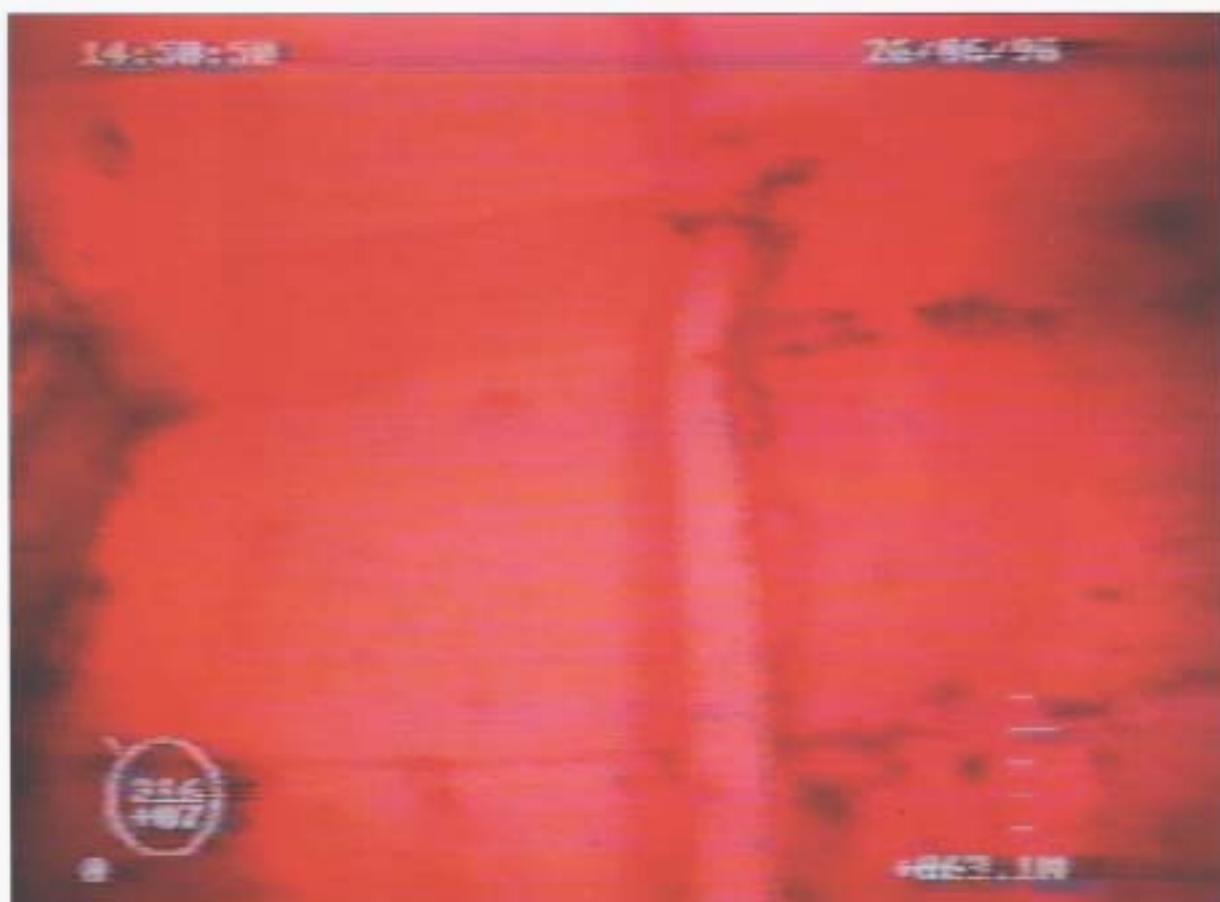
View of hold internal structure showing deformed side stringer due to water pressure

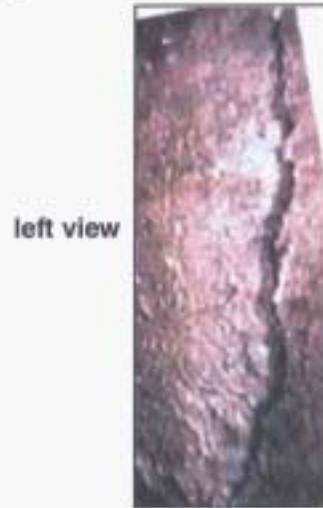
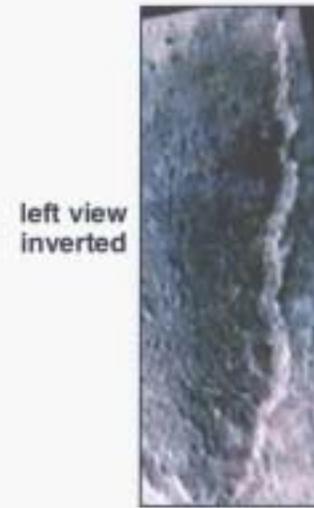
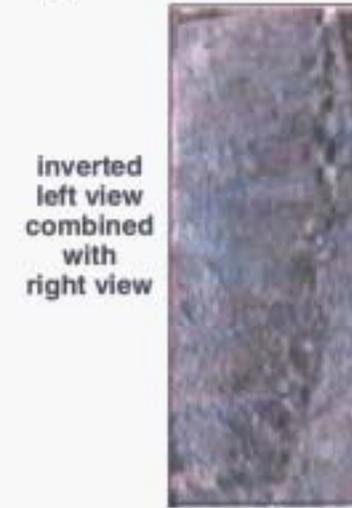
View of damaged area and possible "vertical crack". Image (a) is viewed and illuminated from the right, image (b) is viewed and illuminated from the left. Small images (c) and (d) are details of the "vertical crack", at the same scale and orientation, taken from (a) and (b) respectively. Image (e) is a colour-scale inverted version of (d). Image (f) shows the result of combining (c) and (e): if the vertical feature was a "crack" in the hull casting a shadow, then it would not appear equally, or simultaneously, in both left and right illuminated views. Image (f) shows the "vertical crack" is cancelled out by combining the inverted left view with the right view. This means the "vertical crack" is not a shadow cast by a parting in the plates, but a dark colouration of the hull, and probably damaged paint-work.

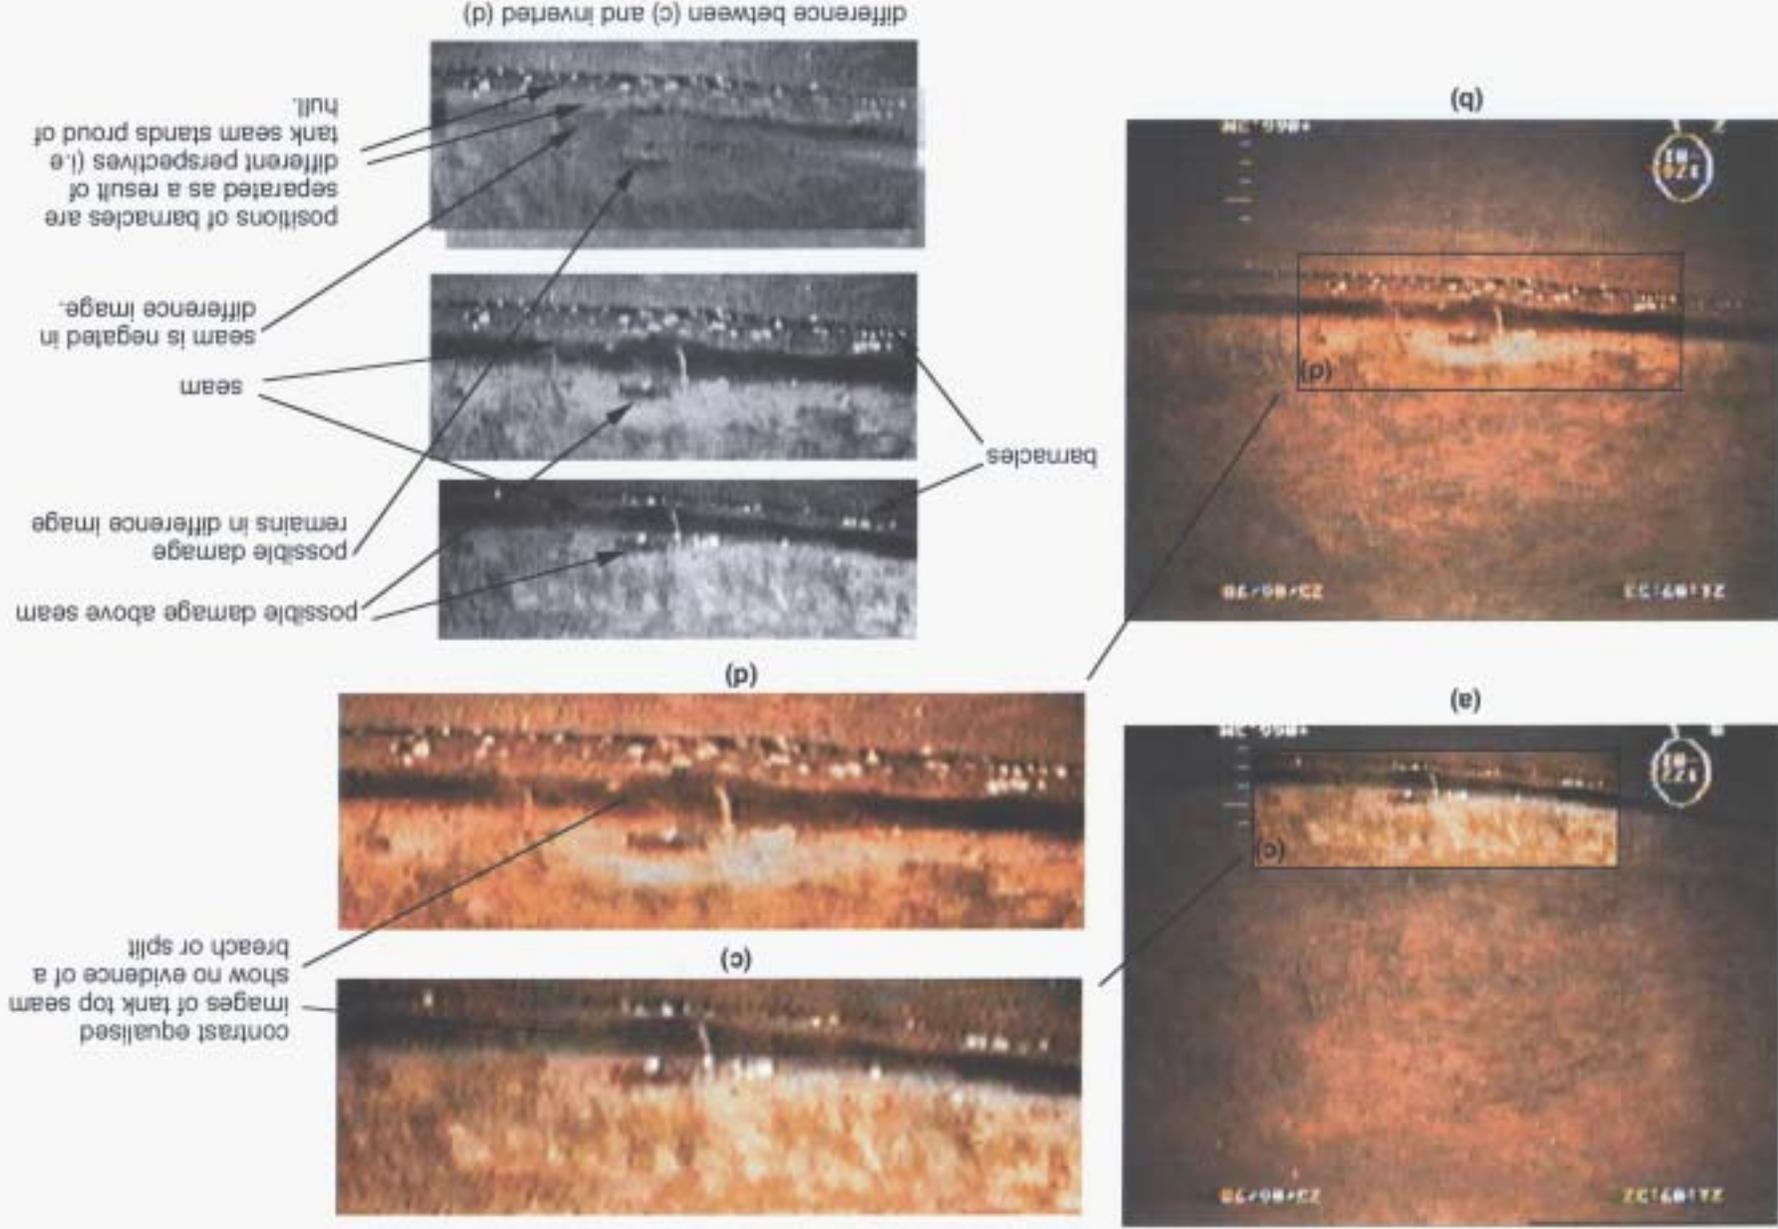
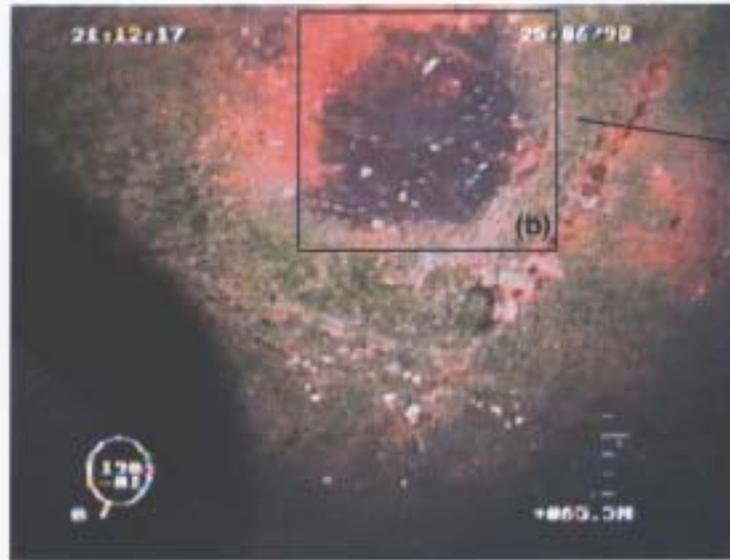
"PIPE INLET"

Image of circular mark possibly indicating seawater intake.

Contrast equalised image of circular mark showing interior features inconsistent with the presence of any inlet hole. Instead, the features show discoloration of metal platework which is continuous across the area.

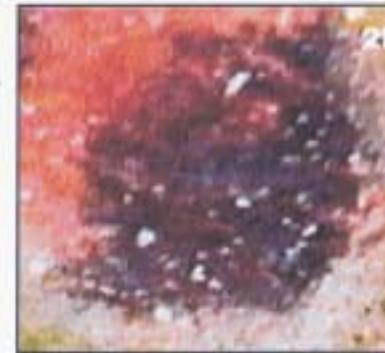
Contouring of contrast gradients within the equalised image of the circular mark showing interior features indicating plate work is continuous across the area of the discolouration.

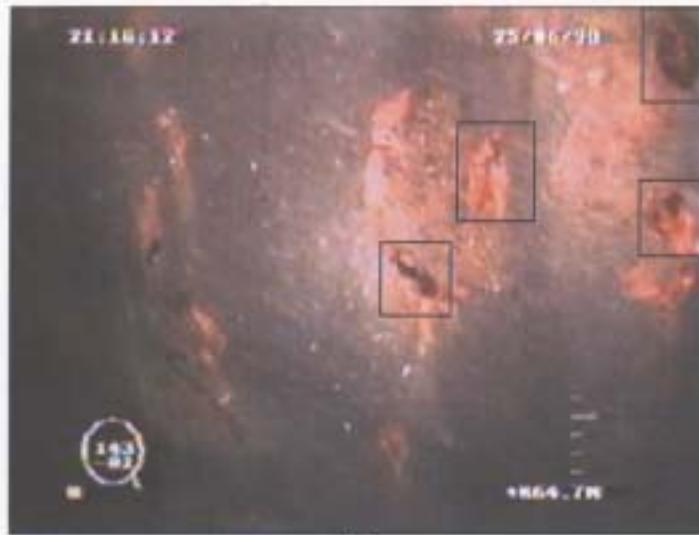
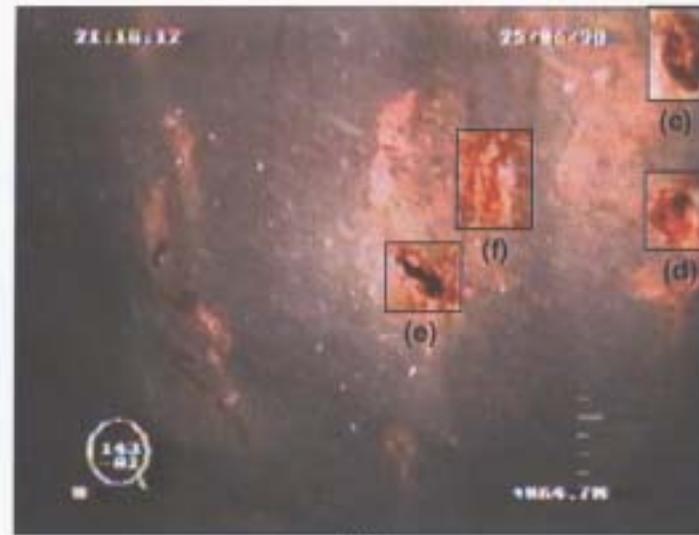
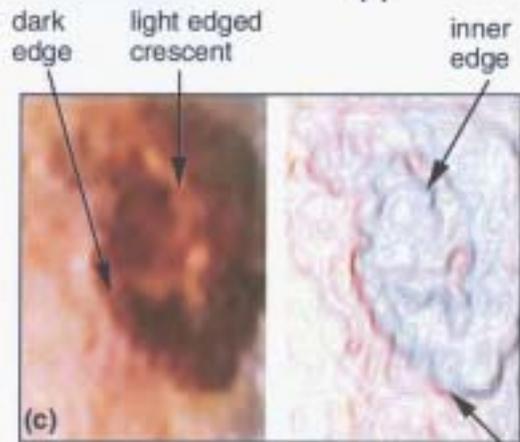
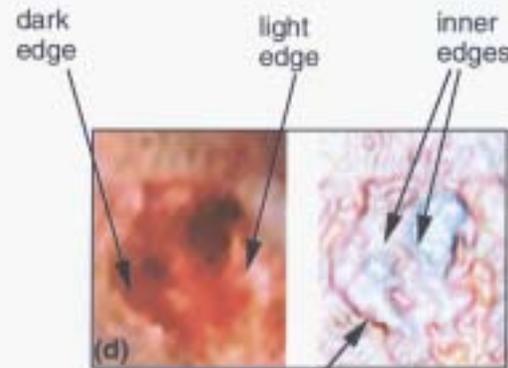
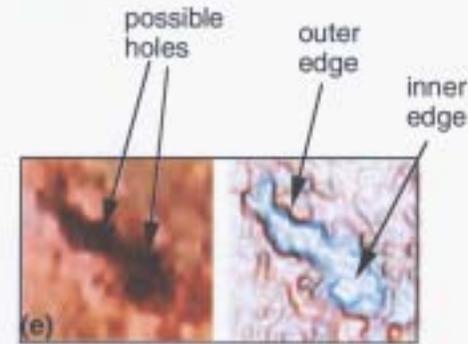
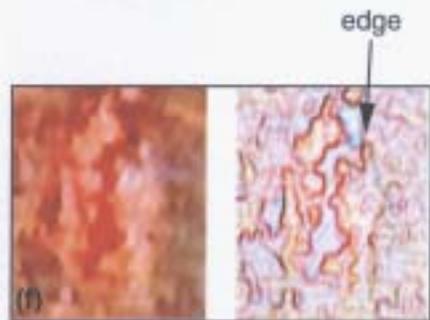
Image of area of "general corrosion" (a), and with contrast equalised details inset (b). The details are shown with gradients between light and dark areas contoured (i.e. showing second differentials in contrast between light and dark areas). The contrast equalised, detailed areas show light and dark edges, and inner and outer rims, consistent with the dark areas having a negative surface relief (i.e. they are indentations or perforations in the surface). By comparison, the dark area in detail (f) does not have light and dark edges, and probably does not have any significant relief.

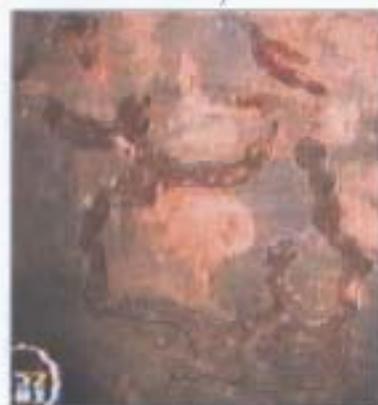
Details of areas of "corrosion" showing outlined edges between darker discolouration and lighter areas.

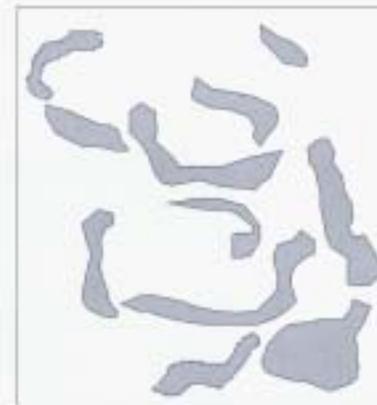
Sketch summary of the differences between the darker and lighter regions, with the darker regions (cross-hatched) being deeper relative to the lighter regions (i.e. indicating areas of general corrosion and wasting).

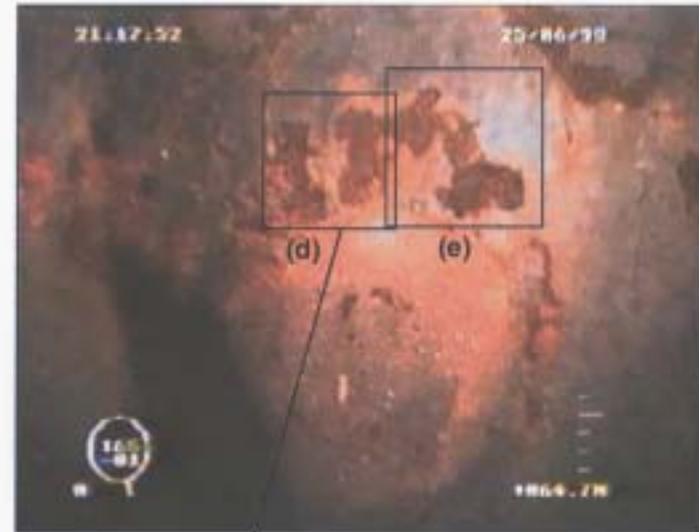
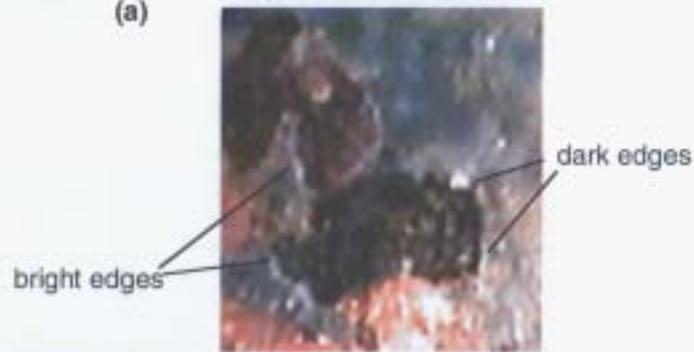
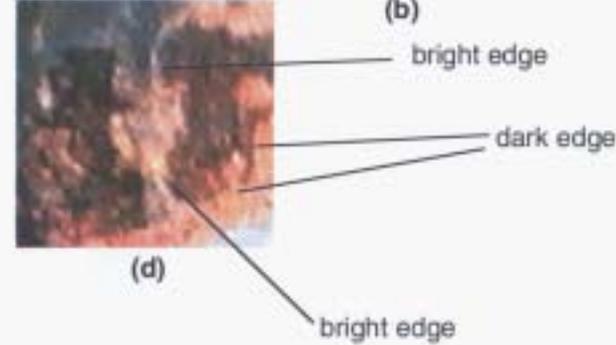
AREAS OF "GENERAL CORROSION"

Areas of "general corrosion", (a) and (b) are views from different positions and perspectives. Views (c) and (d) are details, contrast optimised to show variations in illumination. The dark regions in views (c) and (d) are generally bordered by light rims to the left (reflective edges) and dark rims to the right (shadowed edges). Illumination is from the right, therefore the rims show relief between the dark and light areas such that the darker areas are depressed relative to the lighter areas. This difference in relief is demonstrated by the difference between the detailed areas (f) (after correction for perspective and scale) showing dark rims (i.e. shadow) on the right edge of the dark regions and light rims (i.e. reflective) on the left rims. This suggests the darker regions have lower relief compared with the lighter areas and are probably areas of general wasting of the plates.

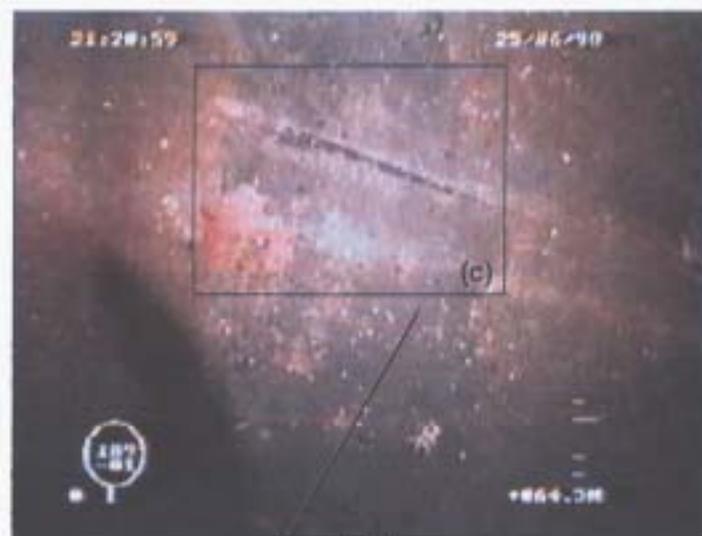
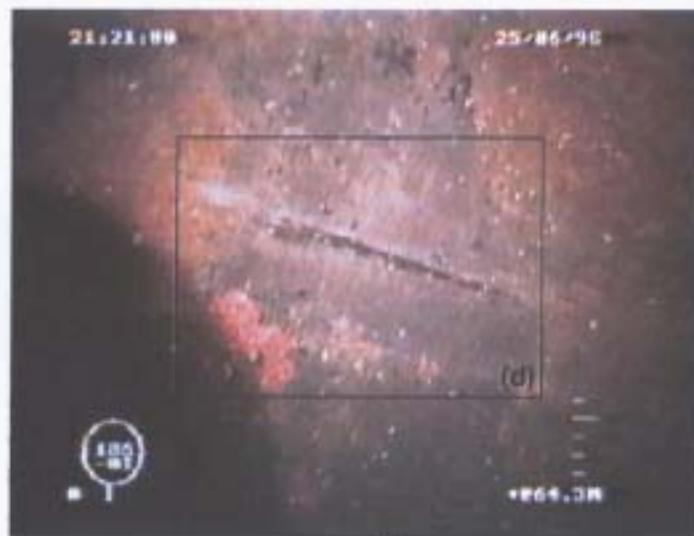
LINEAR DAMAGE

Different views (a) and (b) of a possible "split".

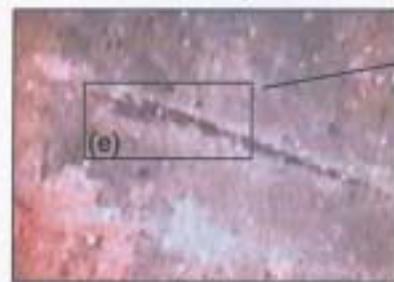
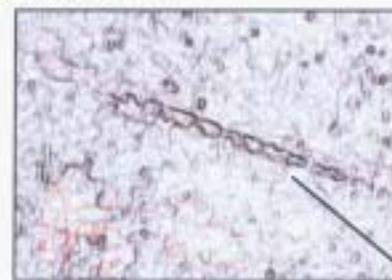
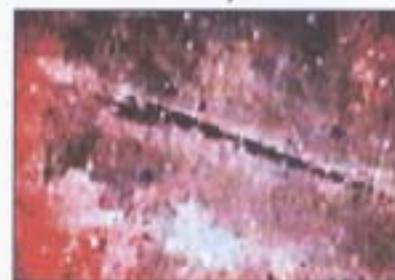
Inset, details of "split" (c) and (d), and enlargement (e) show colour variations within the "split" area, indicating the discolouration of the surface rather than perforation.

Contouring (g) of the contrast gradients between the light and dark regions in image (c) also show that the "split" actually comprises a series of dark areas aligned diagonally across the image, and is not a linear rupture of the surface.

Image (f) is the contrast equalised version of detail (d), and shows the "split" to be an alignment of a series of dark regions.

"split"
Difference (h) between details (c) and (d) (after correction for perspective and scale) also shows the "split" as a line of light and dark regions but with no evidence of surface relief.

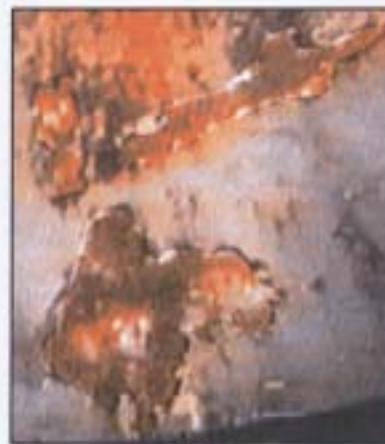
Details of the rust patch: (e) after contrast optimisation, (f) after contrast equalisation and (g) after contouring of edges of different contrast within the area of interest. Both the longitudinal area of damage and the more circular area comprises discoloured plate, but with no obviously very dark regions that would be evidence of perforation.

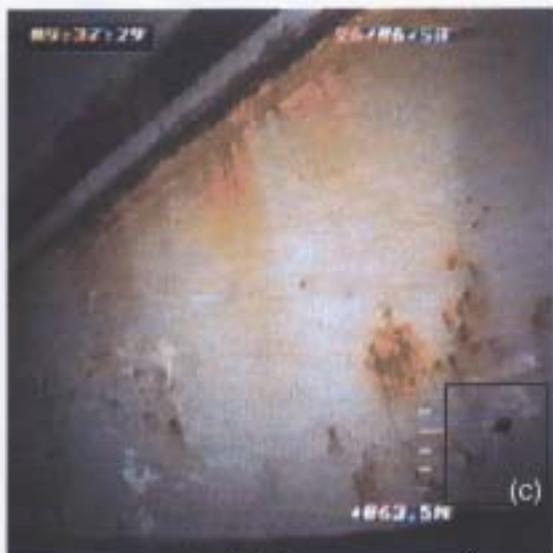
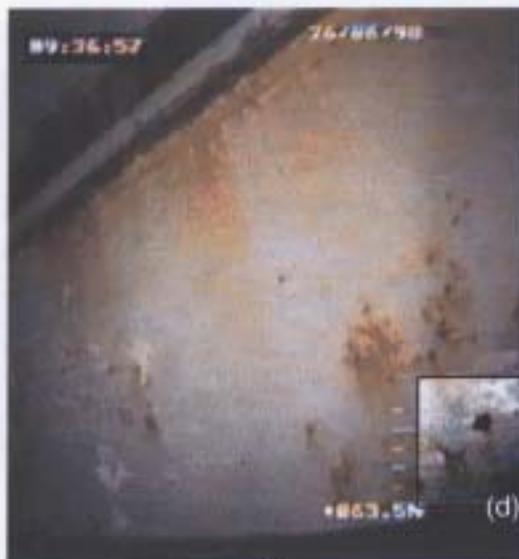
SMALL HOLE OR RUST SPOT

Images of possible "hole" in plates. Image (a) is the "hole", and (b) is the "hole" after contrast equalisation. Images (c) and (d) are enlargements of the areas of interest, and (e) is contoured for edges (second order differential). Both (d) and (e) show complex variations in discolouration within the "hole", indicating wasting. However, contouring of the contrasted edges (images (e) and inset) shows a possible hole, roughly circular in shape, that is consistent with the presence of a perforation of the plate.

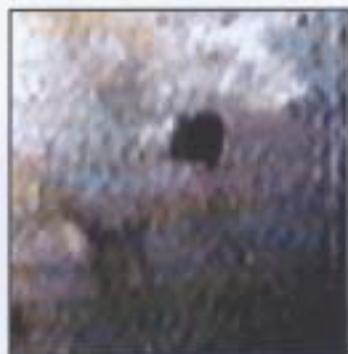
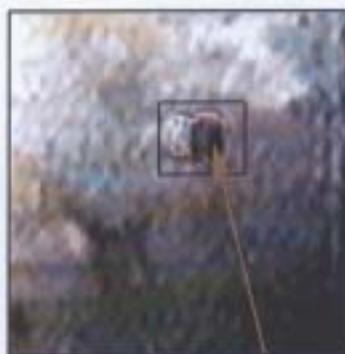
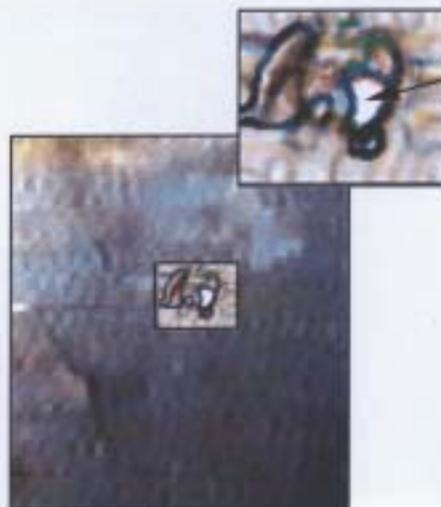
Details of the "hole": (c) after contrast optimisation, (d) after contrast equalisation, and (e) after contouring of edges of different contrast within the area of interest. Inset detail of contoured edges shows no internal structure within the innermost concentric edge, and is therefore probably a perforation of the plate, roughly circular in shape.

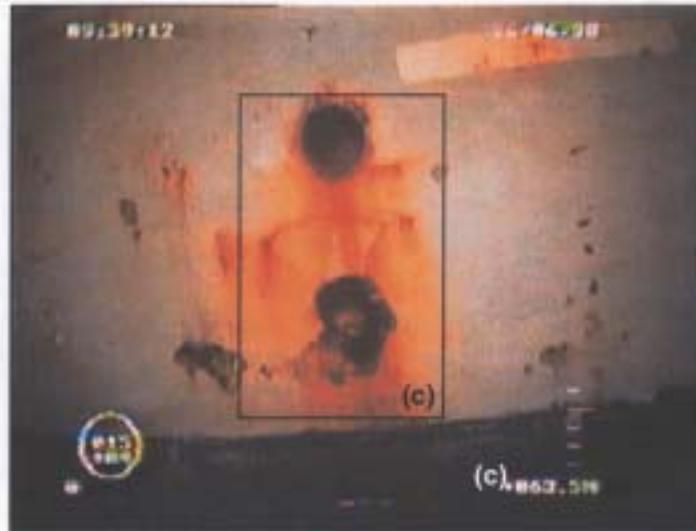
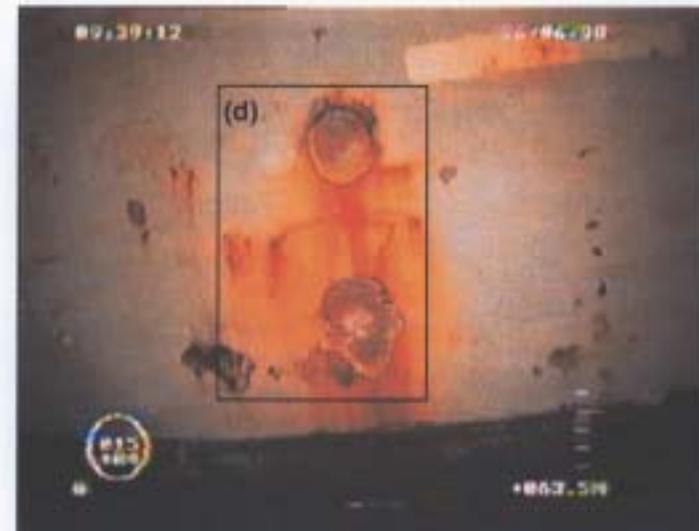
HOLES OR SCUPPER DISCHARGE VENTS

Images of possible "holes or scupper discharge vents" in hull. Image (a) is the area of interest, and (b) is the area of interest after contrast equalisation. Images (c) and (d) are enlargements of the areas of interest, and (e) is contoured for edges (second order differential). Images (c), (d) and (e) show variations in discolouration within the "holes or scupper discharge vents", indicating wasting but no perforation of the plate.

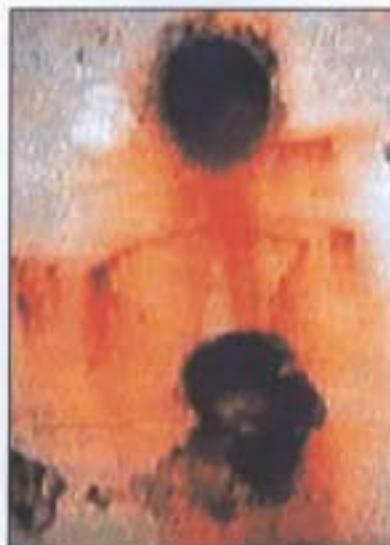
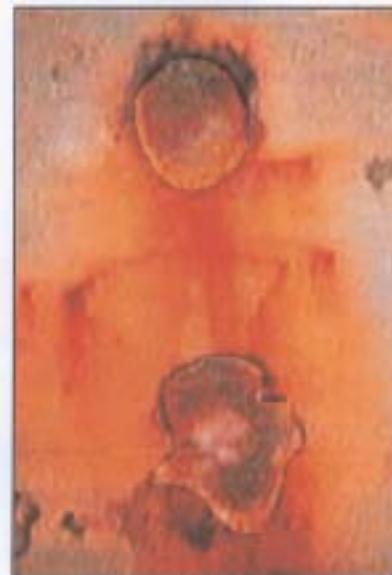
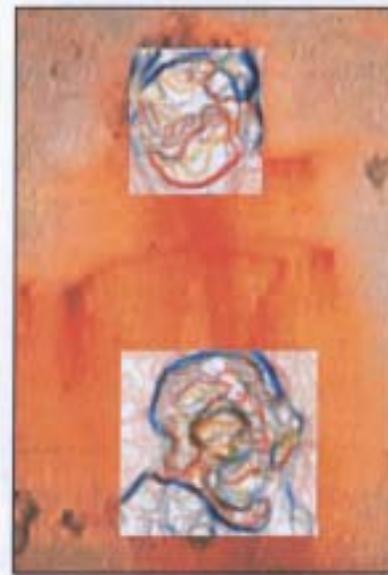
Details of the "holes or scupper discharge vents": (c) after contrast optimisation, (d) after contrast equalisation, and (e) after contouring of edges of different contrast within the area of interest. Internal structure within the "holes or scupper discharge vents", are evidence that there is no perforation in the plates.

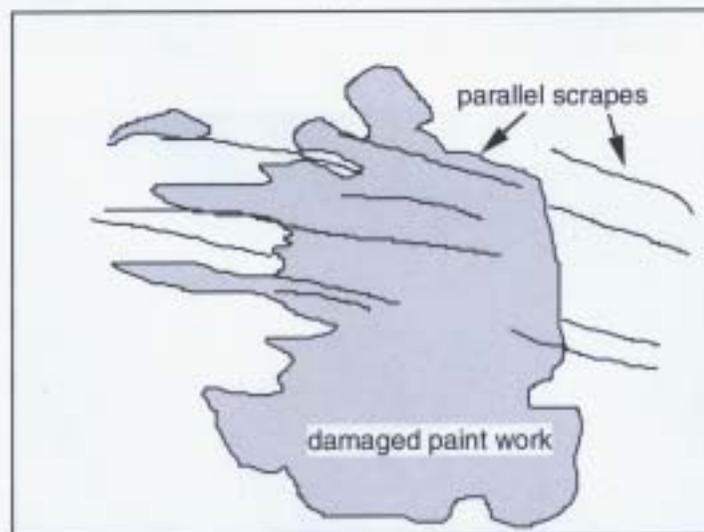
SCRAPES ALONG THE STARBOARD SIDE OF THE HULL

Images of scrapes along the starboard side of the hull. Images (a) and (b) are the areas of interest, and (c) and (d) are line drawings of the essential features in those areas of interest. Significantly, both areas show similar features: a large irregular area of damage to paint work, with parallel and subhorizontal scrapes superimposed upon them. The scrapes clearly cross, and are hence younger than, the damaged paint work.

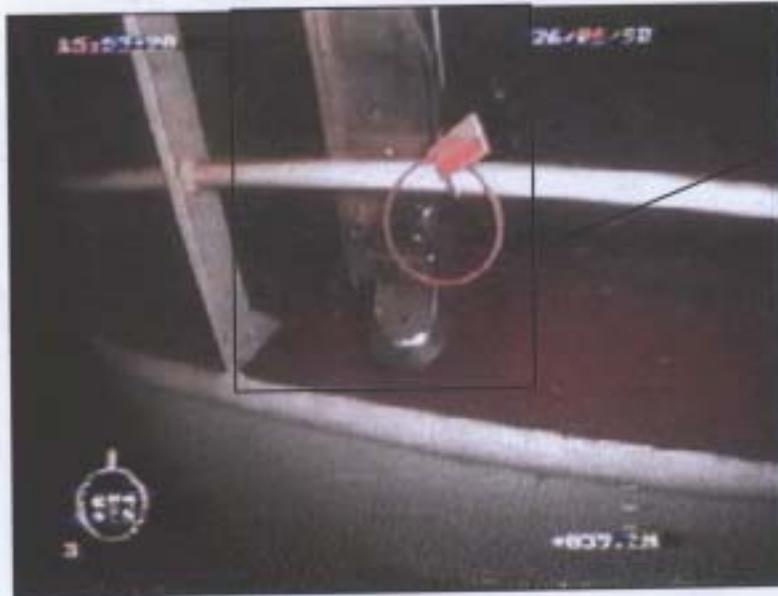
EPIRB on boat deck attached to rail

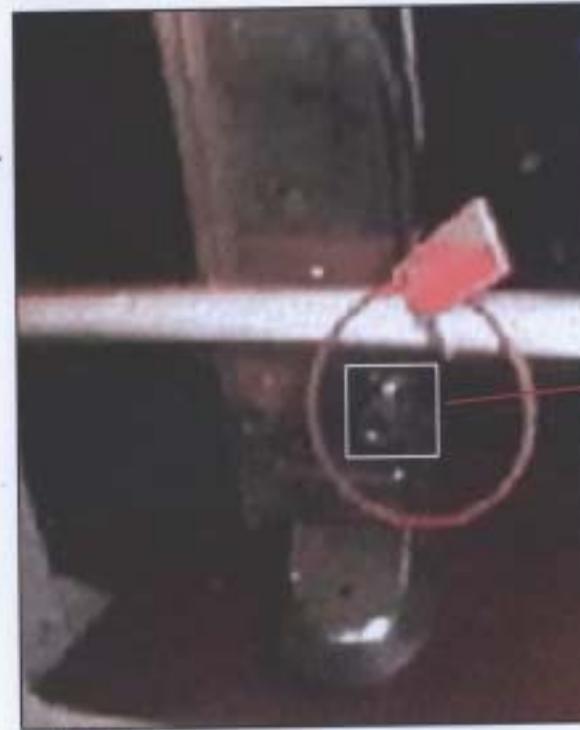
Detail of EPIRB showing catch and loop

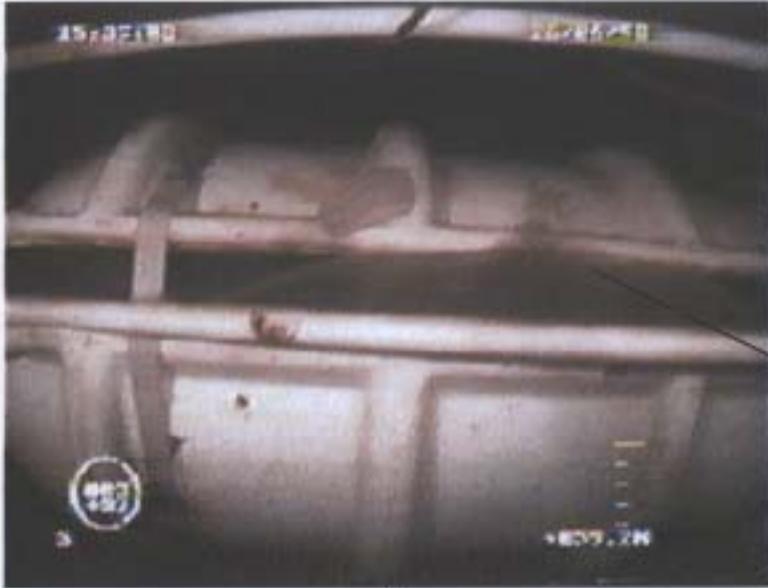
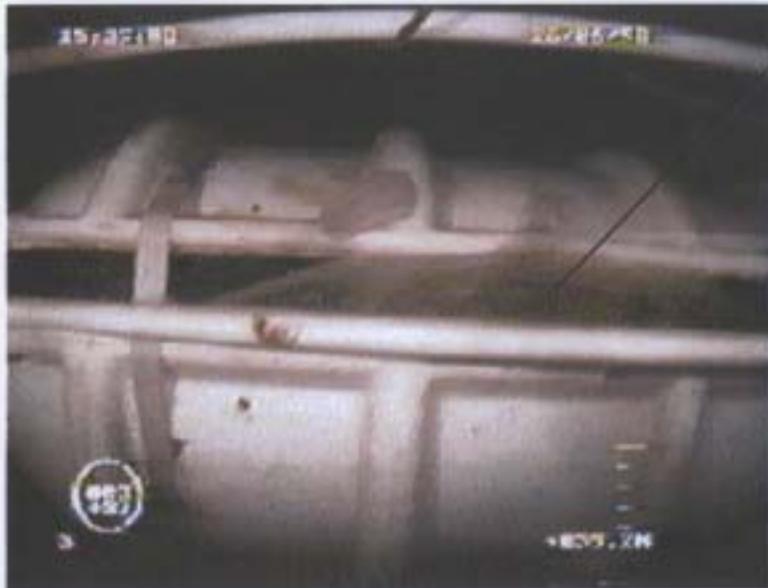
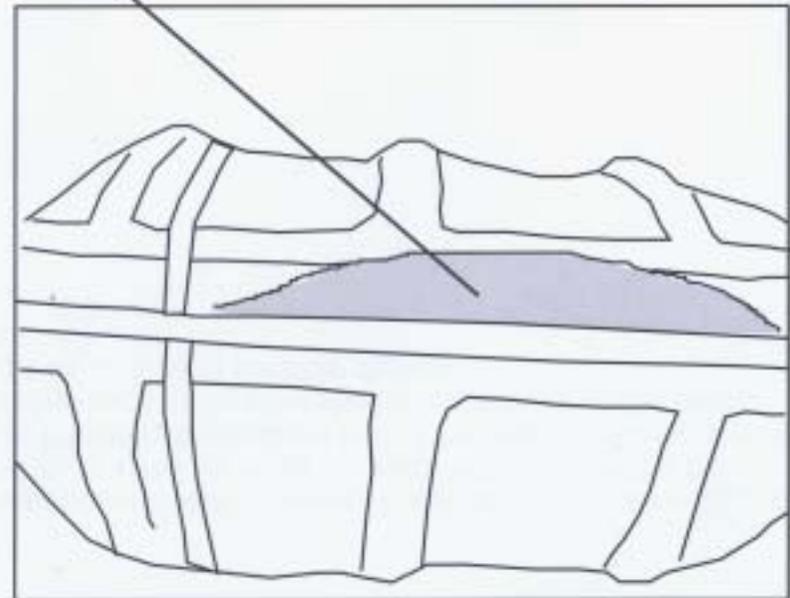
STARBOARD LIFERAFT

Images of starboard liferaft (a), showing exposed part of liferaft that has breached the casing seal and partially escaped the exterior casing. Same image as (a) but after contrast equalisation (b), showing more clearly the exposed liferaft material. Line drawing (c) showing main features of the external casing, the casing seal and the exposed liferaft.

exposed canopy or part of inflatable liferaft, breaching seal on external casing.
