NAME OF VESSEL
REMA

At 0221 the Belize registered MV Rema broadcast a Mayday on VHF ch16 its position approximately 22 miles NE of Whitby. A search of the area using RNLI lifeboats, RAF helicopters and several Merchant vessels located the wreck of the vessel but its 4 crew were not found and considered to have perished with the vessel.

The purpose of this investigation was to perform calculations to explore the extent of flooding that would be necessary to sink the "Rema" in a manner that was consistent with the known circumstances of the casualty and the evidence available from the wreck. If possible, the investigation was to attempt to narrow in on the position and extent of damage that, at least on the balance of probabilities, is likely to have been involved.

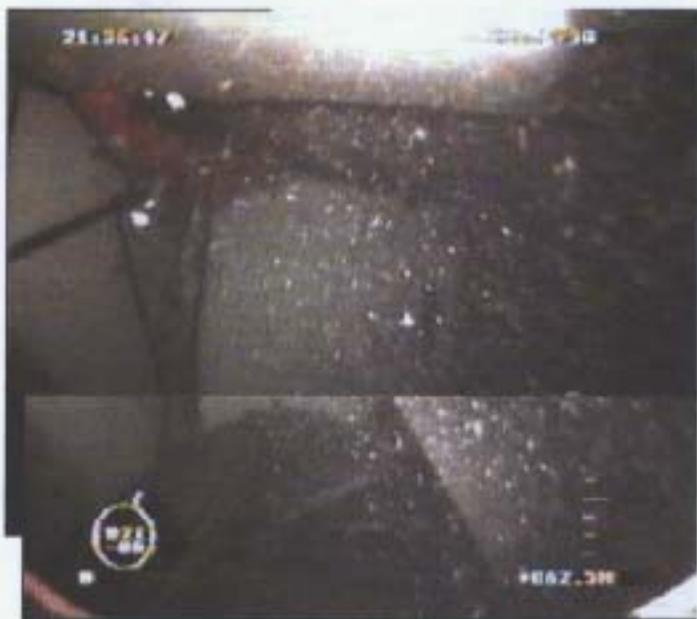
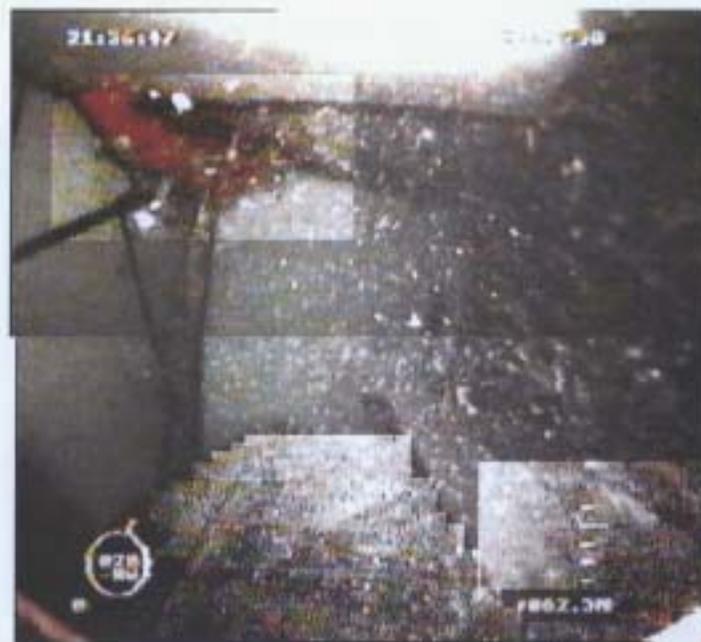
VIEW OF INTERIOR OF ROBERT CLAYTON'S CABIN

Mosaic of two images of interior of cabin.

Contrast equalised regions of image of interior of cabin: upper left object is floating life-jacket, lower areas are the floor of the cabin showing debris only.

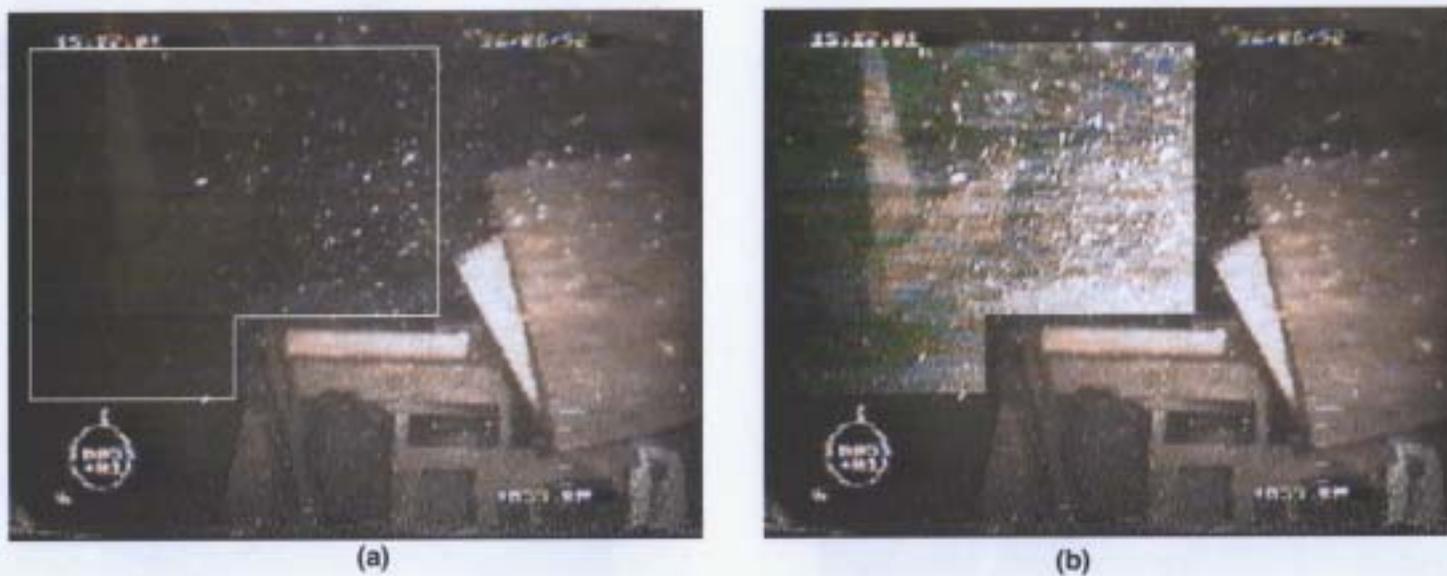
INTERIOR OF BRIDGE

Interior of bridge (a), and (b) contrast equalised darkest regions showing general debris only.

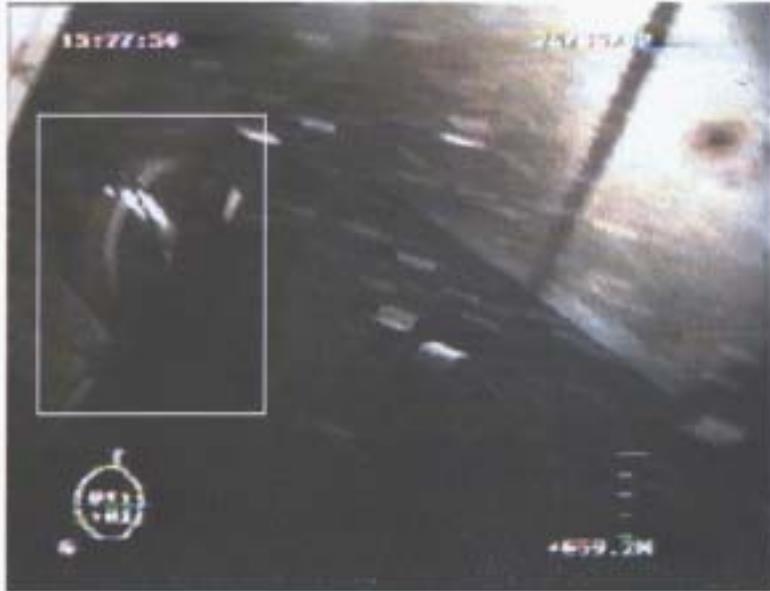
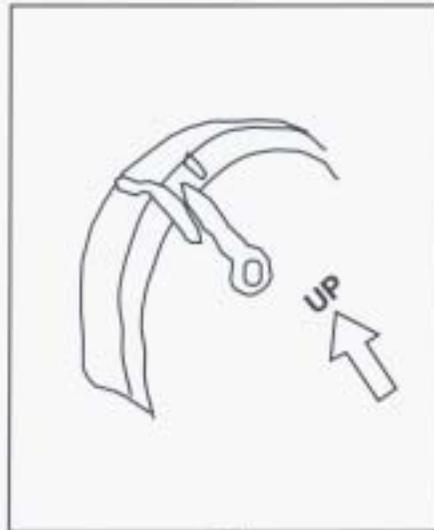
ENGINE CONTROLS

Image (a) of interior of bridge showing possible "engine controls" (outlined). Below, detail of inset (b), enlarged and contrast optimised, showing crescent-shaped bright feature and linear feature extending from crescent centre to mid-point. Line drawing (c) showing prominent features of bright object: curved object with radial spar extending from centre to mid-point and pointing upwards.

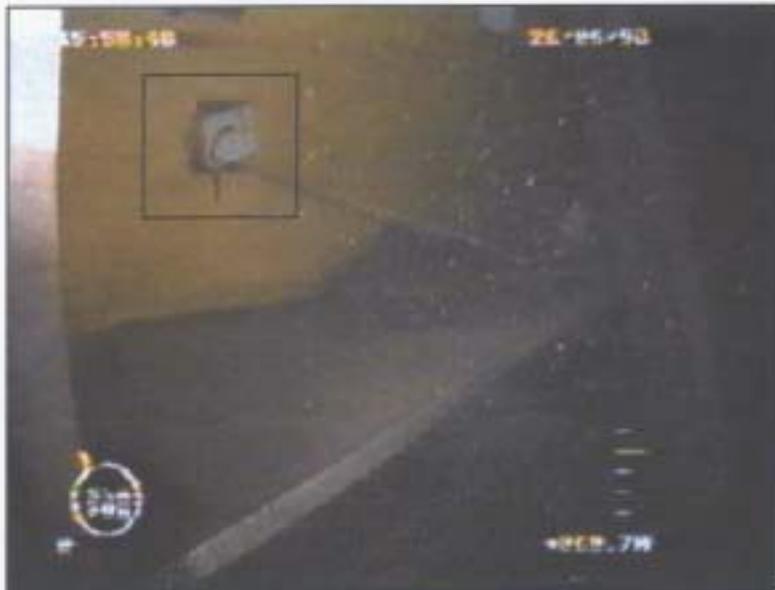
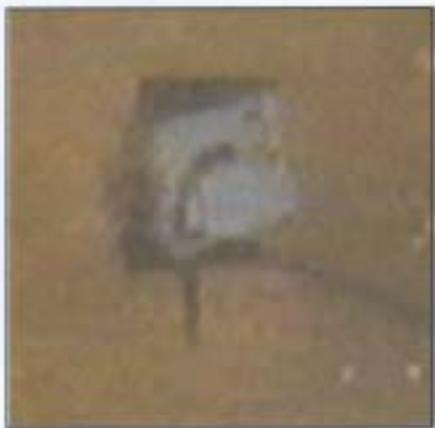
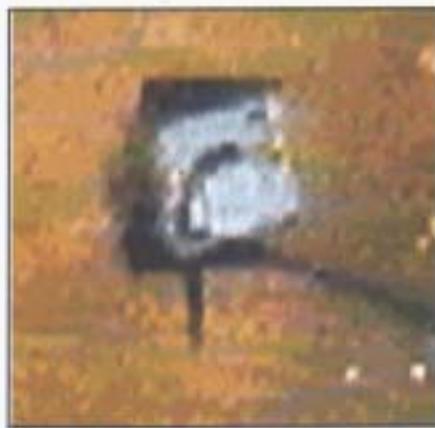
SOCKET AND PLUG ATTACHED TO CABLE IN CREW ACCOMMODATION

Plug and socket with attached cable. The cable leads to the right of the image and is at an angle to horizontal. The plug and socket are rotated anticlockwise by $\sim 15^\circ$.

Detail of plug and socket, showing rotation of socket relative to its wall box.

Detail of plug and socket, contrast equalised, showing rotation of socket relative to wall box, and switch in "on" position..

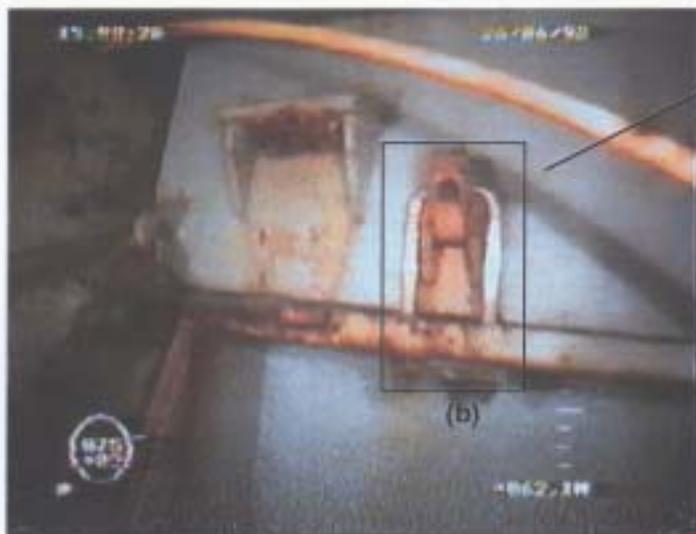
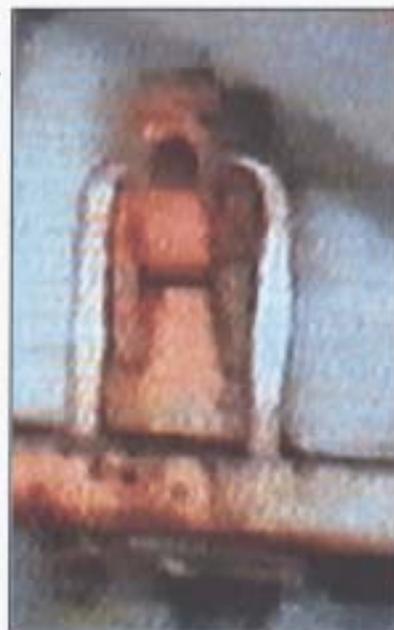
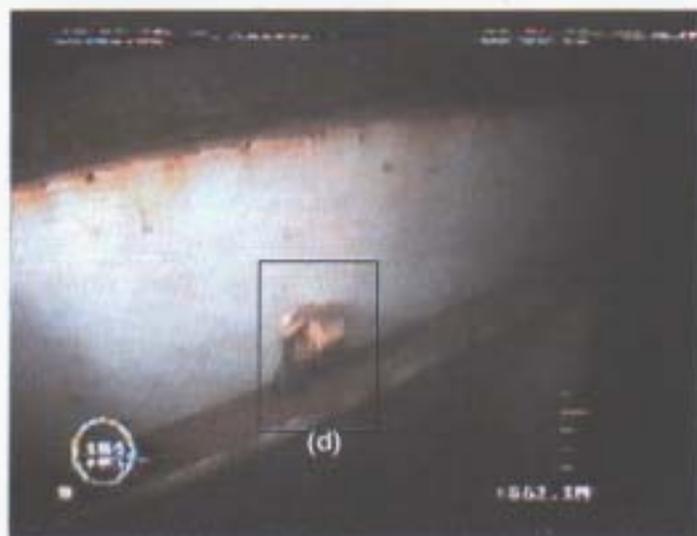
AFT SIDE HATCH COVER CLEATS

Aft side of hatch cover with cleat in place (a). Detail (b) of inset showing cleat in place on hatch cover.

Second hatch cover forward from aft side with cleat in place (c). Detail (d) of inset showing cleat in place on hatch cover.

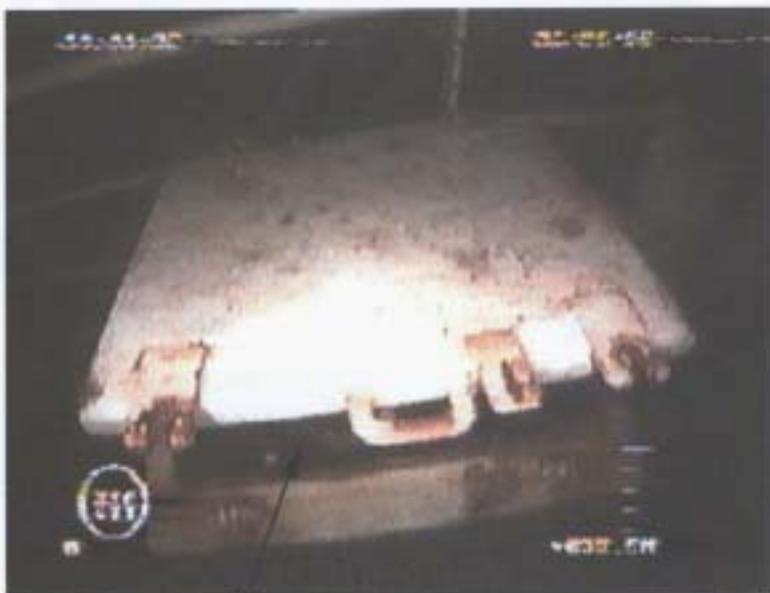
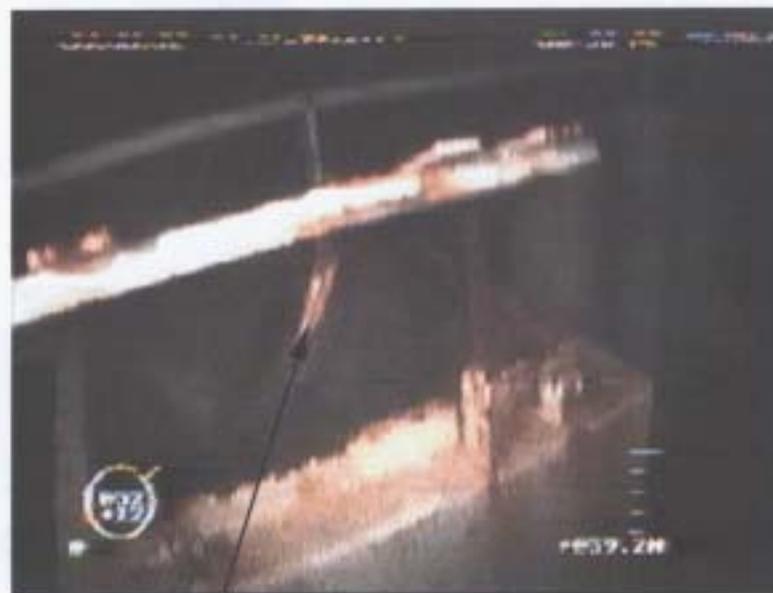
FORWARD, STARBOARD SIDE HATCH COVER

hatch cover partially open

cleat/dog in open position
