Marine Accident Report 5/99

Report of the Inspector's Inquiry
into the loss of

mv GREEN LILY

on the 19 November 1997
off the East Coast of Bressay, Shetland Islands

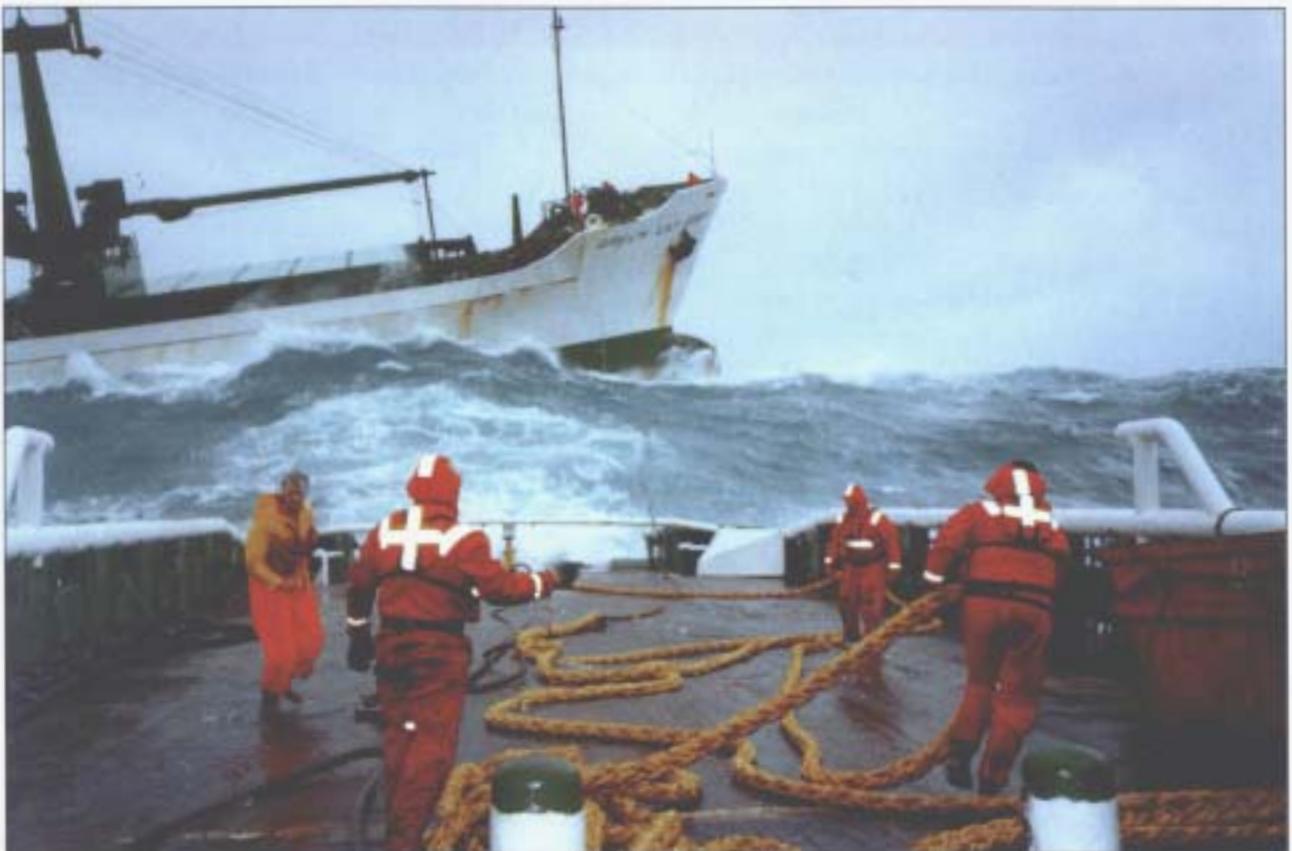
View of MV GREEN LILY from aft deck of GARGANO prior to connection of tow

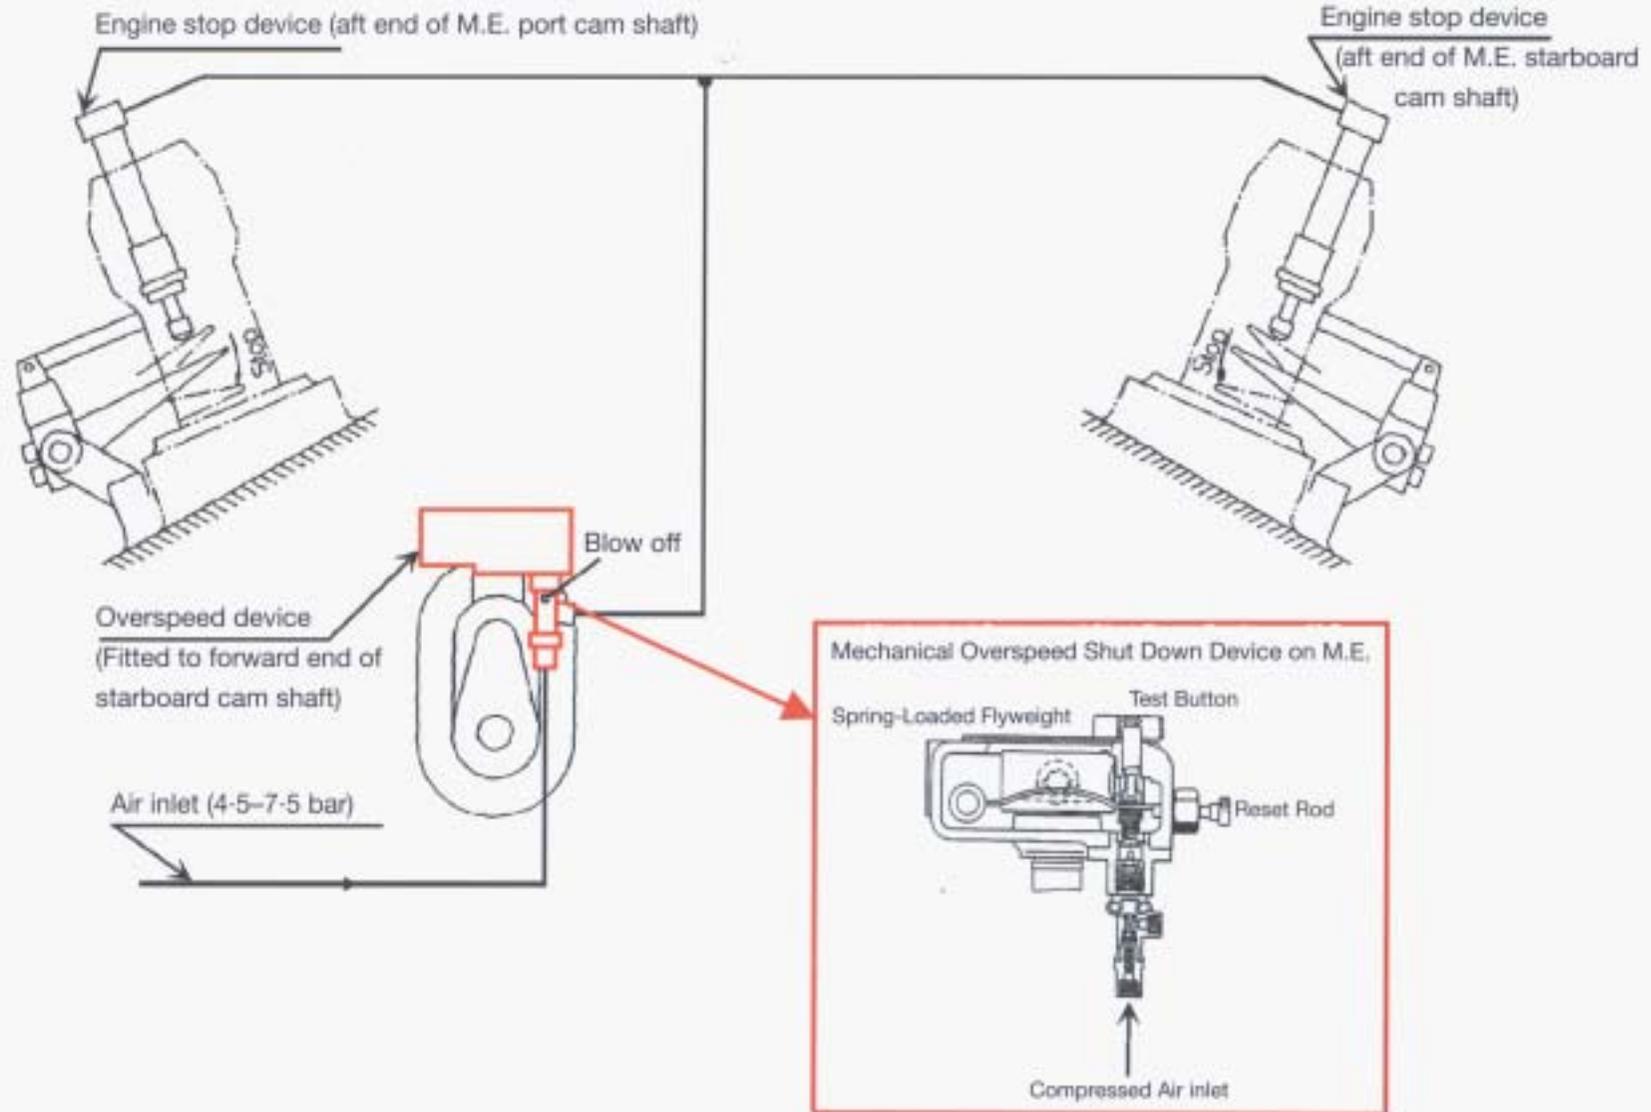
MV GREEN LILY — Arrangement of Mechanical Shutdown System

1.10.2 The engine-driven, mechanically operated, over-speed tripping device was fitted at the front end of the engine and consisted of a spring-loaded flyweight acting on a compressed airball valve. In the event of the engine over-speeding, the spring-loaded flyweight moves outward pushing an operating arm downward. The downward movement of this arm causes the ball valve to open admitting compressed air to two stop cylinders, one on each fuel pump regulating shaft, forcing the linkage of the fuel pump regulator shaft into the stop, or “zero fuel” position. At the same time, the operating arm becomes locked into the down position. Once tripped, manual resetting was required to allow the operating arm to return to the upper position, venting of the engine stop devices, and release of the fuel pump regulating shaft. Without being reset, the fuel pump regulating shaft remained in the “zero fuel” position.
