Marine Accident Report 2/99

Report of the Inspector's Inquiry
into the collision of

mv SAND KITE

with the
THAMES FLOOD BARRIER
on 27 October 1997

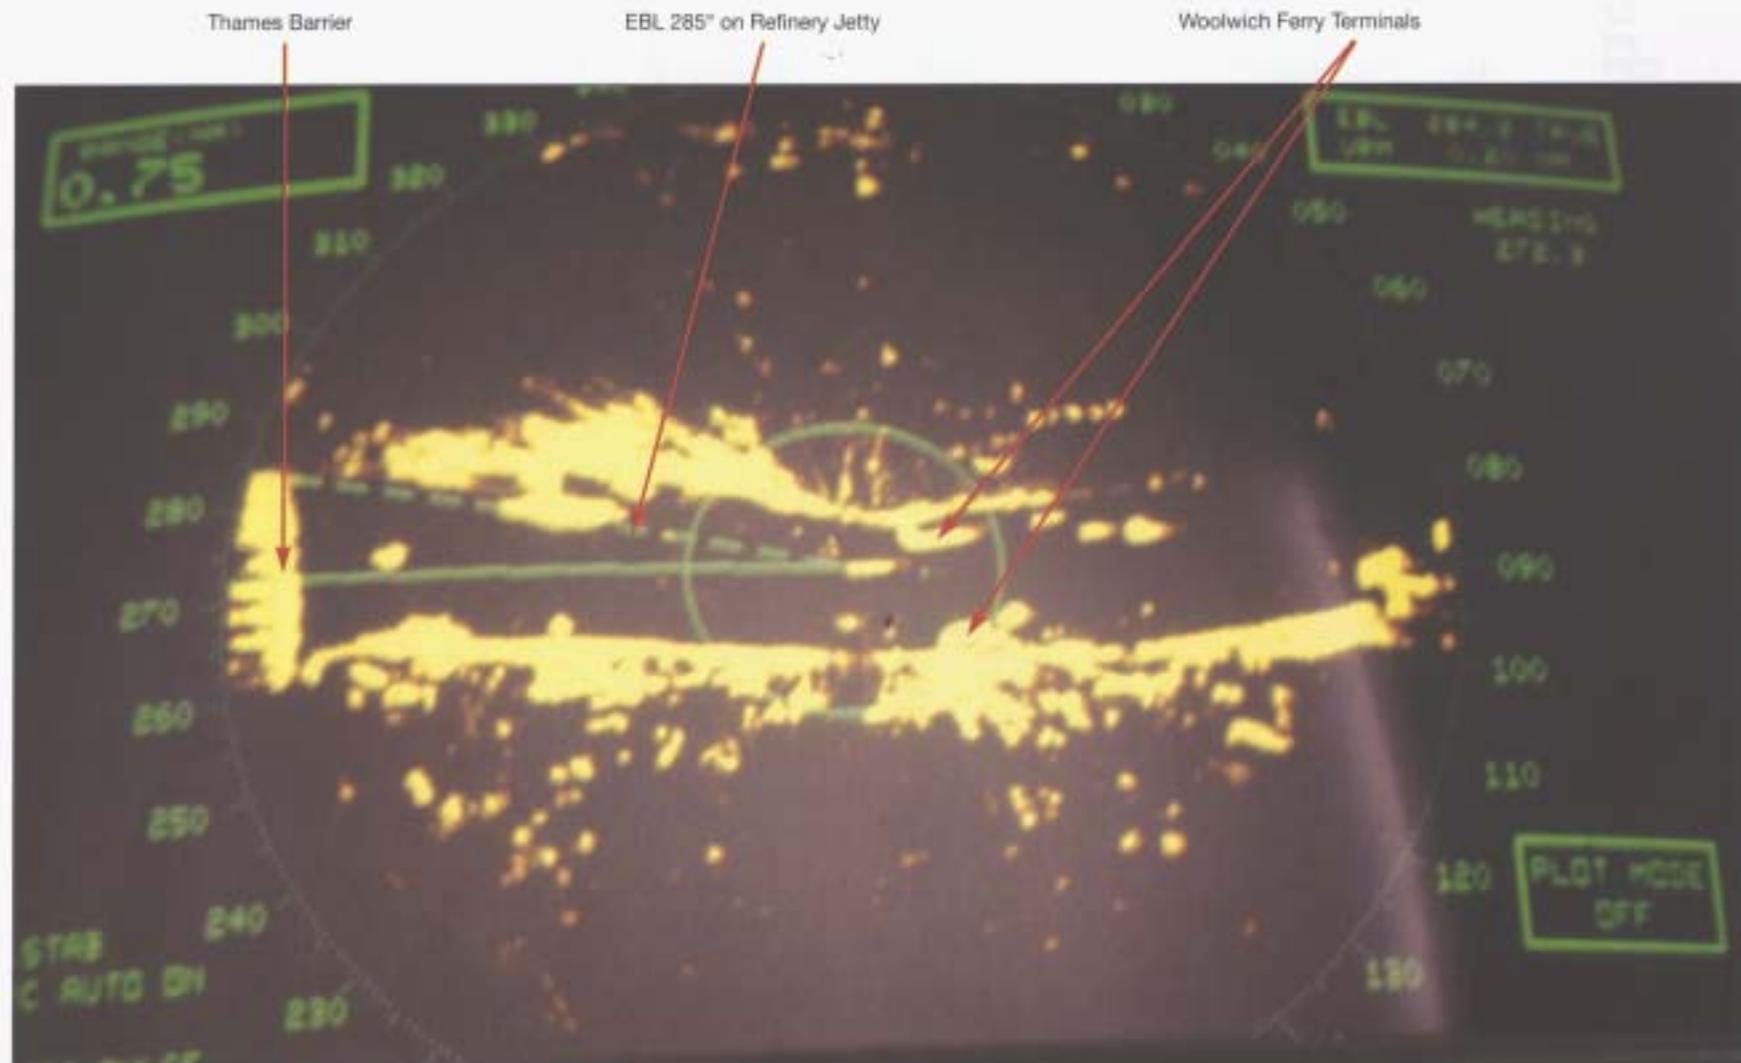
Figure 4: Radar – approach to barrier (N.B. readout shown is not from Sand Kite)

As she passed between the Woolwich Ferry terminals, both good radar targets, *Sand Kite* was in the centre of the channel. It was the master's intention to bring the vessel up to the "top third" of the river by the time she was off the refinery berths at North Woolwich and about 0.35 miles before the barrier, and then steer 265° through the barrier's Echo Span. He told the senior mate, who was still using hand steering, of his intentions. When *Sand Kite* was between the ferry terminals, the master set the radar's electronic bearing line (EBL) on the eastern end of the radar target that indicated the refinery jetty ahead. He read the bearing as 285° and ordered the mate to steer this (**Figure 4**).
