Report on the investigation of
contacts made by the
high speed craft

Norman Arrow

with quays in Portsmouth International Port,

**Report No 7/2011
May 2011**

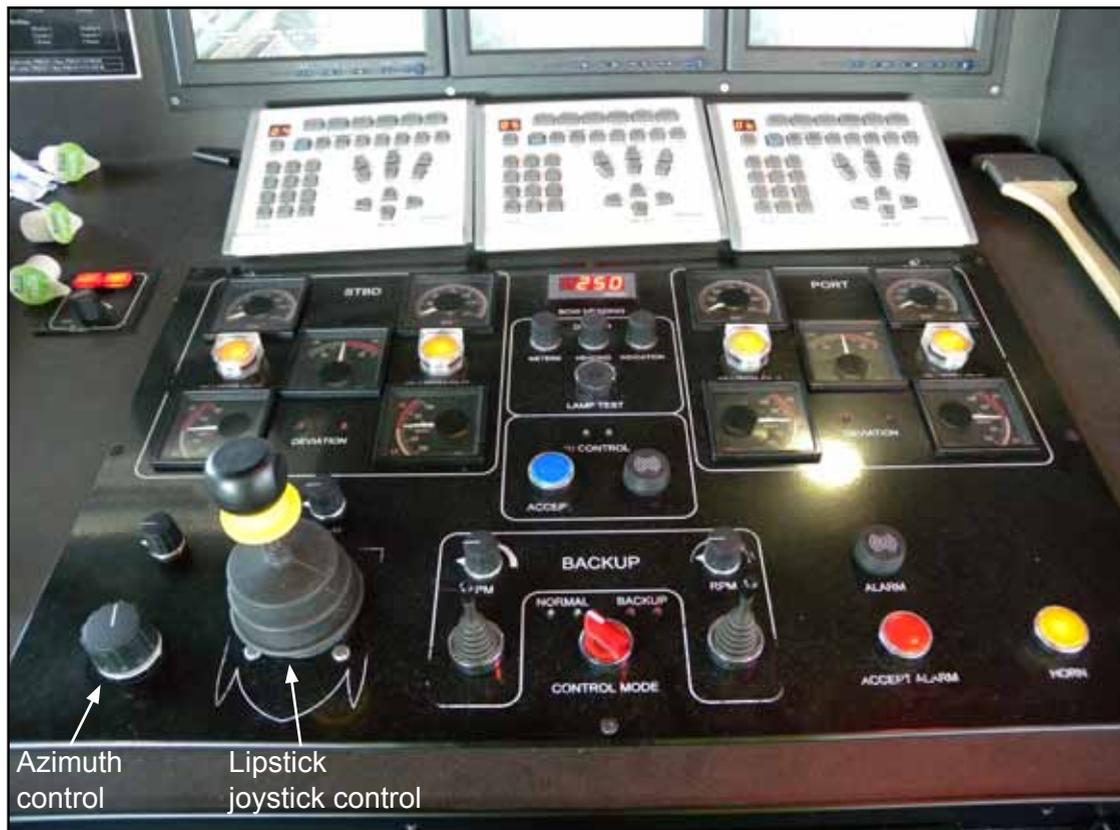
Figure 2

For the move, the master stood at the manoeuvring station (**Figure 2**), from where he was able to see the vessel's sides and stern via closed circuit television (CCTV) monitors. The chief officers and pilot stood close to the master, with the pilot standing on the outer edge of the group. The aft lines were let go at 1617, and 1 minute later the master ordered the forward lines to be cast off.

Manoeuvring station - *Norman Arrow*

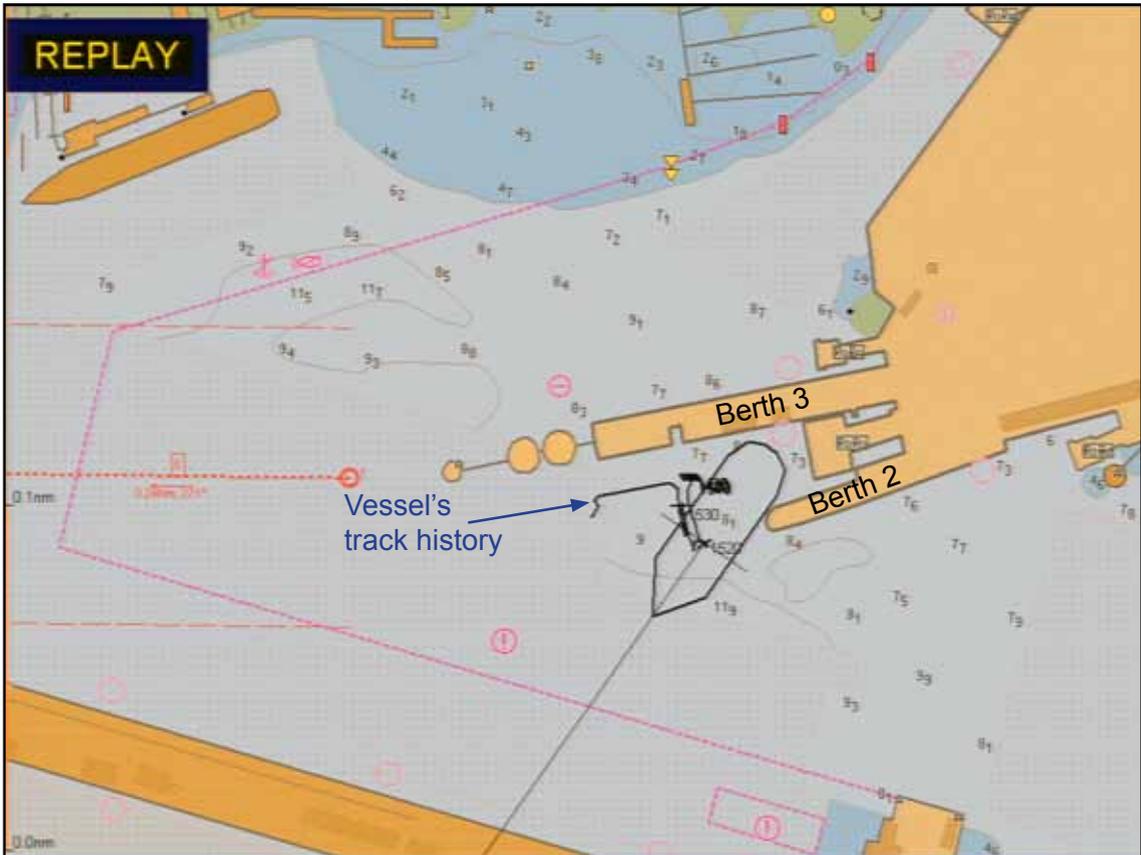
By 1632, the wind had decreased to 20 knots, and the master was able to manoeuvre the vessel off the finger jetty (**Figure 5**). He advised the pilot and chief officer that he intended to manoeuvre *Norman Arrow* into the tidal basin to await the tug. As the vessel moved ahead, her bow came very close to the fenders on caisson 1 and her starboard prow became wedged between the back plate of the first fender and the caisson wall. The fender was detached from the wall and lodged on the starboard prow (**Figure 6**).

Norman Arrow on finger jetty of berth 2, heading 217°

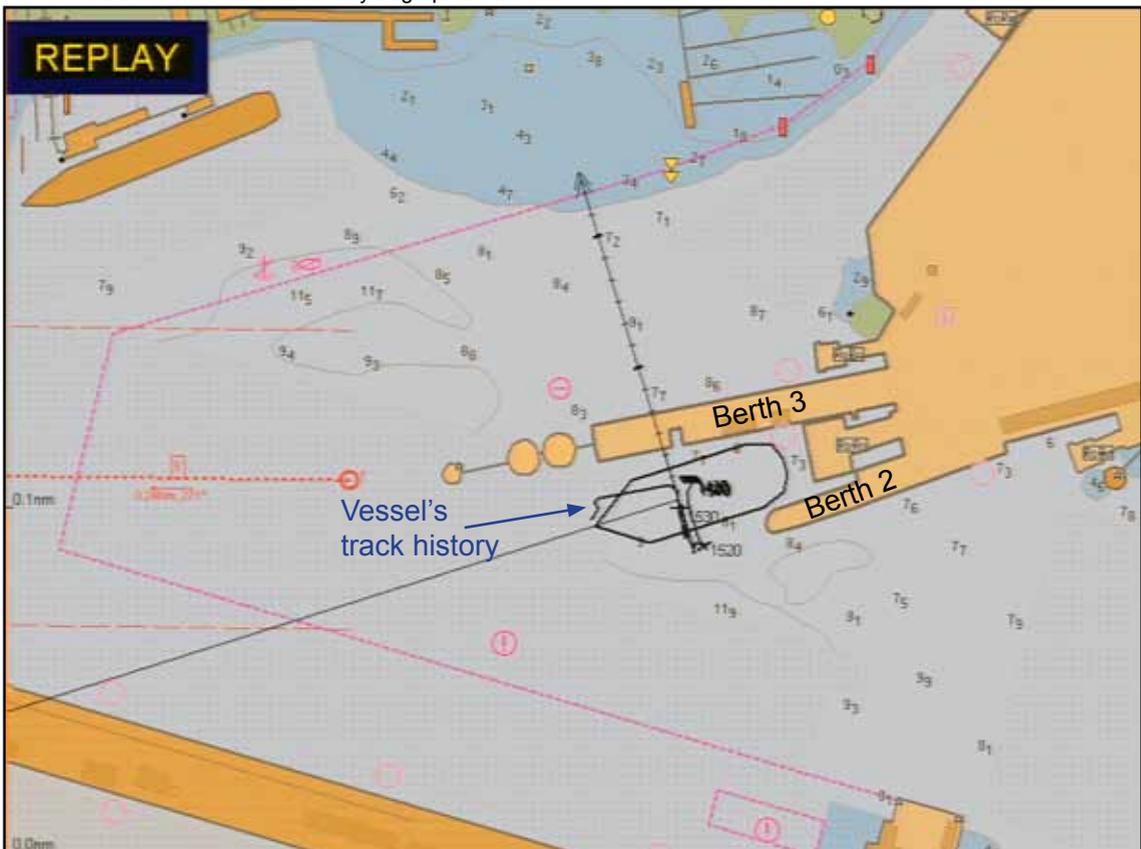
Norman Arrow manoeuvring back to berth 3

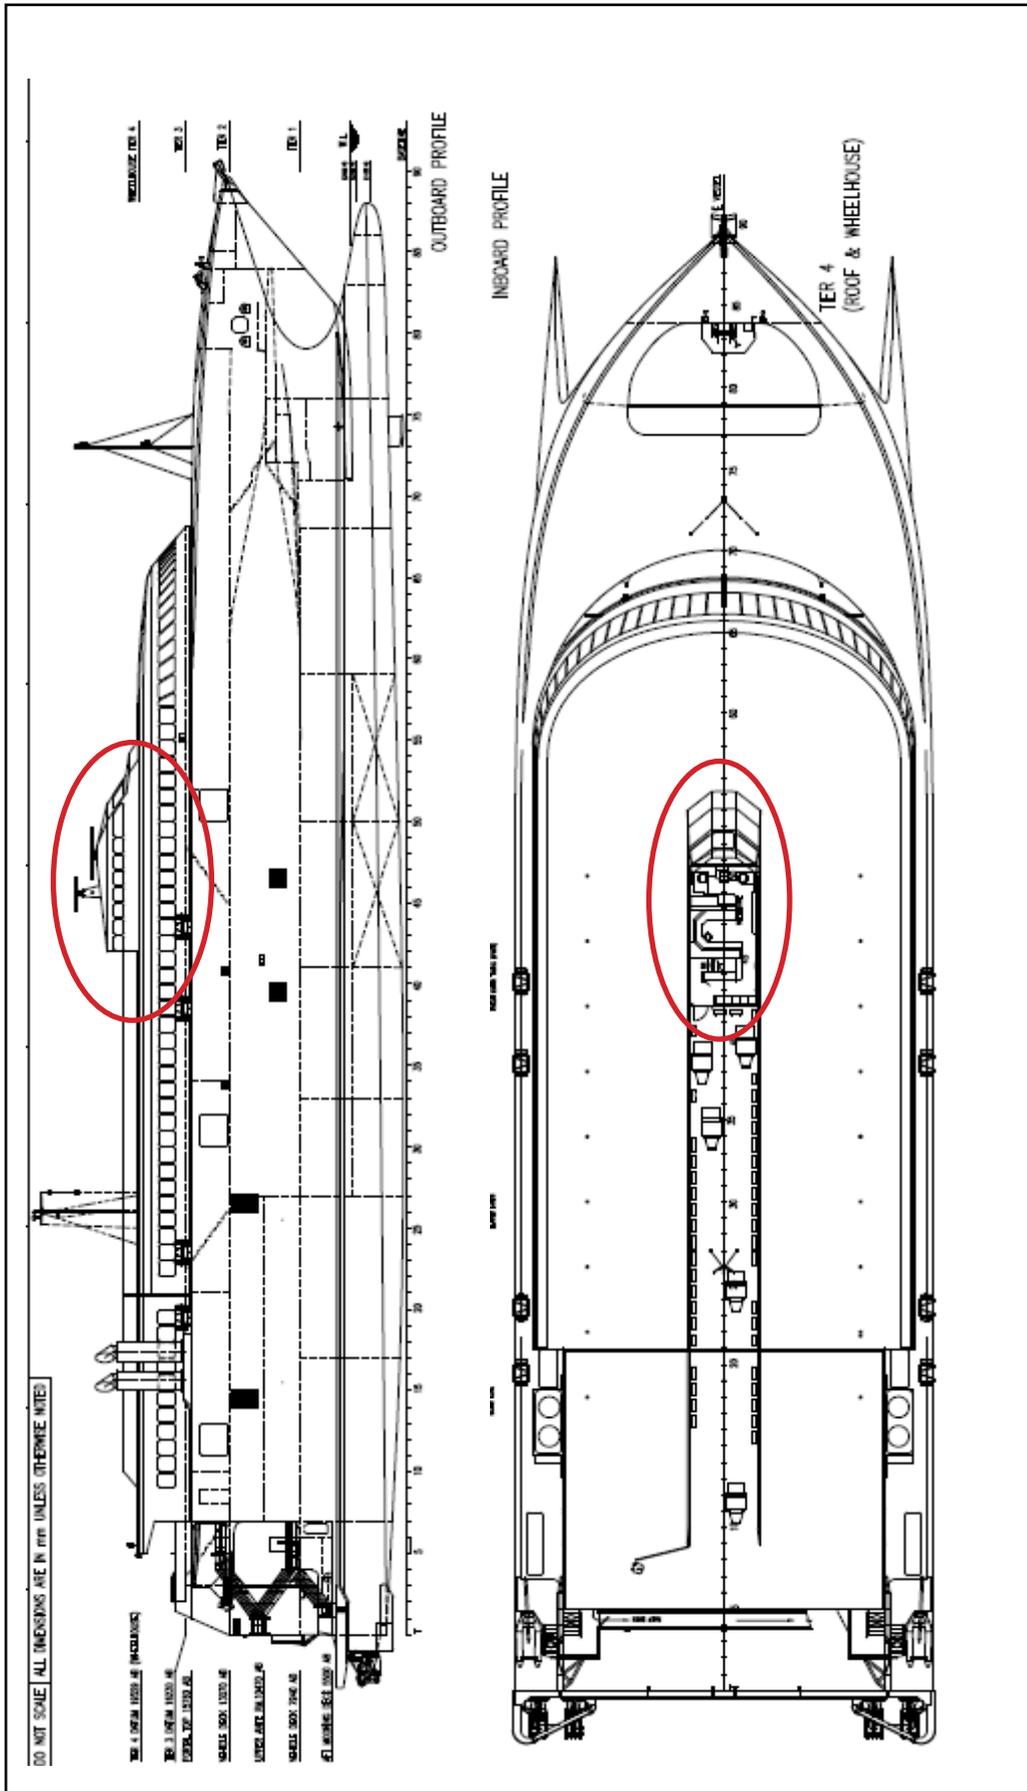
Figure 9

Norman Arrow's bridge was located on the centreline above the passenger accommodation (**Figure 9**). The bridge was fully enclosed and, unlike a conventional ferry, did not have bridge wings extending to the vessel's sides. From within the bridge, an all round 360° view was possible, but the view of the sea surface close to the vessel was obscured by her superstructure (**Figure 10**).

Bridge location

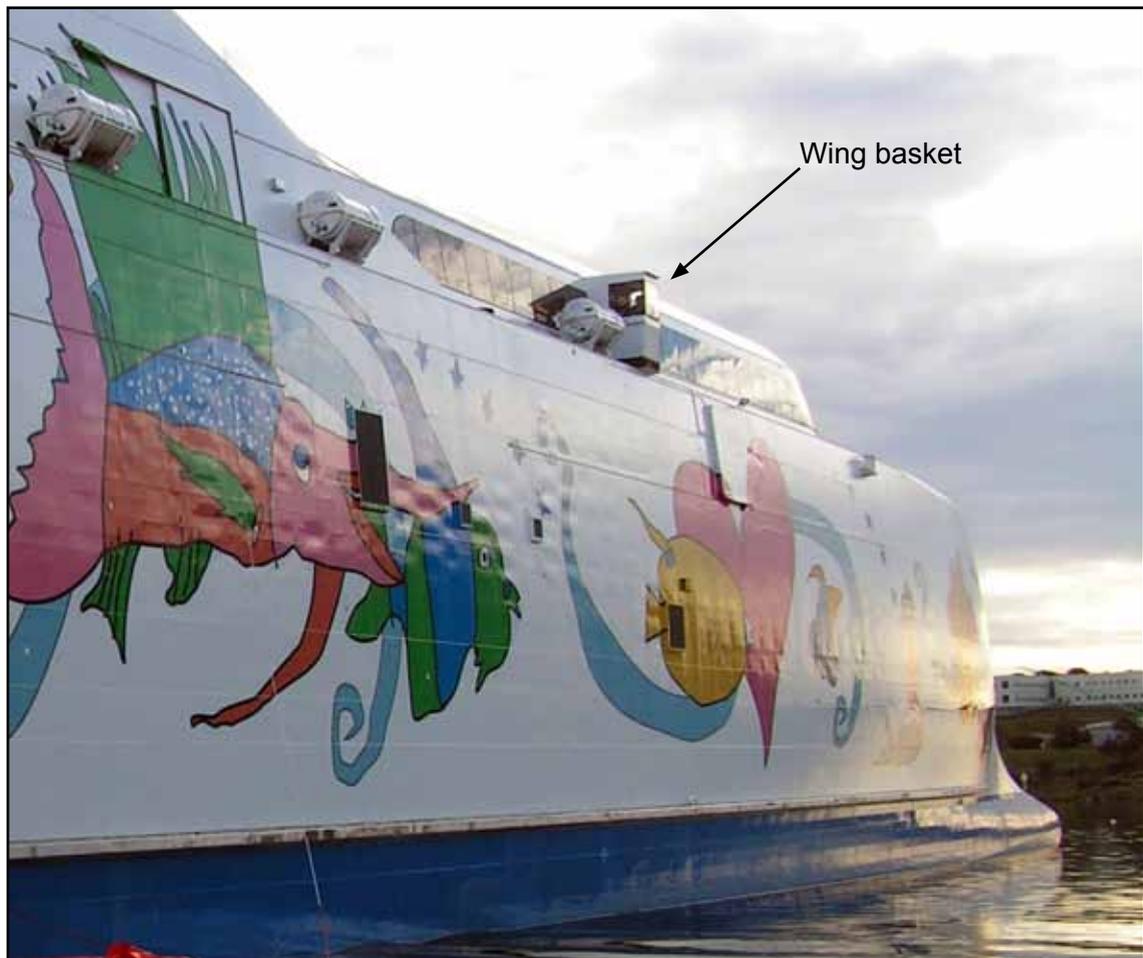
Figure 14

The control station arrangement for the previous two vessels of this class, *Natchan Rera* and *Natchan World*, included manoeuvring stations or wing baskets sited at the vessels’ sides (**Figure 14**). The side manoeuvring stations were also fitted with a talkback communications system that connected to the fore and aft mooring parties.

'Wing basket' fitted to sister vessels

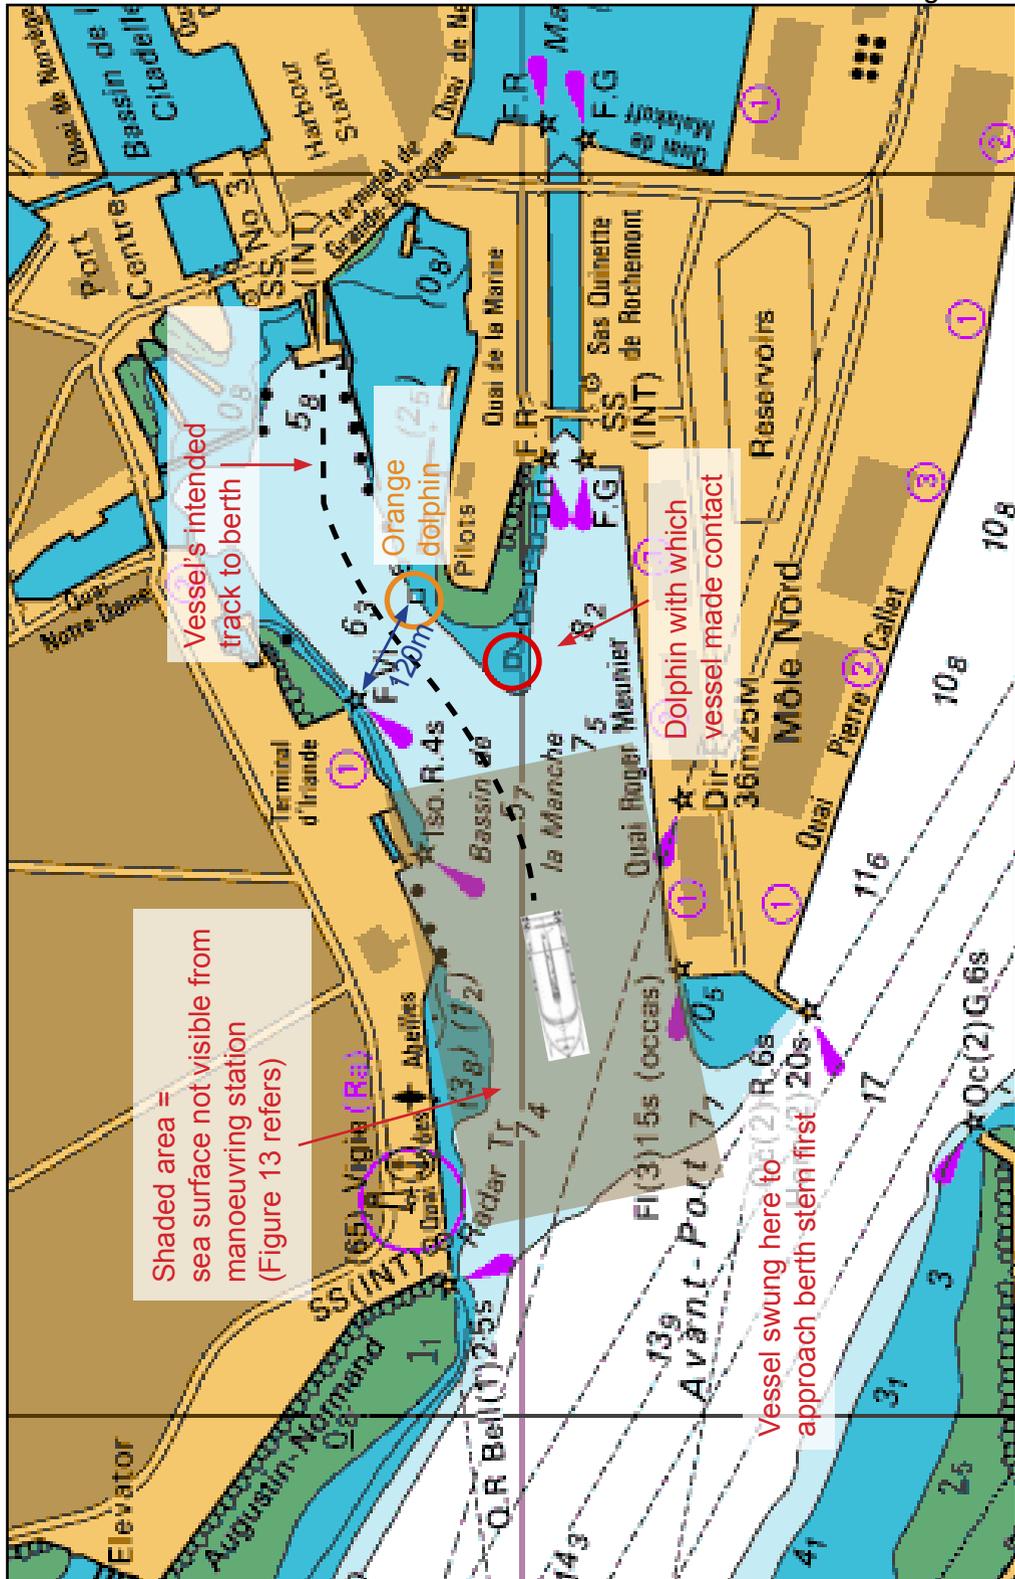
Figure 17

Le Havre port

The master moved to the manoeuvring station (**Figure 2**) and then commenced turning *Norman Arrow* to port. He was navigating the vessel by monitoring visual marks on the shore and by occasionally looking over his shoulder at the ECDIS and radar. By 1122, the vessel had turned through 180° and was moving stern-first towards her berth (**Figure 17**).

One minute later, when *Norman Arrow* was travelling at a speed of 3.2 knots astern, the bosun reported that the vessel's stern was about 100m from the first orange dolphin (**Figure 17**). Two minutes later, the bosun reported that the vessel was about 8m from the orange dolphin (**Figure 18**). The chief officer advised the master that the vessel was being set down onto the dolphin by the wind. The master stopped the astern thrust and gave a short thrust ahead. He then announced that he would vector the jets (**Figure 15**) to move the vessel bodily to starboard.

From *Norman Arrow*'s bridge, the masters were able to see the waterline approximately 86m forward of the bow, 93m abeam, and 184m astern (**Figure 10**). Therefore, although this field of vision complied with the requirements of the HSC Code, the masters were constrained in their ability to see key events and obstructions close to the vessel. When shifting berths in PIP, the master could not see: the difficulties experienced by the shore linesmen when letting go the forward lines; the finger jetty which was less than 5m off the port side; the caissons; or the vessel's starboard prow. Likewise, in Le Havre the master could not see the dolphins, the northerly of which he intended to pass at a distance of about 25m (**Figure 17**).
