Report on the investigations of
heavy weather damage
on board the container ship
Maersk Newport
50 miles west of Guernsey
on 10 November 2008
and fire
alongside at the container berth in Algeciras, Spain
on 15 November 2008

Report No 13/2009
June 2009

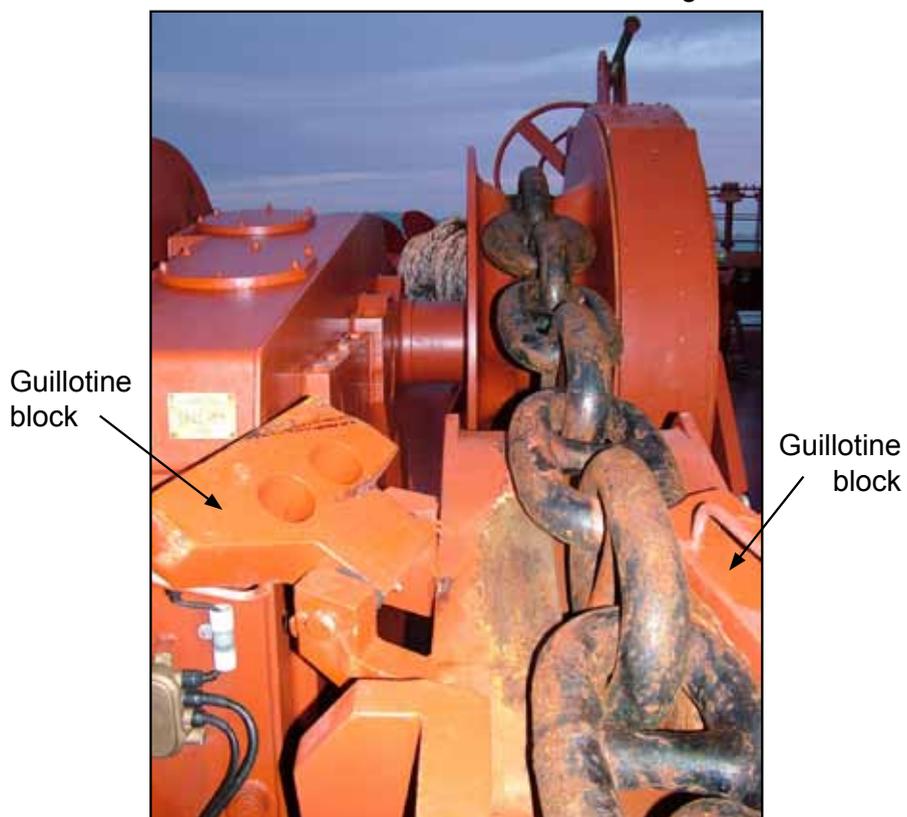
Figure 8

The forecastle team found that about $\frac{1}{2}$ to $\frac{3}{4}$ shackle of the port anchor cable had been released. The lashing chain Senhouse slip tapered securing pin had become detached from the slip and was hanging by its chain (**Figure 7**) and that the lashing chain was hanging loose. It was also found that the forward guillotine block was in the upright open position while the after guillotine block was in the horizontal closed position – **Figure 8**. Before the anchor cable was recovered, the chief officer checked the winch brake and managed to apply one full turn of the brake handwheel. After the port anchor was fully secured, checks were made to confirm that the starboard anchor was also fully secured.

Position of the port anchor guillotine blocks

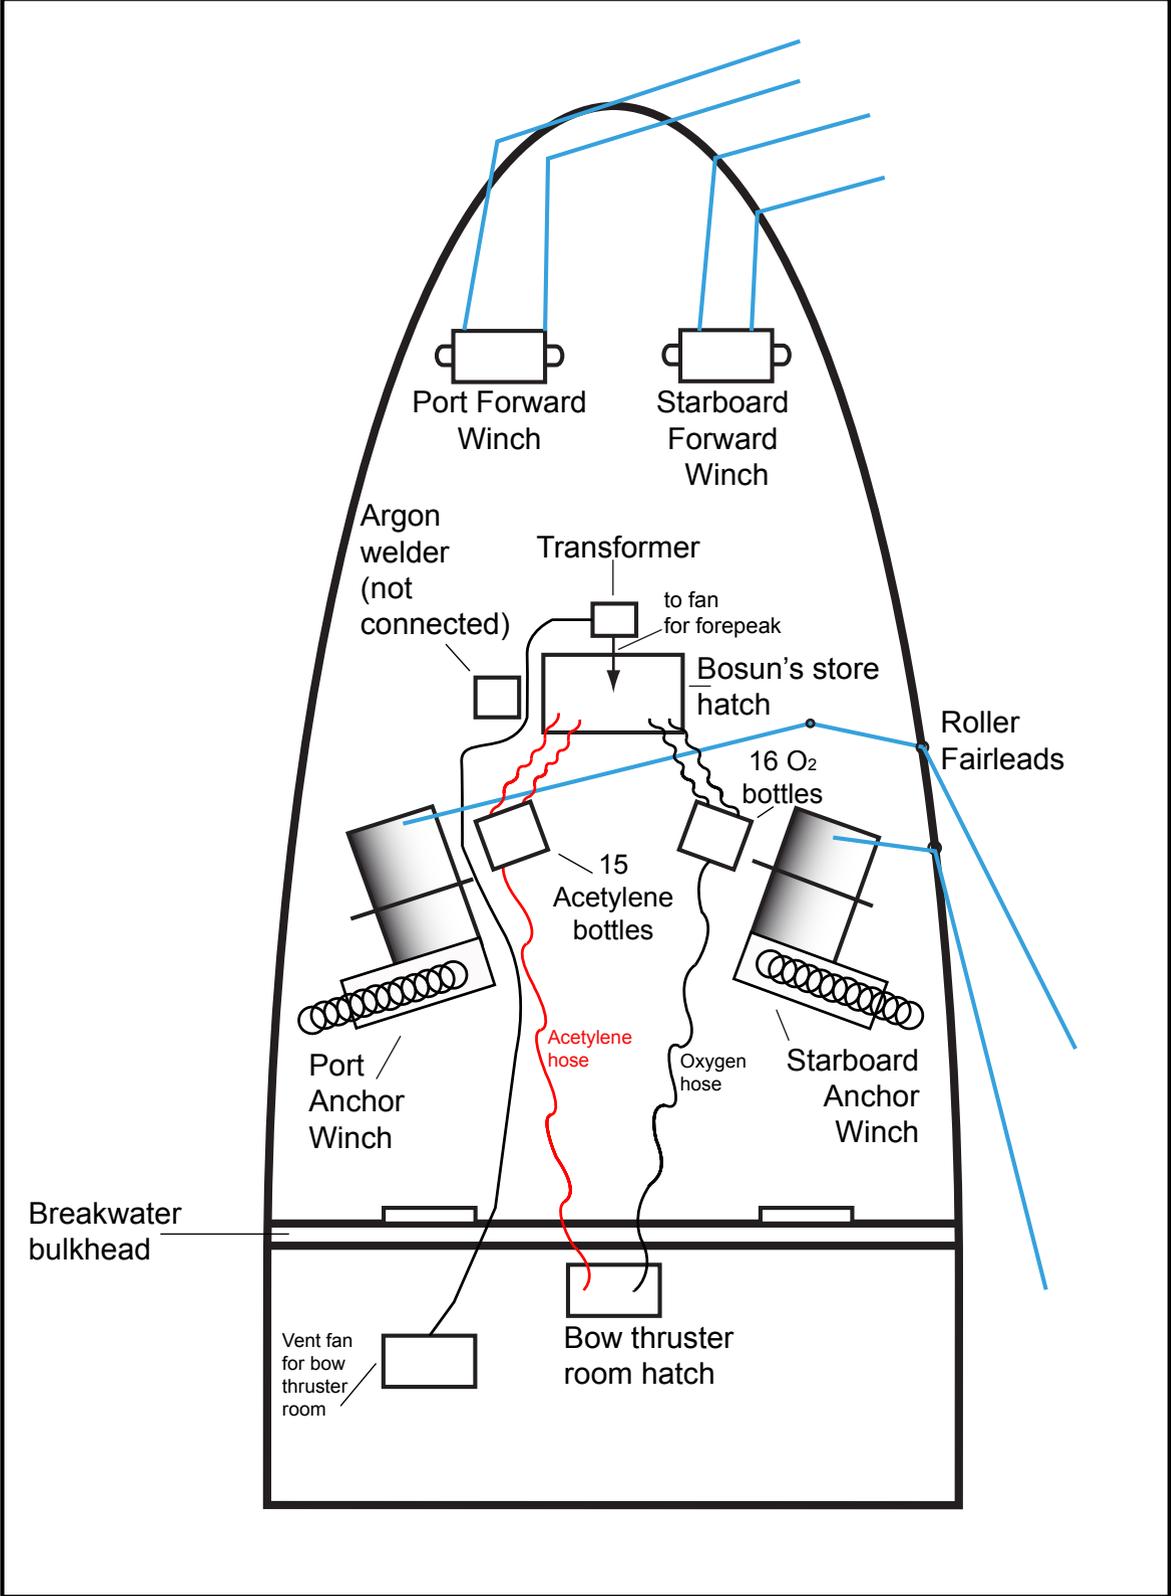
At about 0055 the burning stopped in both the forepeak and the bow thruster room. The blowtorch gas valves were shut, but the gas bottle valves were left open as the contractors started to grind off the rough, burnt edges of hull plating.

Diagrammatic layout of the contractor's equipment and forward mooring arrangements

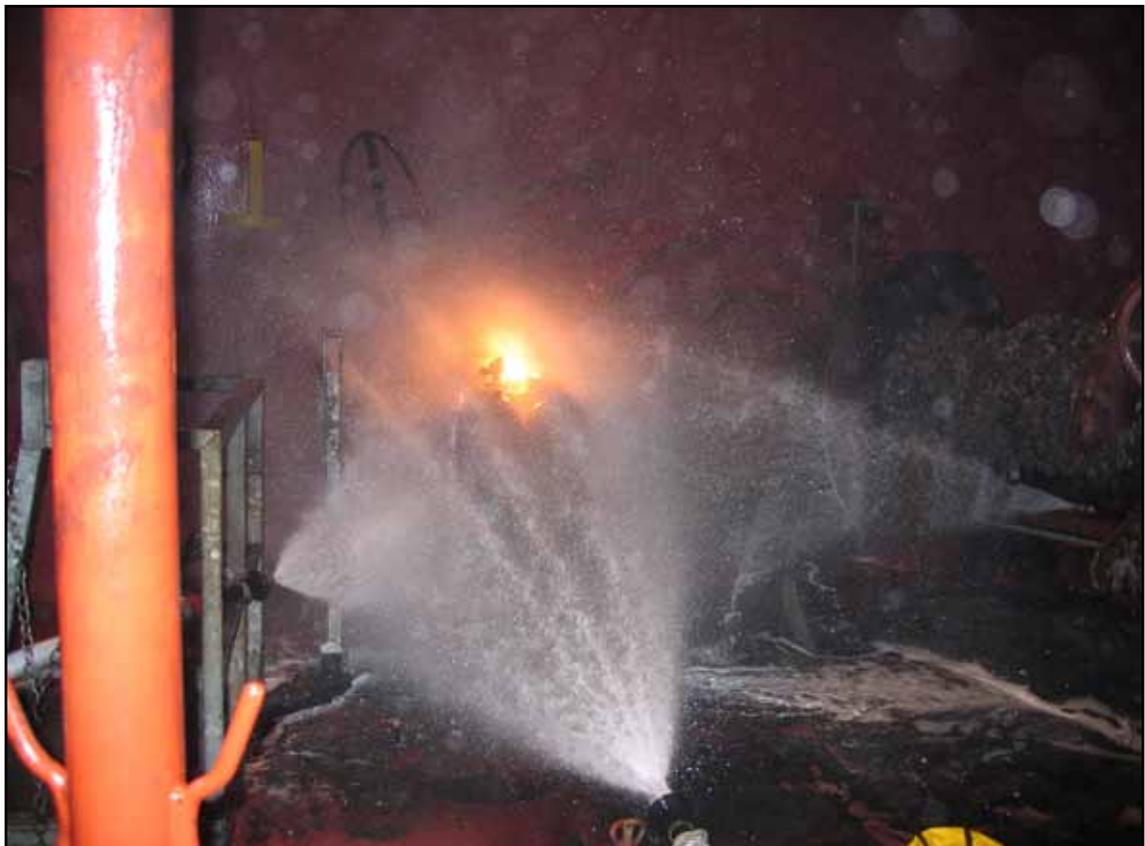
Figure 15

At 0252 the Head of Inspection and Survey recommended that the accessible acetylene bottles be dropped into the harbour to rapidly cool them down in view of the particular dangers associated with heated acetylene bottles. This was rejected by the OIC on pollution grounds. It was then decided to secure the fire-fighting hoses and direct the nozzles on to the acetylene and oxygen bottles and vacate the vicinity of the forecastle (**Figure 15**).

Hoses rigged to cool down the acetylene and oxygen bottles

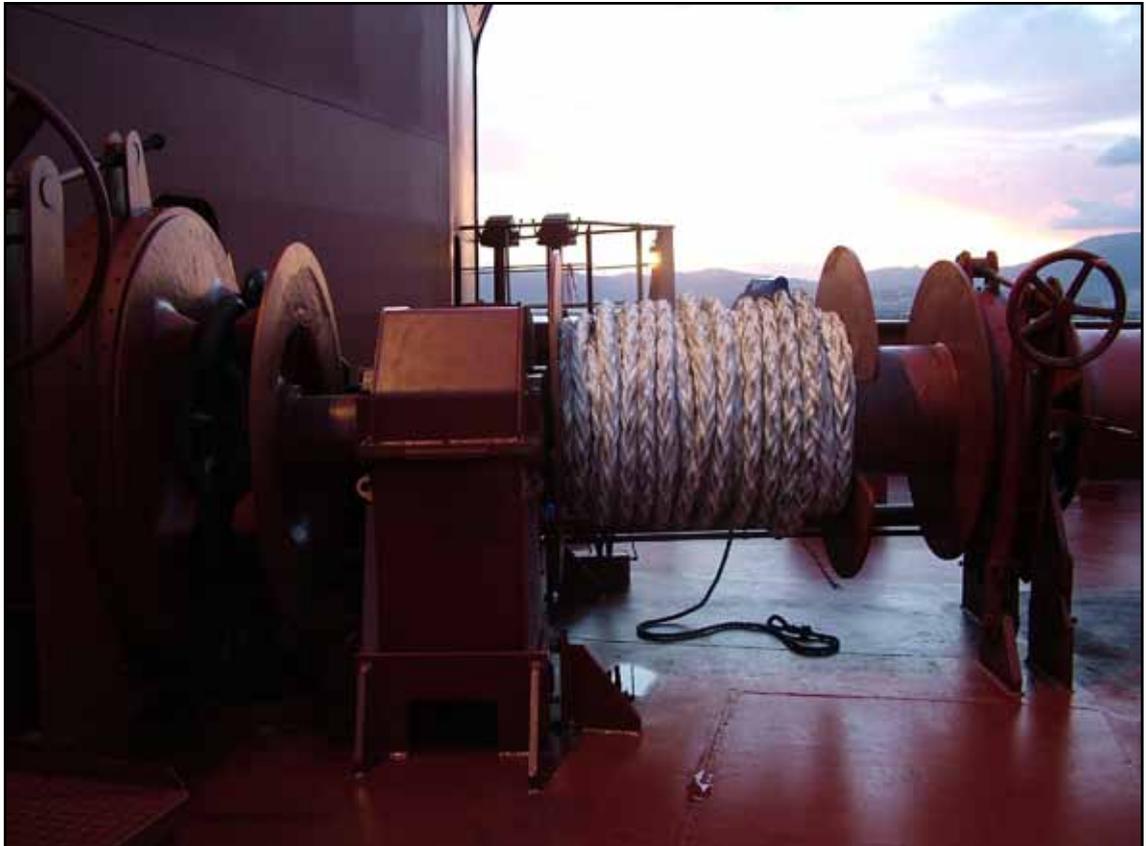
Figure 22

Maersk Newport was fitted with two, type 2 AMW 120/76 K3 R, twin drum windlass winches on the forecastle (**Figure 22**). The winches were designed and manufactured in 2008 by KGW Marine GmbH based in Schwerin in Germany.

General view of the port windlass winch

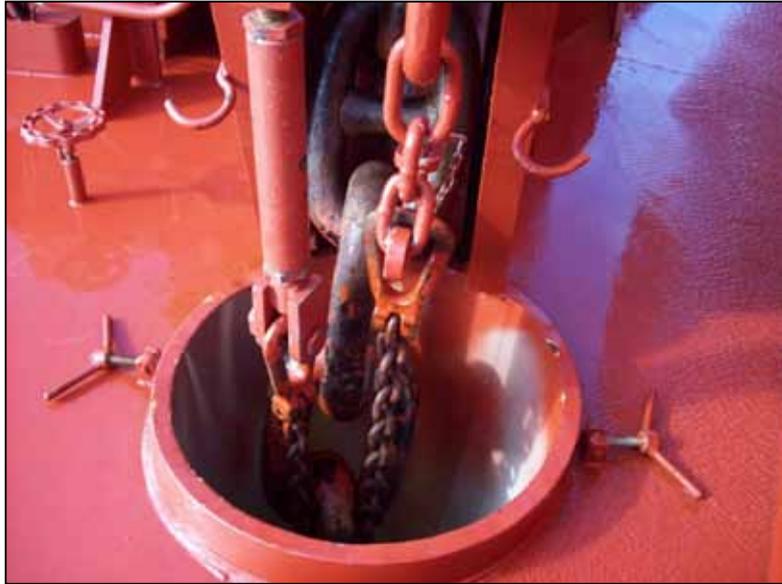
Figure 23

The lashing was passed through the anchor chain and was secured to a quick release Senhouse slip. The moveable part of the slip link was secured by an 83mm long, slightly tapered pin which passed through the tongue of the slip (**Figures 23 and 24**). The chain lashing was then tensioned by a bottle screw adjuster.

Chain lashing arrangement

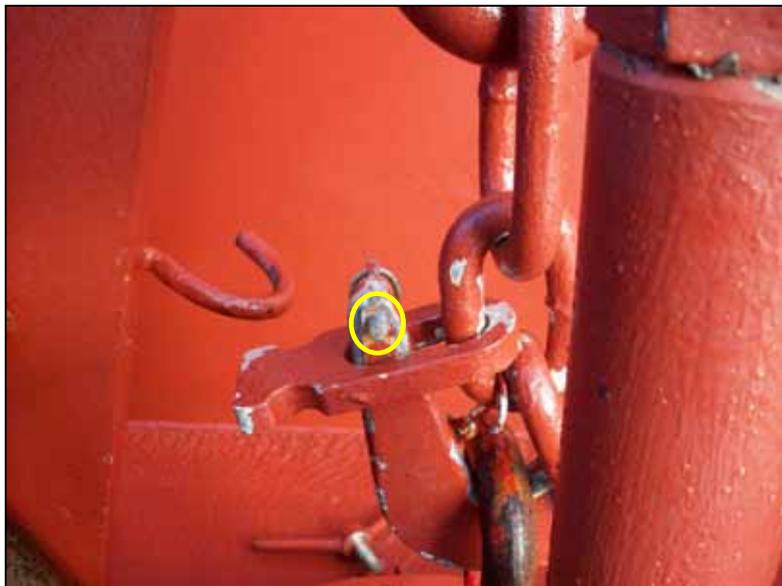
Figure 24

Chain lashing Senhouse slip tapered securing pin

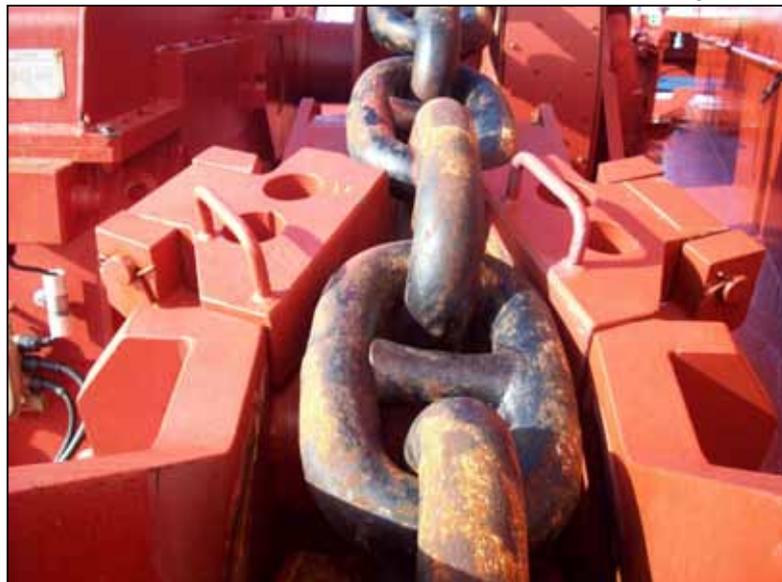
Figure 25

Both windlass winches were fitted with two heavy guillotine blocks (**Figure 25**) which could be lowered to the horizontal closed position when the anchor cable was fully secured. The purpose of the blocks was to take the load of the anchor cable when the ship was at anchor by allowing the face of one of the horizontal anchor chain links to rest against the face of the guillotine blocks.

Guillotine block arrangement

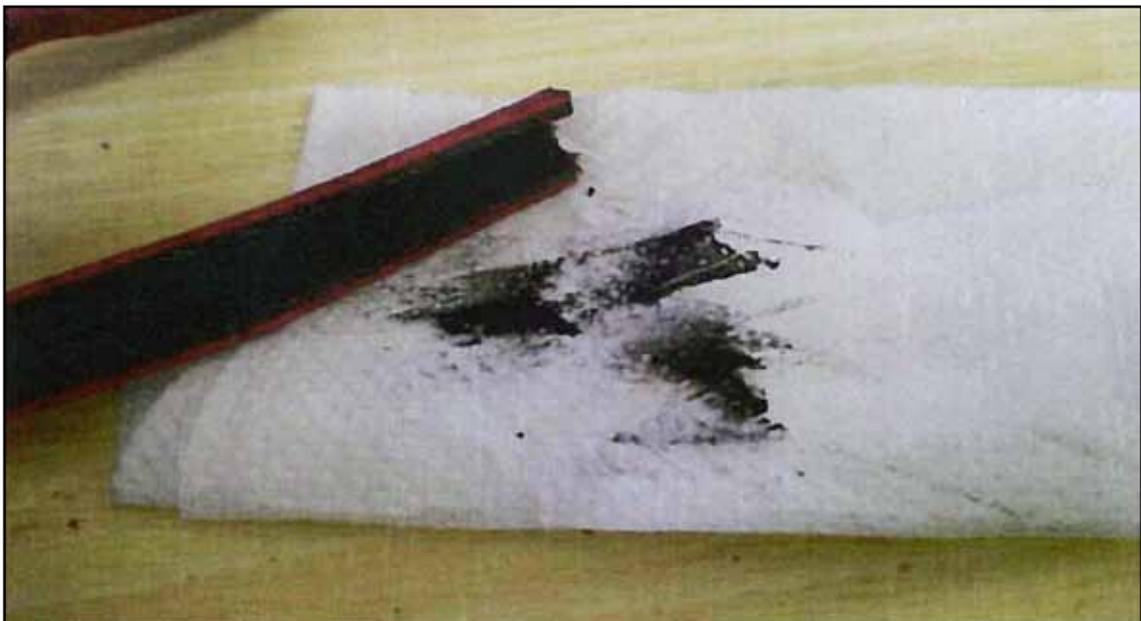
Figure 27

The flame front which precedes the flame can exceed the pressure test of the acetylene hose and cause it to fail, with the result that the flame will become exposed. A flashback is typically evidenced by carbon deposits on the inside of the hose walls – **Figure 27**.

Carbon deposits on the inside of an acetylene hose -
typical indications of a flashback
