Rail Accident Investigation Branch

# Rail Accident Report

## Uncontrolled evacuation of a London Underground train at Holland Park station 25 August 2013

Report 16/2014  
July 2014

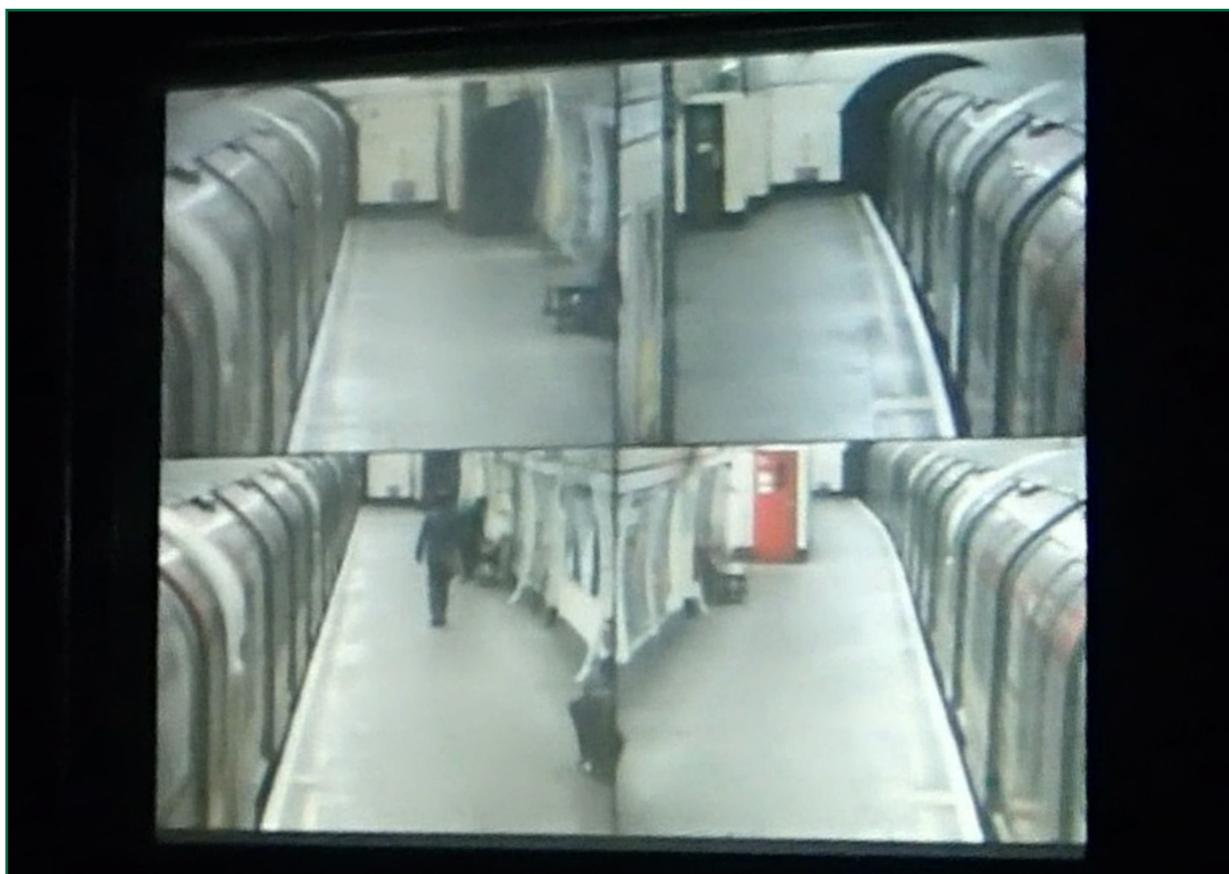
Figure 6: An example of CCTV images of the platform-train interface displayed in the cab of a Central Line train at Holland Park station

- 77 The train operator stated that once the train had been brought to rest by the passenger emergency alarm activation, he acknowledged the emergency alarm and selected the talkback facility (figure 6). Talkback is a two-way communication system connecting the train operator with the car in which a passenger emergency alarm has been activated. When the train operator presses the talkback button in the cab all loudspeakers and microphones in the car concerned are switched on so the train operator can be heard throughout the car and anyone in the car can respond. Talkback communications are not recorded and there is no record of which car is contacted.

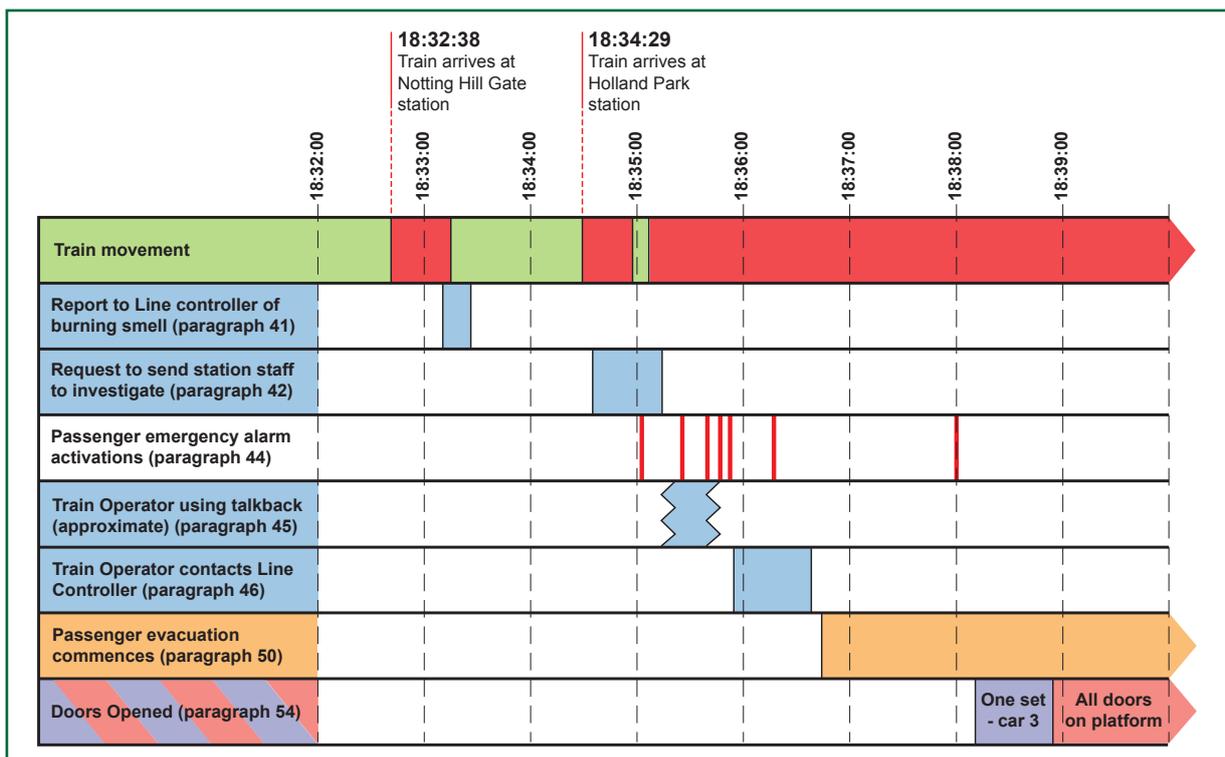
Figure 8: Timeline of key events

- 41 Just over 20 minutes later, when the train was at Notting Hill Gate station (the station before Holland Park), platform staff reported to the station controller that there was a burning smell coming from the train. There is a voice recording of the station controller passing on this report to line controller 2 as train 003 departed for Holland Park station. Figure 8 shows the timeline of the incident from this point onwards.

- 44 Around 18:35 hrs, train 003 moved off from the platform at Holland Park station but within seconds was brought to a stand by the activation of a passenger emergency alarm (figure 6) in car 5. The train had travelled about five metres, putting the leading car partly in the running tunnel. Twenty-two seconds later a passenger emergency alarm activation was made in car 7, followed at short intervals by activations from cars 3, 6, and 4. Over a period of almost three minutes there were seven passenger emergency alarm activations in total (figures 5 and 8). The train doors remained locked.
